Metallurgical Analysis of Failed Valve

Southwest Research Institute®

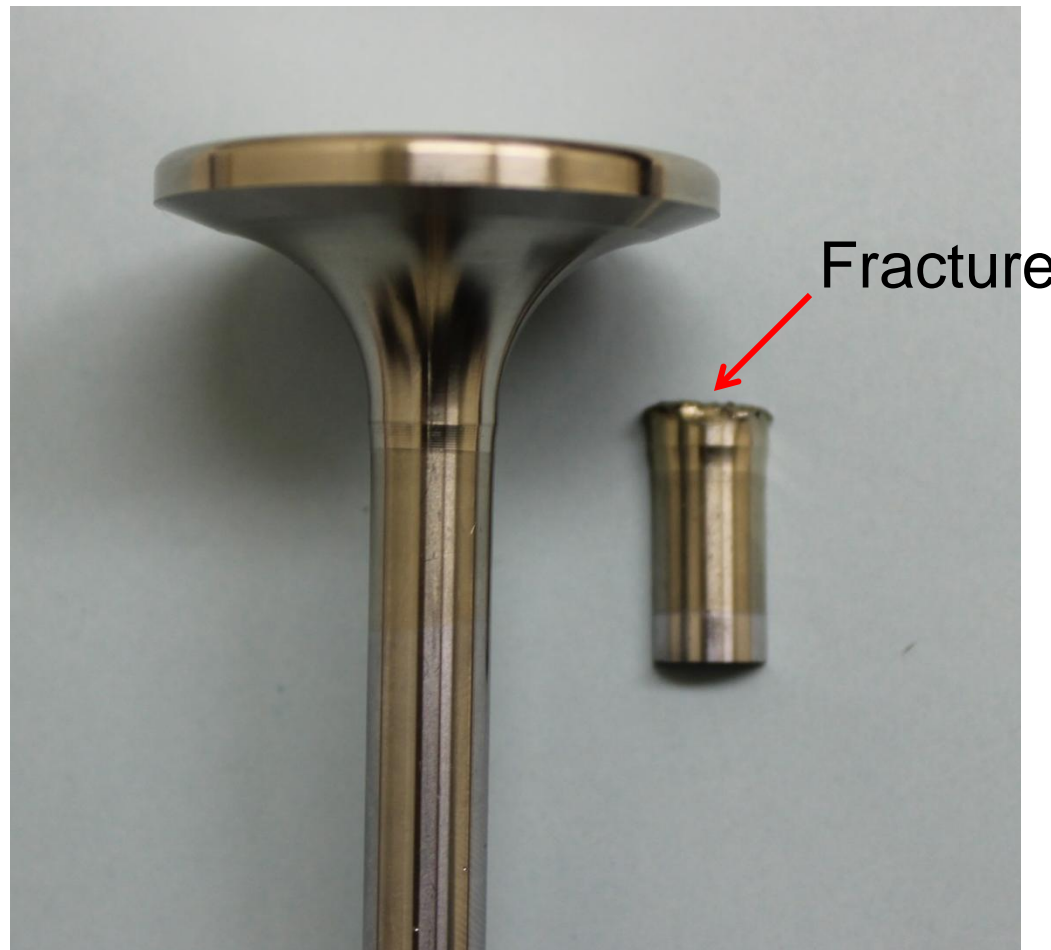
Fracture Location

Fracture separated the valve from the stem approximately 0.16" above the transition

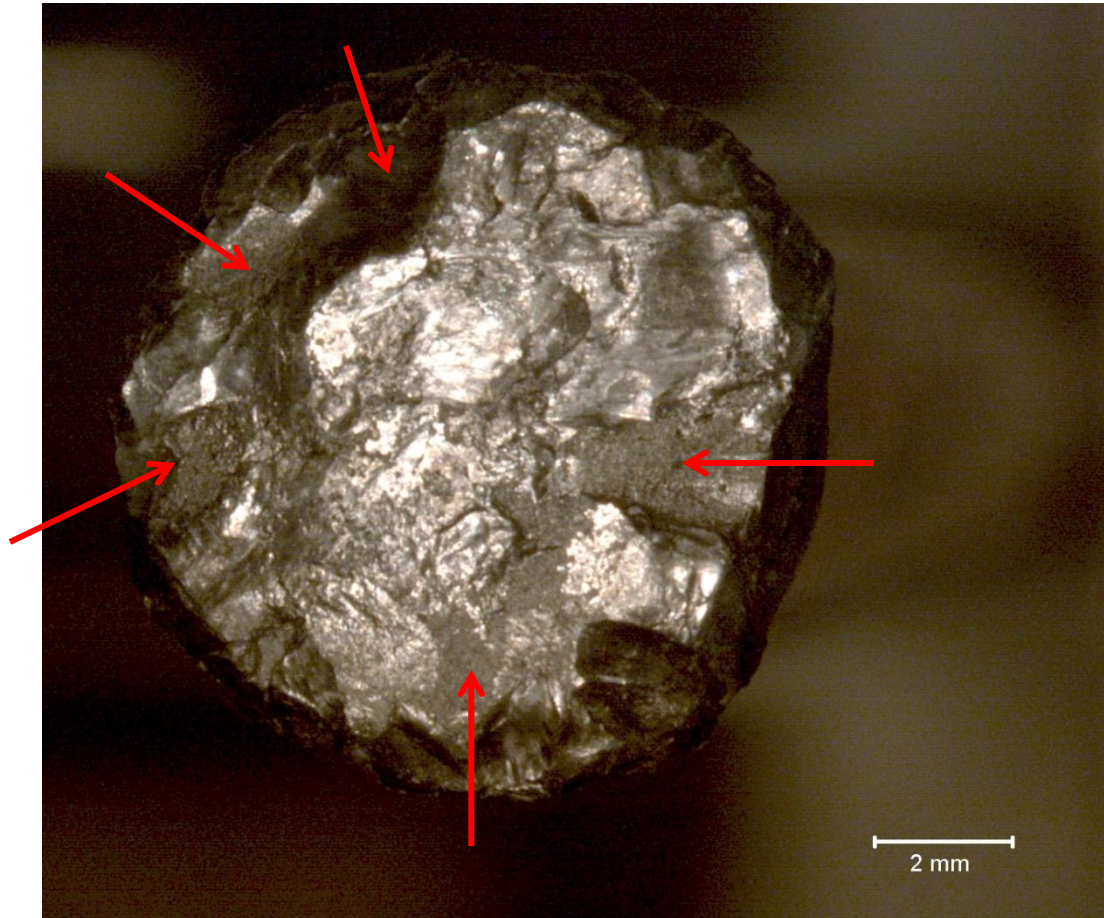
Valve Stem Fracture Surface

- Most of the fracture surface features had been destroyed by repeated contact following fracture
- Some recessed regions avoided this contact damage

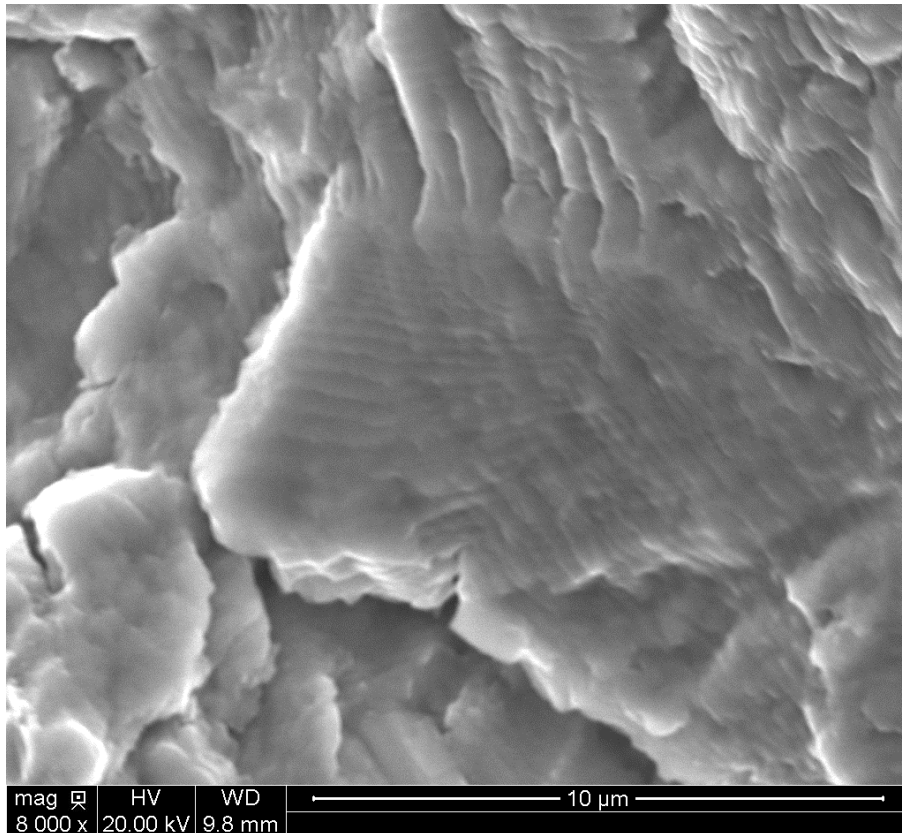
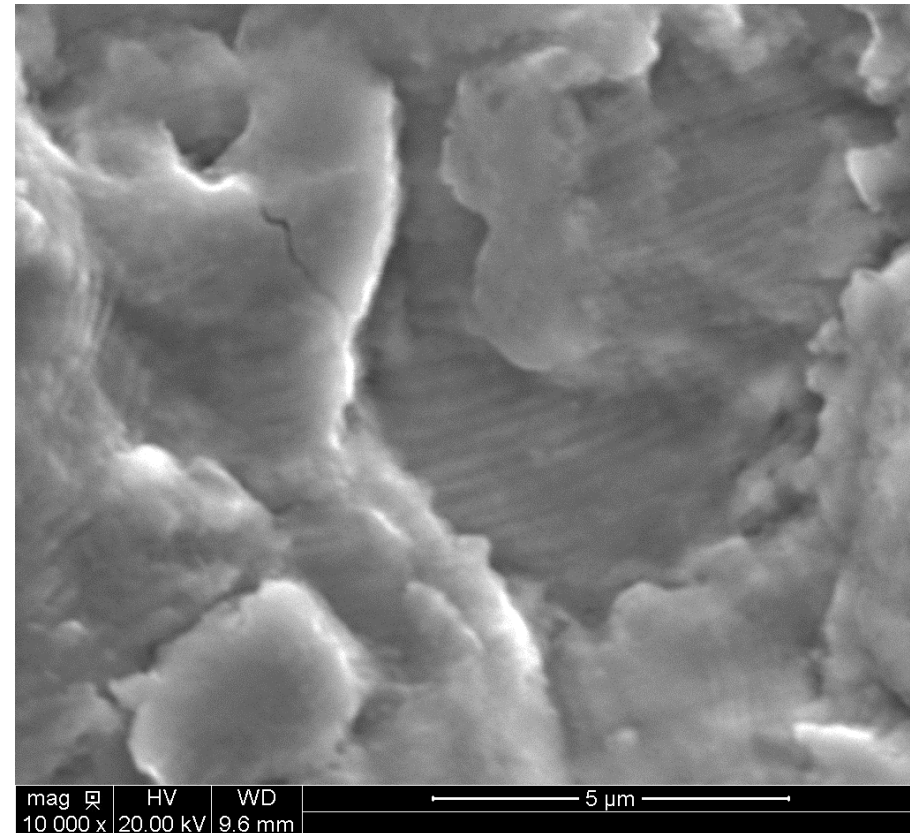
SEM Fractography

Fatigue striations were present on areas of the fracture that had not been affected by repeated contact following fracture

- Extensive post fracture contact damage made it impossible to identify crack growth directions and the crack initiation site(s)
- Therefore, it was not possible to determine if material or geometric defects contributed to crack initiation
- The fracture morphology that was present in the areas that did not experience post fracture damage (fatigue striations) indicated that failure was by high cycle fatigue

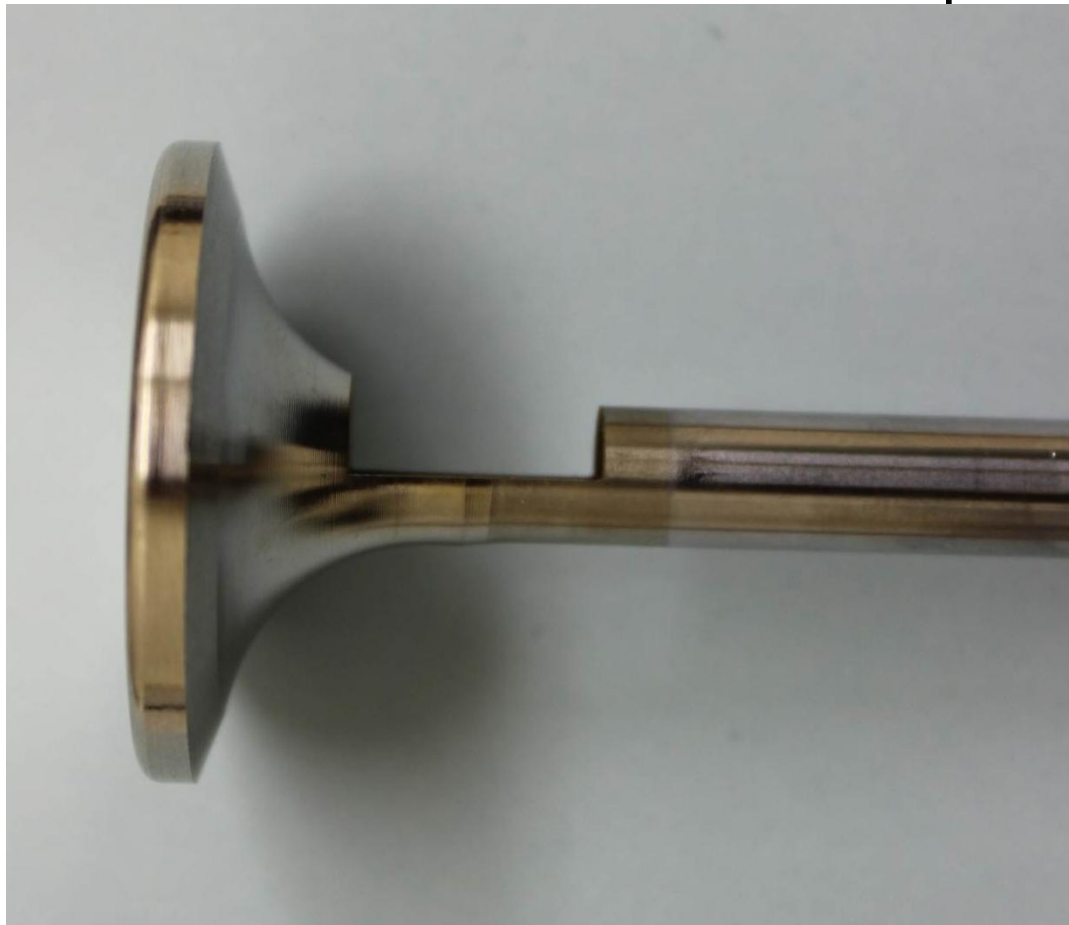
Metallography

Metallographic sections were prepared from the fractured valve and from unused valves from the same batch as the fractured valve and from a batch that has not experienced any failures

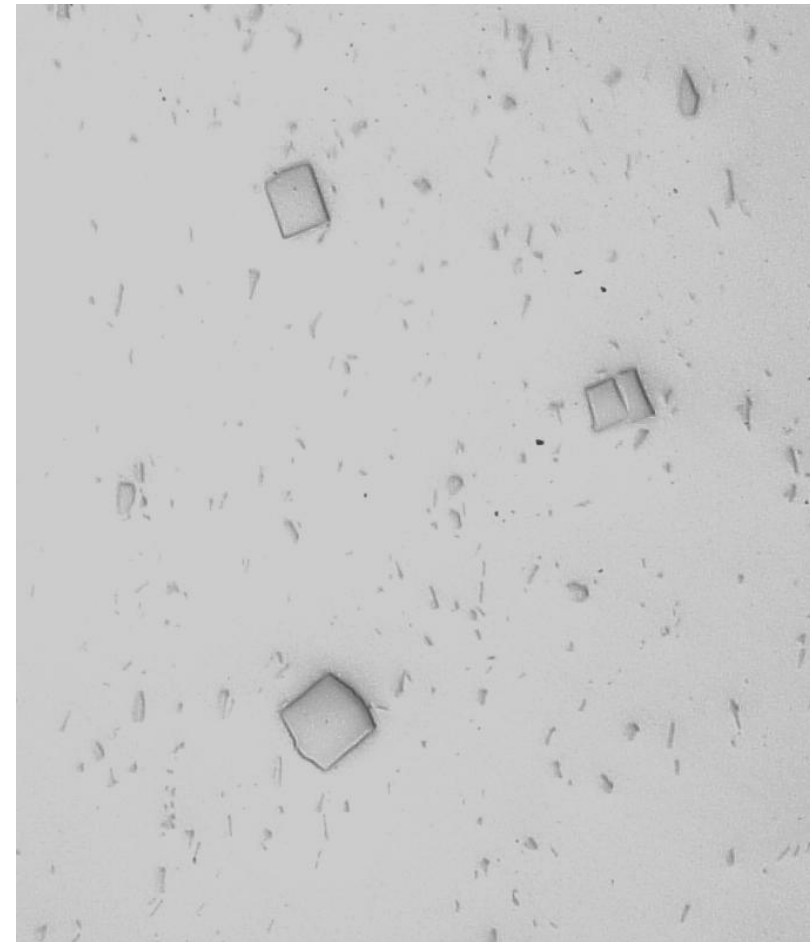
Fractured
Valve

Metallography – Large Carbides

- Large Niobium carbides are present in both the fractured valve stem and in the intact stem from the same batch but not in the intact stem from the good batch
- Many of these carbides are located along, or near, the OD surface.
- A difference in the amount of recrystallization along the OD edge is also present
- These microstructural differences suggest a difference in the processing between the valve batches

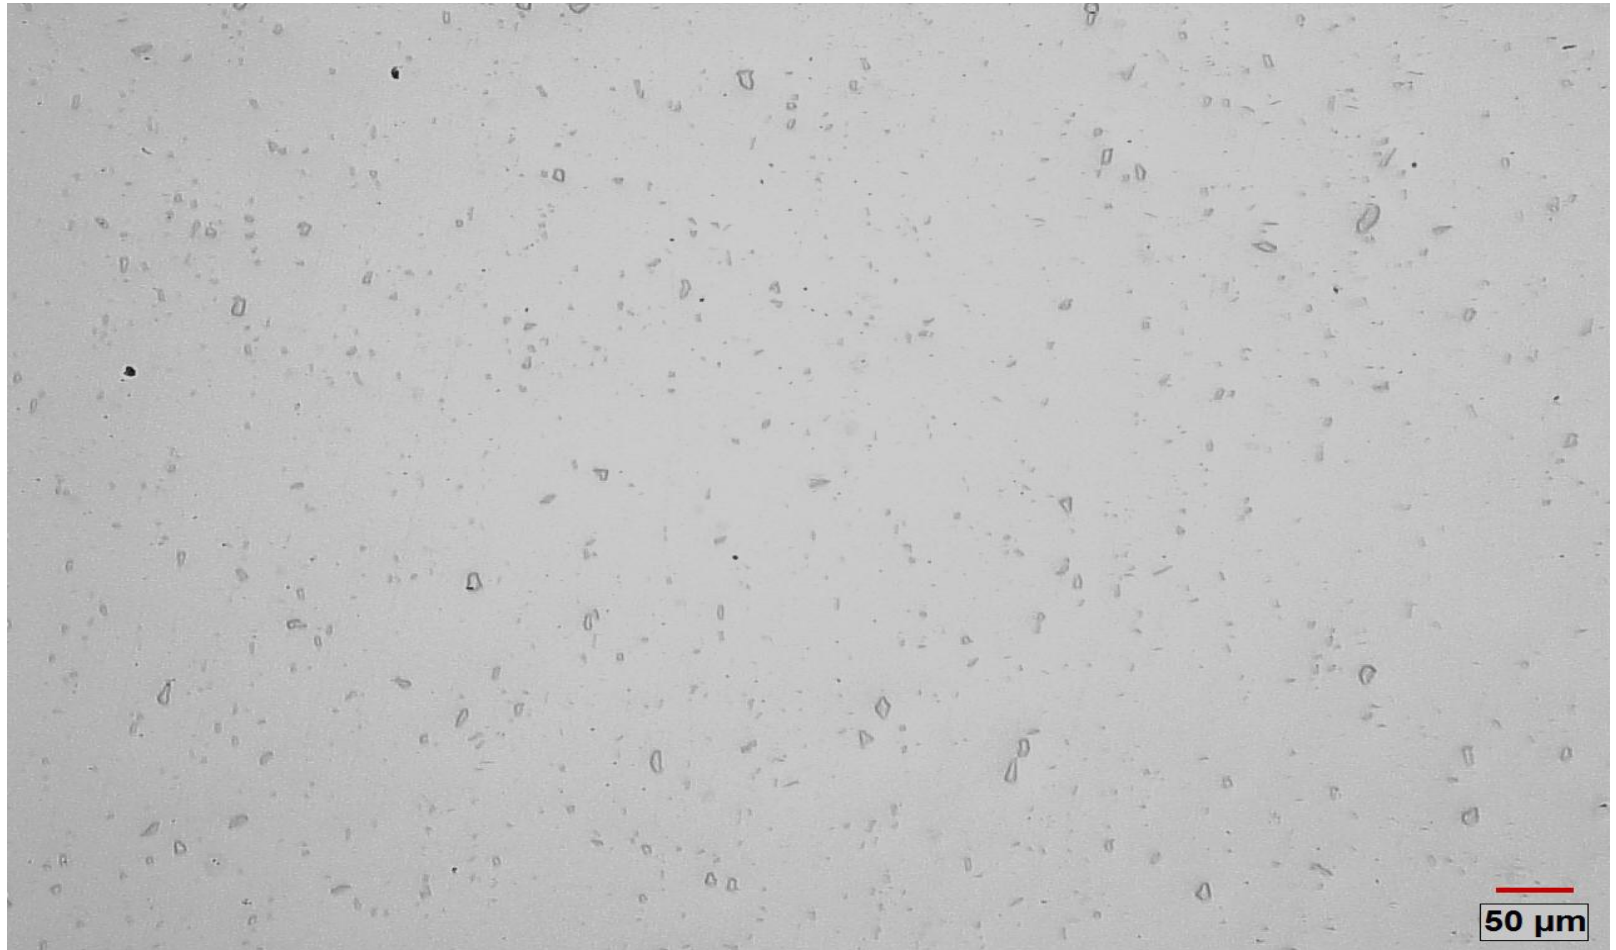
Metallography – Large Carbides Absent

Blocky carbides were absent on the section from the good batch

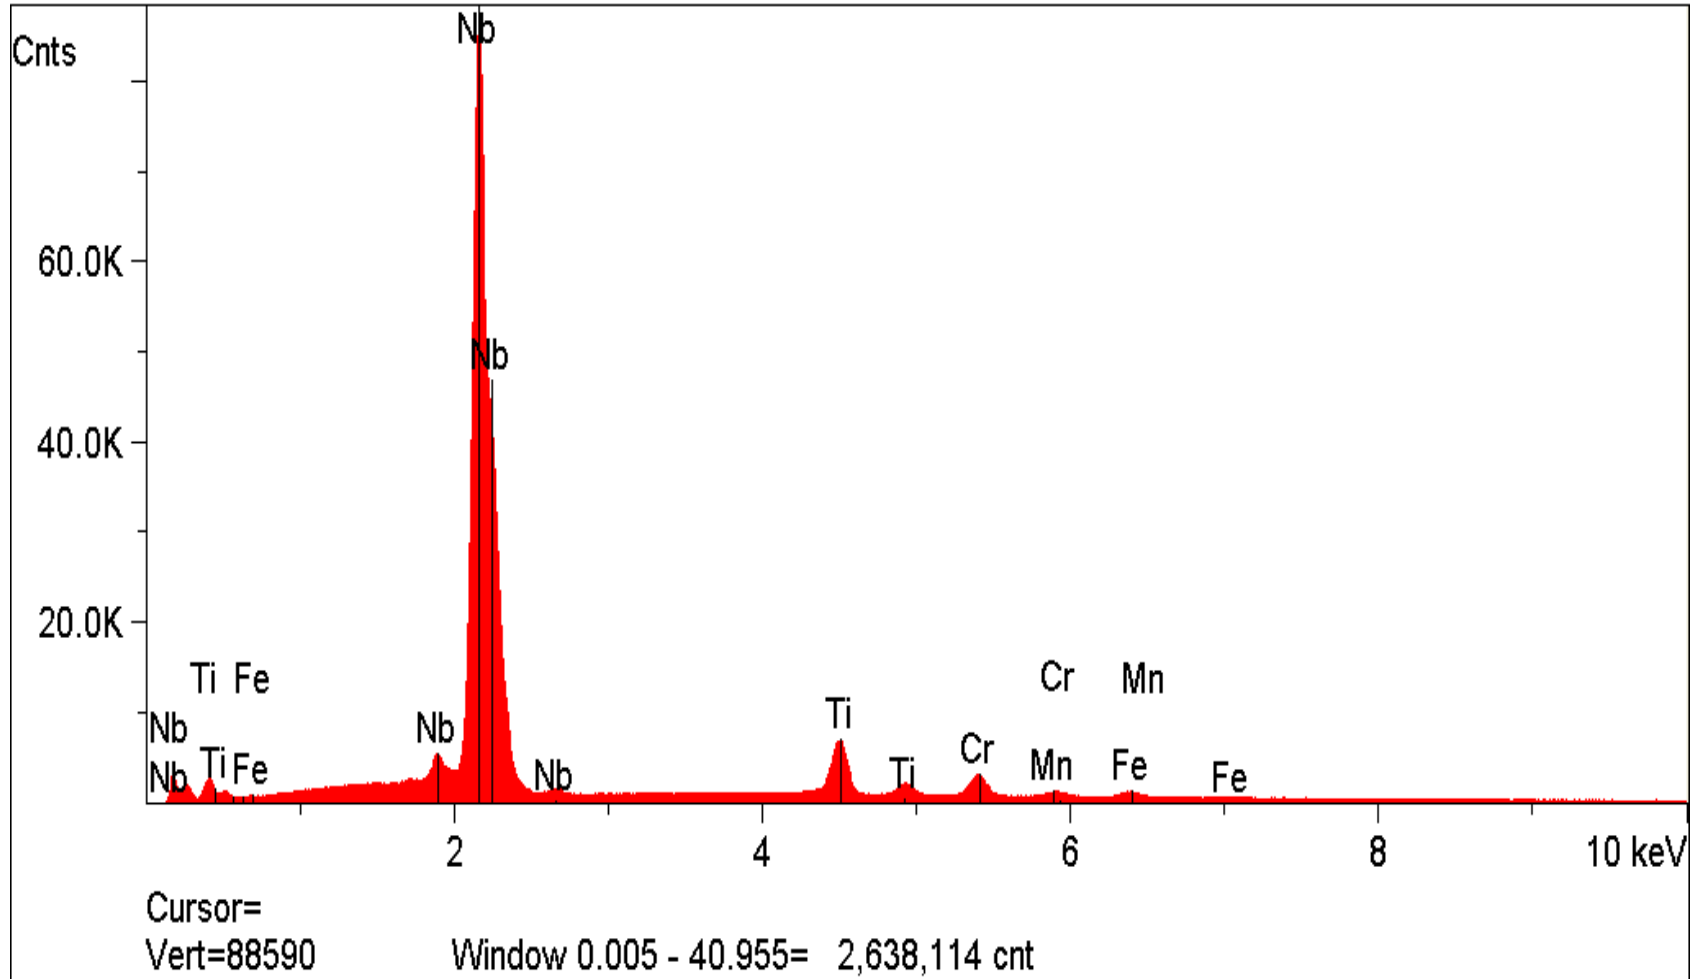
Metallography

EDS indicated blocky carbides were rich in Niobium
