VOLVO

T13 Bearing Roughness

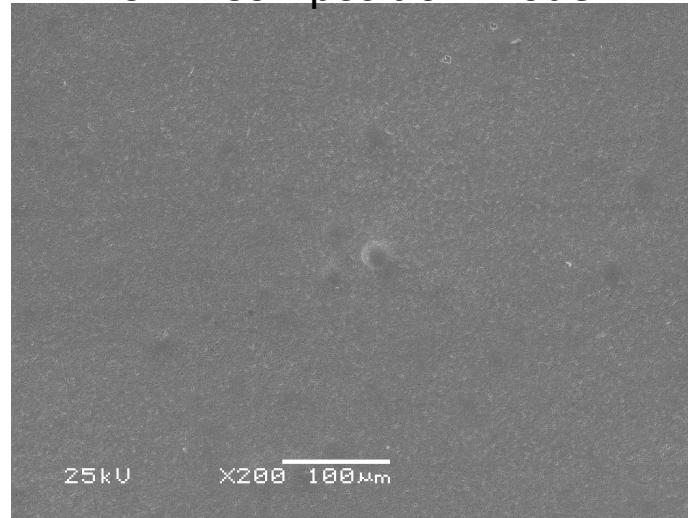
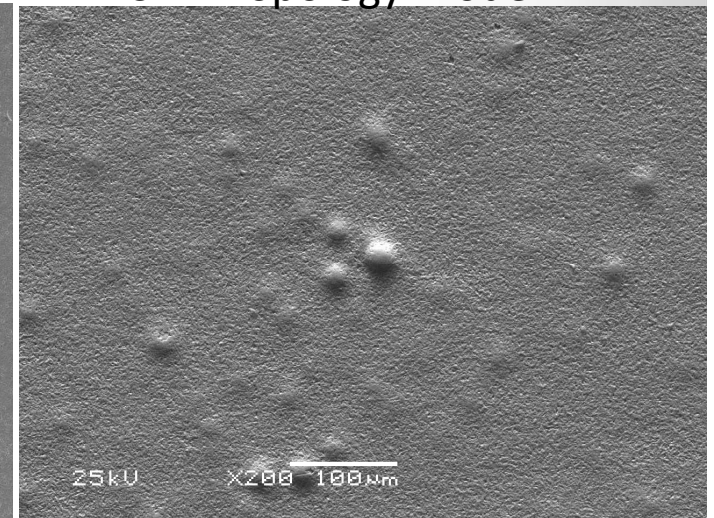
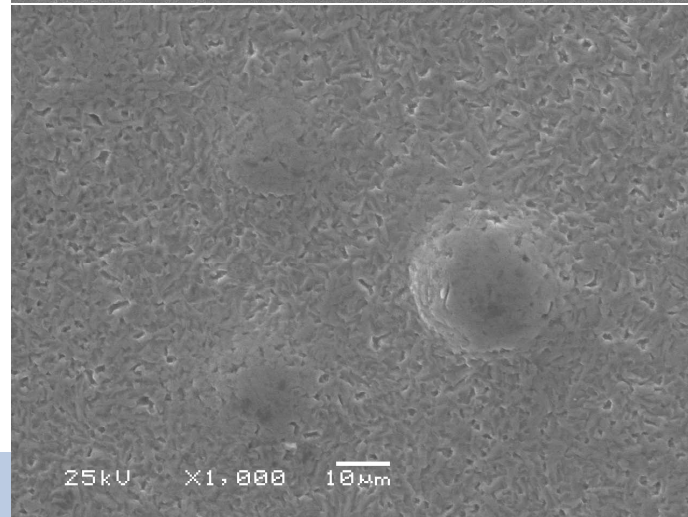
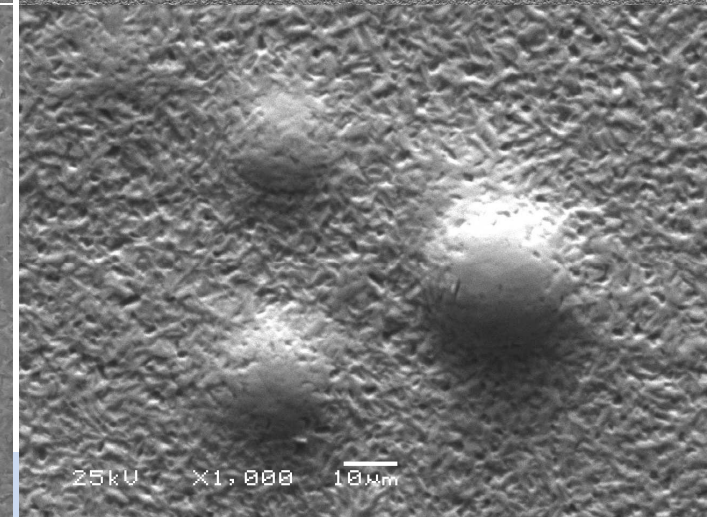
SEM Composition Mode

Top surface analysis shows that the lumps do stand proud to the surface, but the Sn overlay material is constant across the surface (suggests the source of the lumps are subsurface)

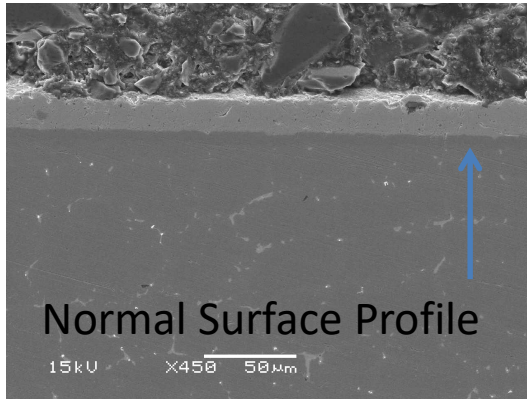
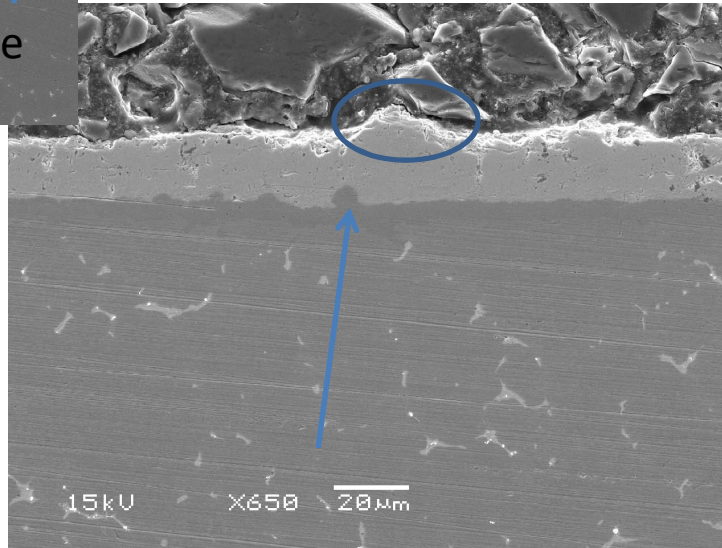
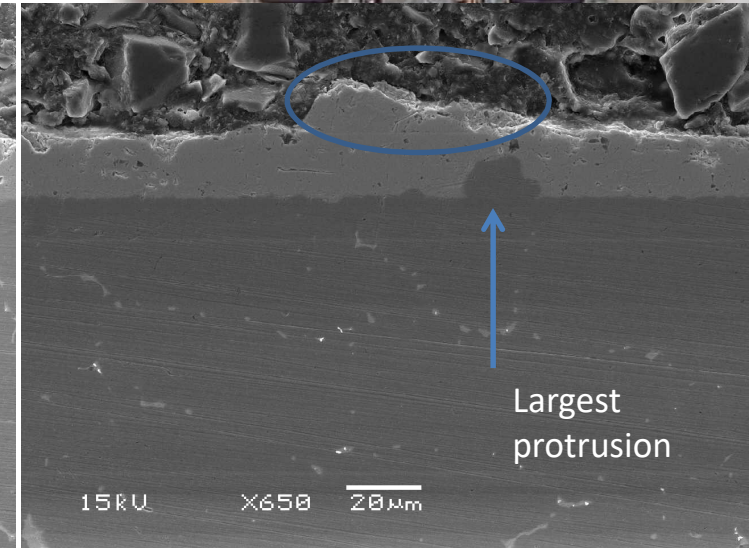
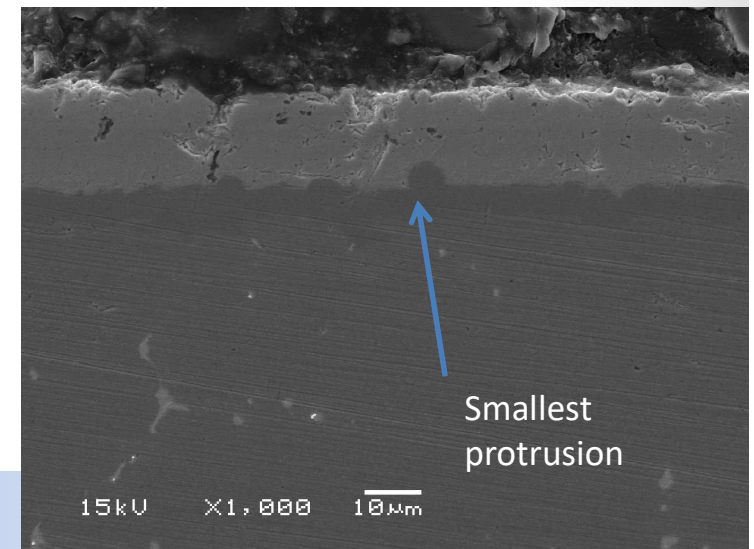
Cross Section

The Sn bumpy surface appears for the most part to be in the vicinity of subsurface protrusions (however there was 1 example of that not being the case. But this is just a planar cross section and the entire region in the vicinity of the subsurface protrusions aren't examined. The subsurface bump that didn't have a surface bump was also the smallest seen)

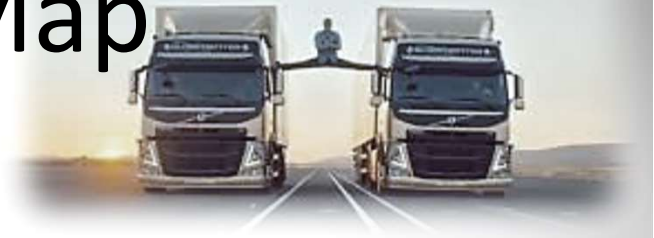
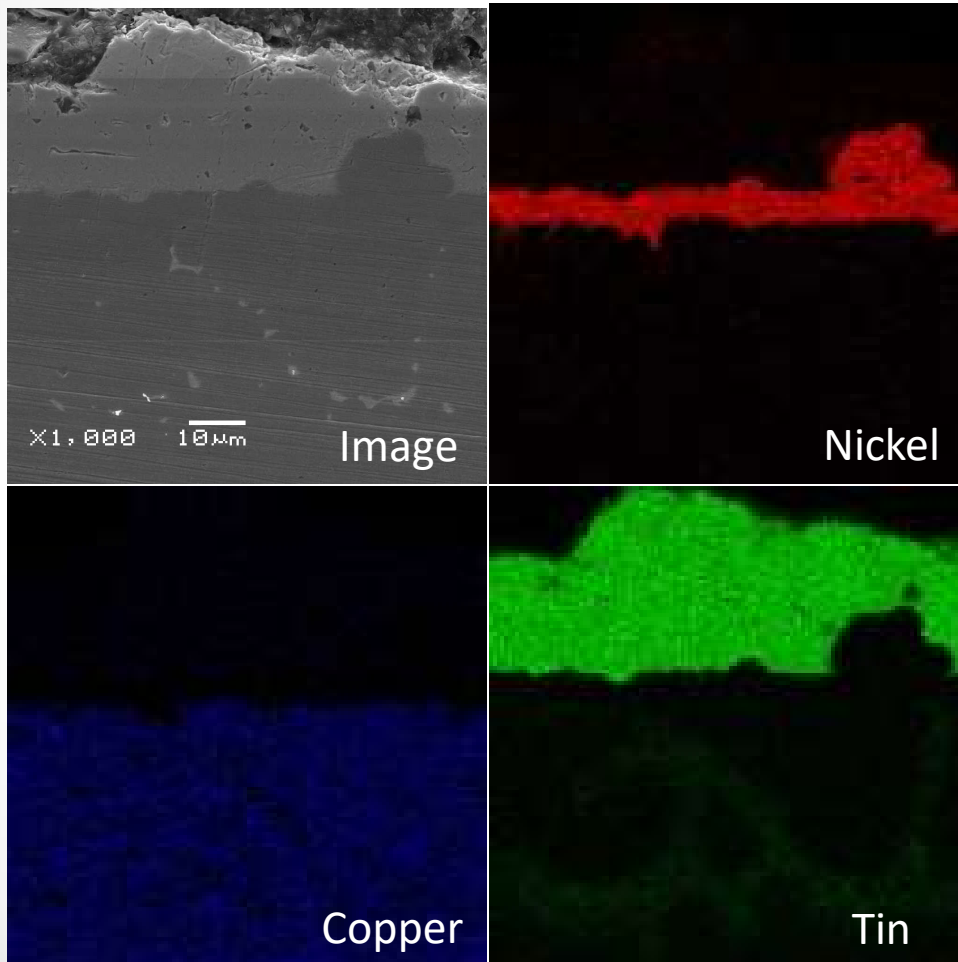
Cross Section Element Map

Surface protrusions appear to be the result of the nickel plating process that leaves asperities on the order of 20um tall
