19R-04-14 Volvo Nodules

Rob Cumming

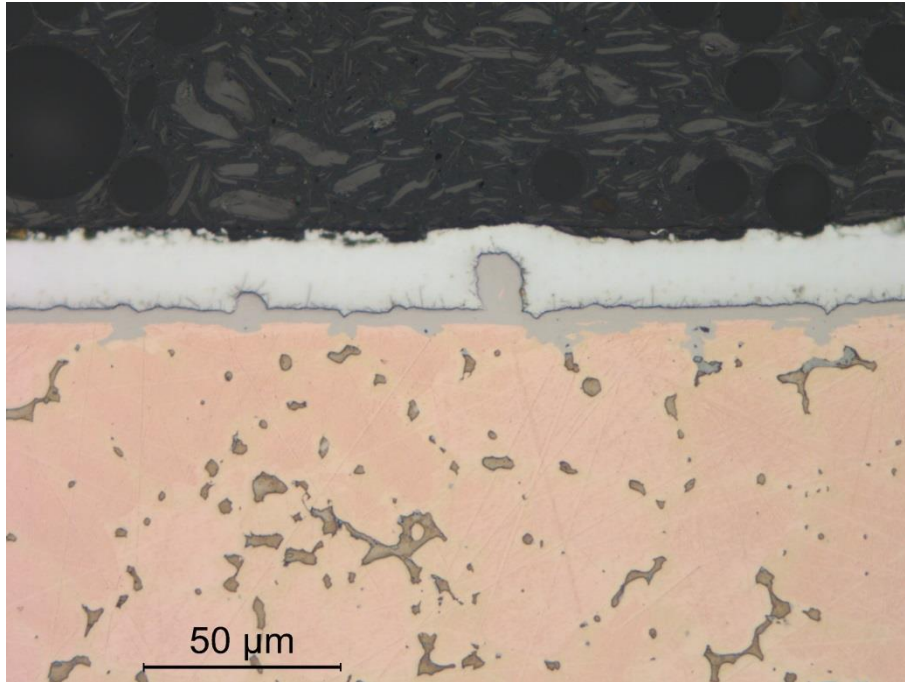
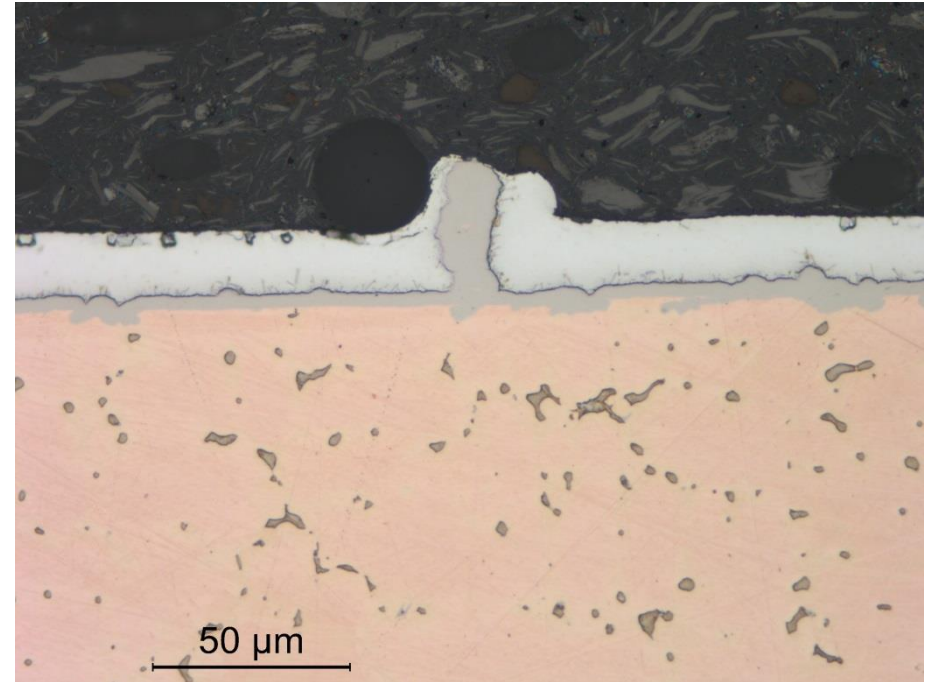
- Nodules were seen beneath the tin overlay.
 - In the image on the right, the nickel does not quite manage to penetrate to the surface
 - Our mounting process does tend to damage tin overlays

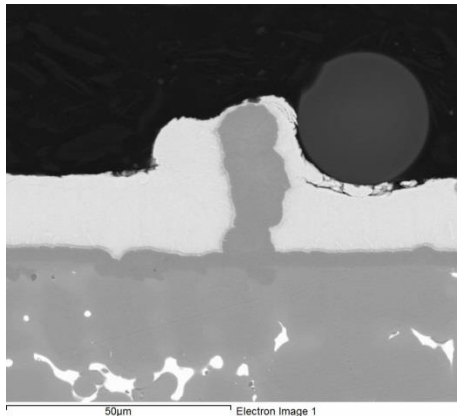
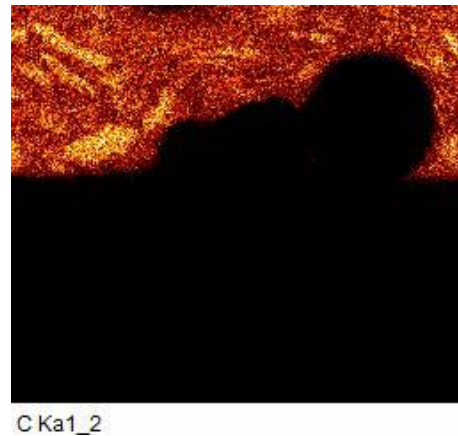
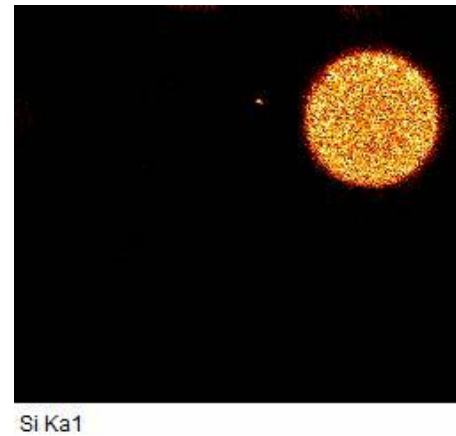
- Nickel nodule underneath tin overlay, almost penetrating the surface

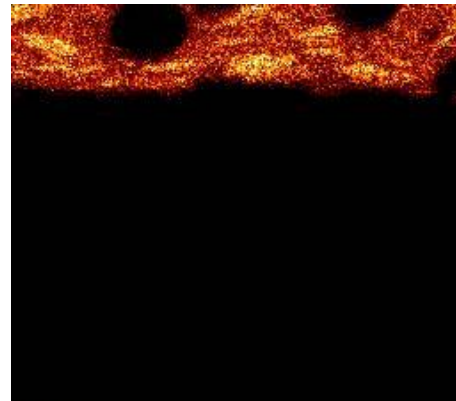
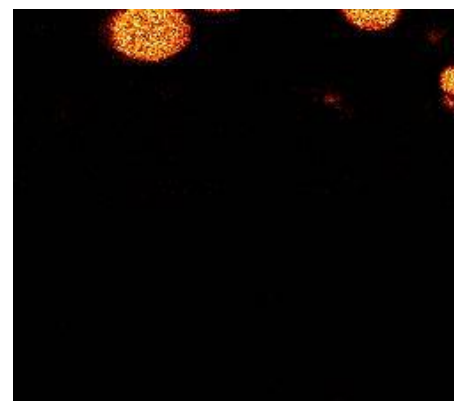
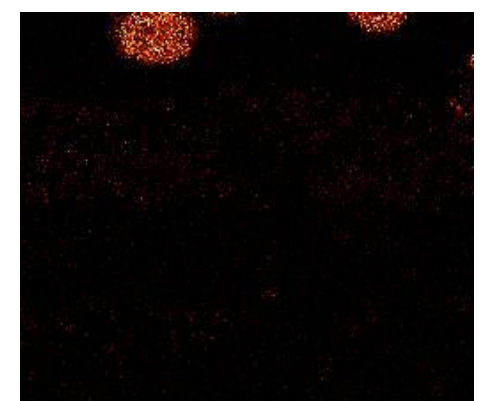
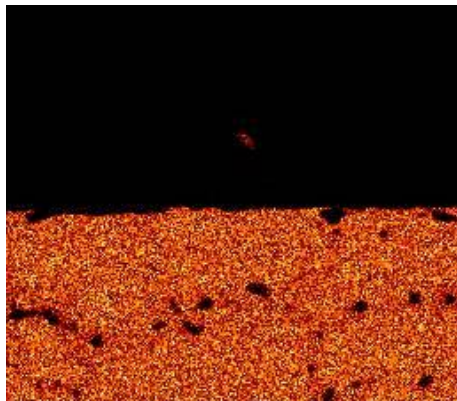
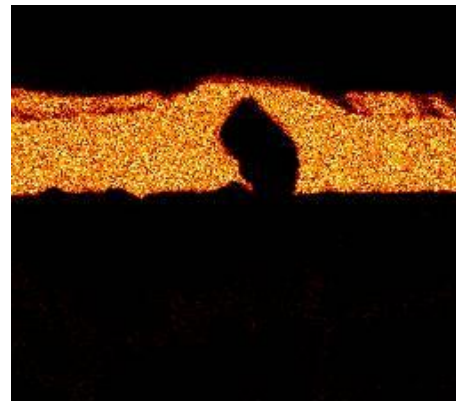
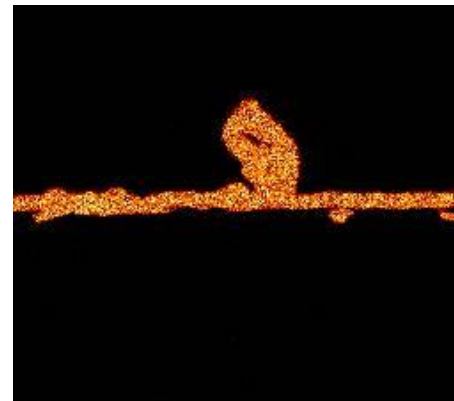
■ Nickel nodule
seen underneath
the tin overlay
