**Report of Meeting**  
**L-37 Surveillance Panel Teleconference**  
July 24, 2007

**DANA SHARED SERVICES  
A.S.G. TECH CENTER  
3939 TECHNOLOGY DRIVE, MAUMEE, OH 43537  
MATERIAL SCIENCE DEPARTMENT REPORT**

ASG LAB NO.	: 2007-0412	PART NO.	: 060GP104
PART NAME	: PINION – HYPOID DRIVE FIN	PRINT REV.	:
REP. TITLE	: GEAR, PINION	MODEL	:
MARKINGS	: #2 0 DANA 05 060GP104 41 7 PM3216 #5 0 DANA 05 060GP104 41 7 3206TG	HEAT CODE	: #2 B6L566 #5 B6L566
MATERIAL	: STEEL, SAE 8625, OPTIONAL GROUP C	MFG. DATE	:
VENDOR	: DANA – FORT WAYNE	SAMP. REQ.	: NA
CUSTOMER	: ASTM (L-37 COMMITTEE)	VIN	: NA
TAR NO.	:	MAR NO.	: 2772
TEST ENG.	:	REC'D DATE	: 6/27/2007
REQ. BY	: JOE GUZIKOWSKI	REP. DATE	: 7/6/2007
REP. BY	: TOM WOODARD	PAGES	: 7
TRP LAB NO.	: 907142		
ADD. COMMENTS	: THIS GEARSET HAS NOT BEEN ABLE TO DISTINGUISH BETWEEN ACCEPTABLE AND UNACCEPTABLE REFERENCE OILS.		
COPIES	: GREG FETT, JOE GUZIKOWSKI, DANA COMBS		
REQUEST	: EVALUATE GEAR SET THAT WAS L-37 DYNO TESTED BY THE ASTM SUB-COMMITTEE SAMPLES FROM A HEAT CODE BATCH OF GEARSETS THAT ARE TO BE USED AS THE OFFICIAL HARDWARE FOR TESTING AND APPROVING NEW LUBRICANT CANDIDATES TO SAE AND MIL STANDARDS. THE GEARS ARE EXPERIENCING WEAR, RIDG

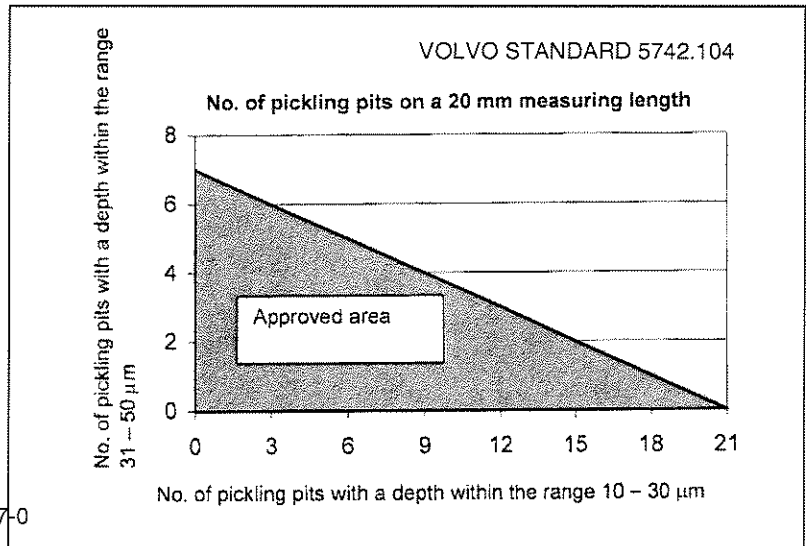
SIZE 10µM – 30µM	#2 *100+	#5 *100+
SIZE 31µM – 50µM	NONE	NONE
SIZE > 50µM	NONE	NONE

PITS WERE MEASURED AT 1000X MAGNIFICATION ON THE UNWORN COAST SIDE AND THE ROOT.

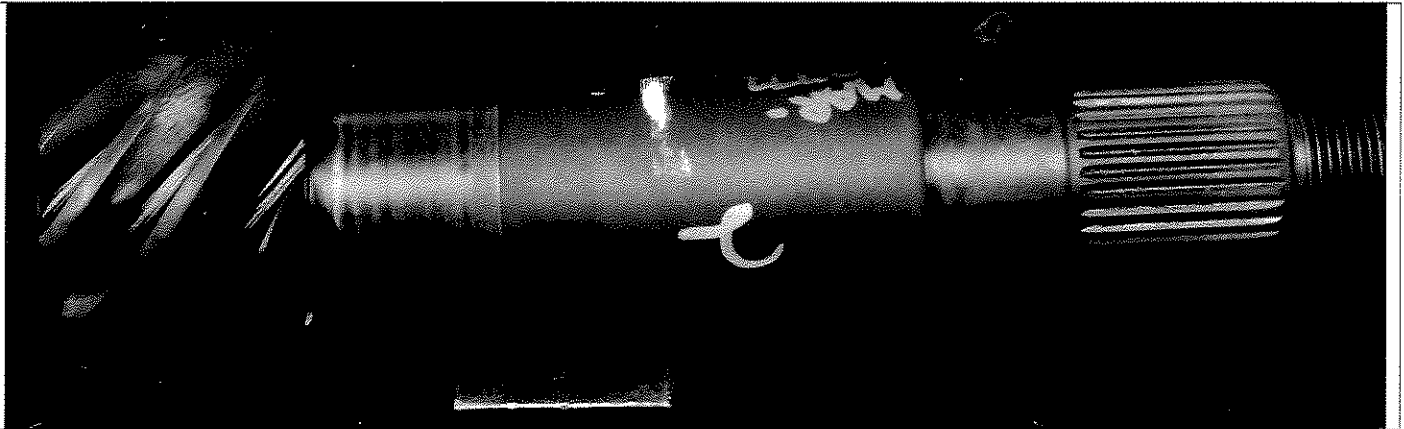
GEAR #2 HAD NO BROKEN OR CRACKED TEETH. THE DRIVE SIDE TEETH HAD A POLISHED CONTACT PATTERN THAT STARTED APPROXIMATELY 3/16" FROM THE HEEL AND ENDED FLUSH WITH THE TOE.

PHOTO 1. PINION #2 AS RECEIVED

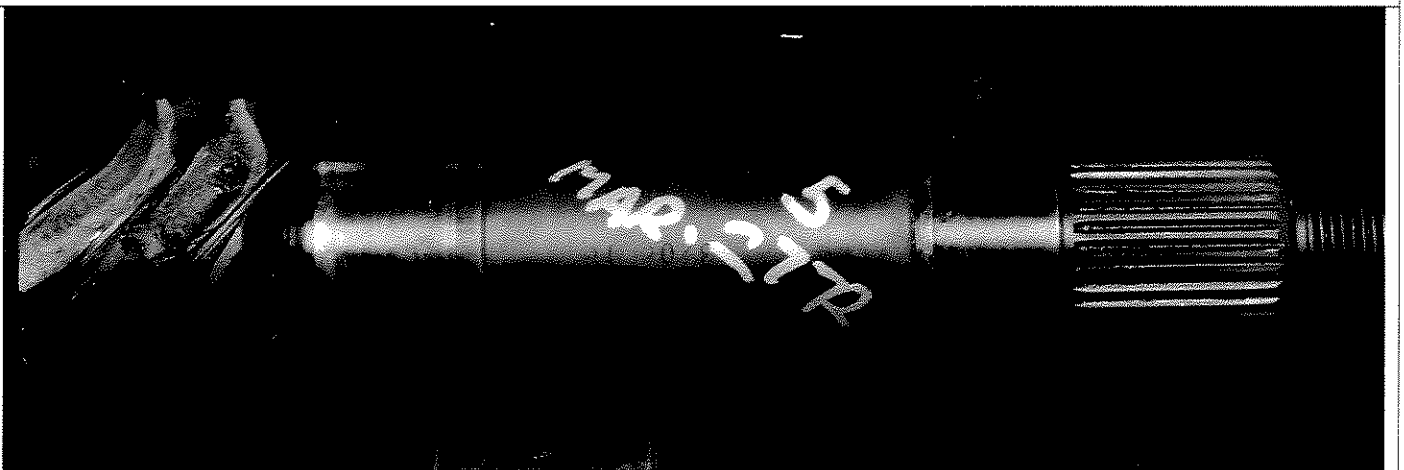
GEAR #5 HAD TWO BROKEN TEETH. THE CONTACT PATTERN ON THE DRIVE SIDE STARTED APPROXIMATELY 3/16" FROM THE HEEL AND ENDED FLUSH WITH THE TOE. EXAMINATION AT LOW MAGNIFICATION SHOWED PITTING ALONG THE ROOT LINE ON THE DRIVE SIDE. BOTH GEARS HAD RIDGING AND WEAR ON THE TEETH.

PHOTO 2. PINION #5 AS RECEIVED

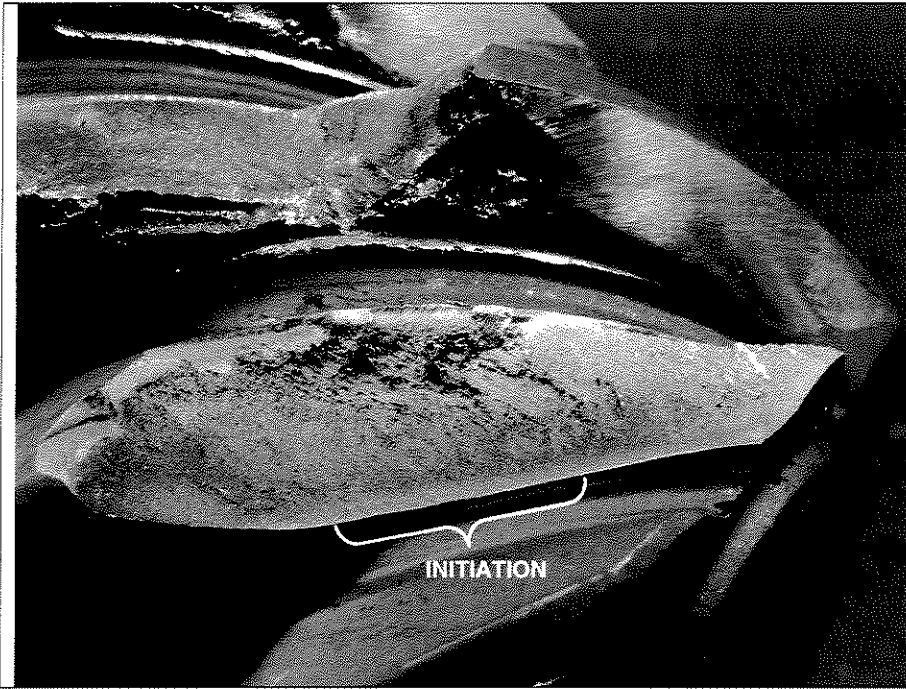
: THE PARTS MEET PRINT SPECIFICATIONS EXCEPT FOR THE CASE BEING SLIGHTLY DEEP. THE PITTING IS EXCESSIVE, PER THE VOLVO SPECIFICATION, WITH PITS TOO NUMEROUS TO COUNT. THE FRACTURED TEETH ON GEAR #5 WERE LIKELY A RESULT OF THIS SEVERELY PITTED SURFACE BEING TESTED AT THE L-37 LOADS. SEVERE PITTING CAN CAUSE ABNORMAL WEAR AND RIDGING WHICH CAN IN TURN LEAD TO PITTING, SPALLING, AND TOOTH BREAKAGE. THE SURFACE HARDNESS SPECIFICATION OF 61 – 63 HRC IS NOT REASONABLE. LONG TERM A RANGE OF 6 OR 7 POINTS HRC IS NECESSARY.

PHOTO 3.  
CLOSE UP OF THE FRACTURED TEETH. THE LOWER TOOTH FAILED FIRST AND THE OTHER TOOTH DAMAGE WAS SECONDARY.

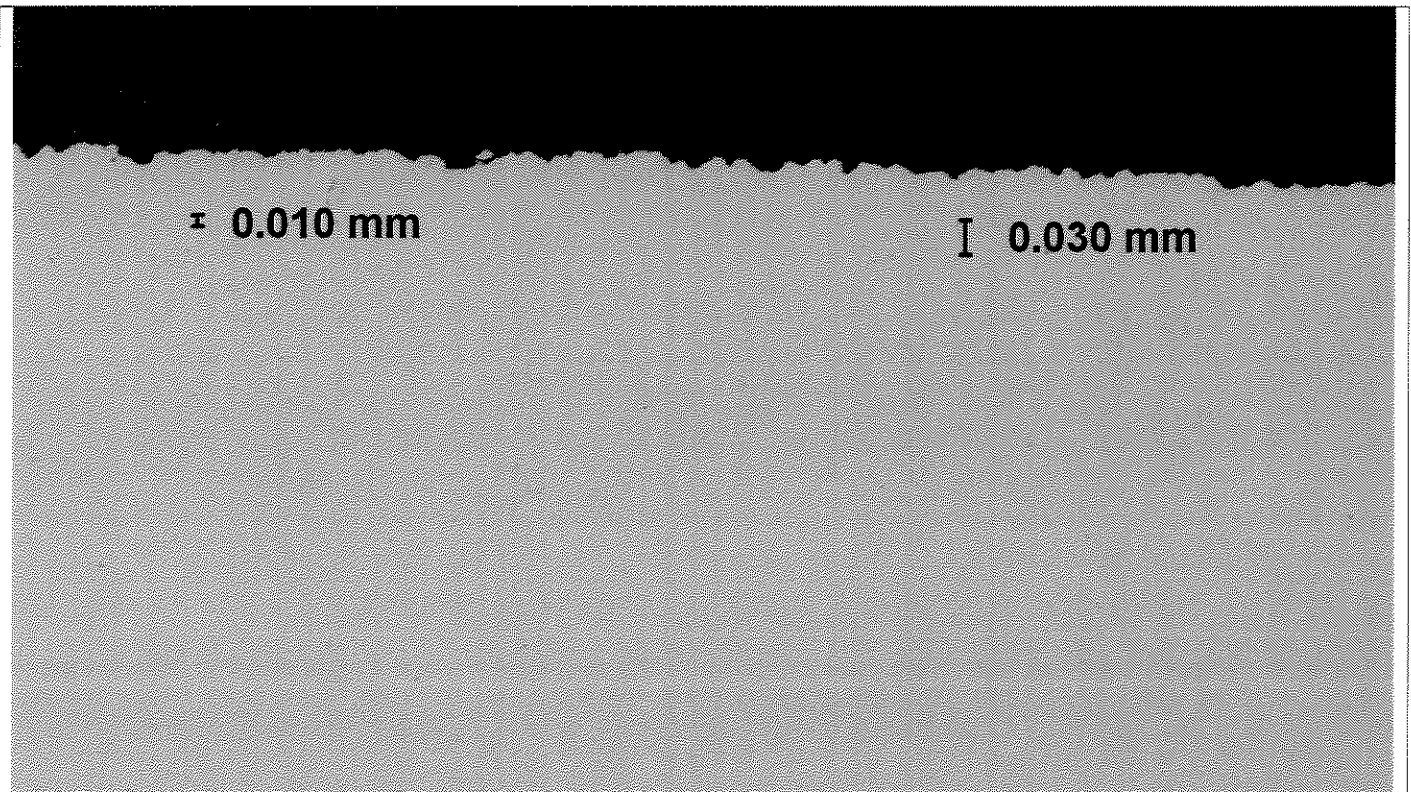
PHOTO 4. PICKLING PITS FROM THE PHOSPHATING PROCESS PINION GEAR #2 100X NO ETCH

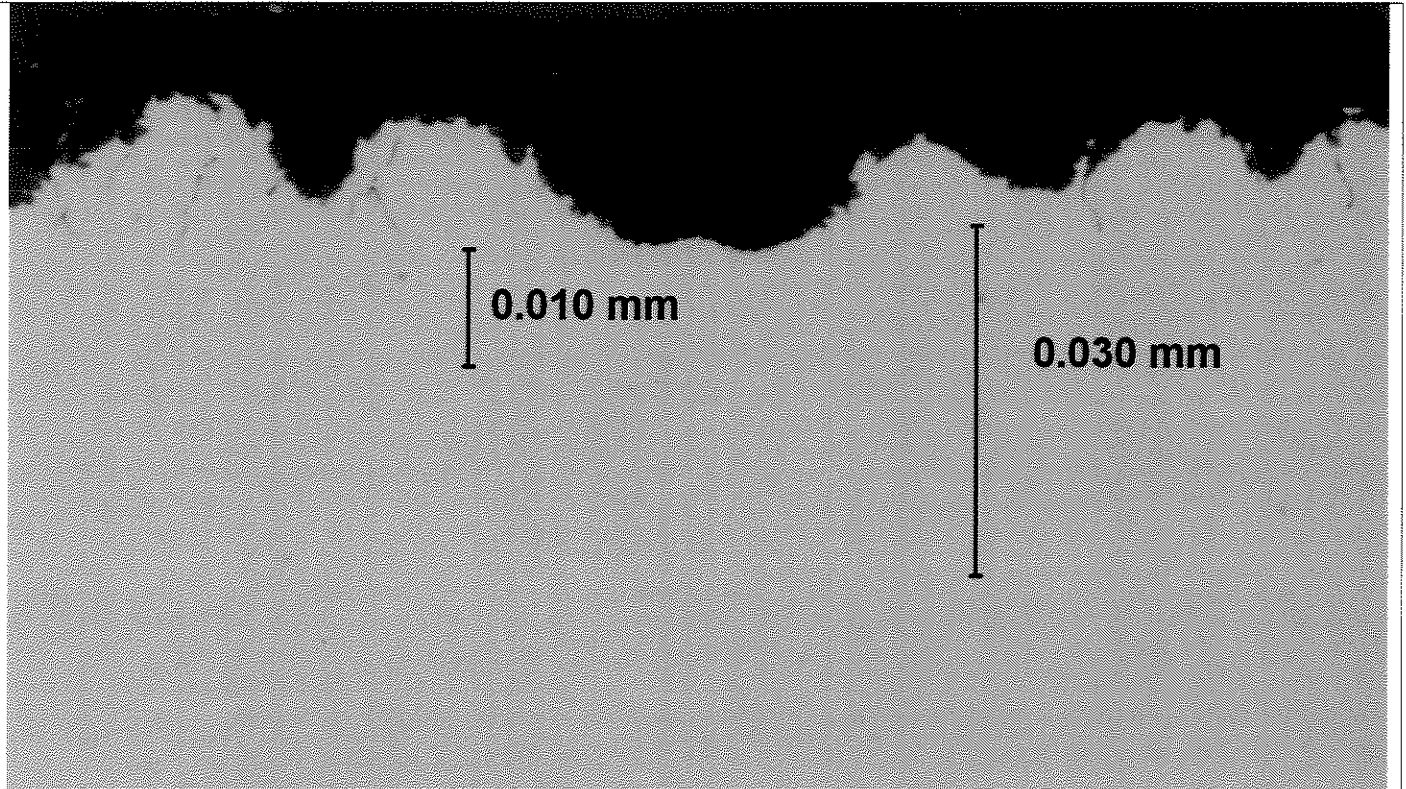
PHOTO 5. SAME AS PHOTO 4 BUT AT HIGHER MAGNIFICATION

PINION GEAR #2

1000X NO ETCH

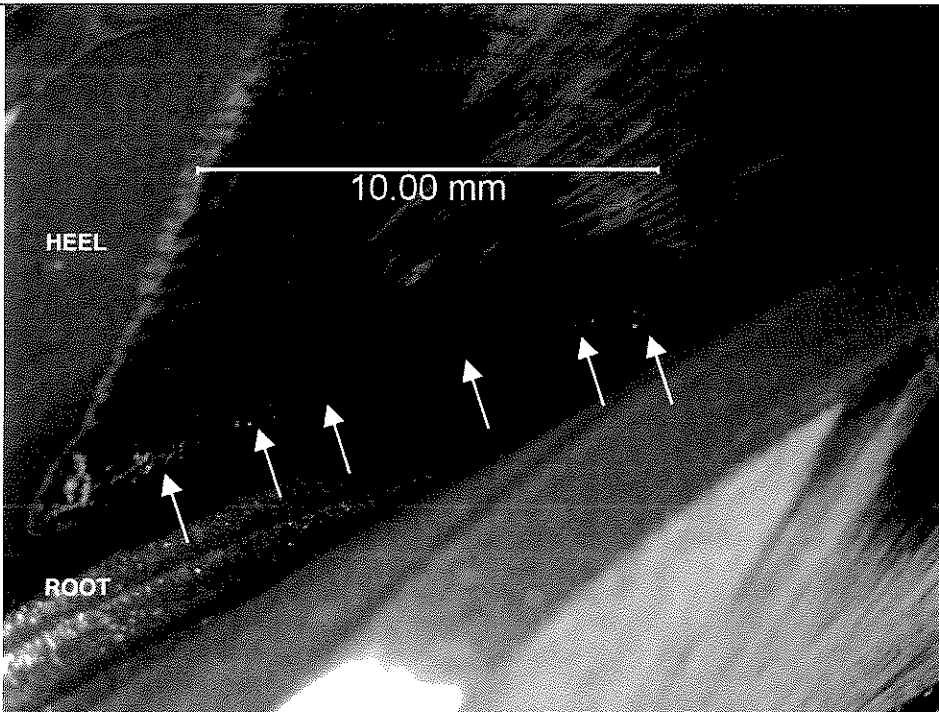
PHOTO 6.

EXAMPLE OF THE PITTING SEEN AT THE ROOT ON THE DRIVE SIDE OF GEAR #5.

7.1X MAGNIFICATION

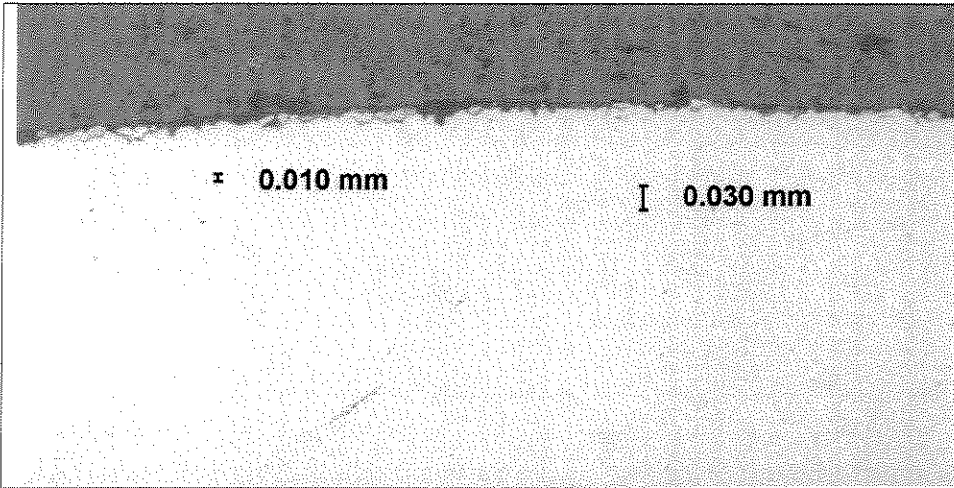
PHOTO 7.  
PICKLING PITS FROM THE  
PHOSPHATING PROCESS.

GEAR #5  
100X MAGNIFICATION  
NO ETCH

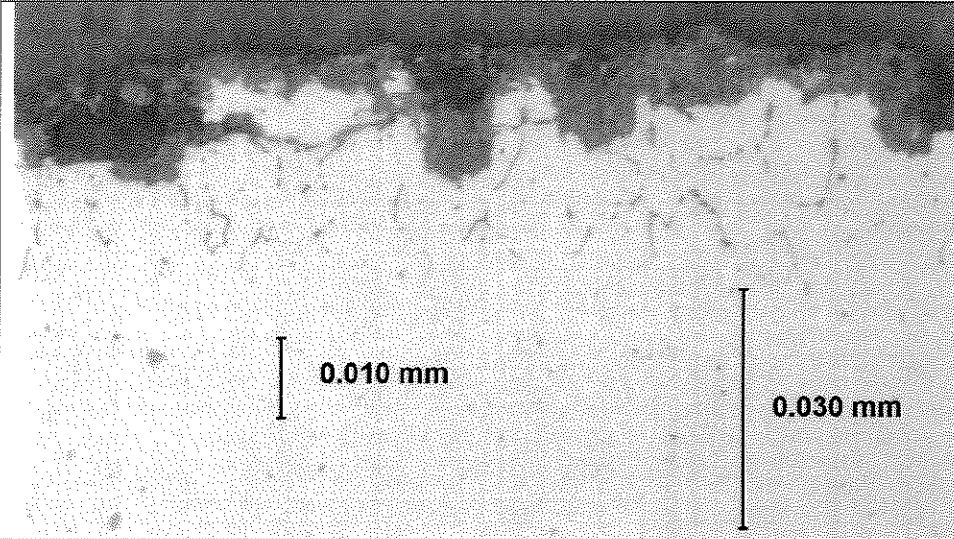
PHOTO 8.  
SAME AS PHOTO 7, BUT AT HIGHER  
MAGNIFICATION.

GEAR #5  
1000X MAGNIFICATION  
NO ETCH

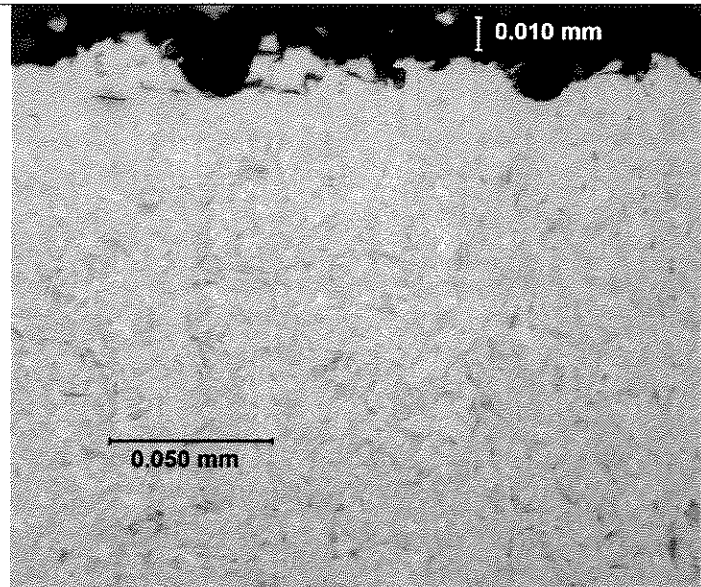
CASE: TEMPERED MARTENSITE WITH 5 – 10% RETAINED AUSTENITE

PHOTO 6. TYPICAL CASE MICROSTRUCTURE.  
500X 2% NITAL ETCH

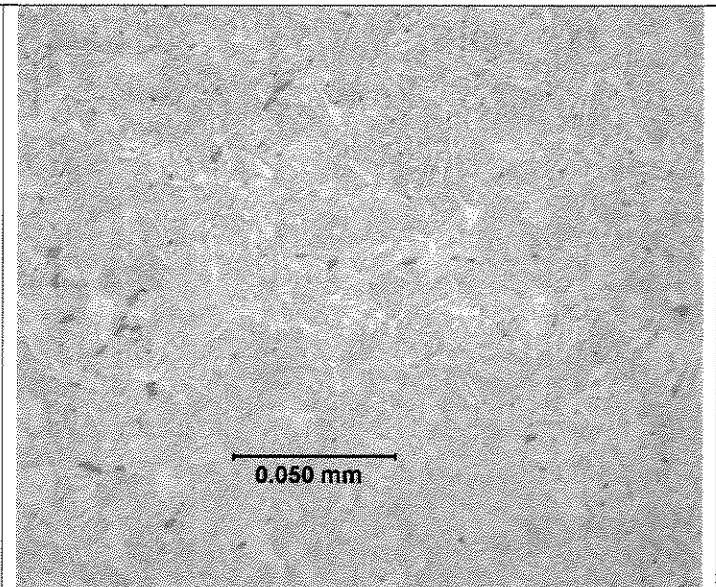
CORE: TRANSFORMATION PRODUCTS

PHOTO 7. TYPICAL CORE MICROSTRUCTURE.  
500X 2% NITAL ETCH

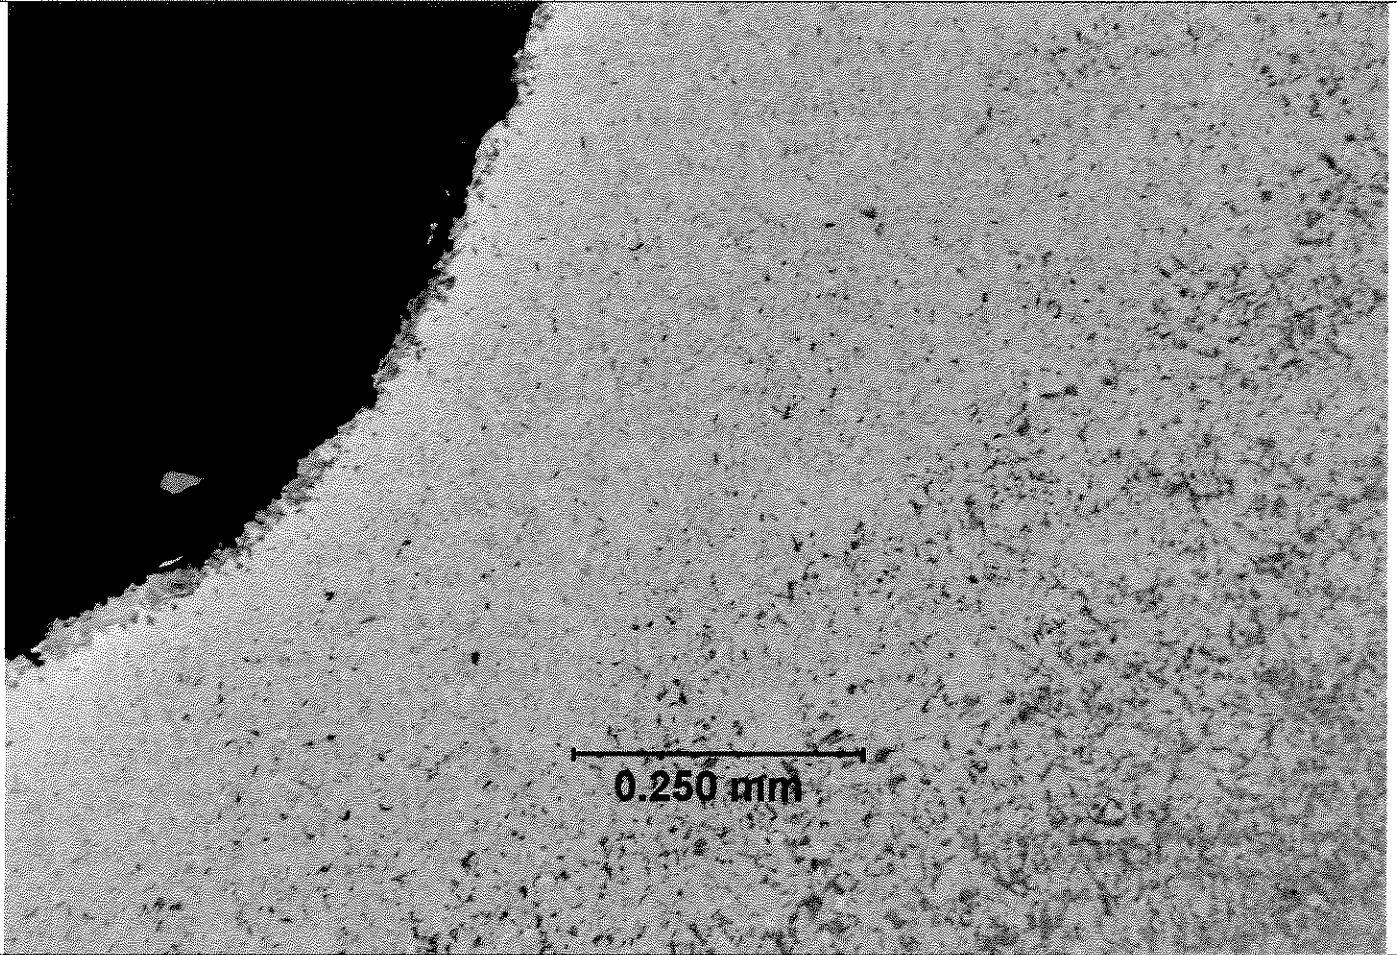
PHOTO 8. TYPICAL CASE / CORE MICROSTRUCTURE.

100X 2% NITAL ETCH

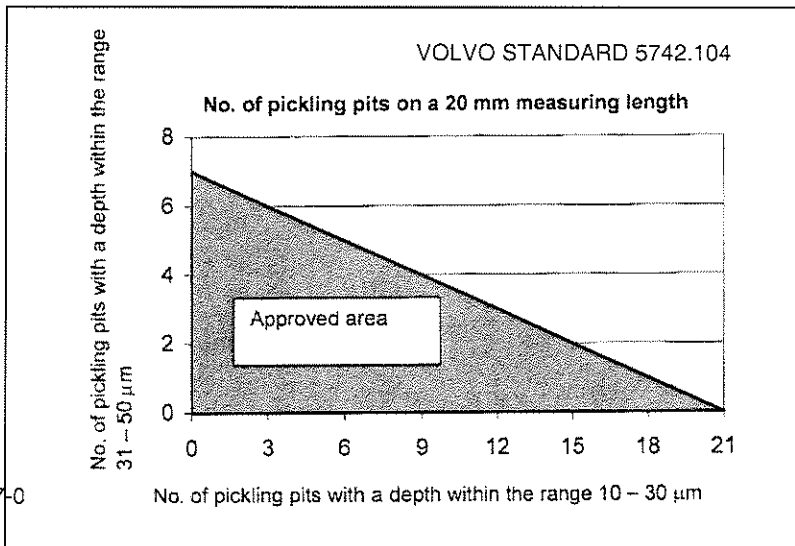
SIZE 10µM – 30µM	#2 *100+	#5 *100+
SIZE 31µM – 50µM	NONE	NONE
SIZE > 50µM	NONE	NONE

PITS WERE MEASURED AT 1000X MAGNIFICATION ON THE UNWORN COAST SIDE AND THE ROOT.

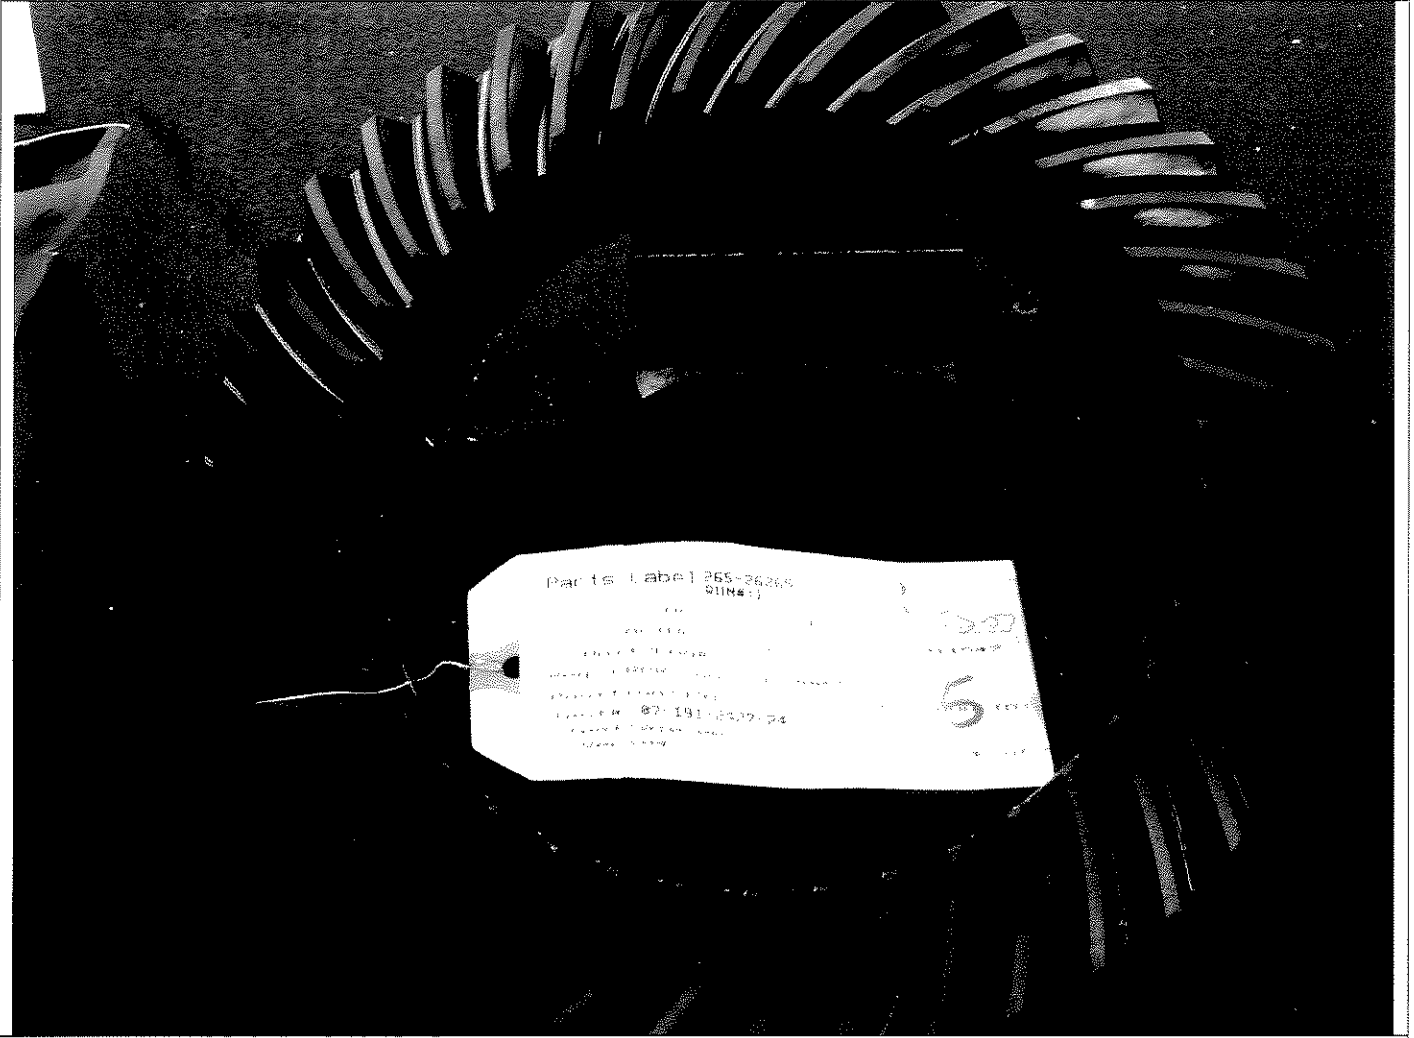
#2 – THE TOOTH CONTACT PATTERN RAN FROM THE HEEL TO JUST SHORT OF THE TOE WITH EVEN WEAR FROM ROOT TO TIP.

PHOTO 1. RING GEAR #2 AS RECEIVED

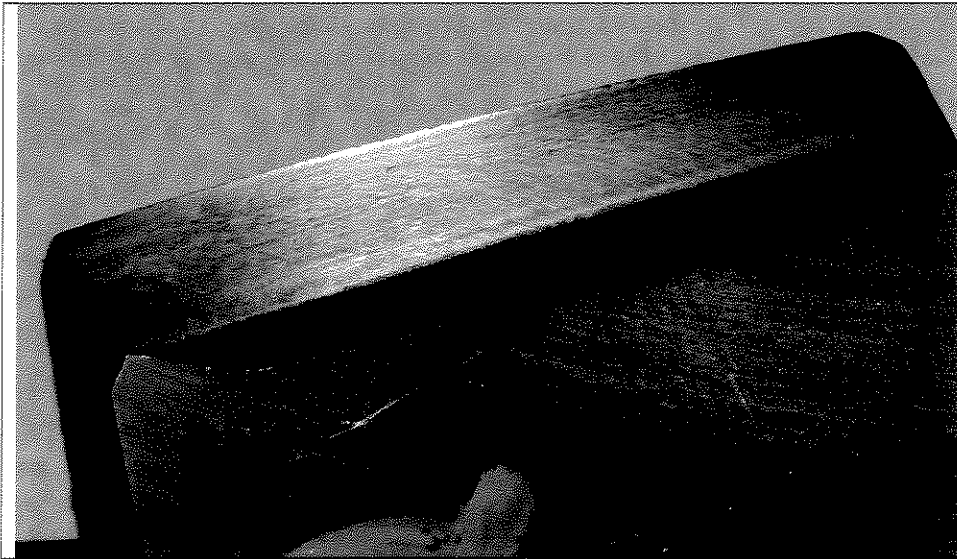
PHOTO 2.

CLOSE UP OF THE CONTACT PATTERN ON THE DRIVE SIDE OF GEAR #2.

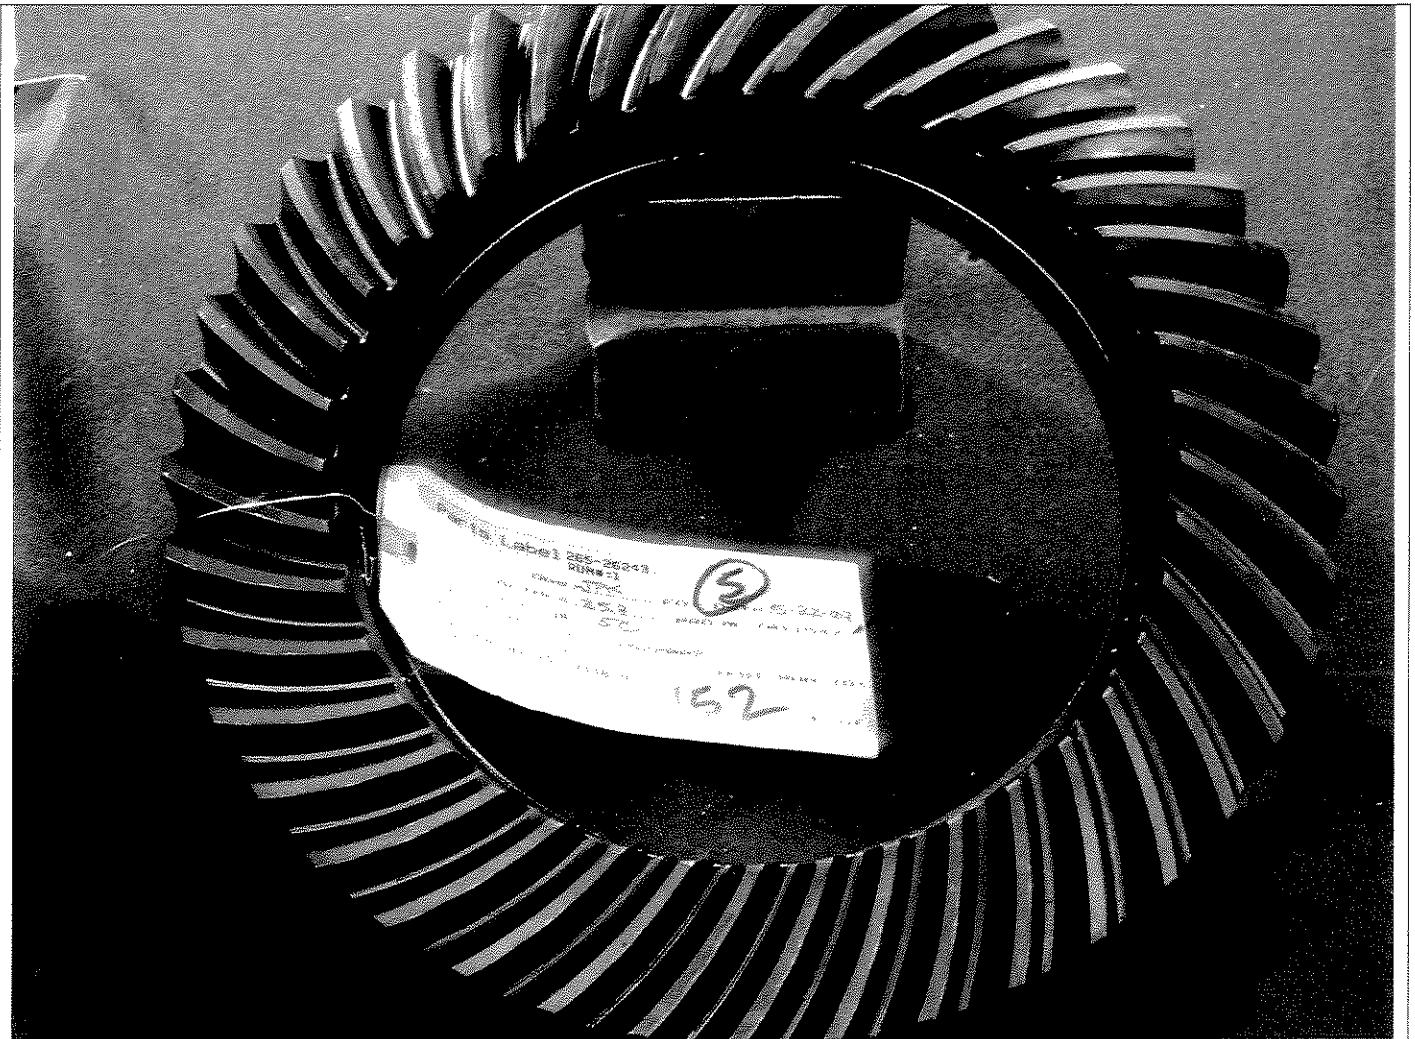
#5 -THE CONTACT PATTERN ON THE GEARS WAS POLISHED AT THE HEEL AND TOE WITH HEAVY RIDGING AT THE HEEL. THERE WERE NO BROKEN TEETH.

PHOTO 3. RING GEAR #5 AS RECEIVED

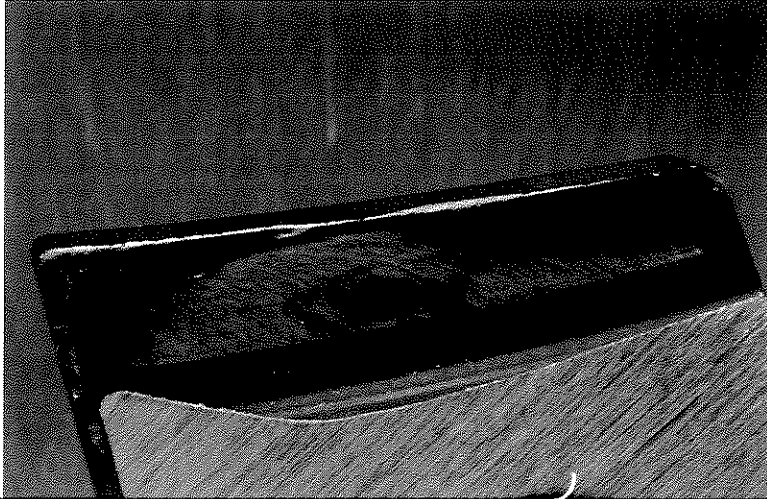
PHOTO 4.

CLOSE UP OF THE CONTACT PATTERN ON THE DRIVE SIDE.

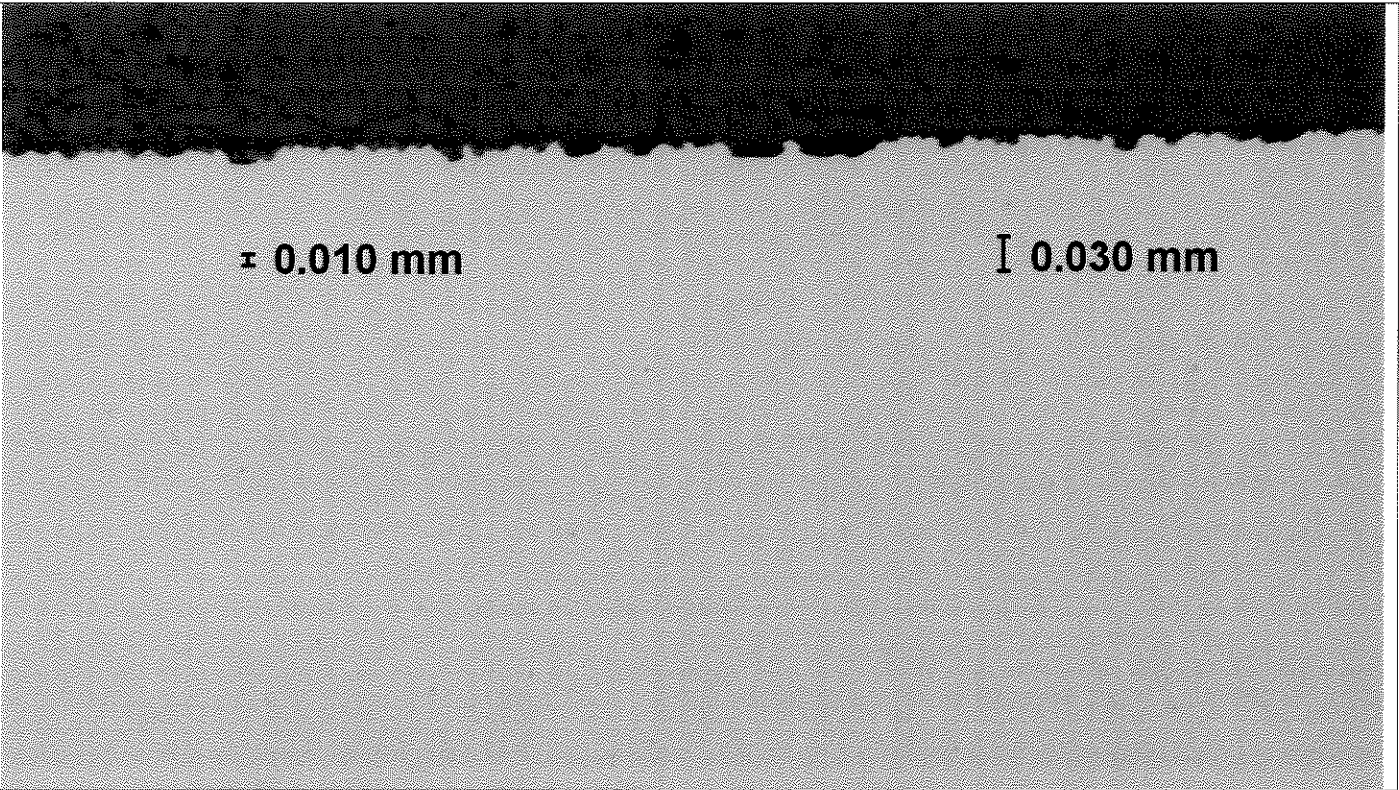
PHOTO 5. PICKLING PITS FROM THE PHOSPHATING PROCESS, GEAR #2.

100X MAGNIFICATION

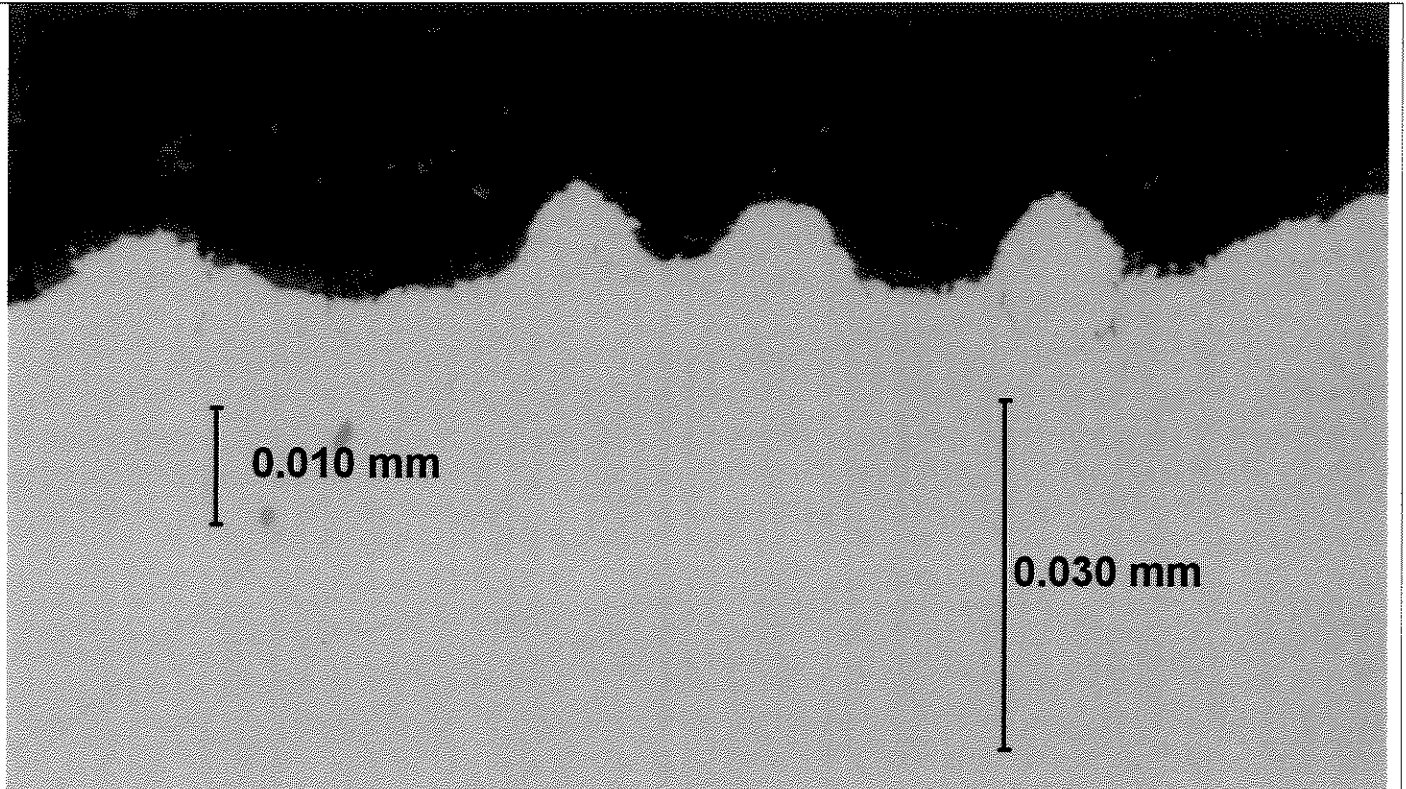
PHOTO 6. SAME AS PHOTO 5, BUT AT HIGHER MAGNIFICATION.

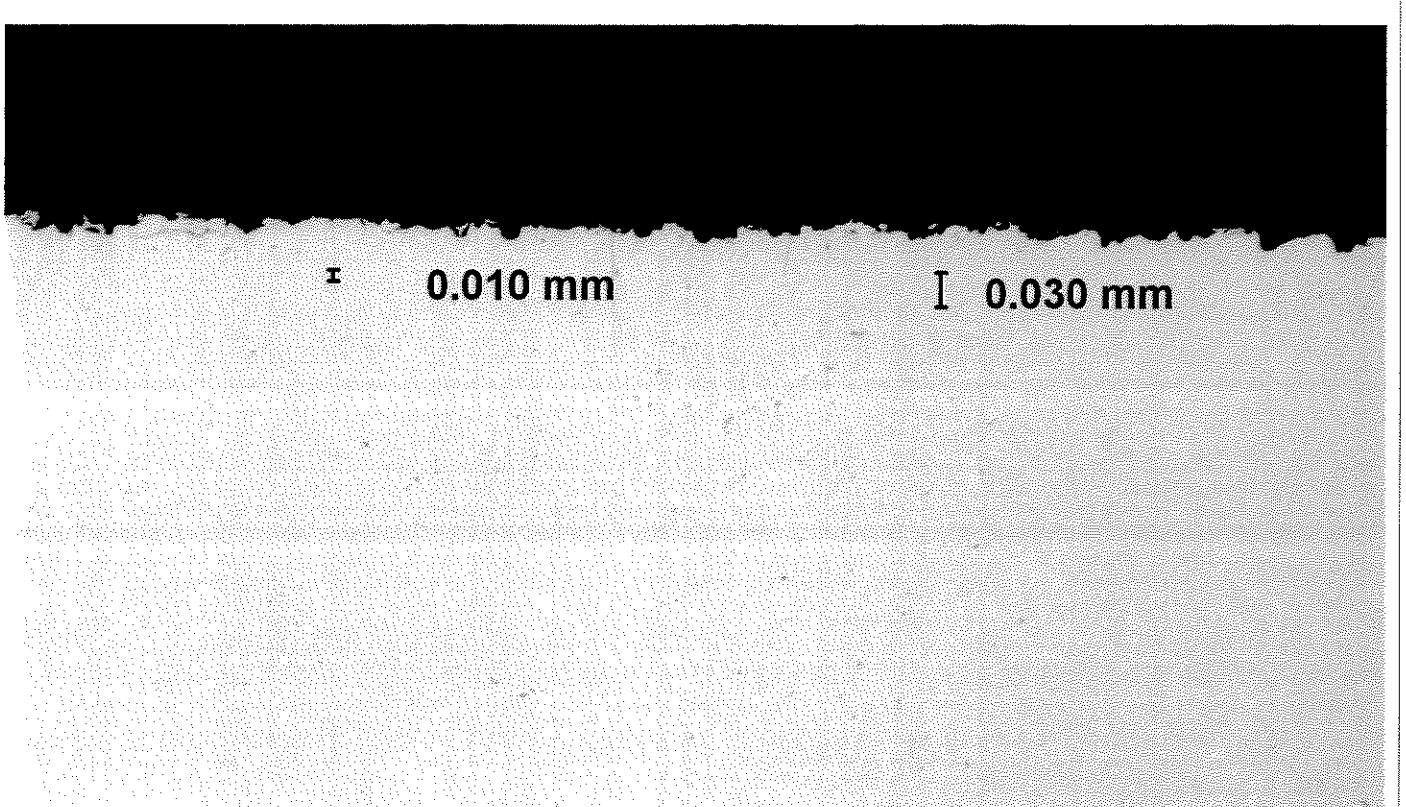
PHOTO 7. PICKLING PITS FROM THE PHOSPHATING PROCESS.

100X MAGNIFICATION

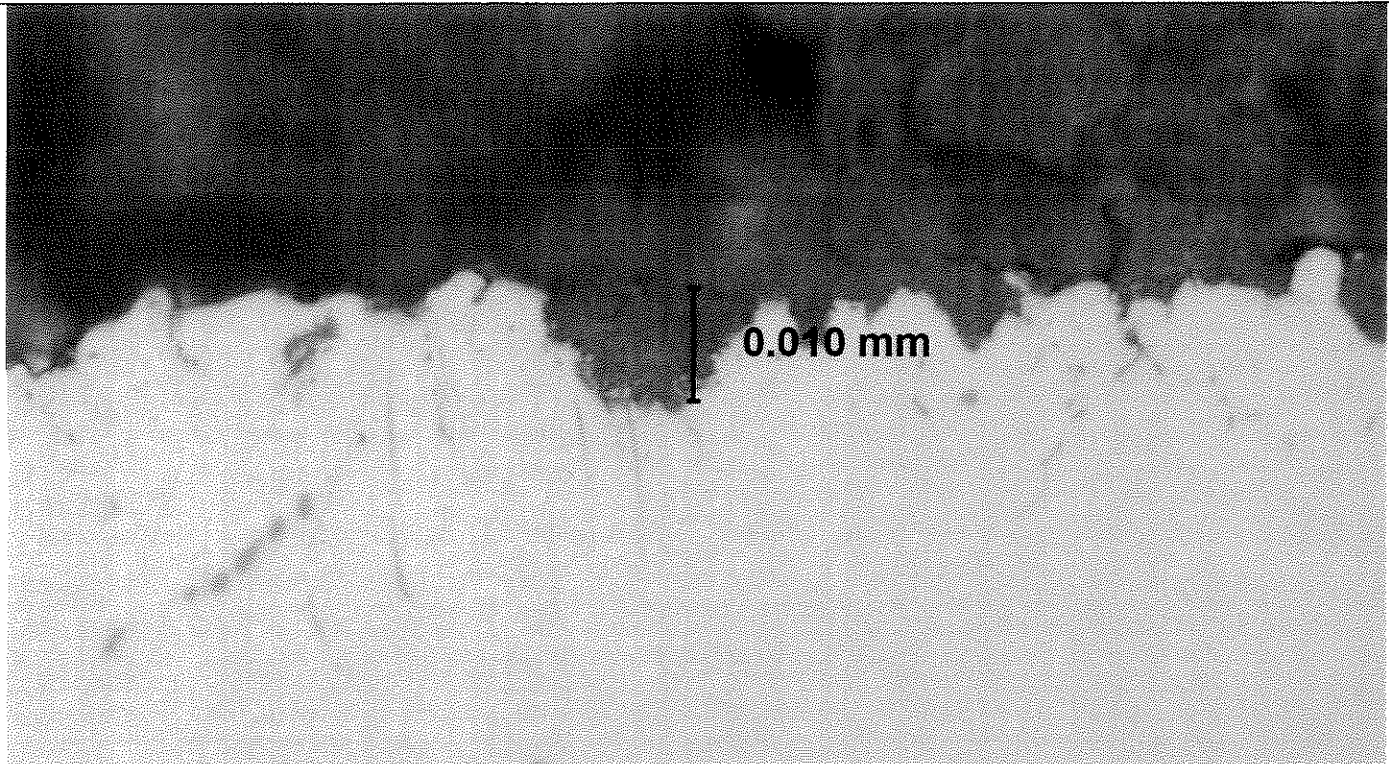
PHOTO 8. SAME AS PHOTO 7, BUT AT HIGHER MAGNIFICATION.

1000X MAGNIFICATION

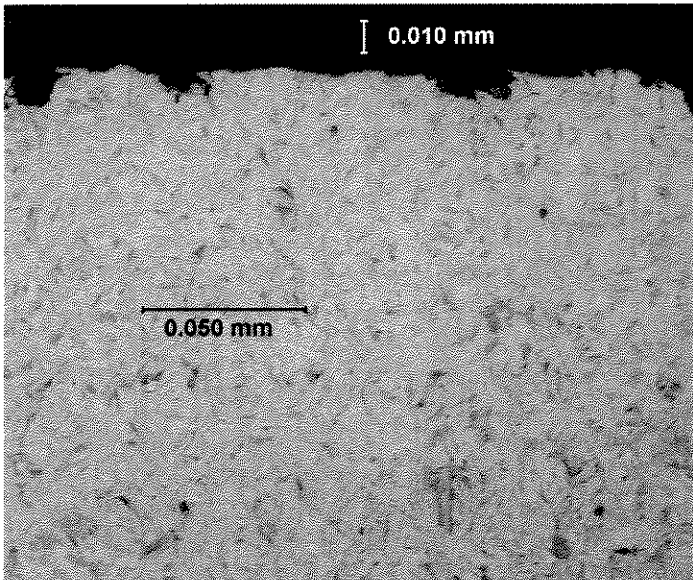
CASE: TEMPERED MARTENSITE WITH 5 – 10% RETAINED AUSTENITE

PHOTO 9. TYPICAL CASE MICROSTRUCTURE.

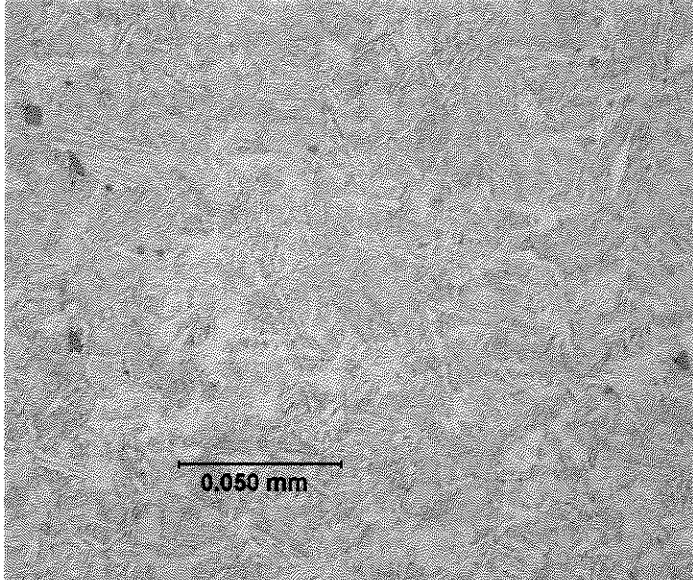
CORE: TRANSFORMATION PRODUCTS

PHOTO 10. TYPICAL CORE MICROSTRUCTURE.

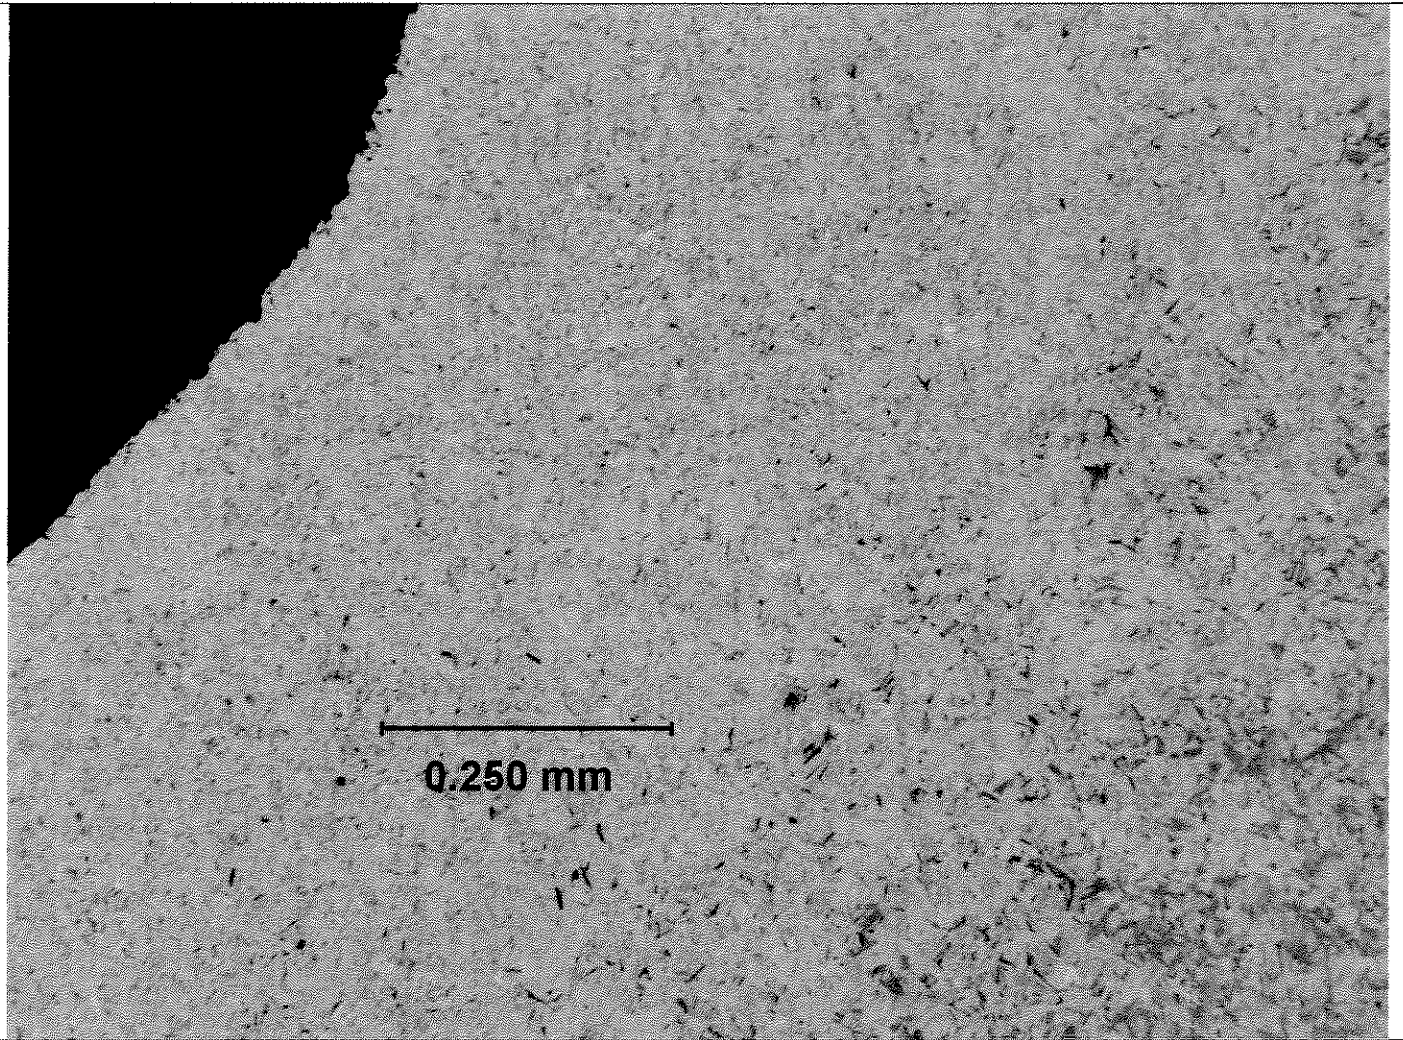
PHOTO 11. TYPICAL CASE / CORE MICROSTRUCTURE.

100X 2% NITAL ETCH
