Committee D02 on PETROLEUM PRODUCTS AND LUBRICANTS

Unapproved Minutes of the October 27, 2015
Sequence IV Surveillance Panel Meeting.

Intake Camshaft Lobe Failure Issue

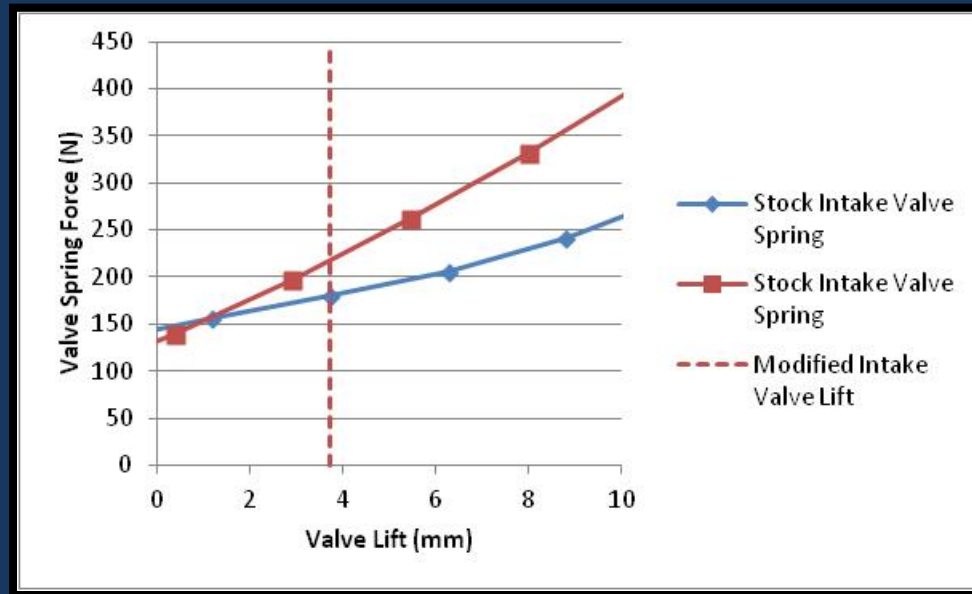
Stiff vs. Production Springs

- Stiffer spring increases spring force by ~30% over production spring at max valve lift (for modified intake cam lobe profiles)
- Stiffer springs are ~12mm shorter than production springs

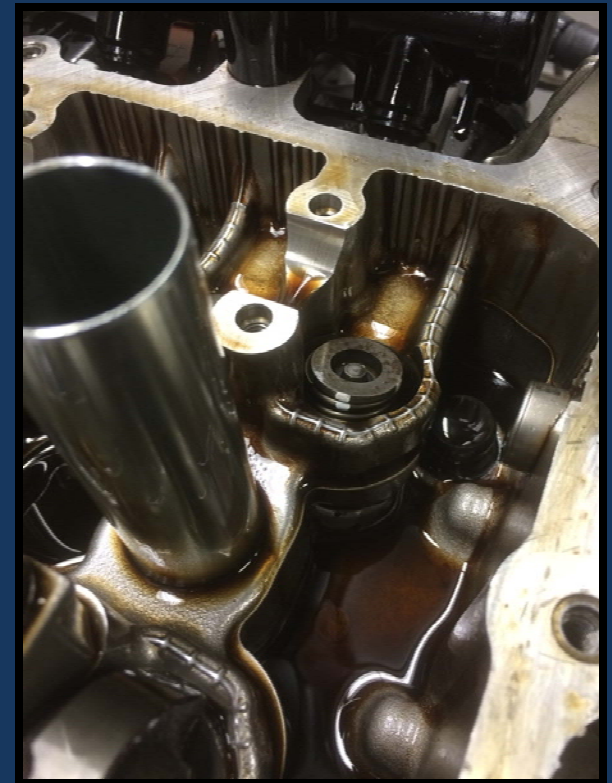
Other Observations

- Marked valvespring and retainer with white marker before testing to track valve spring rotation
- Valvespring does not rotate with respect to engine and retainer
- Lifter most likely lifts off from valve stem to rotate

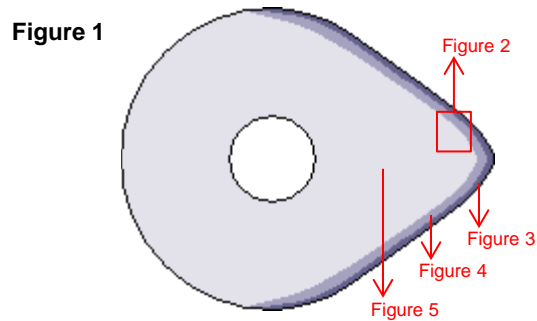
Microstructure: Production Cams

Probing the microstructure of a production cam lobe (provided by Toyota in 2012) reveals a case hardened grey cast iron microstructure. Case hardening in this case appears to have been achieved by laser surface processing (laser surface melting in this case) which has resulted in three distinct microstructural layers as shown the schematic of figure 1 and the low magnification metallograph of figure 2 capturing all three layers.

The outer layer is about 0.5mm thick is predominantly feathery ledeburite consisting of cementite (carbide) and martensite. The microstructure of this layer is shown in the micrograph of figure 3.

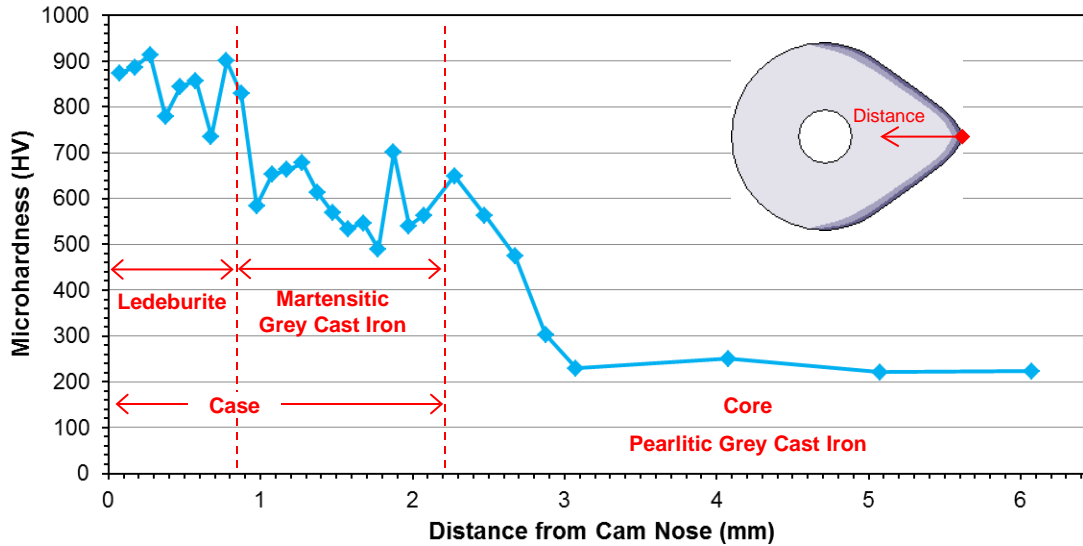
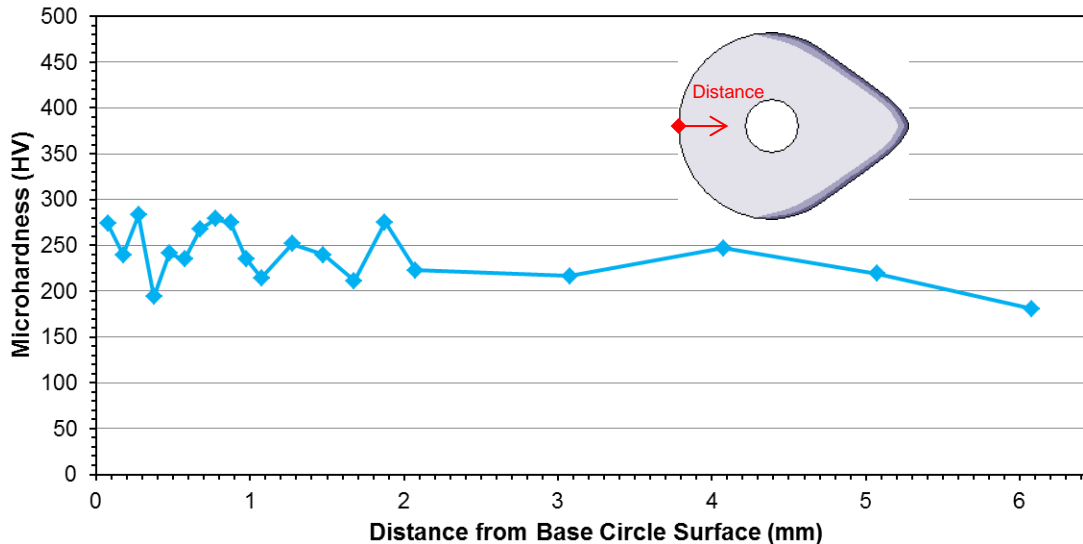
Microhardness: Production Cams

The microhardness values measured on the across the nose of the cam is shown in the top graph. The hardness near the surface is about HV900 which is consistent with the ledeburite structure observed on the surface (see previous page). Through the second layer of the case (martensitic grey cast iron) the hardness is about HV600 (again consistent with the observed microstructure). The core (pearlitic grey iron with type A graphite) has a hardness of about HV250.

The microhardness values measured across the surface of the base circle (lower graph) hover around HV250 as no case hardening has occurred in this region and the microstructure is that of the pearlitic case iron observed in the bulk of the cam lobe. The small fluctuations closer to the surface here are due to the work hardening effects of the machining process.

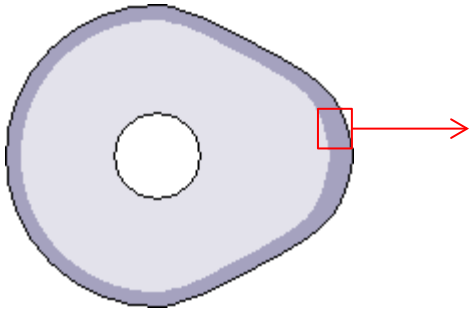
Figure 1

The microstructure of the test cams (used at Intertek and SWRI) also consists of a case hardened structure typically seen in flame hardened or induction hardened grey cast iron specimens. The schematic of figure 1 shows the observation that the case is present through out the entire periphery of the lobe (unlike the production cams discussed in previous pages). The low magnification micrograph of figure 2 encompasses the observed hardened surface layer (case) and the core microstructure. The microstructure of the case (fig. 3) consists of a fine type D (dendritic) graphite network in a martensite and retained austenite matrix (giving the observed HV400 hardness). The microstructure of the transition region between the case and the core mainly consists of similar dendritic graphite in bainite and fine pearlite and small volumes of free carbide (figure 4). Further away from the surface of the lobe, the microstructure of the core (figure 5) transitions from dendritic graphite in a pearlitic matrix to more of type A graphite flakes also in a predominantly pearlite matrix.

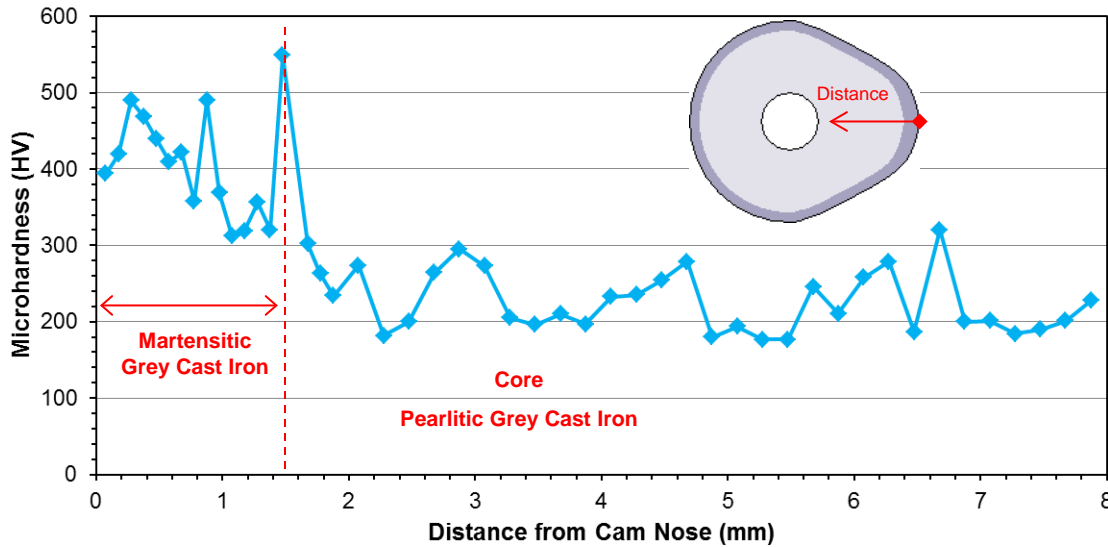
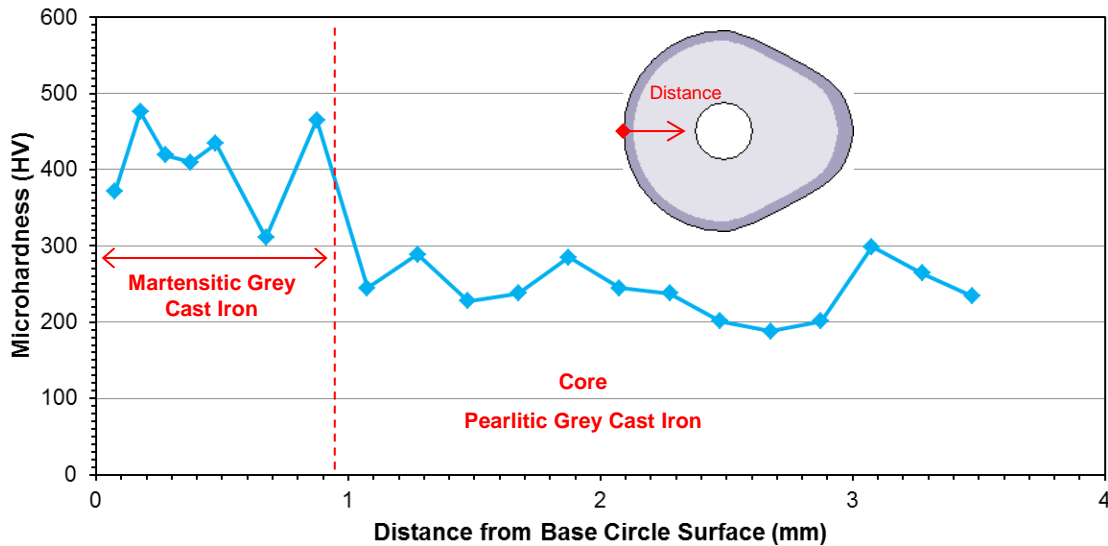
Microhardness: Test Cams

Microhardness is measured across the nose of the test cam similarly to the case of the manufactured cams. The hardness of the hardened case averages around HV450 near the surface and transitions to HV250 in the core (see top graph). Both these values are consistent with the observed microstructure of the cam in the case (i.e. martensitic grey cast iron) and the core (pearlitic grey cast iron with type D and A graphite).

As the case hardening is done along the entire surface of the cam, microhardness measurements across the surface of the base circle (lower graph) yield the same values as the measurements across the surface of the cam nose with a slightly thinner hardened case due to geometry of the cam and its effect on heat transfer during the case hardening heat treatment process.

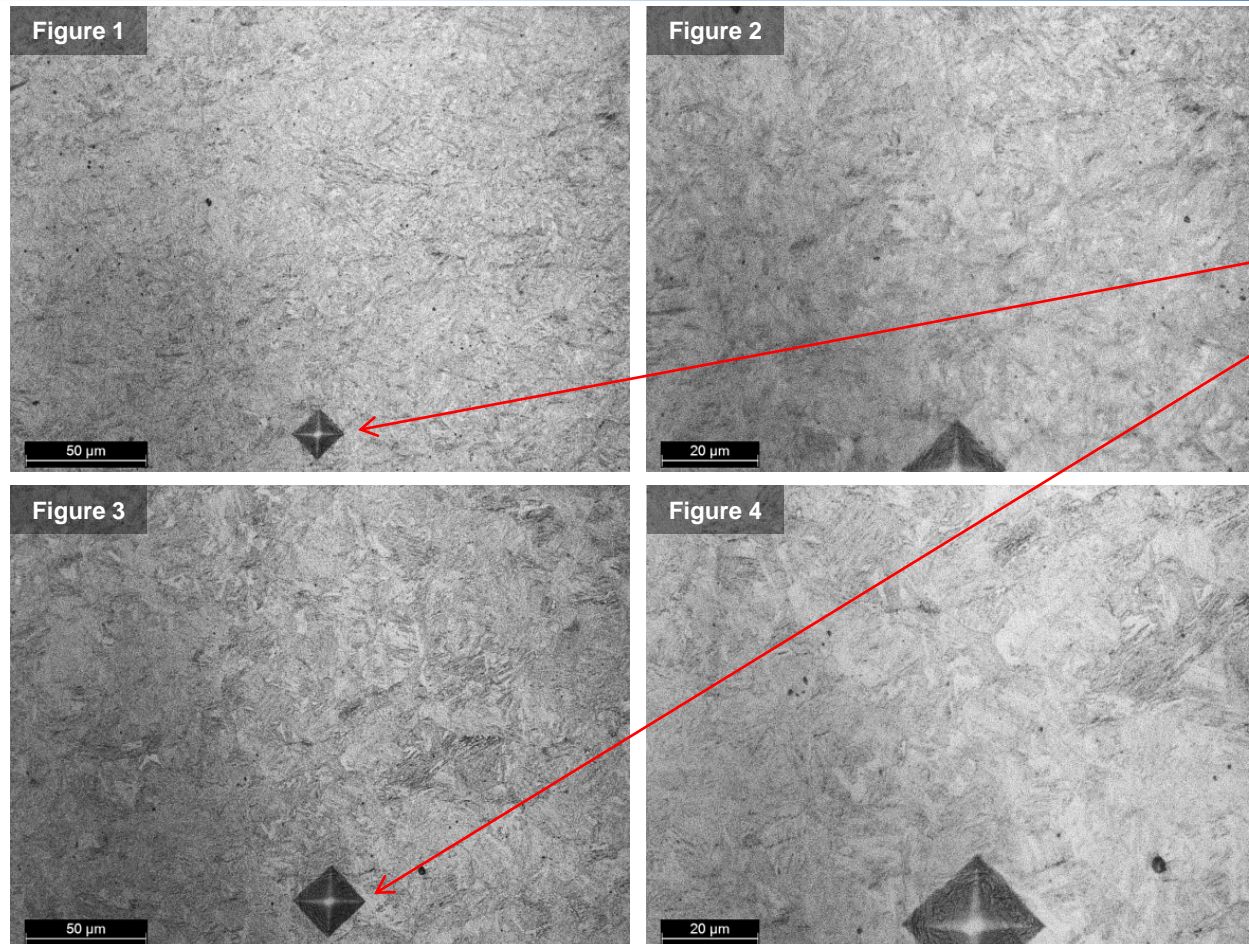
Microstructure: Lifter

Microhardness measurement indentation marks (same scale/magnification)
Note difference in size of indentation marks in spite of similar microstructure.

Microstructure observed in these micrographs appears to be Widmanstätten Pearlite/Ferrite that has undergone case hardening. The microstructure in case (surface region) is visually identical to the core microstructure (compare figures 1 and 2 with 3 and 4). The etched pattern on the surface (similar to the schematic shown here) as well as the microhardness data (see next page) along the cross section of the tappet suggest the existence of hardened case. The microhardness values measured, along with the microstructural observations shown here point to nitriding as the mostly likely case hardening heat treatment used on this part.

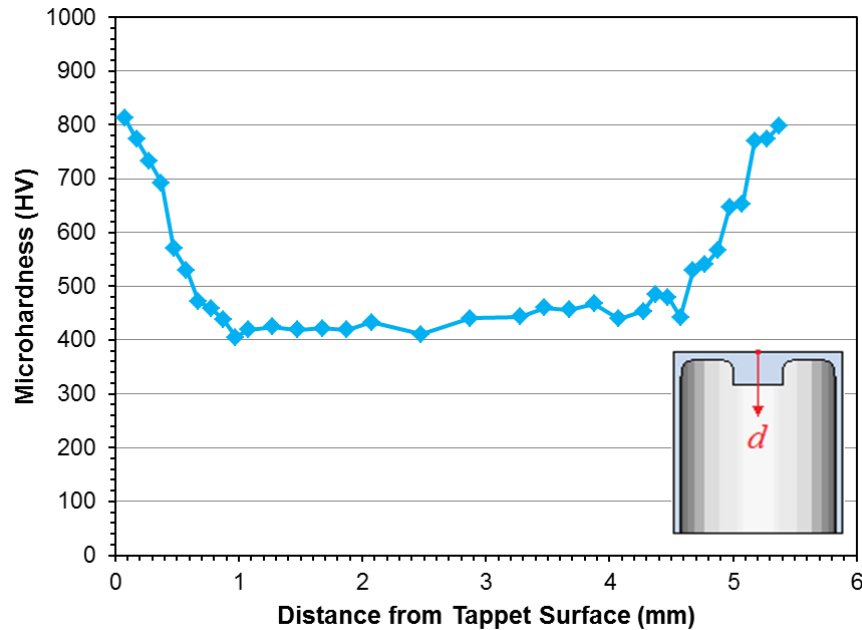
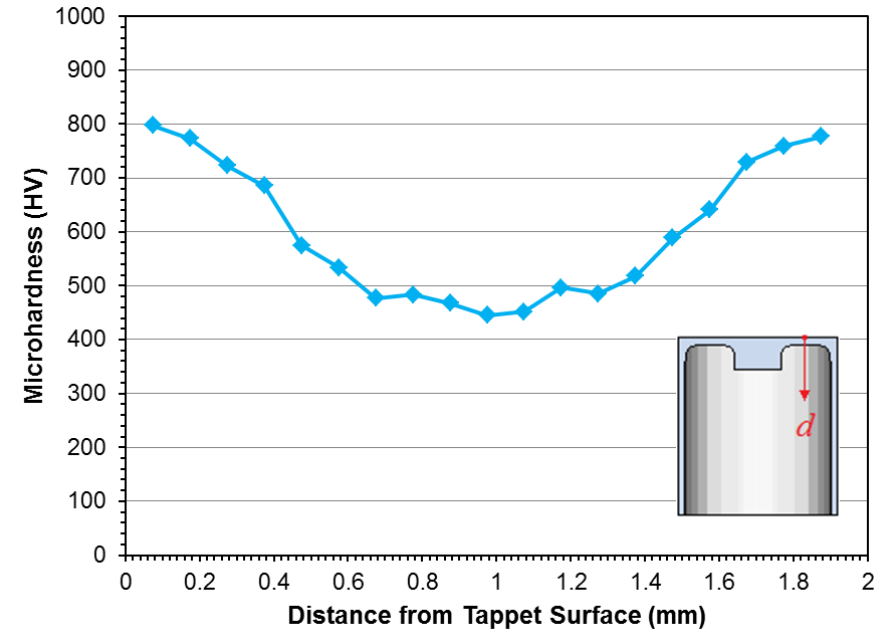
Microhardness

The two graphs show the microhardness data measured across the cross section of the tappet at two different locations as shown in the schematics that accompany each of the graphs. With an average hardness of about 850 HV near the surface, this layer is substantially harder than the core which has an average hardness of about 420 HV (see next page graphs).

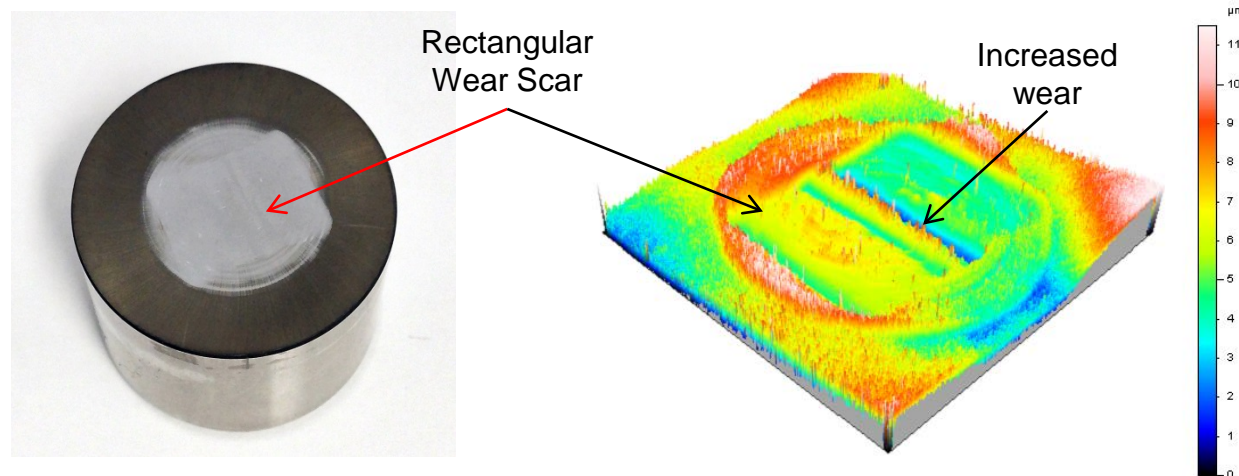
Wear Analysis – Tappets

- An examination of the wear scar on tappets reveals a wear pattern indicating lack of rotation in most tappets from the failed test. While the intake tappet of the passing test have circular scratches and a symmetric wear pattern indicating full and constant rotation of the tappets, the wear scars from the failing test, although appearing to have general circular shape, do not have a circular and symmetric topography with some of them having a rectangular wear scar within the circular polished area. The intake tappet 1 from that test is shown here as an example in which the wear scar indicates lack of constant rotation of the tappet during the test. The three dimensional profile of the wear scar clearly shows a rectangular area of increased wear due to stopping of rotation and the sliding of the cam nose on one location on the surface of the tappet.

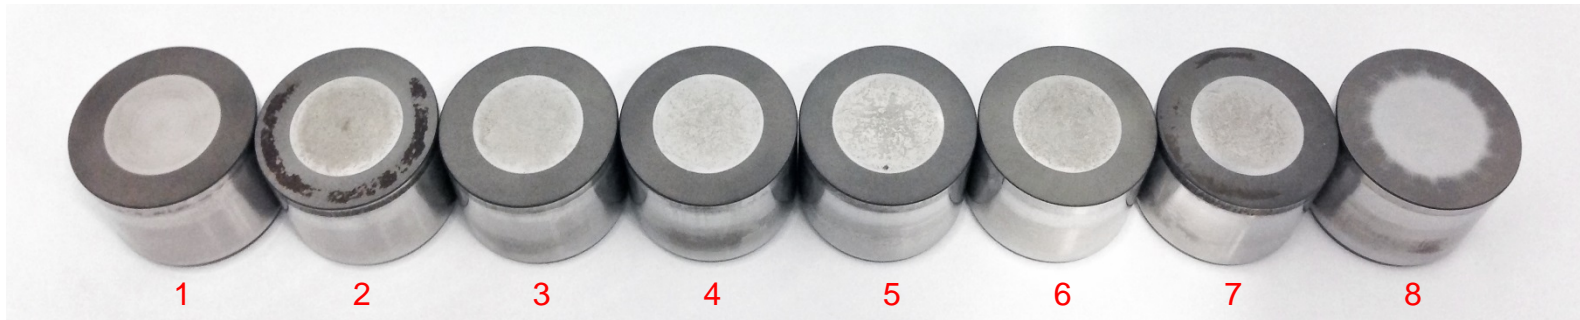
Intake tappets from a failed test

- The wear scars on the top contact surface of each tappet as well as the wear scar on the integrated tappet shim were probed to examine any quantitative and qualitative correlation between cam wear and wear at these contacts.

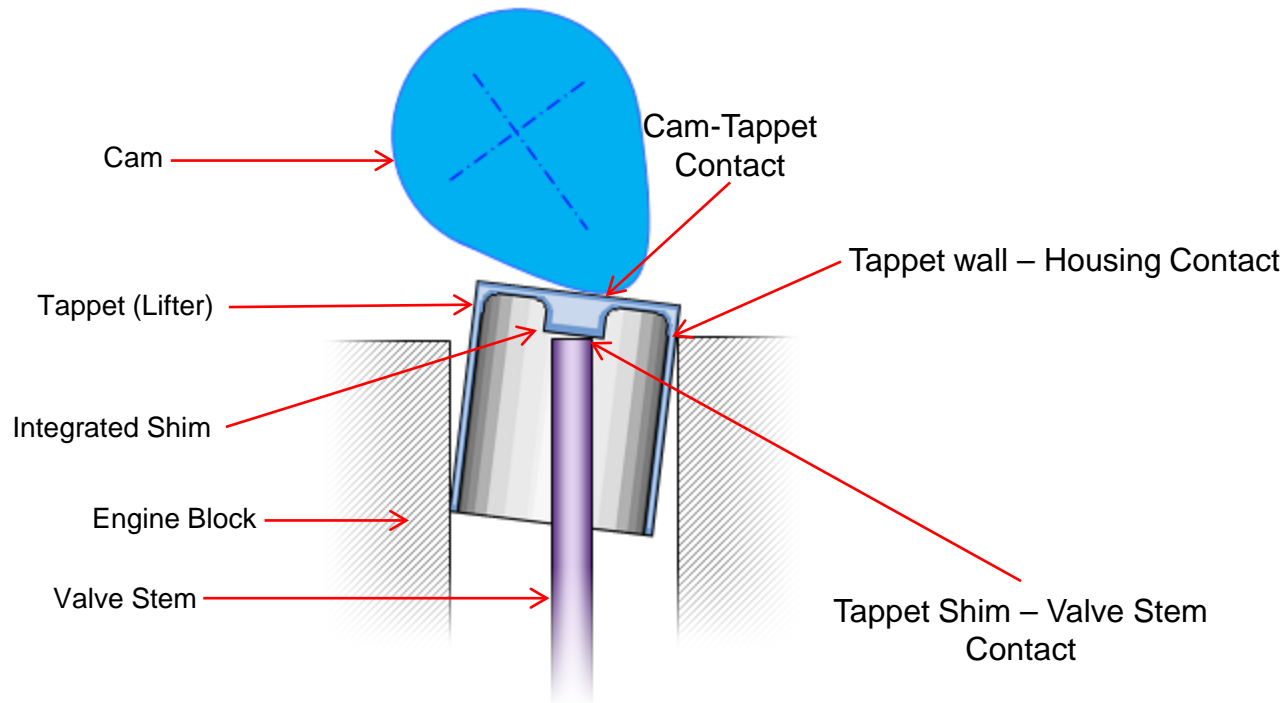
5. Tilting of the tappet: Due to issues such as excessive wear of the bore walls of the tappet housing in the engine block or certain distortions in the engine block, the tappet may become tilted and stuck inside its housing preventing its rotation. This is schematically shown on next page.
