Report of Meeting
L-37 Surveillance Panel Teleconference

April 20th, 2010

**MATERIALS ENGINEERING LAB REPORT
DANA HOLDING CORPORATION
3939 TECHNOLOGY DRIVE.
MAUMEE, OH 43537**

LAB NO.	: 2010-0351	PART NO.	: 060-GP-105
PART NAME	: PINION - HYPOID DRIVE FIN	PRINT REV.	: F
REP. TITLE	: GEAR, PINION	MODEL	: 60
MARKINGS	: CH DANA D5 060GP105 41 7 V1L500 JH DANA D5 060GP105 41 7 V1L417 336HG	HEAT CODE	: V1L417 & V1L500
MATERIAL	: STEEL, SAE 8625 PER ES-PM-FW0001	MFG. DATE	: UNKNOWN
VENDOR	: DANA - FORT WAYNE PLANT	SAMP. REQ	: N/A
CUSTOMER	: ASTM (SWRI, LUBRIZOL, AFTON)	VIN	: N/A
TAR NO.	: NONE	MAR NO.	: MAR-4723
JOB NO.	: N/A	REC'D DATE	: 04/09/10
TEST ENG.	: N/A	REP. DATE	: 04/13/10
REQ. BY	: JOE GUZIKOWSKI	NO. OF PAGES	: 3
REP. BY	: JOE GUZIKOWSKI

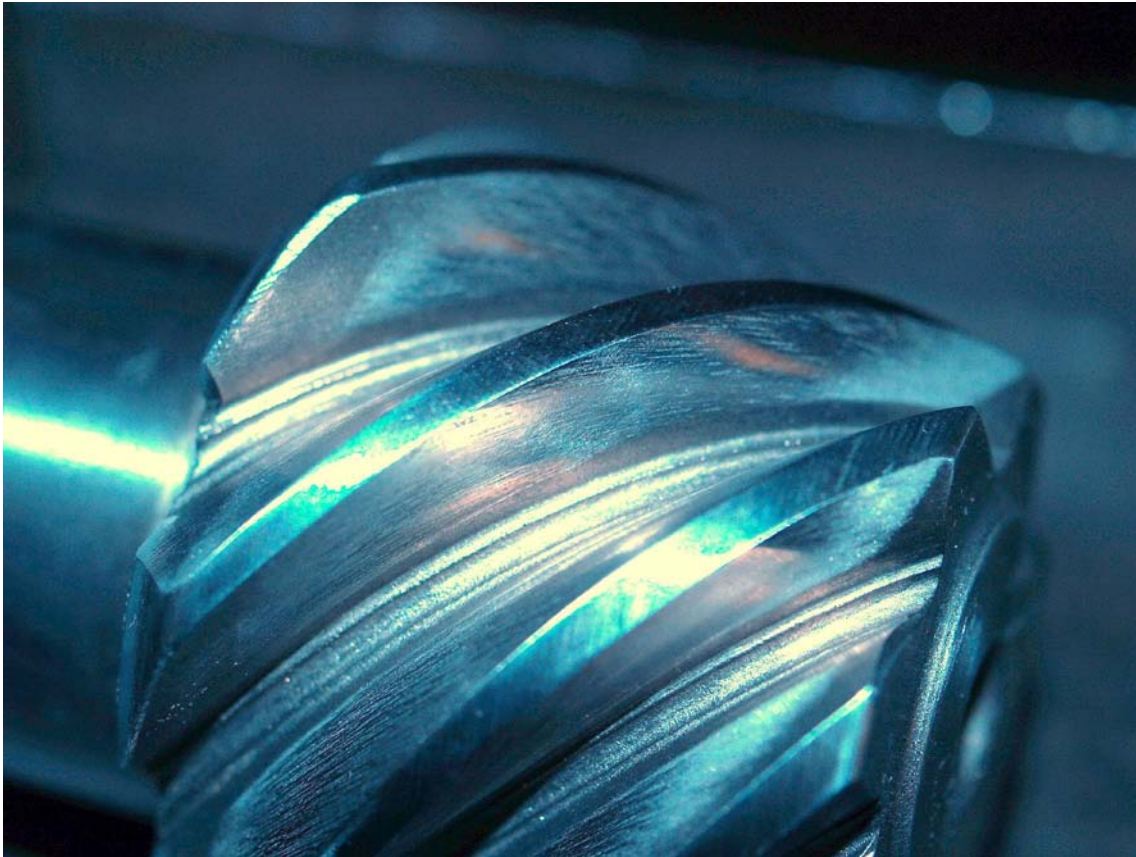
THE V1L417 PINION HEAD EXHIBITS OVERLAPPING DIMPLING ON THE TOOTH FLANK AND ROOT THAT IS CONSISTENT WITH A NORMAL SHOT PEENED PINION HAVING GOOD COVERAGE. THE TOOTH FLANKS HAVE THE EXPECTED APPEARANCE OF LIGHT TO NORMAL LAPPED SURFACES STILL EVIDENT AT BOTH THE HEEL AND TOE ENDS.

FIGURE 1 OVERALL MACRO OF V1L417 PINION HEAD

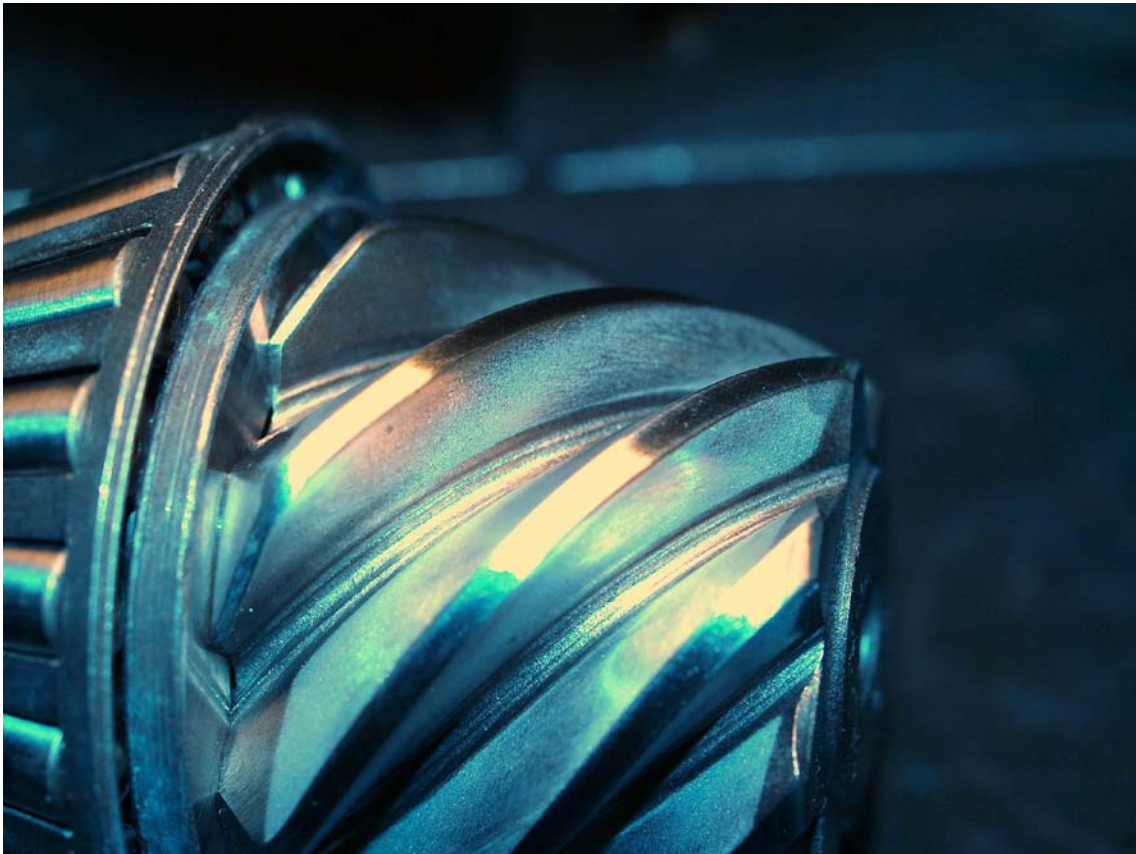
THE V1L500 PINION HEAD EXHIBITS CONSIDERABLE DIMPLING ON THE TOOTH FLANKS AND ROOT THAT IS CONSISTENT WITH PARTS THAT HAVE BEEN SHOT PEENED FOR AN EXTENDED LENGTH OF TIME. THE TOOTH FLANKS HAVE THE APPEARANCE OF BEING ONLY SLIGHTLY LAPPED WITH THE LAPPING EXTENDING ONLY FROM THE MID-TOOTH TOWARDS THE TOE.

FIGURE 2 OVERALL MACRO OF V1L500 PINION HEAD

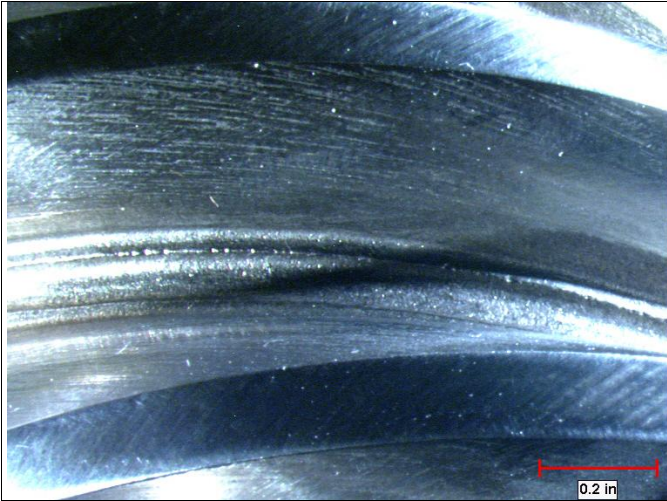
FIGURE 3 V1L417 MID-TOOTH FLANK AND ROOT

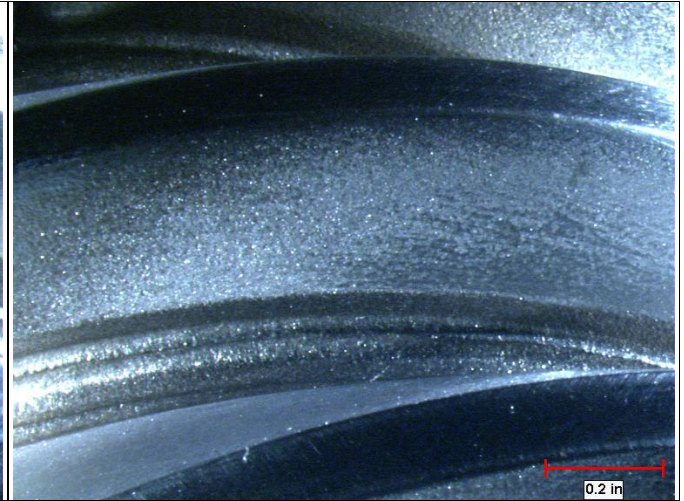
FIGURE 4 V1L500 MID-TOOTH FLANK AND ROOT

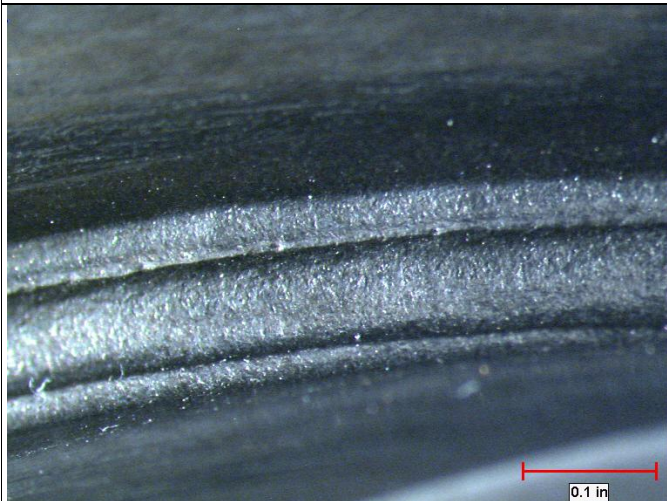
FIGURE 5 V1L417 MID-TOOTH ROOT

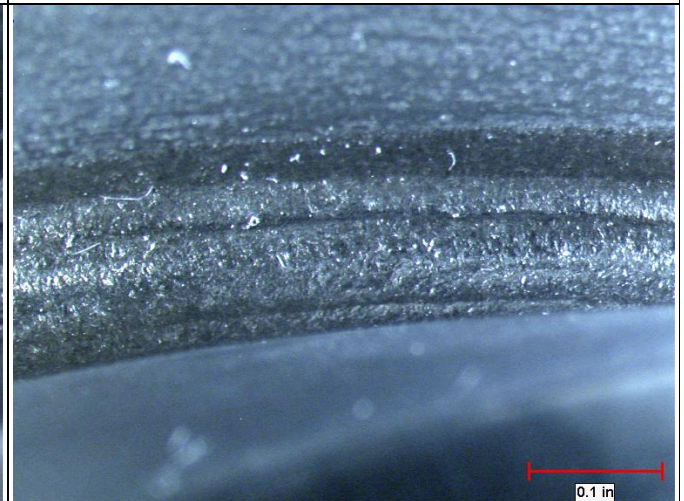
FIGURE 6 V1L500 MID-TOOTH ROOT

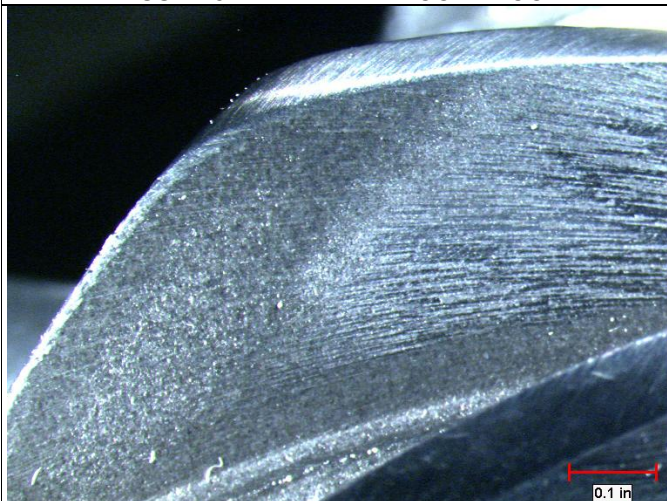
FIGURE 7 V1L417 HEEL TOOTH FLANK

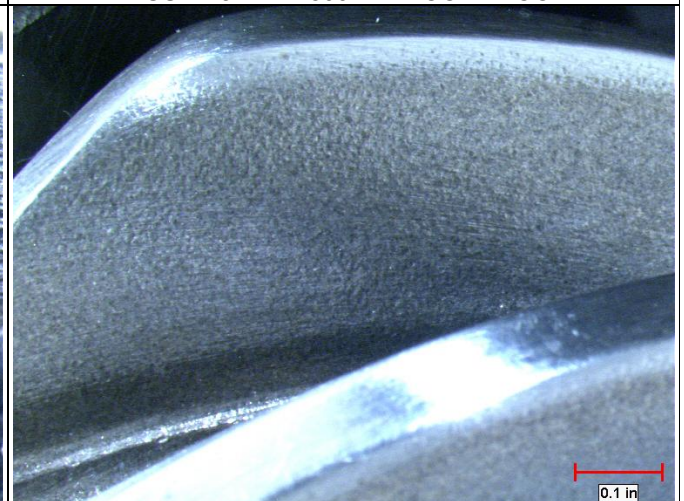
FIGURE 8 V1L500 HEEL TOOTH FLANK
