L42-1 Task force teleconference meeting 4-11-2006

Dana model 44 2006 axle build

To: Cory Koglin
From: Kenny Miller
Date: April 7, 2006
Subject: Problems / progress with current L-42 order.

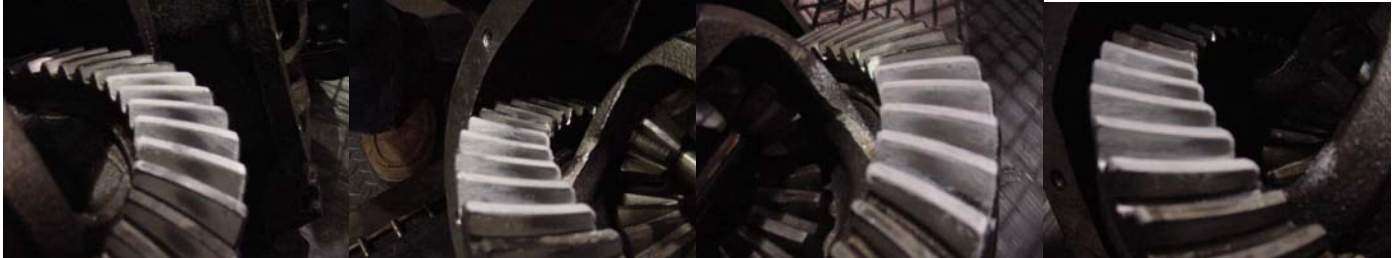
I went to the Lugoff plant last Monday, April 3rd to work with Derek Ottley and the Lugoff assembly team to build the L-42 axle hardware. Through the course of the day, we built 9 diff carrier assemblies. From the start we had an issue of the drive-side contact pattern too near to the toe, i.e. L1 to L0.5. While L1 may have been a deviation-allowed contact pattern, L0.5 was not. The majority of the 9 carriers were the latter. Please see the following pictures:

Picture 2 and 4 above represent the range of drive side variance (includes assy variance for trying to correct the DS toe pattern).

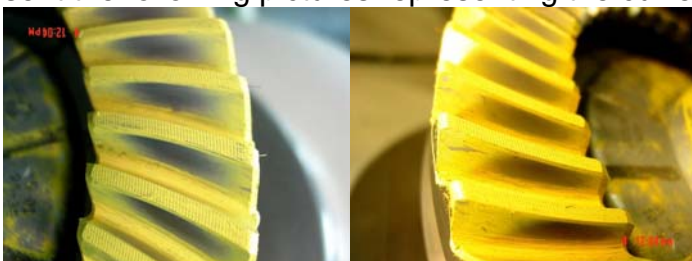
We contacted Lou Pappademos (Quality Mngr, Bevel Gr Products) at Fort Wayne to determine the current lot 'as-manufactured' Gleason test machine contact pattern for the L-42 gearset. Lou sent the following pictures representing the current run of 044GA103X:

The contact pattern development exhibits exactly the desired goals, drive side L2F0 and coast side L3F+1.

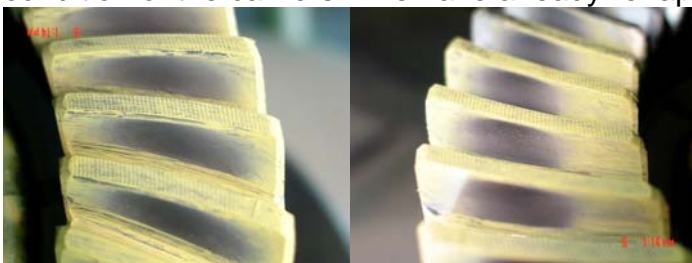
In summary, the L-42 differential carrier assembly is critical to have adequate gerset contact pattern development along with very accurate carrier machining for those features locating the ring and pinion. My assessment is that Fort Wayne met the required development, but due to carrier tolerance stack error, we need to re-lap the drive side of the gerset to account for the condition of the carriers. We have already re-lapped (10) gersets with the following result:

I believe this rework will build correctly (drive L2F0 and coast L3F0 or +1). Note that no re-lapping of the coast was done. I will be traveling back to Lugoff first of next week to build these. Upon achieving successful build patterns (and with your permission), we will proceed with re-lapping the remaining sets to resolve this issue. I perceive this rework will cause no detrimental effects to the labs' testing. Should you have questions or comments, please call.

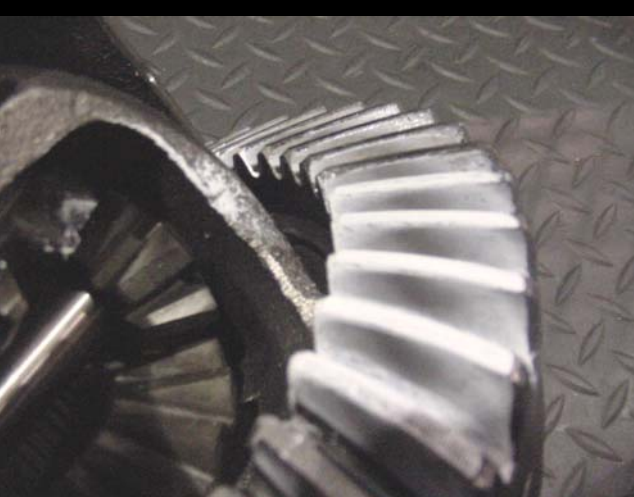
#1 CS L2.7 F0 B/L =.010

This report represents sampling from (10 qty) diff builds of re-lapped (drive side only) gearsets. Re-lap was done to correct too much toe-ward contact pattern position on the drive side. 5 gearsets were recorded and represent the total build variance of all 10 sets.

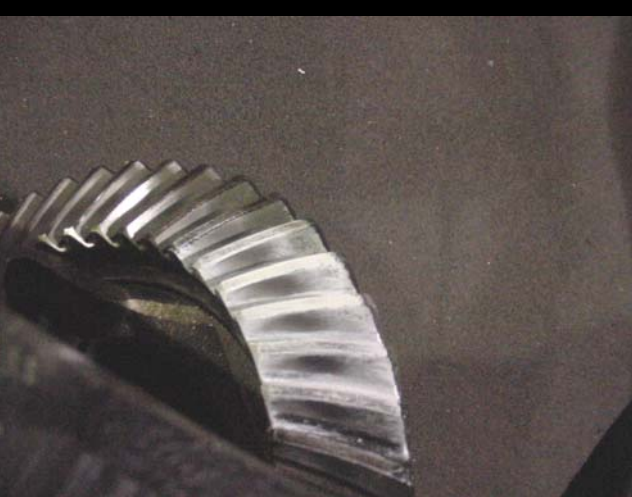
#4 CS L2 F0 B/L =.011

This report represents sampling from (10 qty) diff builds of re-lapped (drive side only) gearsets. Re-lap was done to correct too much toe-ward contact pattern position on the drive side. 5 gearsets were recorded and represent the total build variance of all 10 sets.

Note: Backlash is more than specified maximum of .009". This is necessary to control the coast side -F- number.
