CAT Aeration Test Task Force meeting July 10, 2014

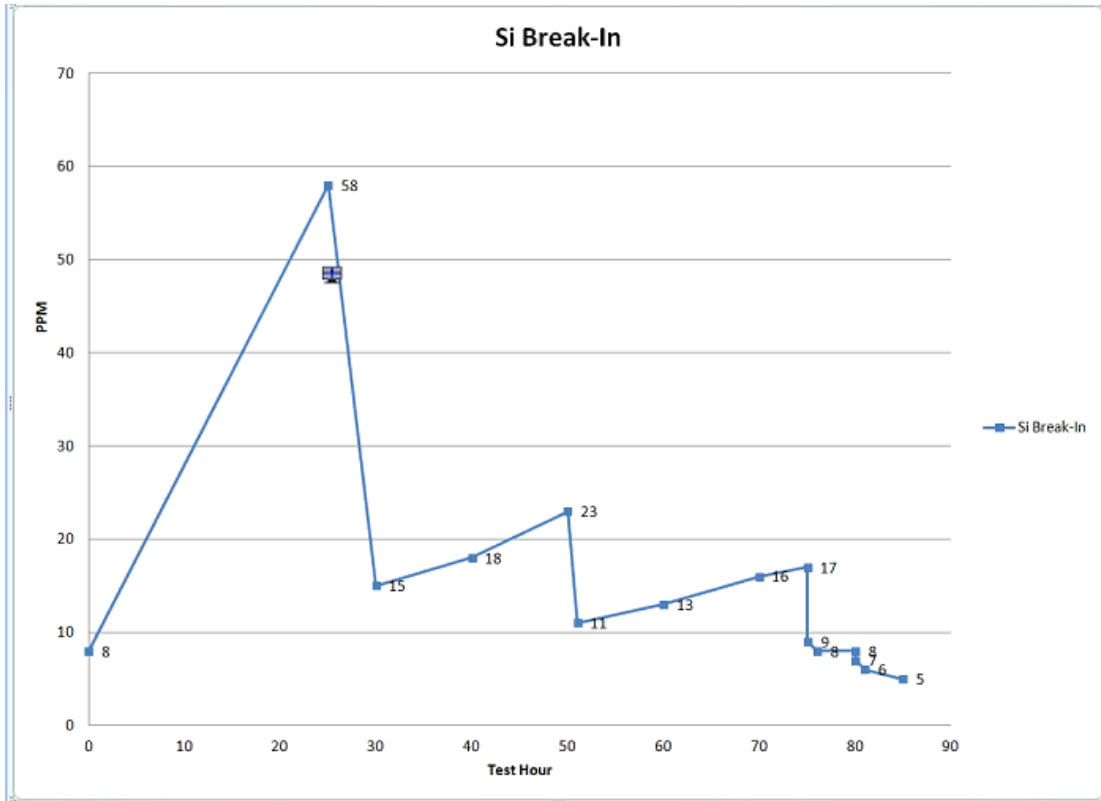
SWRI has completed 75 hours of break-in on engine#2 which was composed of three 25hr full power runs. Then there were two additional 5hr runs for a total of 85hrs. The Si levels came down after the 2 x 5hr additional runs.

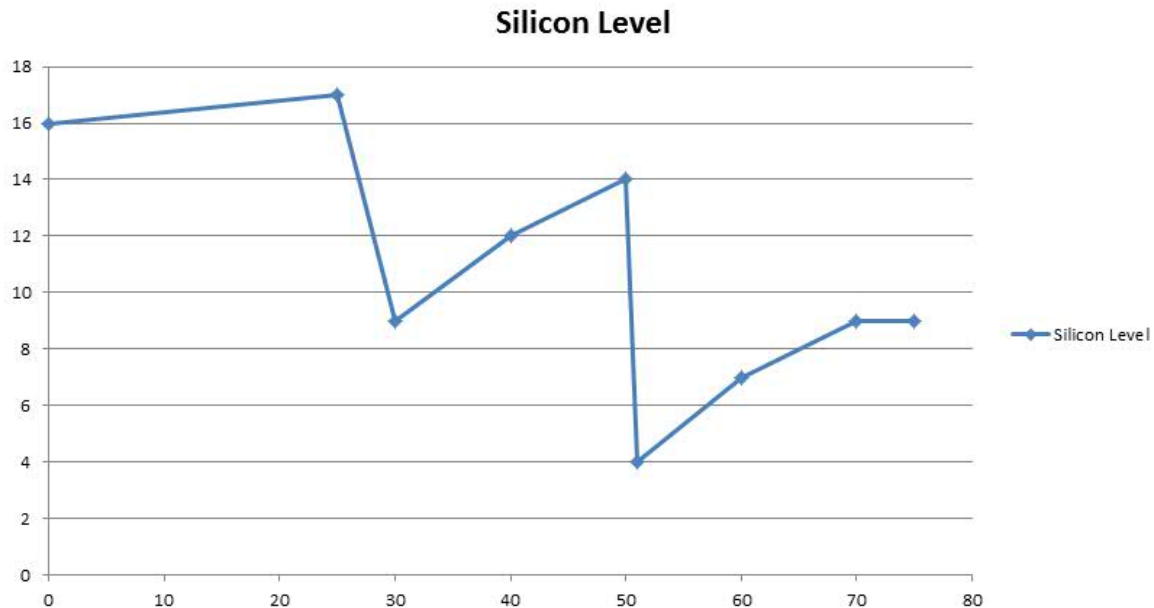
3- Lubrizol engine @ CAT (Engine s/n: KCB48186): 85hrs total on the engine as of this morning. The Si data through 75hrs is shown below. The engine has completed the two 5hr extra drains but we don't have the Si levels back from the lab yet. CAT confirmed that the ICP method used is D5185. **Action:** CAT will send the engine break-in operational data out to everyone including the oil sample data. CAT will work then work with LZ to get the shipping information.

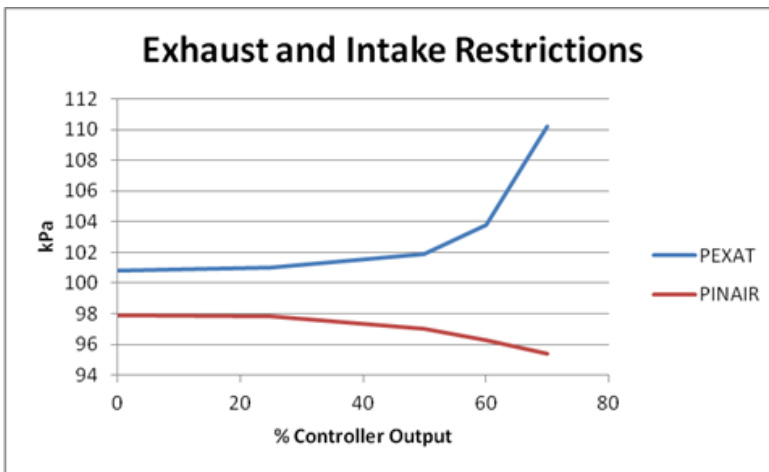
Martin @ SWRI ran a sweep/study on the intake and exhaust restrictions. He observed about a 0.7kpa drop across the new air filter. The TF agreed on decided **96kpa** absolute to the intake, **104kpa** for the exhaust back pressure.

%	0	25	50	60	70
PAMB	98.6	PINAIR	97.9	97.8	97	96.25	95.4
		PINMAN	28	27.9	26.5	25.4	23.9
%	PEXAT						
0	100.8		28				
25	101		28				
50	101.9	27.5			26		
60	103.8	27					
70	110.2	25

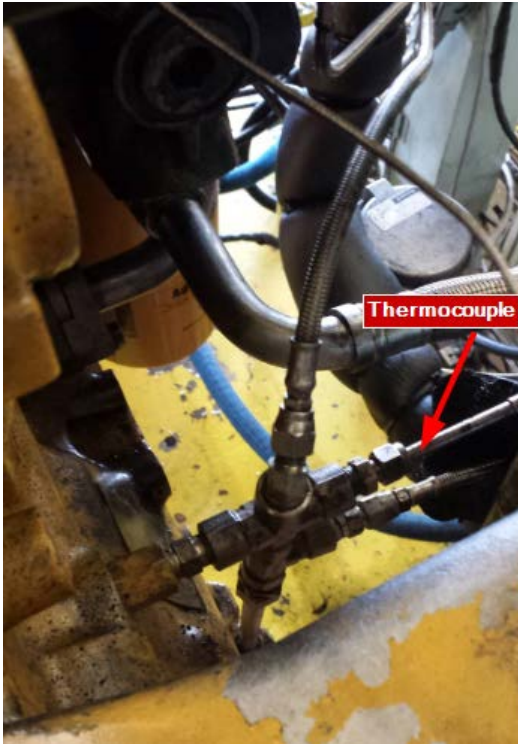
Operational differences discussion: oil gallery fittings & thermocouple depth. The current SWRI thermocouple is too big. The team agreed to replace the current thermocouple with an 1/8" thermocouple. This will prevent it from restricting the flow. Also, the thermocouple will be pushed in all the way into the oil gallery in order to obtain a more accurate reading.
