COAT Test Variability

CAT Surveillance Panel Meeting

4/18/16

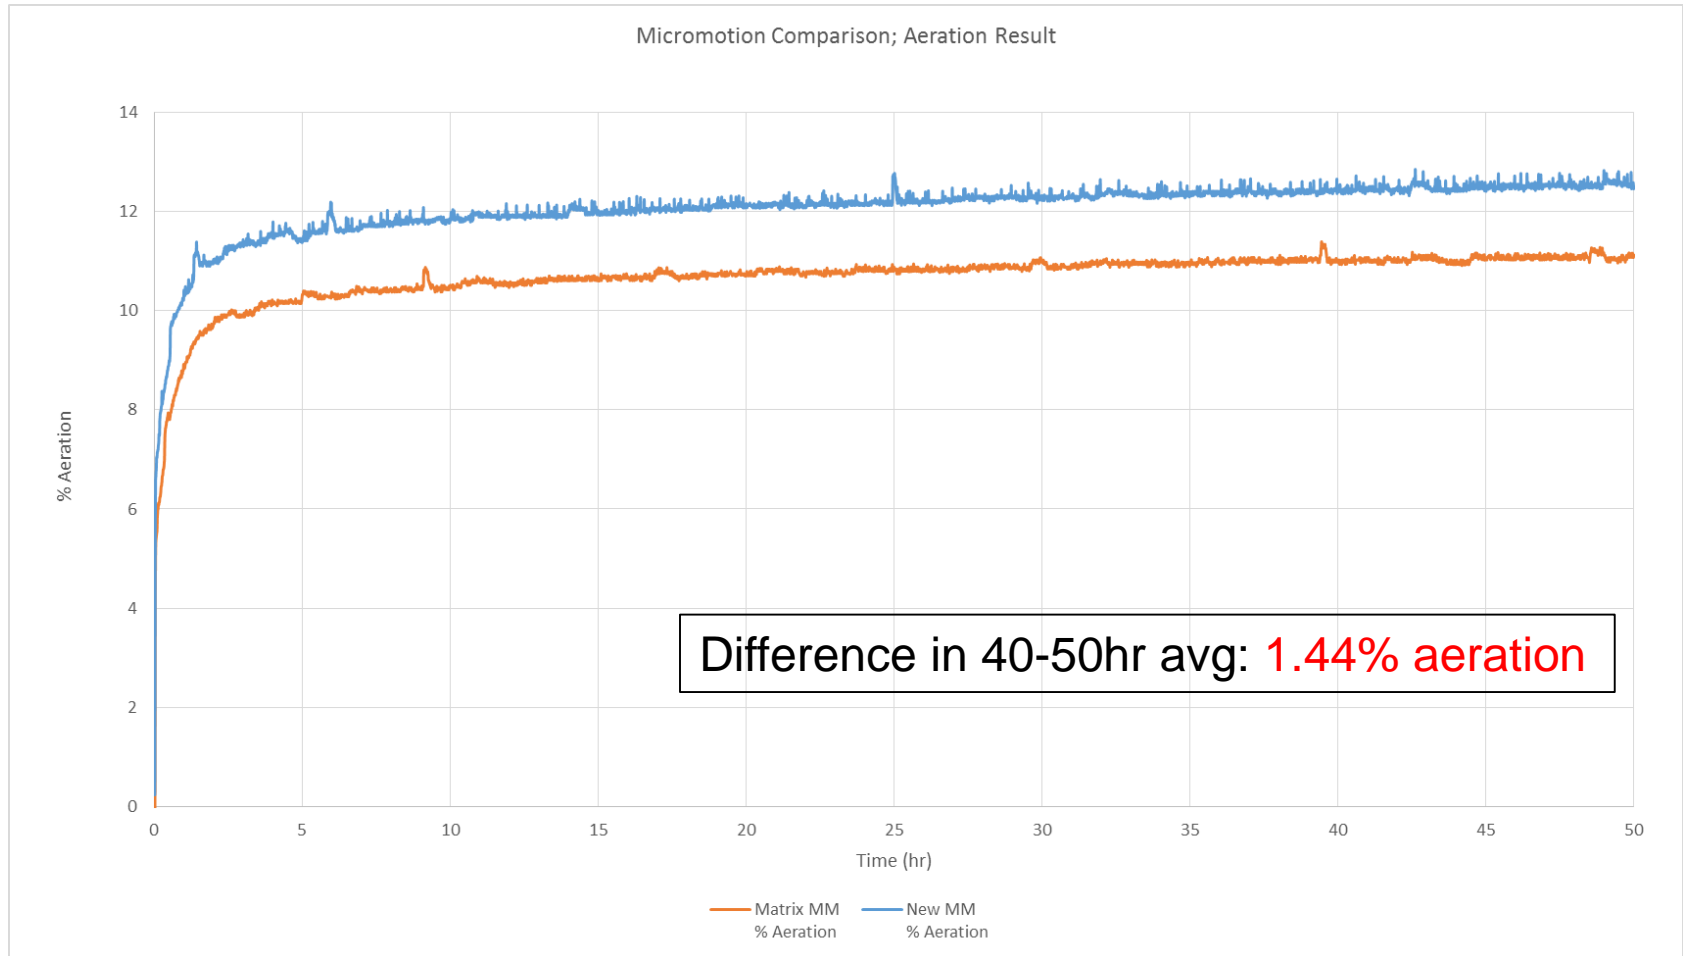
- ❑ Lubrizol introduced a second MicroMotion (MM) instrument to the existing LZ COAT test stand following SP agreement of a one year calibration period on the MM instrument.
- ❑ Reference run on the new instrument resulted in a significant severe shift.
- ❑ Lubrizol followed-up with an internal experiment to assess the potential variability between manufacturer “calibrated” MM instruments within a single test stand.
 - **New MM vs. Matrix MM**
- ❑ Internal work continued to find potential causes for such variability

| New Micromotion TEST RESULT | Average | StDev |
| 40-50 Hour Average % Aeration | 12.4981 | 0.072515 |
| Final Test Hour Average % Aeration | 12.5818 | 0.062921 |

| Matrix Micromotion TEST RESULT | Average | StDev |
| 40-50 Hour Average % Aeration | 11.0519 | 0.058479 |
| Final Test Hour Average % Aeration | 11.0638 | 0.044397 |

Manufacturer “calibrated” MicroMotion instruments that are compliant with the COAT procedure can yield significantly different COAT results in evaluating an identical oil.

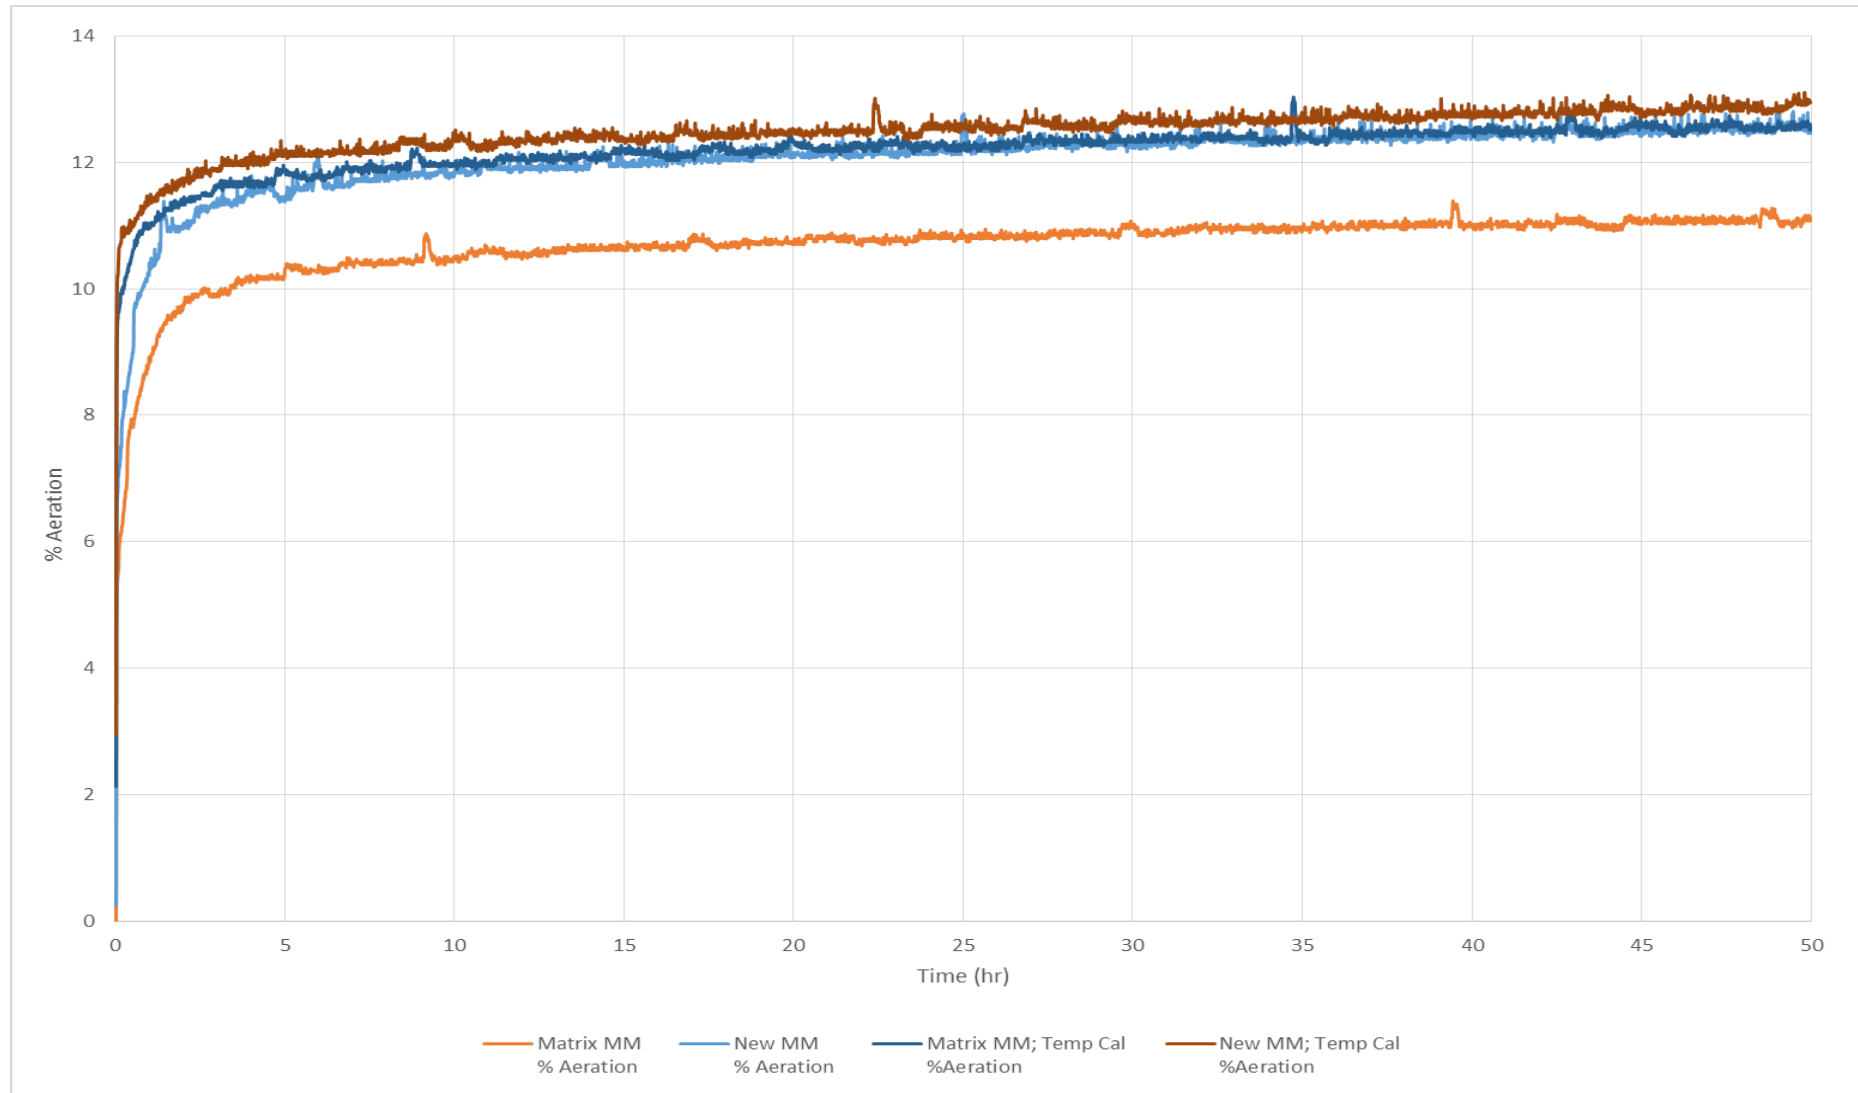
Results – New MM w/ Temp Calibration

- ❑ Density measurement in “older” model MM sensors/transmitters **ARE** affected by the MM temperature calibration.
- ❑ Density measured in the “newer” model MM sensors/transmitters **ARE NOT** affected by the MM temperature calibration.
- ❑ MM temperature measurement on newer MM units is more responsive; i.e. faster time response.
- ❑ “Older” units were utilized for the COAT Precision Matrix.
