# **Detroit DD13 Taskforce Agenda**

## **Meeting Minutes**

**Friday March 1, 2013**

# *Lubrizol* DD13 Taskforce

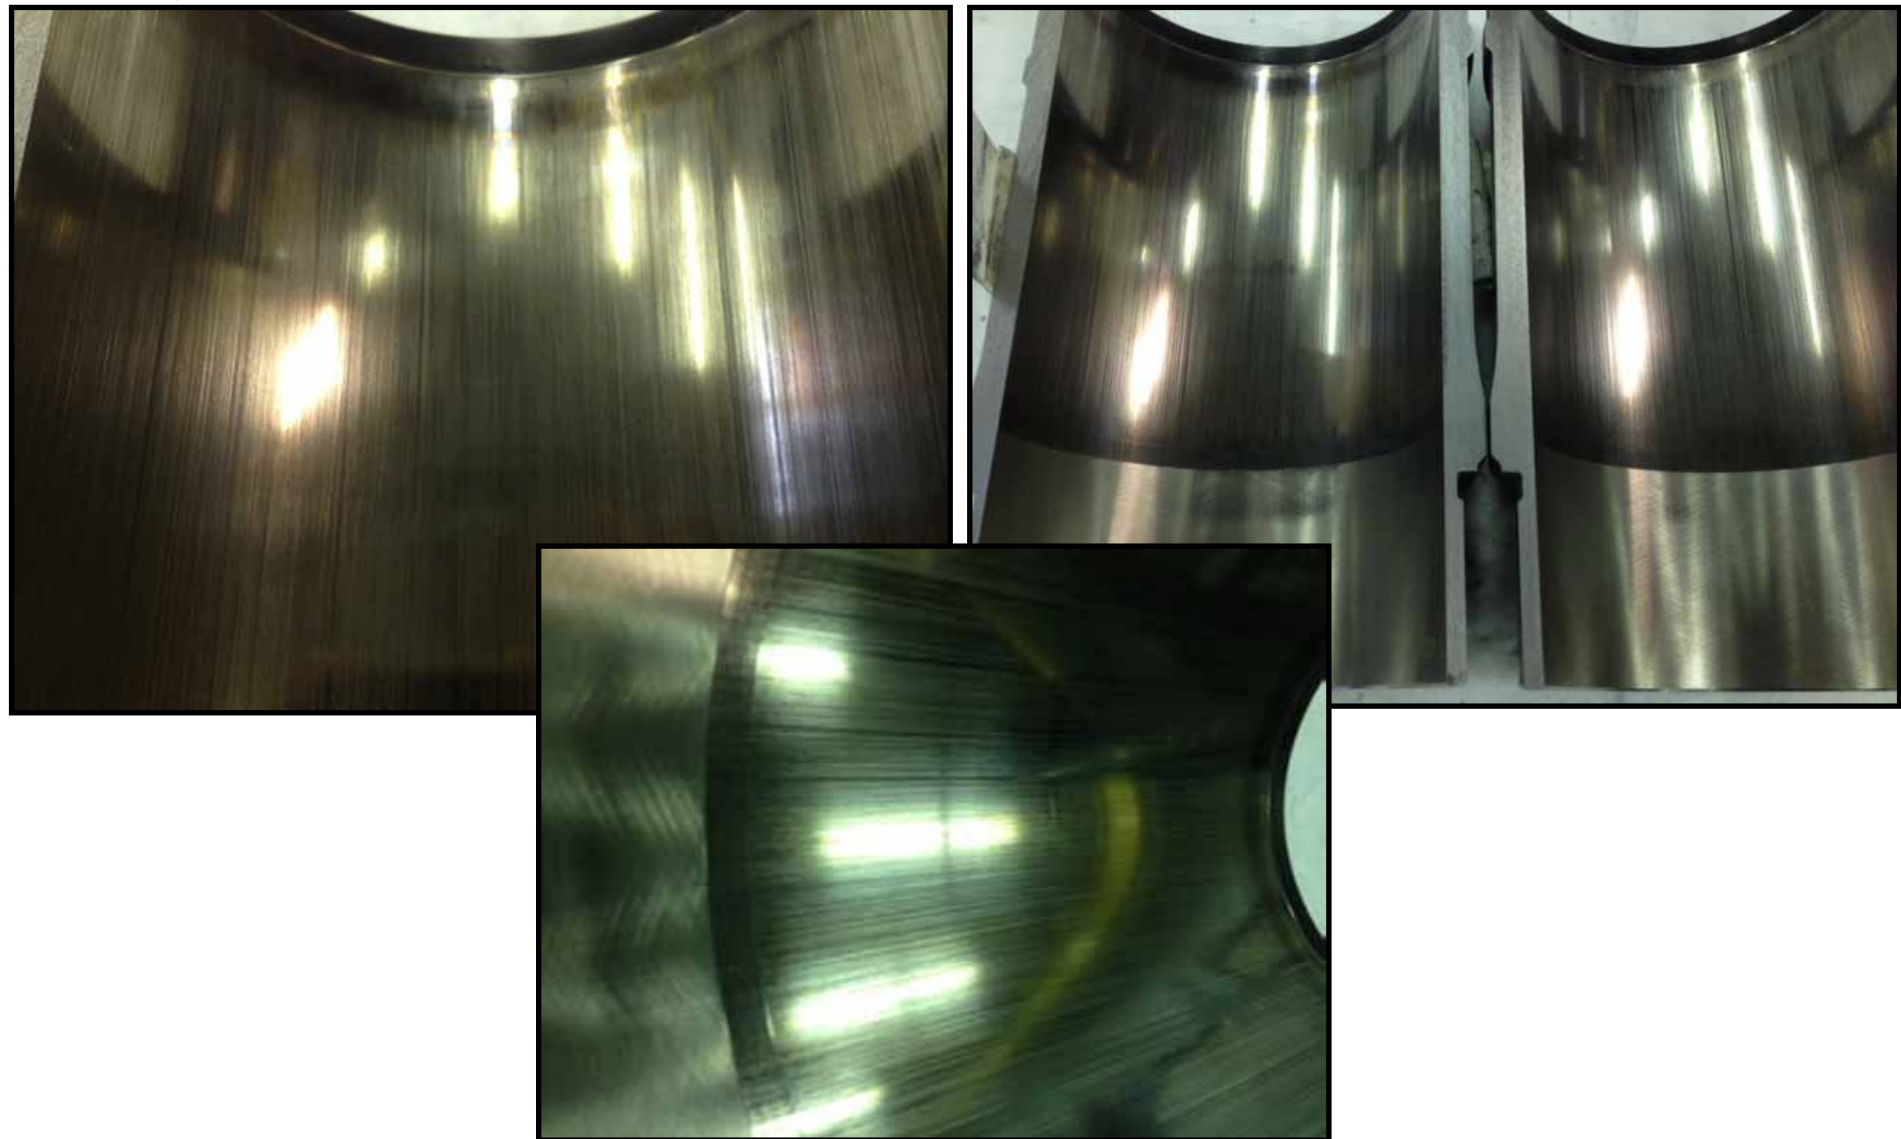
# Cylinder #4

Cylinder #4 was 200 microns. All others were less than 1 micron.

Jim reviewed information about the previous test completed by LZ. Discussion about the oil used, Non-coated vs. coated rings and the test cycle that was run. There was a question about whether there was evidence of oil breakdown and it was stated that there was no data yet. Noted that copper levels were somewhat higher and believed to be from the camshaft bushing area. Reviewed wear data and pictures of all 6 cylinder liners and scuffing of cylinder 4 liner.

- Used LZ “Poor” 2.9HTHS oil
- Non-Coated Top Rings
- Used Detroit “Scuffing” MCM Calibration
- Ran Scuffing Test Cycle
- Test ran for 39 hours
  - Shutdown due to increase in Blowby Flow/ Crankcase Pressure
    - Began increasing at 25hrs when test went to 75% throttle
  - Found Cylinder #4 scuffed

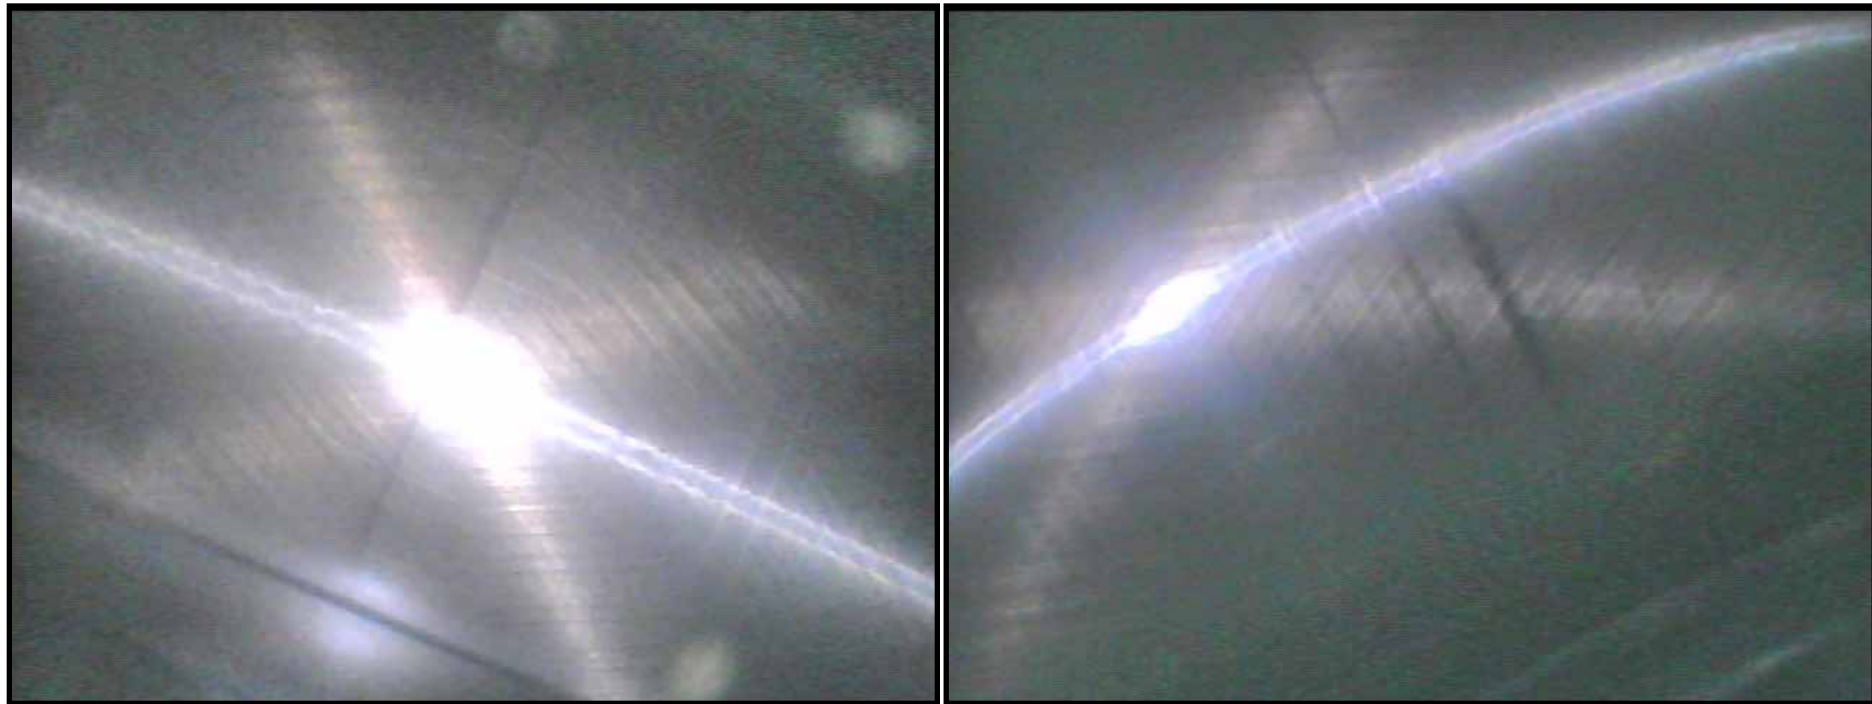
## 700hr Inspection with Coated Rings (borescope)

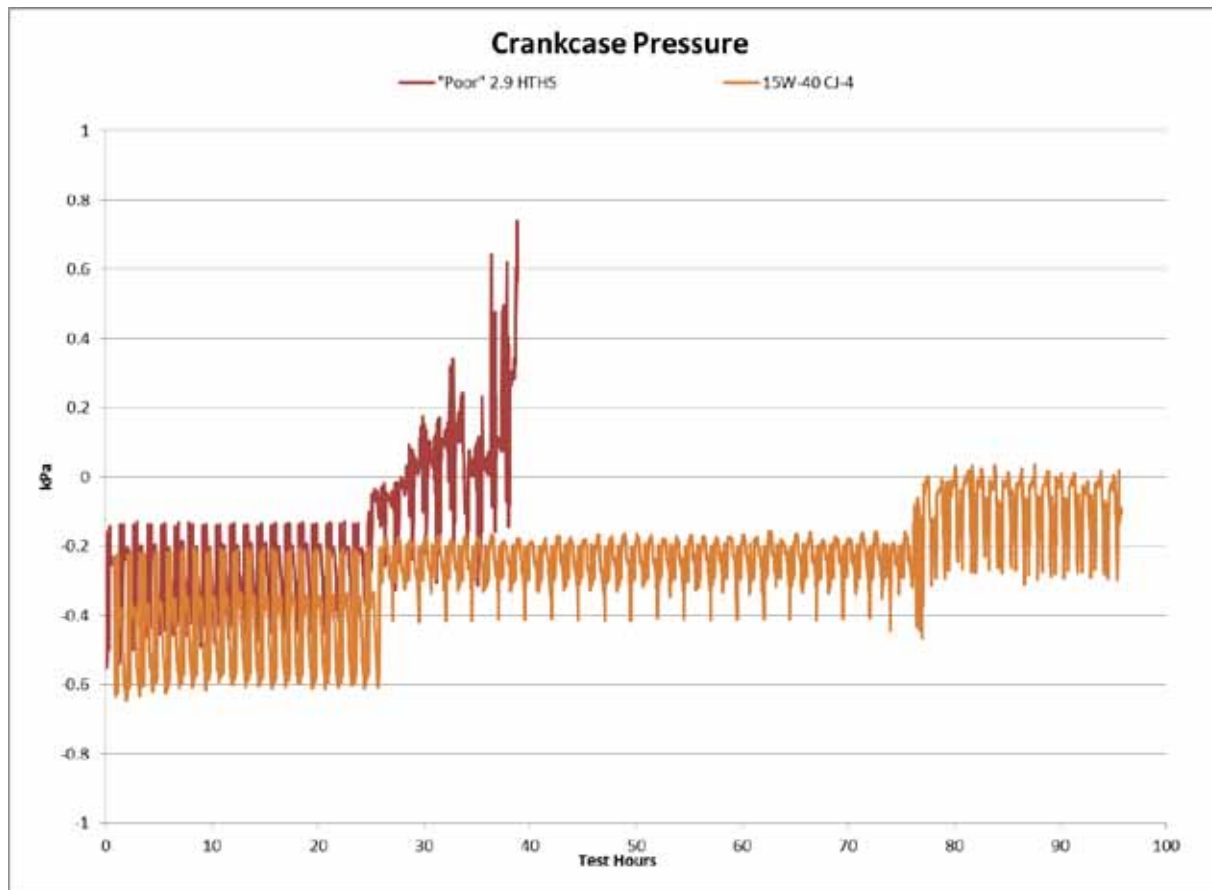
- Commercially available CJ-4 15W-40
- 95 hours on 3-1-13

Jim Matasic presented information on currently running test. Crankcase pressure comparison between previous test and current test presented. There was discussion about why the CCP was "jumping around" less during certain portions of the test. Attributed to throttle position during those test points. Question about controlling oil temp. LZ is not controlling oil temp during testing and has not noted a temp difference between tests. It was noted that difference in labs may drive control of oil temp. A question was asked about live thermostats and they are being used; however the coolant thermostat is blocked open.
