Daimler Surveillance Panel Meeting Minutes

May 8, 2018

DD13 Scuffing Test Liner Analyses

Microstructure Analysis of Batch C & PNB Liners

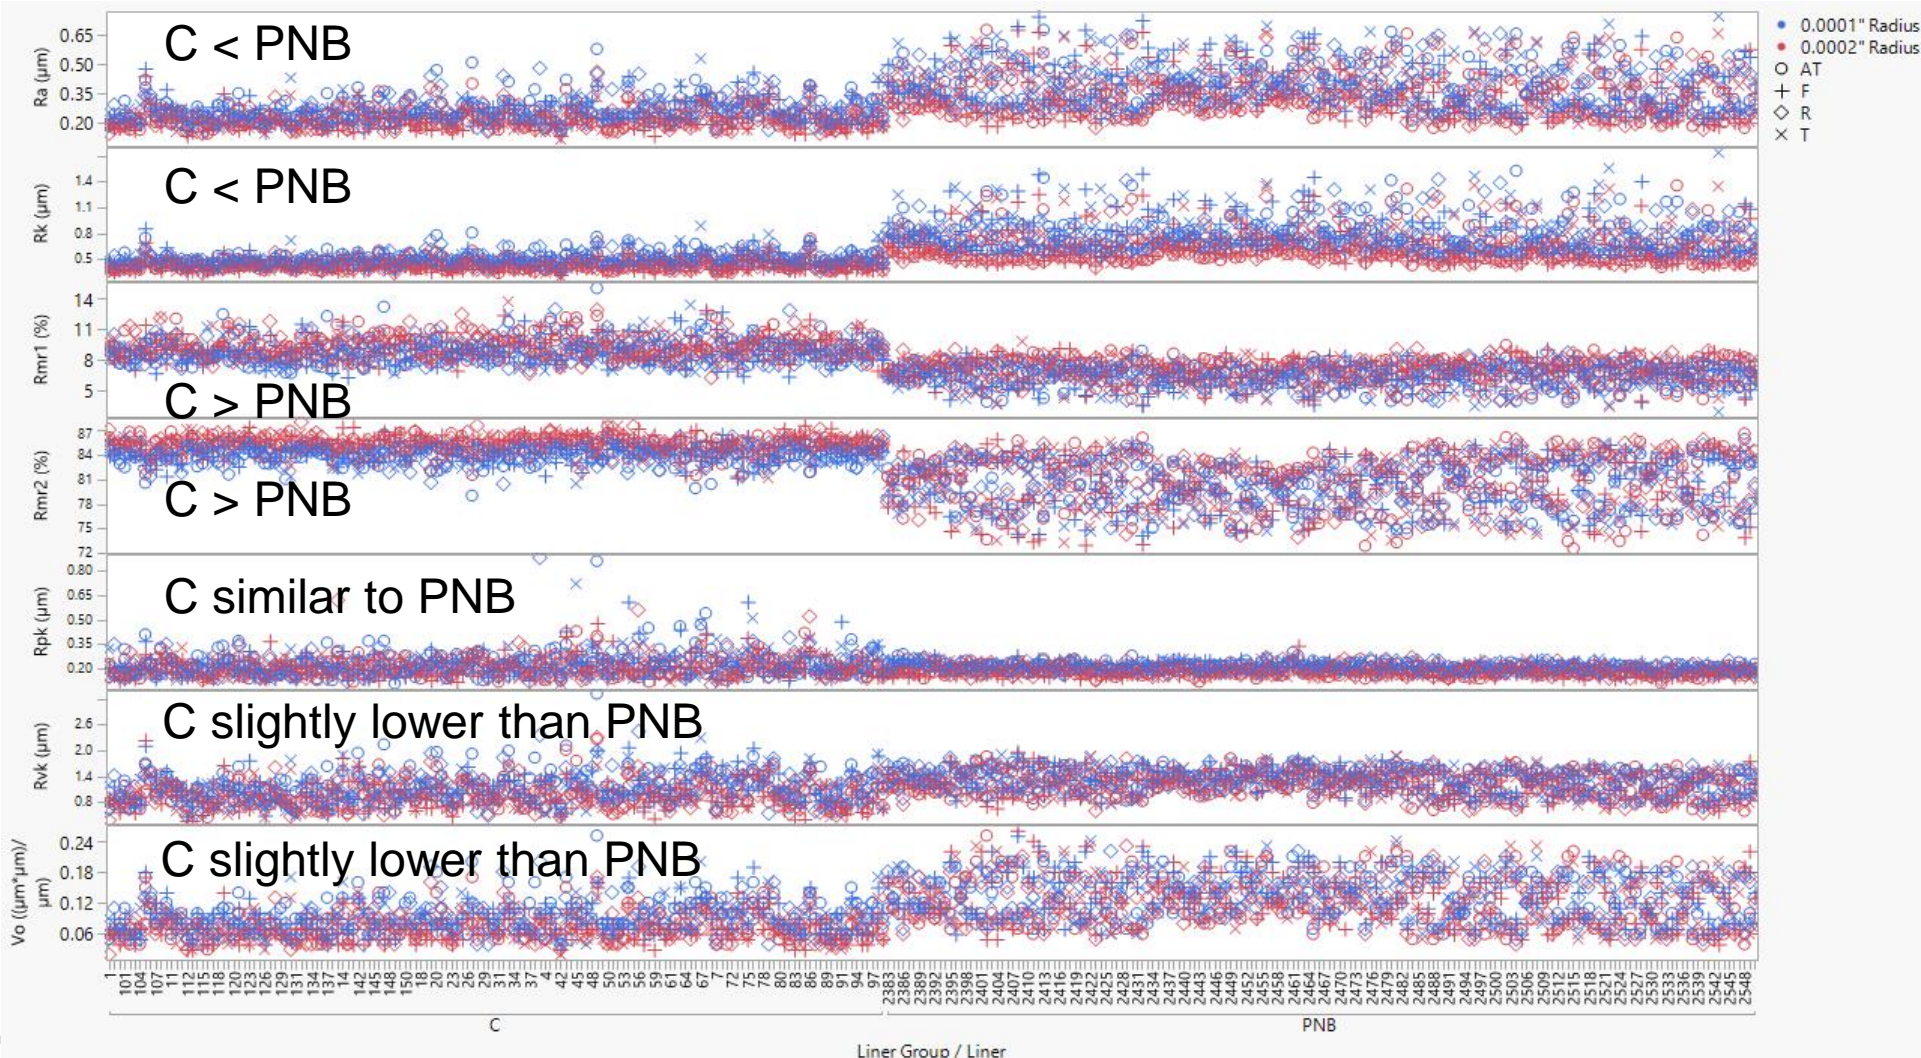
Plot of TEI Liner Measurements shared during March SP Meeting; Recall, liner batches differ for some liner attributes; Batch C liner specs were finalized at that time

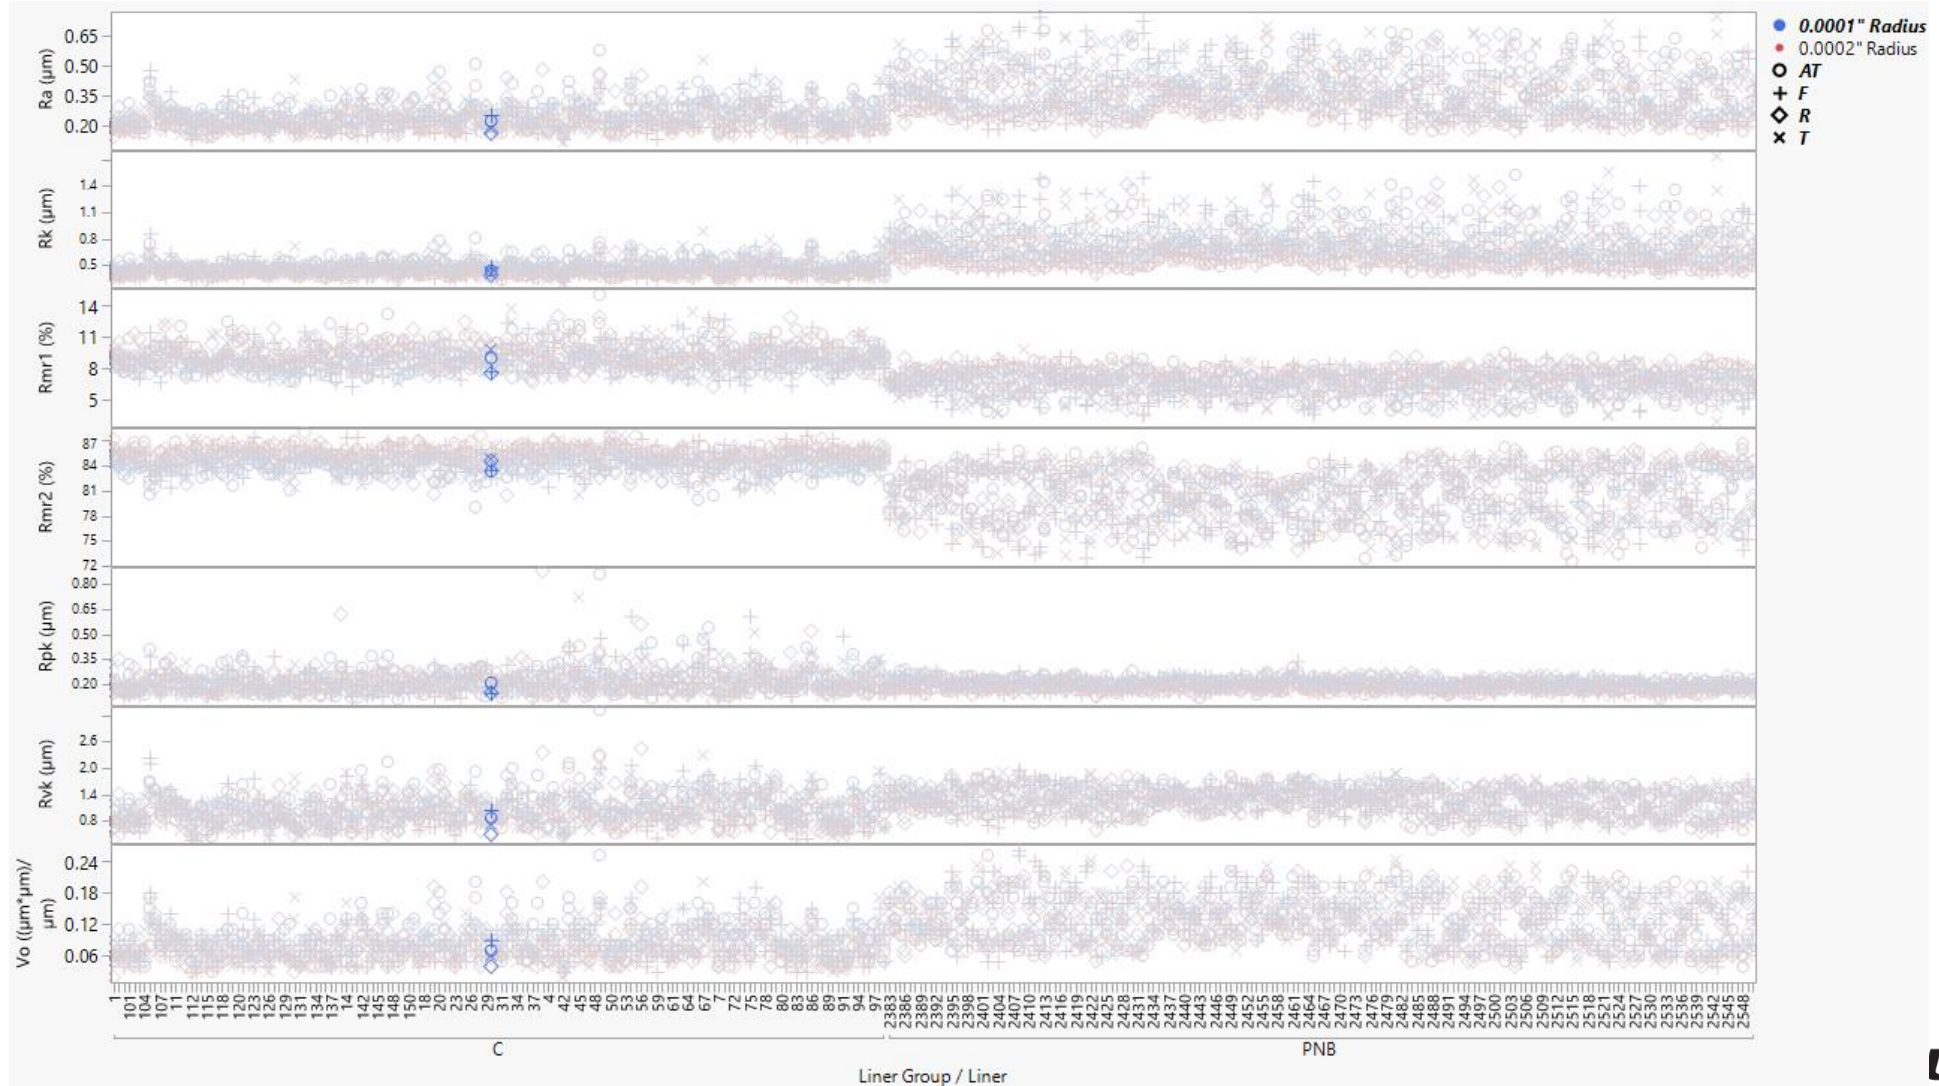
TEI Liner Measurements

Batch C Liner 0003 highlighted (using 0.0001" stylus); in line with other Batch C liners

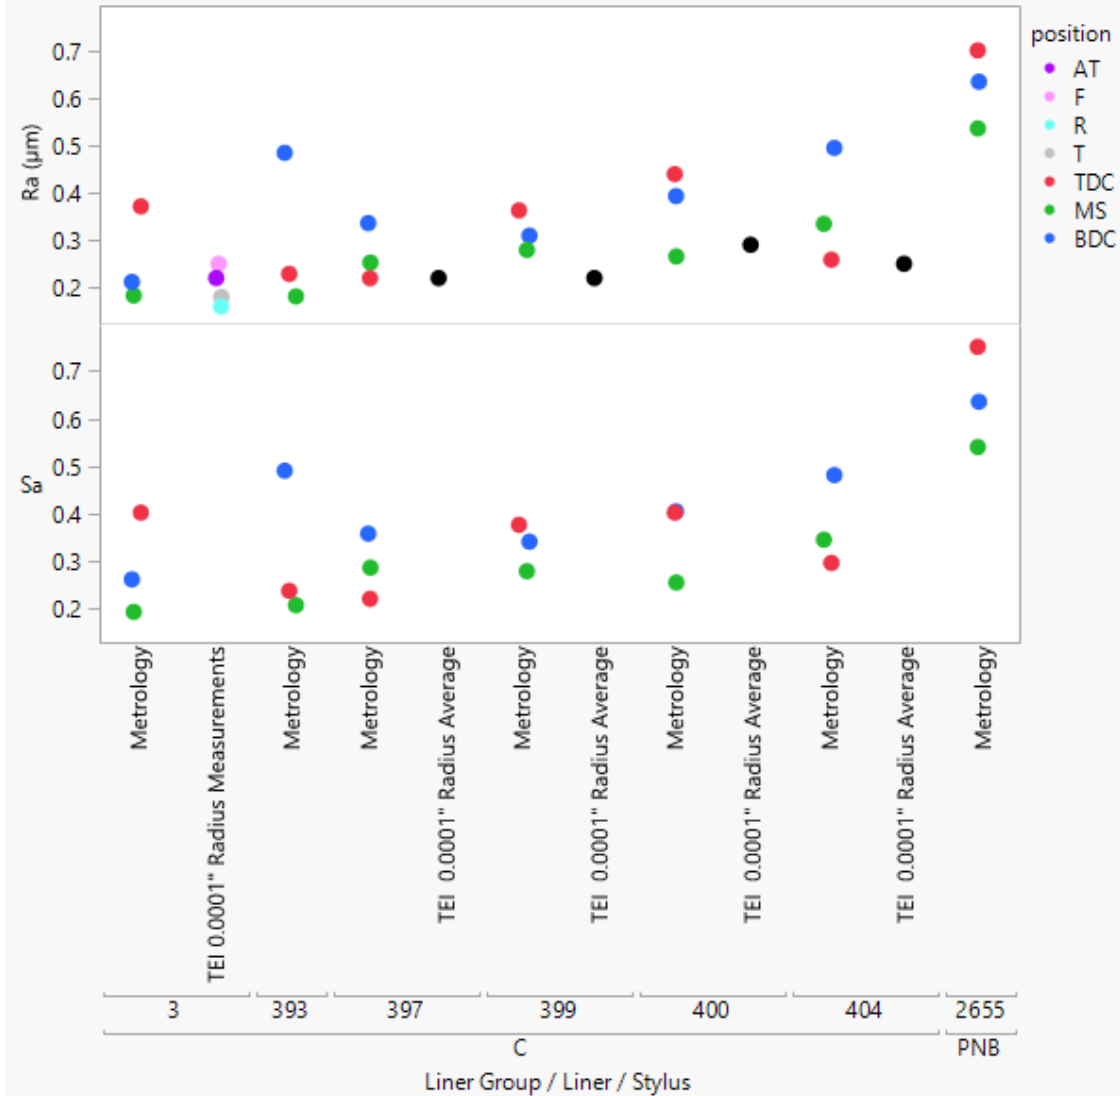
Ra & Sa

The difference between PNB and Batch C liners is consistent with what was observed when TEI measurements were compared between batches (PNB > C)

Metrology measurements appear slightly higher than TEI measurements

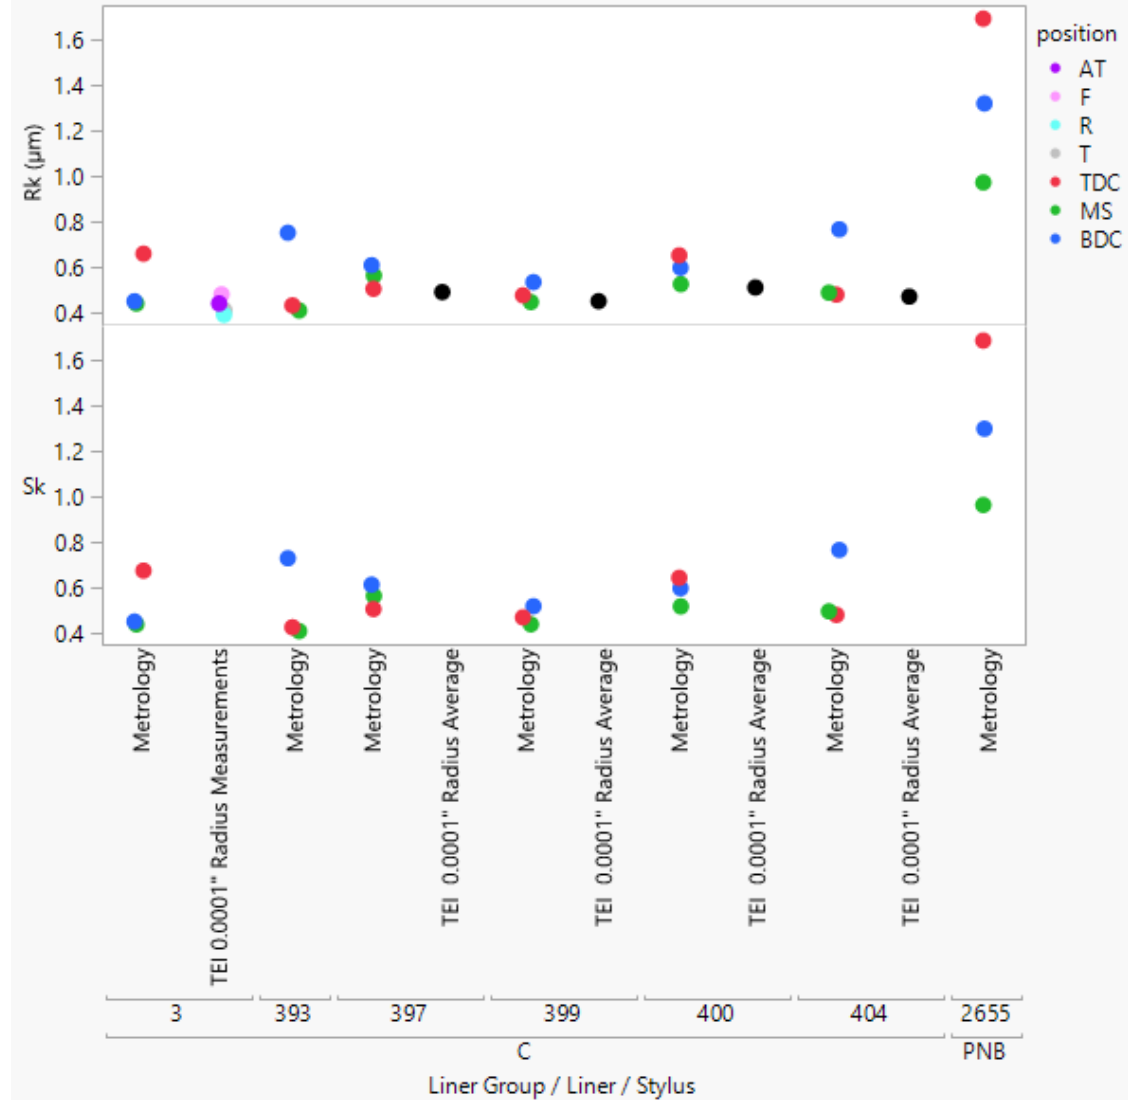
Rk & Sk

The difference between PNB and Batch C liners is consistent with what was observed when TEI measurements were compared between batches (PNB > C)

Metrology measurements appear slightly higher than TEI measurements

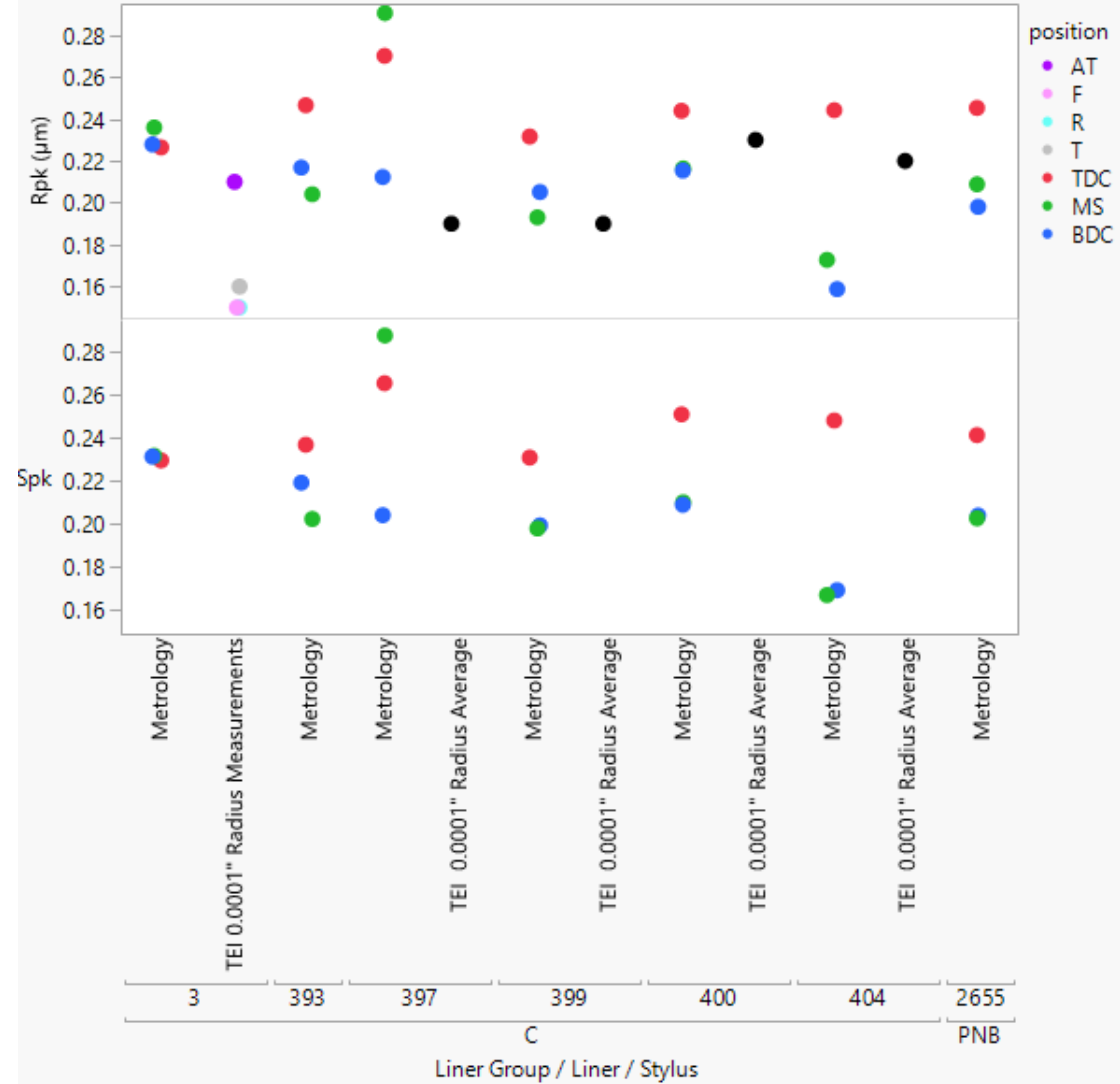
Rpk & Spk

There is no visual difference between Batch C and PNB liners. This is consistent with what was observed when TEI measurements were compared between batches

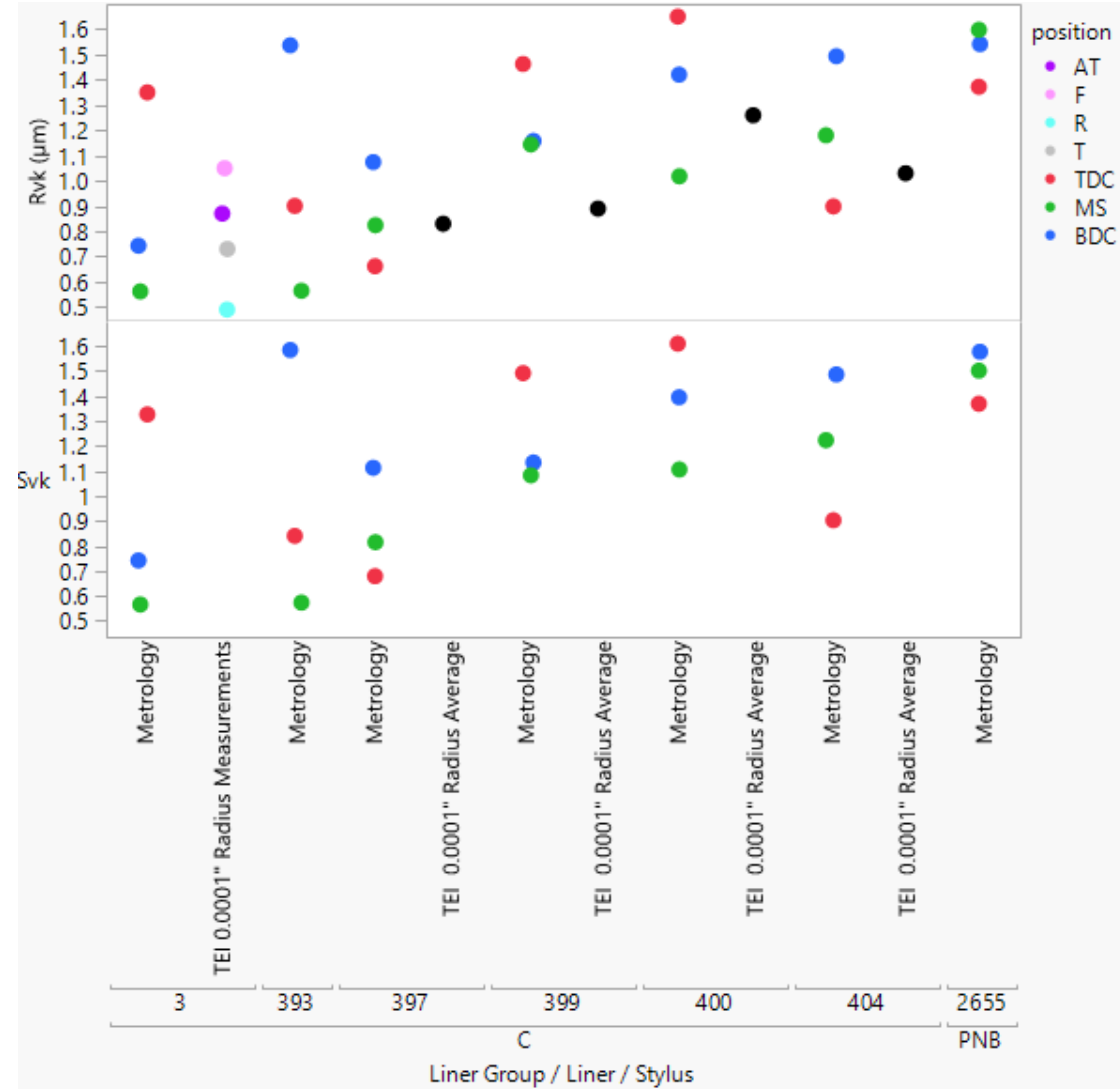
Rvk & Svk

The difference between PNB and Batch C liners is consistent with what was observed when TEI measurements were compared between batches (PNB slightly higher than C)

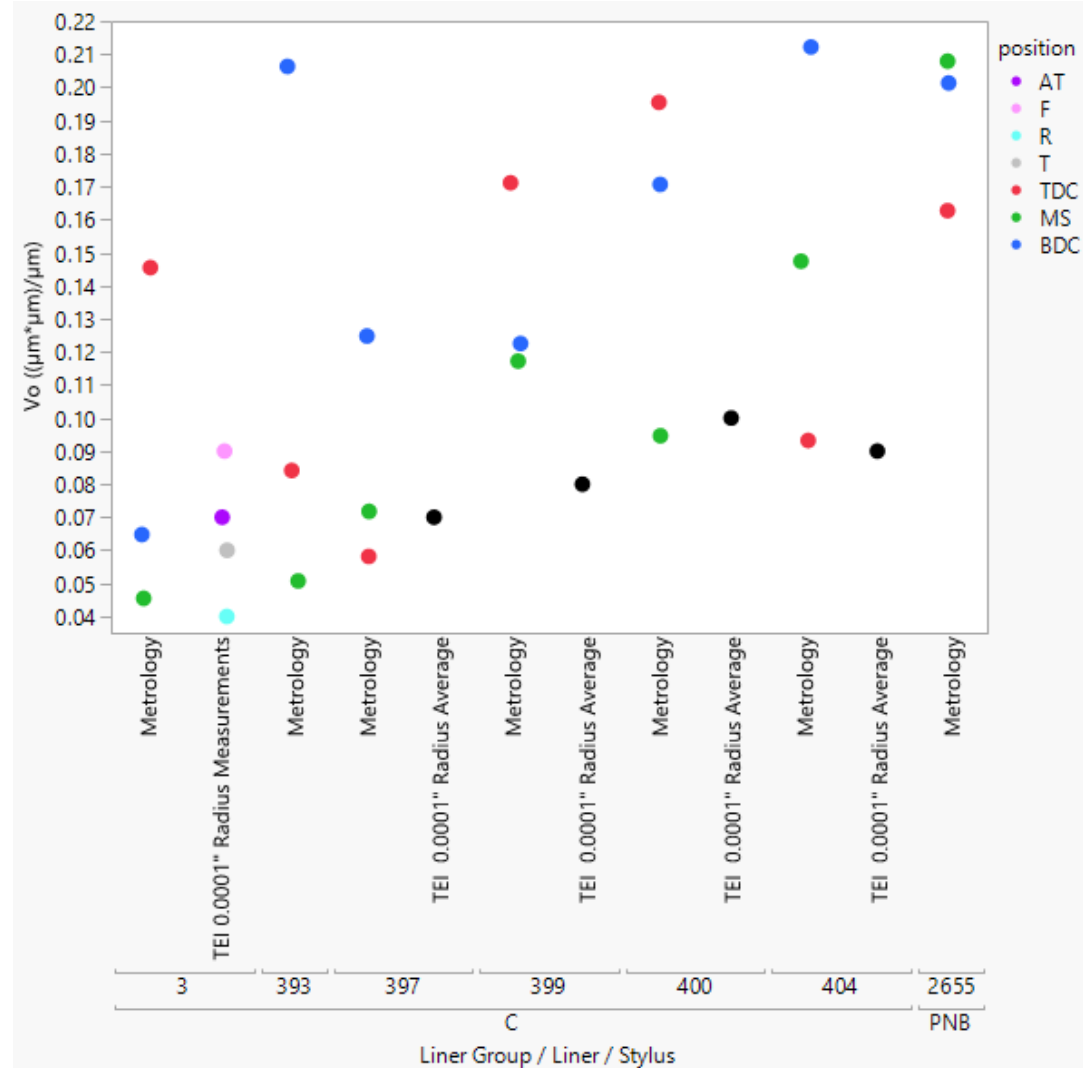
The difference between PNB and Batch C liners is consistent with what was observed when TEI measurements were compared between batches (PNB slightly higher than C)

Metrology measurements appear slightly higher than TEI measurements

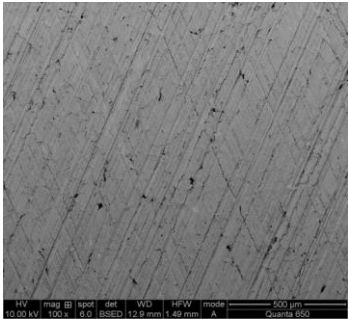
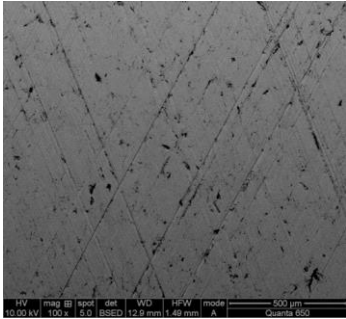
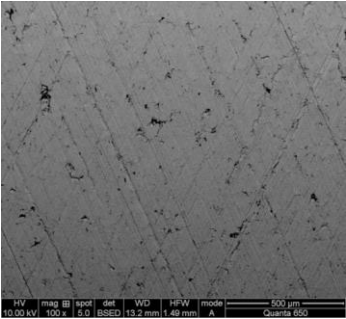
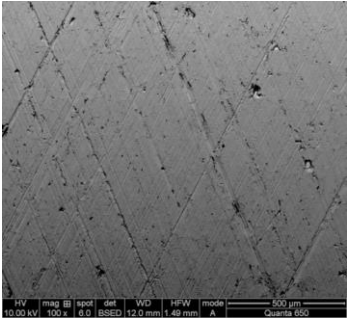
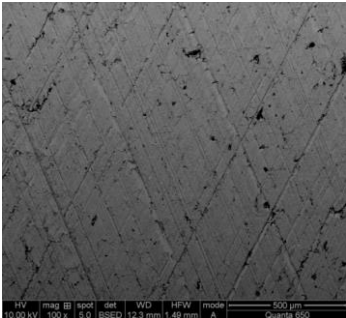
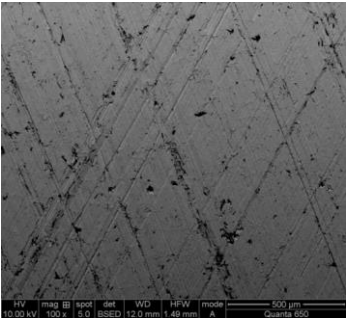
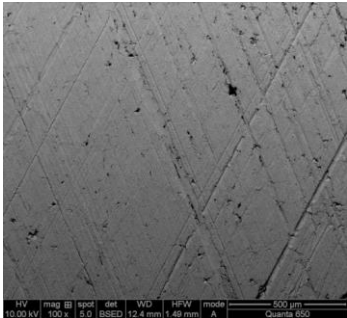
SEM Images of surface

All the Batch surfaces are similar. The PNB looks slightly different.

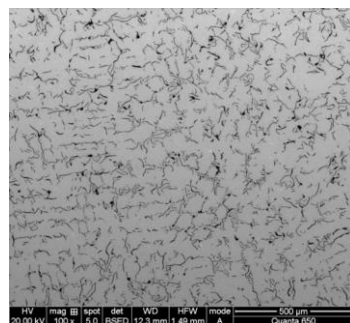
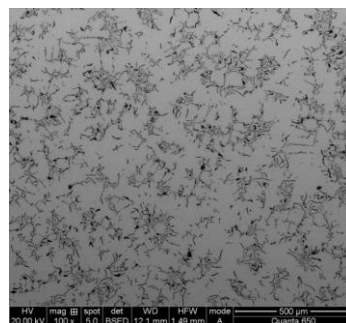
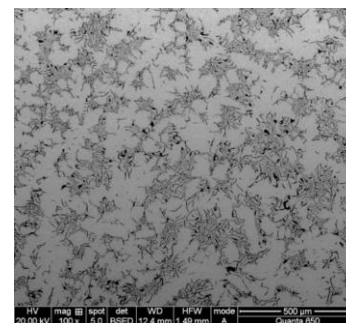
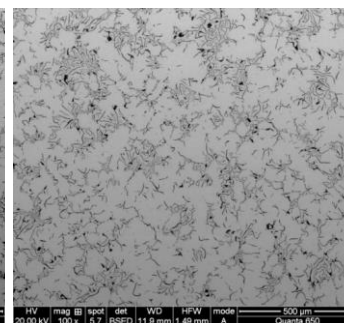
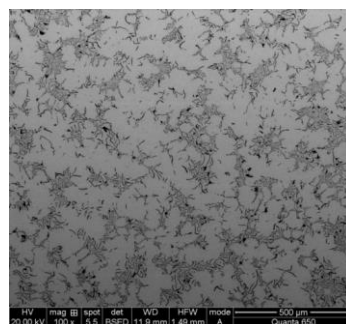
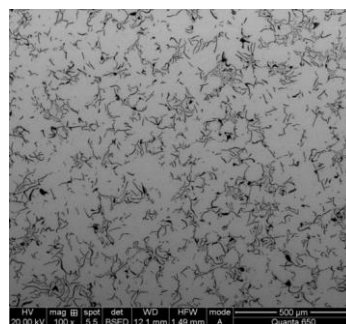
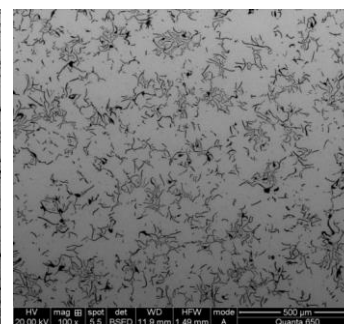
SEM images of cross section

The cross sections show how the graphite flakes are distributed throughout the microstructure.

The random distribution is about the same, except for the PNB which has a little bit of direction to it. This may be due to a different casting technique.

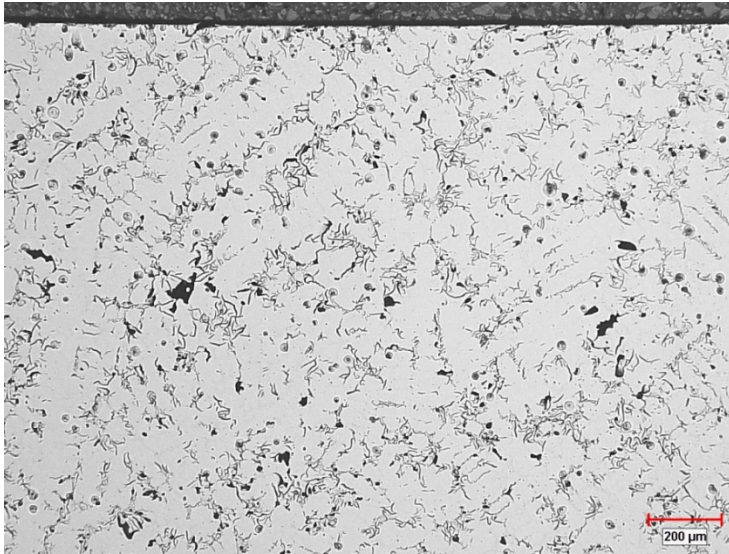
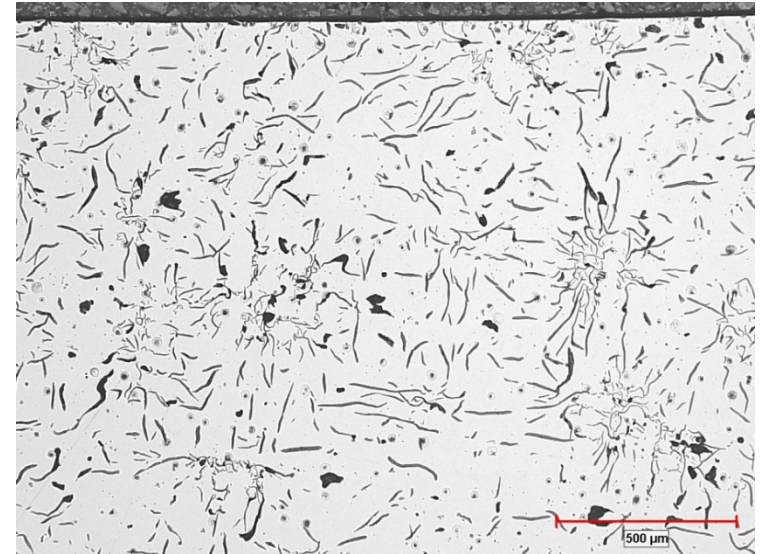
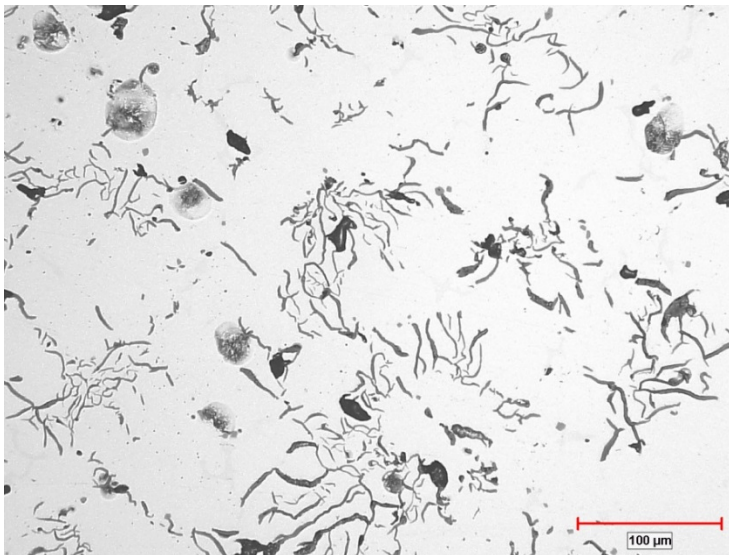
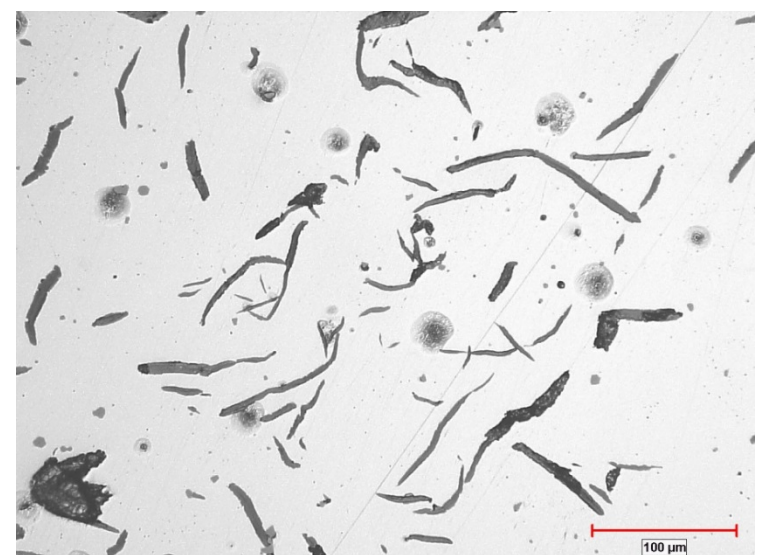
Piston Liner Comparisons — As-Polished Near Liner ID

Batch C Transverse Section

PNB Transverse Section

- Examination of the as-polished samples revealed significant differences in the microstructures. The Batch C sample exhibited a cellular dendritic structure defined by clusters of relatively short (~10 microns) graphite flakes.
- The PNB sample exhibited much larger graphite flakes (~100 microns in length). These flakes tended to be less tightly clustered compared to the Batch C sample flakes
- Etching the samples revealed each samples matrix was principally composed of pearlite
- Neither sample exhibited a significant difference in morphology with respect to location. The material adjacent to the ID surface of the sample appeared to have a similar density and size distribution of graphite flakes compared to the material adjacent to the OD surface
- Only one Batch C and one PNB liner was analyzed.

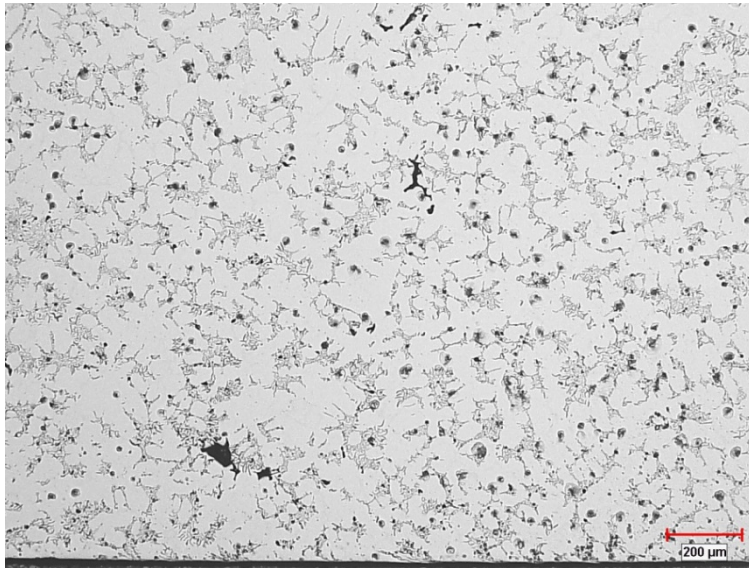
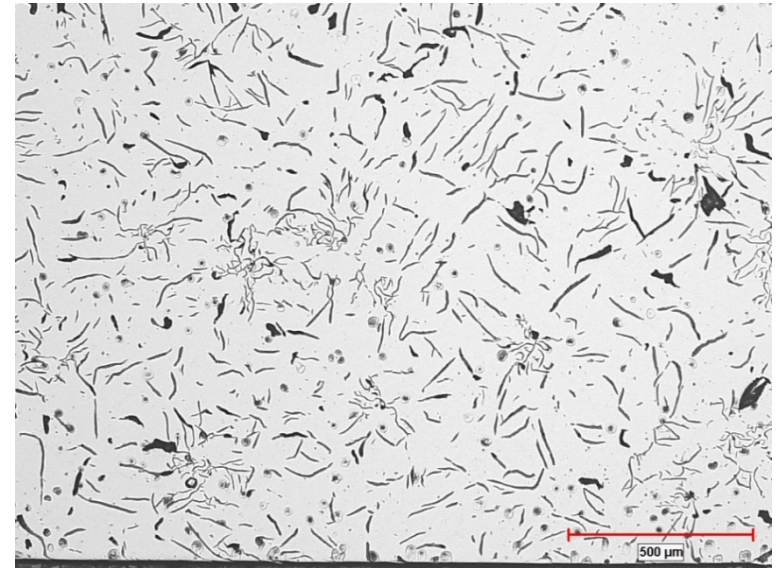
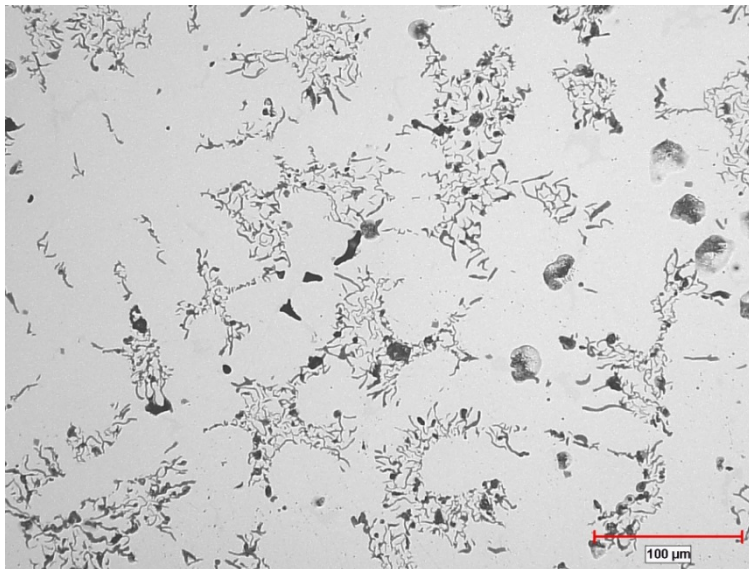
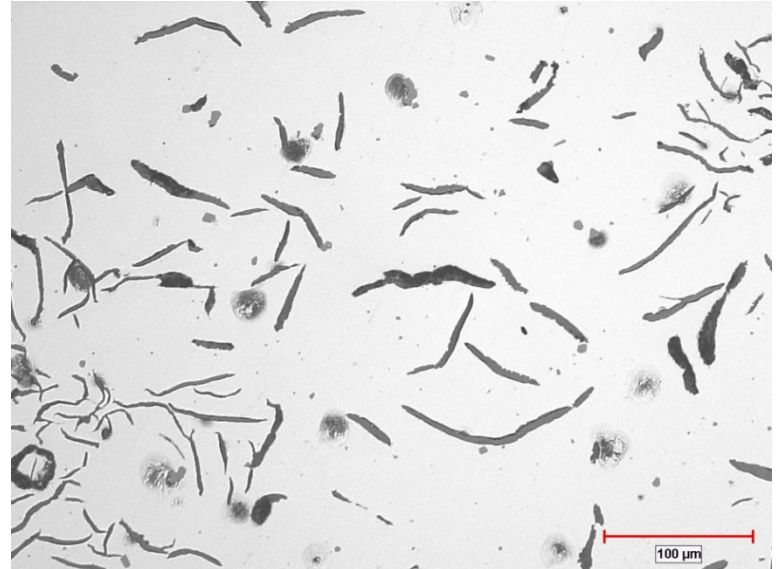
Piston Liner Comparisons — As-Polished Near Liner OD

Batch C Transverse Section

PNB Transverse Section

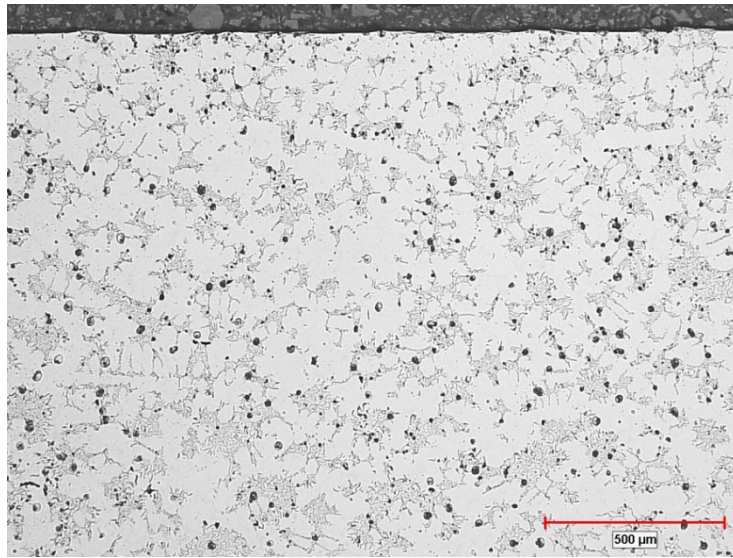
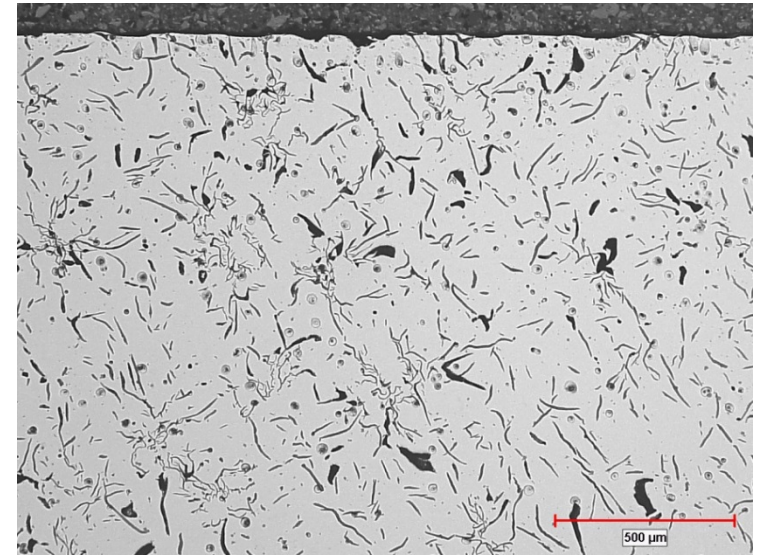
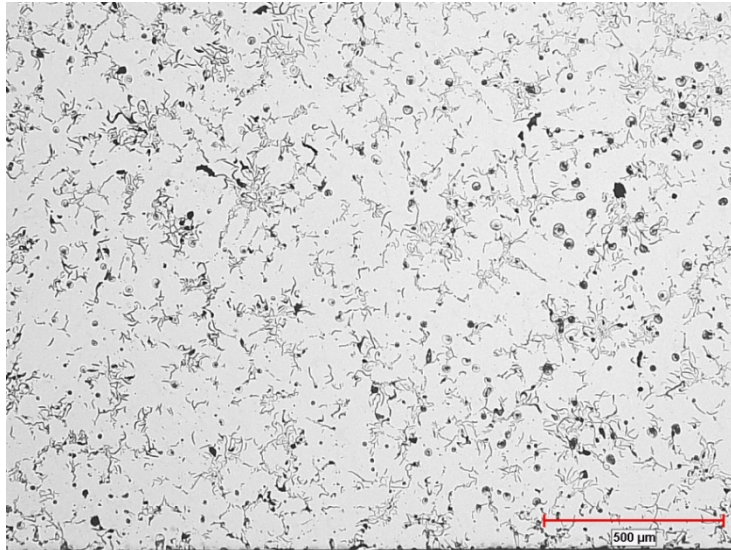
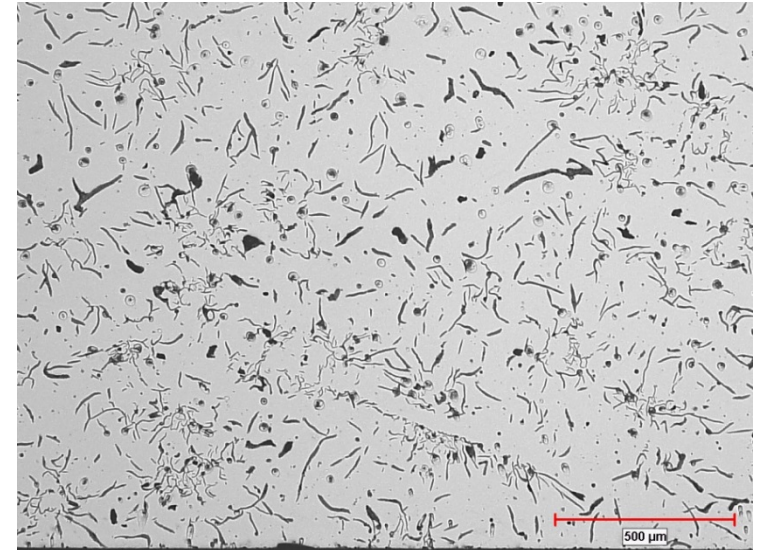
Piston Liner Comparisons—Longitudinal Specimens

Batch C Longitudinal Section

PNB Longitudinal Section

OD
Region

ID
Region

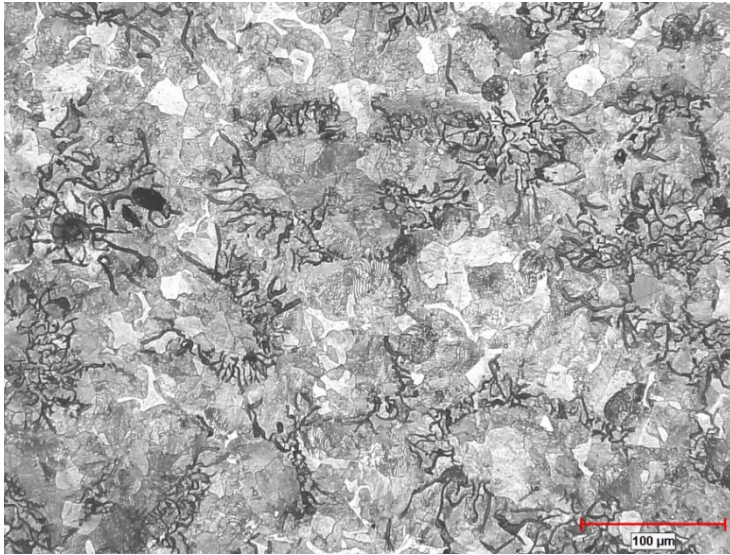
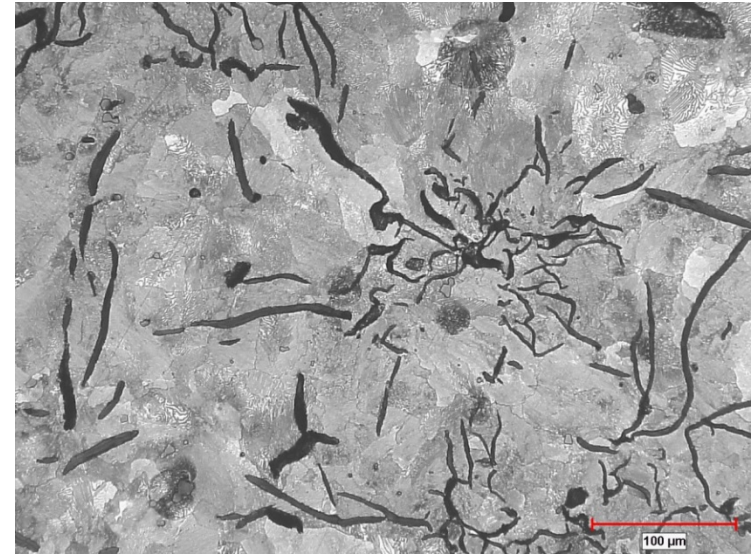
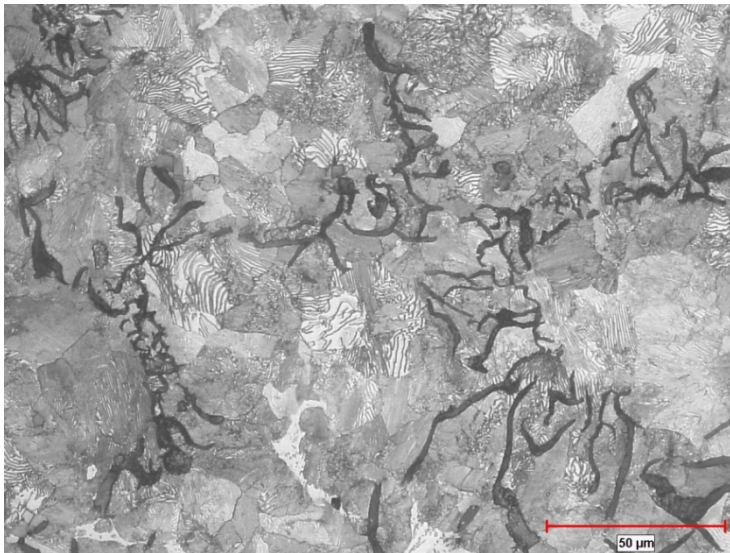
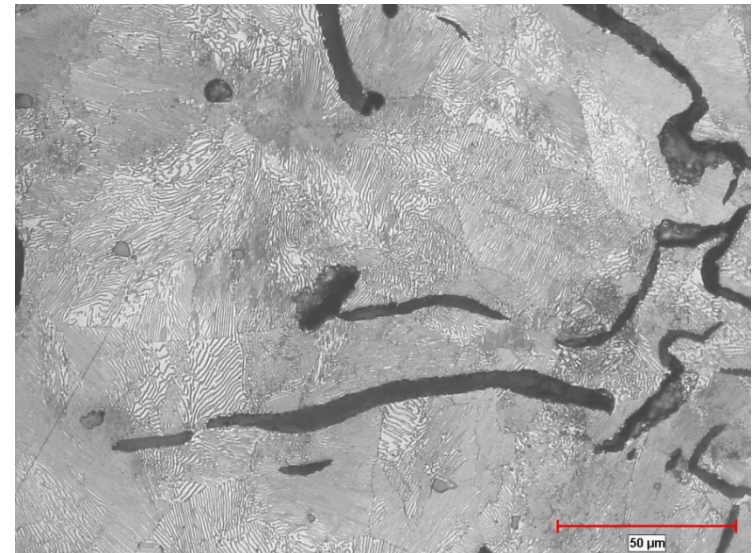
Piston Liner Comparisons—Transverse Specimens Etched

Batch C

PNB

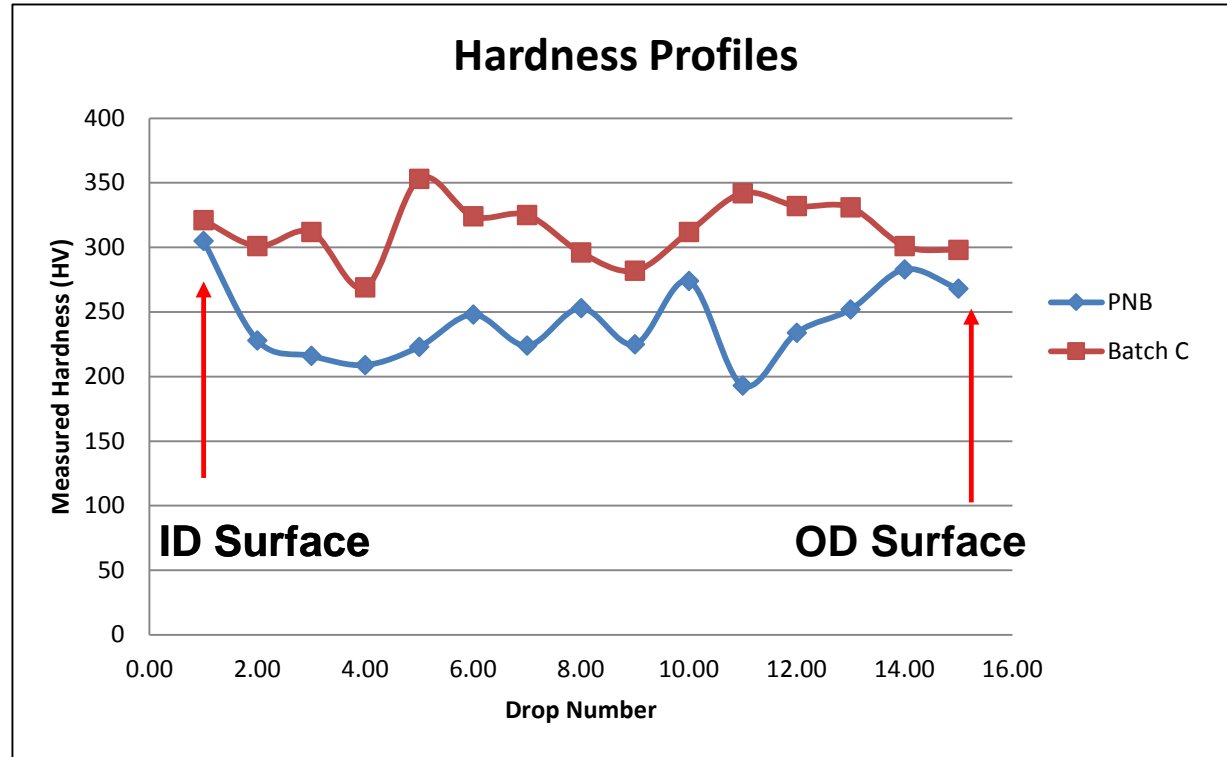
Hardness Measurements

- Hardness profiles were taken across both transverse samples
- The average hardness value obtained from the PNB sample was significantly lower than the Batch C sample
- Neither profile exhibited clear evidence of case hardening/other trends
