Daimler Surveillance Panel Meeting Minutes

June 24, 2019

Daimler SP Face-to-Face Meeting
June 24th, 2019

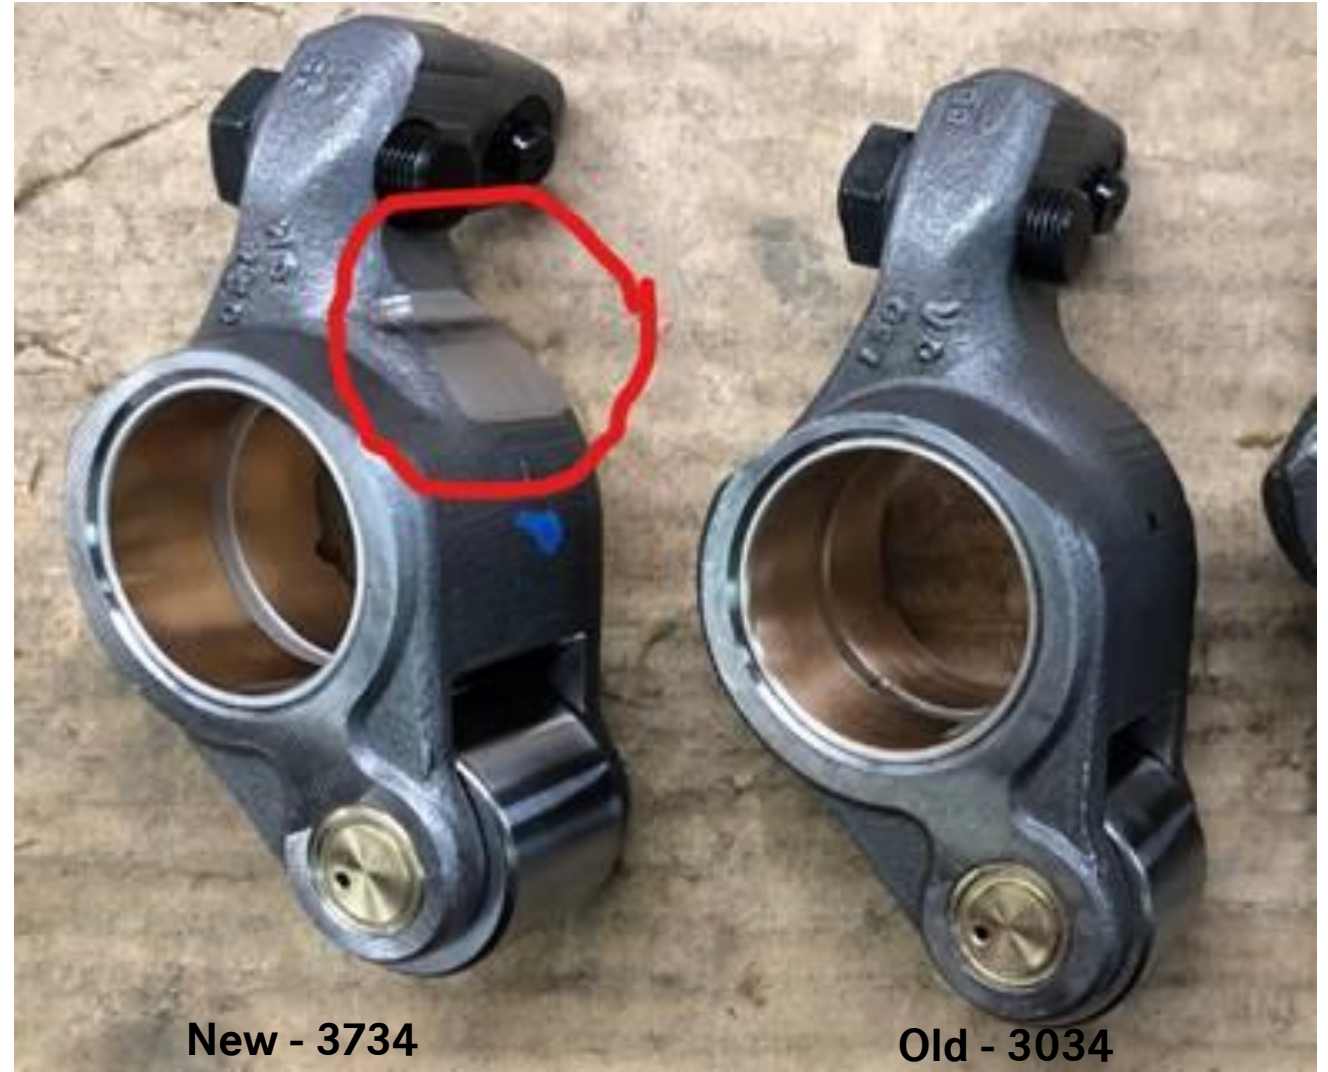
Additional Information Showed During Meeting: 3734 vs. 3034 Rocker Arms

- The 3734 and 3034 are the same except the 3734 has a clearance cut to accommodate a change to the brake rocker. The 3734 can be used universally going forward.

- **Rocker Arms:** We have received some of the new rocker arms, p/n A4720503634 which will be replacing A4720503234. Detroit has stated that if you are to use the new rocker arms you can no longer use p/n A4720503034 and MUST use the replacement, A4720503734.
- If any of the labs want some of the new rocker arms so that they can put them into the kits that they already have in inventory, we can charge you for the A4720503234 and A4720503734 rockers minus the cost of the A4720503034 rockers, and we will take them back.

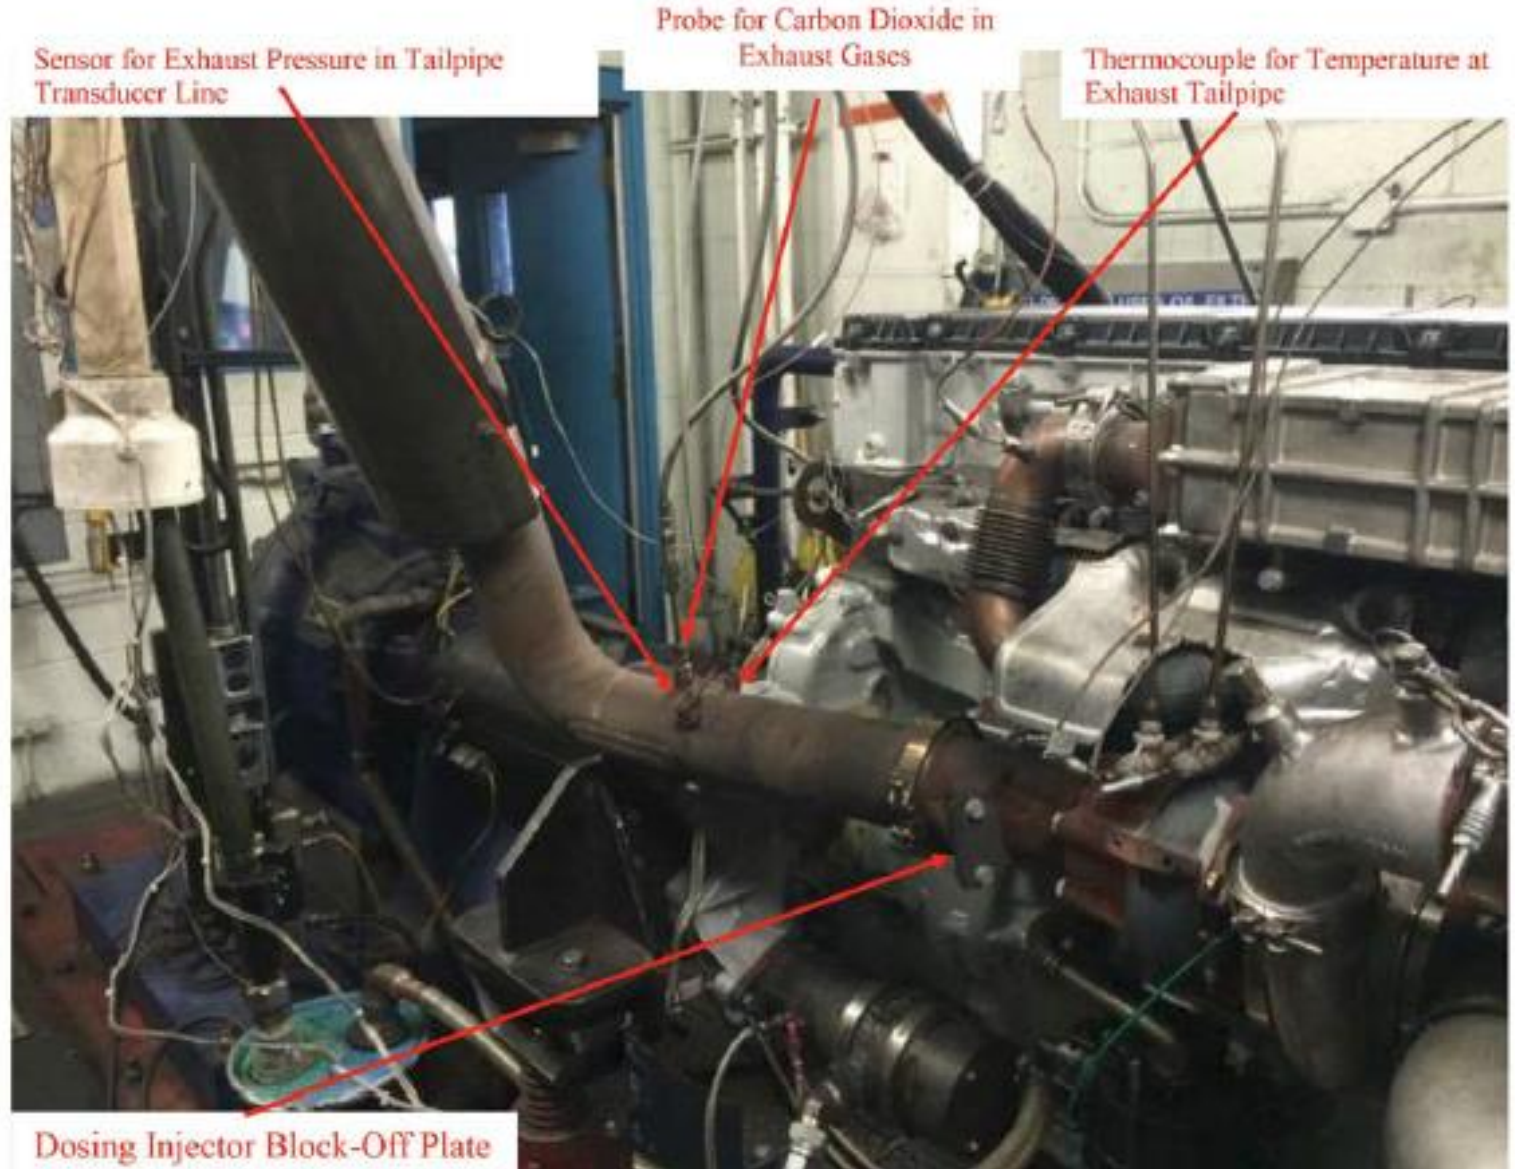
FIG. A4.15 Location of Exhaust Tailpipe Sensors

Exhaust Measurement Location Procedure Clarification - Sean Moyer

8.6.2.12 *Exhaust Temperature in Tailpipe*—Locate the thermocouple in the exhaust pipe approximately 270 mm downstream of the turbocharger outlet. Locate the thermocouple downstream of the exhaust pressure tap, and upstream of the CO₂ probe. Refer to Fig. A4.15.

8.6.3.4 *Exhaust Pressure in Tailpipe (Exhaust Back Pressure)*—Measure in a straight section of pipe upstream of the exhaust tailpipe thermocouple, with a pressure tap hole as shown in Fig. A4.15. Do not locate the tap downstream of either the temperature thermocouple or the CO₂ probe.

Sean brought up that the wording in section 8.6.3.4 of the exhaust pressure in tailpipe and CO2 placement did not align with the corresponding Figure A.15. It was stated that it is difficult to see in the figure, however the position of these items do meet the wording requirements. **Action Item:** Patrick will be updating the image in this figure so that it is can increase the accuracy in how this is depicted and avoid confusion.

8.6.2.12 *Exhaust Temperature in Tailpipe* – Locate the thermocouple in the exhaust pipe downstream of the Exhaust Pressure in Tailpipe measurement location and upstream of the CO₂ probe. Refer to Fig A4.15.

8.6.3.4 *Exhaust Pressure in Tailpipe (Exhaust Back Pressure)* – Locate the pressure tap in a straight section of the exhaust pipe 270 +/- 50 mm downstream of the turbocharger outlet. Locate the pressure tap upstream of the Exhaust Temperature in Tailpipe thermocouple and CO₂ probe as shown in Figure A.15.

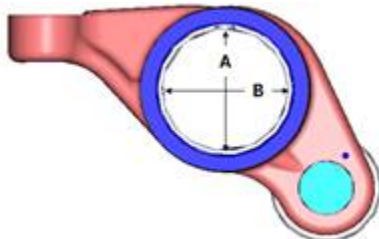
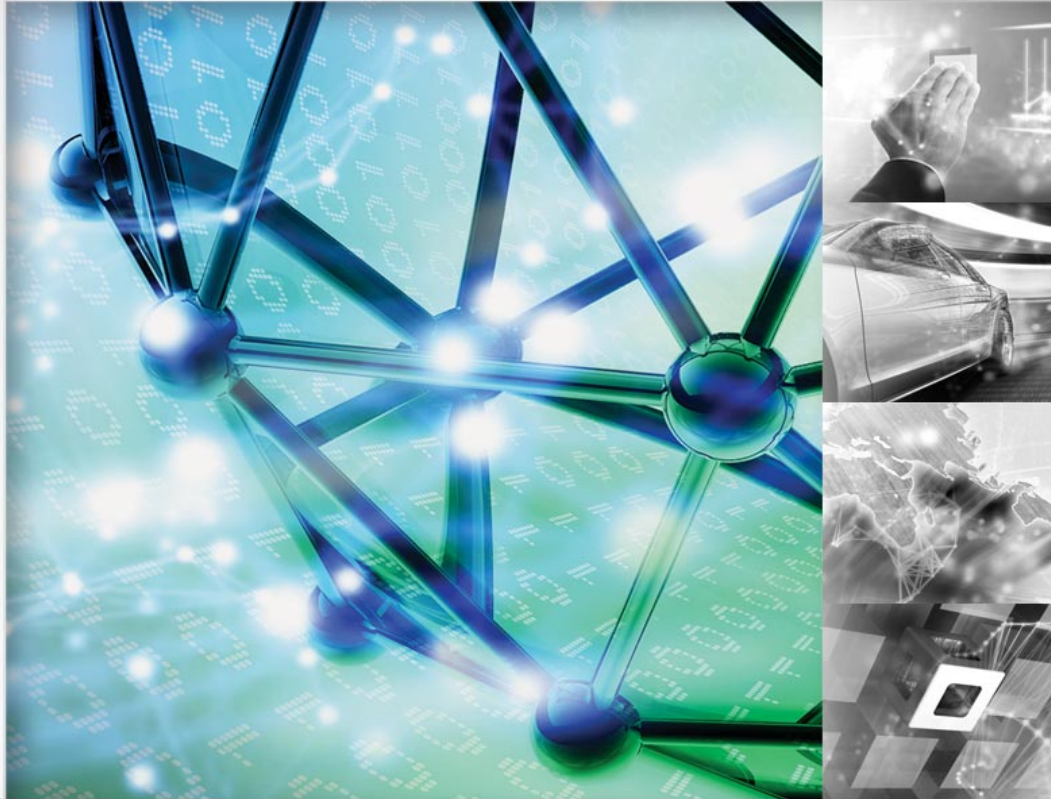
Measure the parts as shown below.

“B” is the original DIA (or close to it)

Exhaust spec: 36.000 – 36.025

Inlet spec: 26.000 – 26.021

“A” is the wear dimension

Exhaust

<36.050	Green	Ok to reuse
<36.100	Yellow	Can be reused, but keep an eye on it
>36.100	Red	Scrap

Inlet

<26.050	Green	Ok to reuse
<26.100	Yellow	Can be reused, but keep an eye on it
>26.100	Red	Scrap

A1 and A2 both need to be below the wear limit.

Daimler Rocker Arms Re-use Guidelines as presented to the Daimler Surveillance Panel

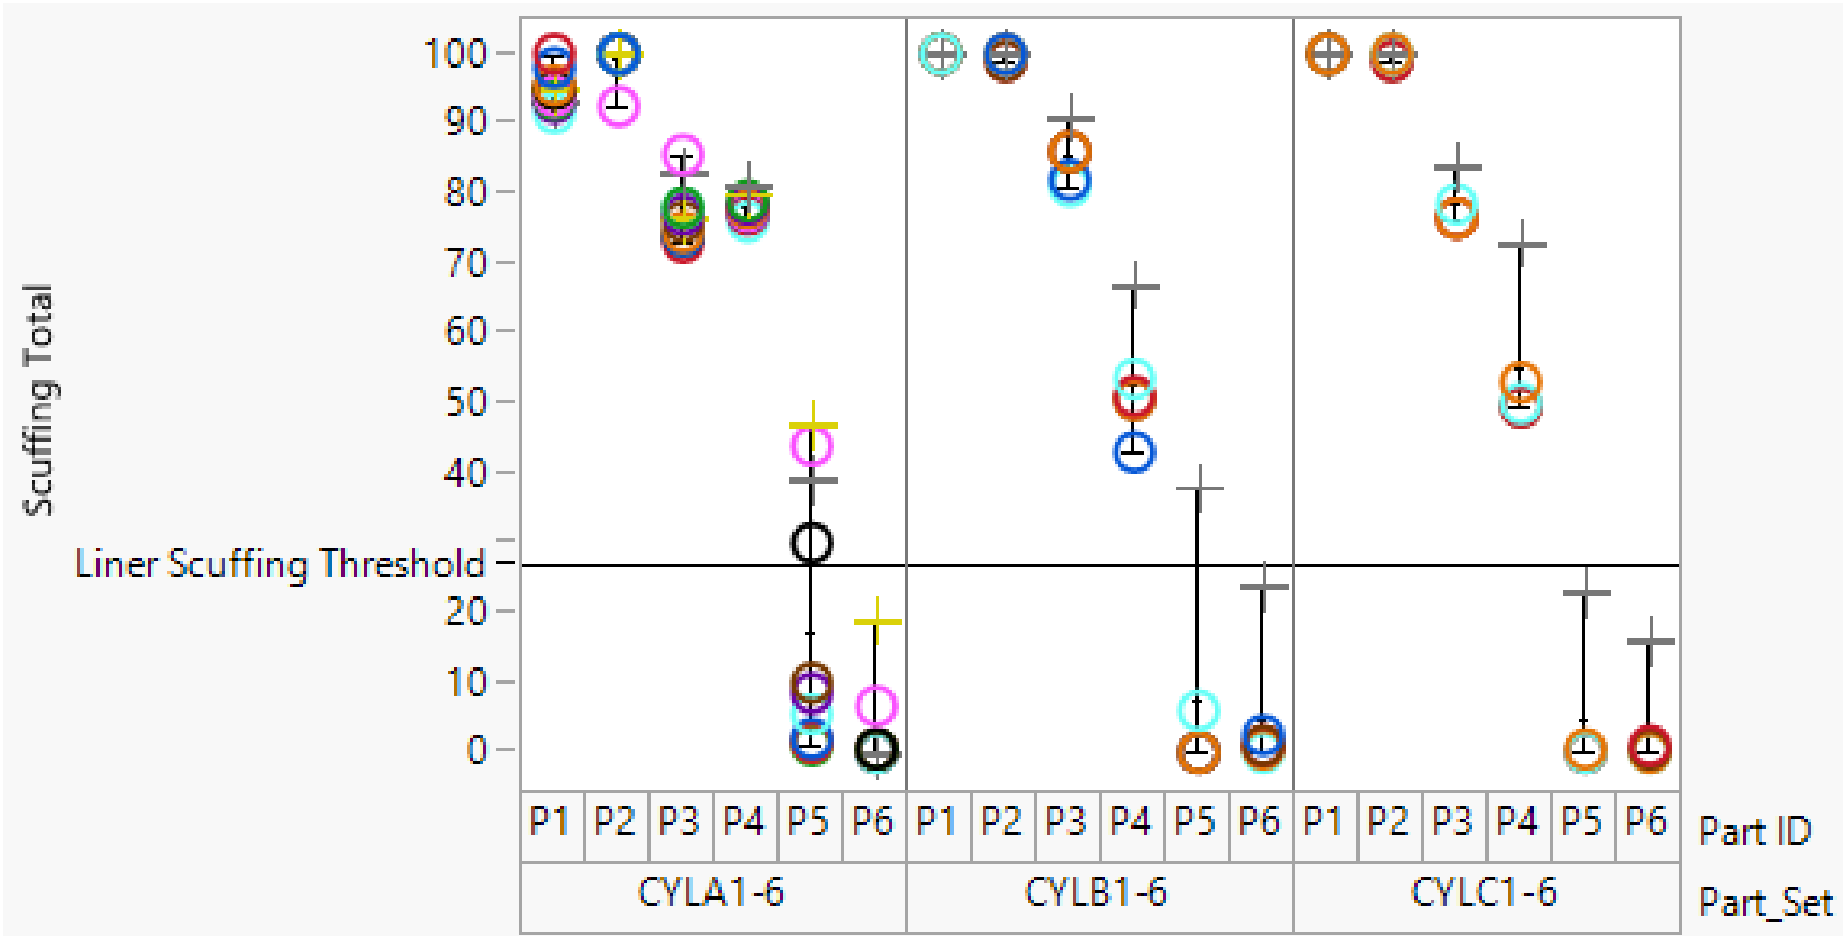
Cylinder Liners

Colors represent different raters

“O” Indicates a High Volume Rater

“+” Indicates Not a High Volume Rater

Review of the data from the Daimler SP Rater workshop from 2017 shows that there may be improvements that could be made to increase the accuracy of the ratings and perhaps remove un-necessary items from being rated. Please see attached “2017 Daimler SP Rater Workshop” presentation by Lubrizol. At the moment there is no criteria as to who can rate DD13 Scuffing test hardware. The data from the workshop shows that there is decent variation between a small number raters which are both high and not high volume raters. This data outlines that perhaps more training is required for raters or that there should be specifications on who is allowed to rate these components.

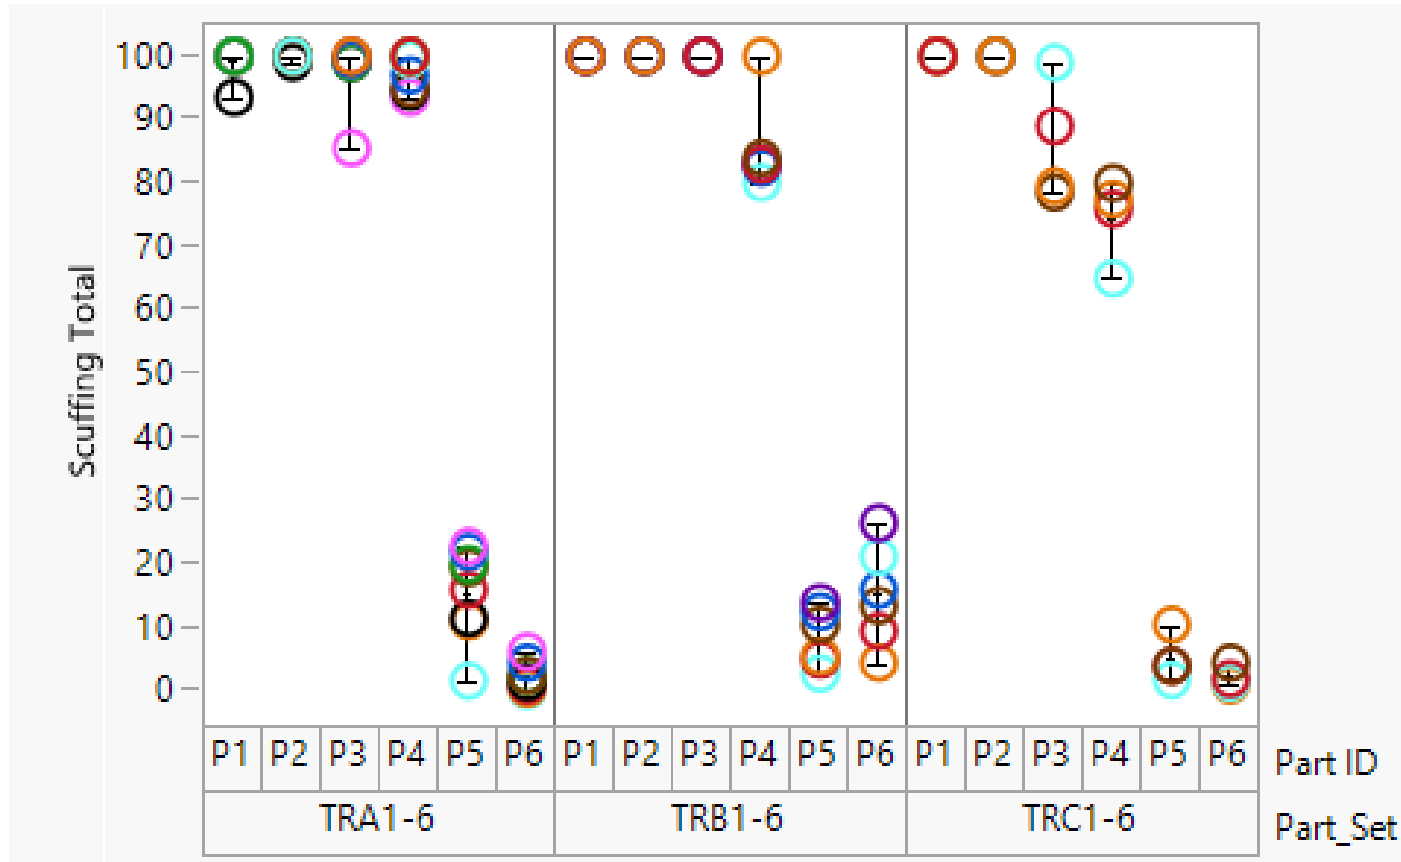
Top Rings

Colors represent different raters

“O” Indicates a High Volume Rater

“+” Indicates Not a High Volume Rater

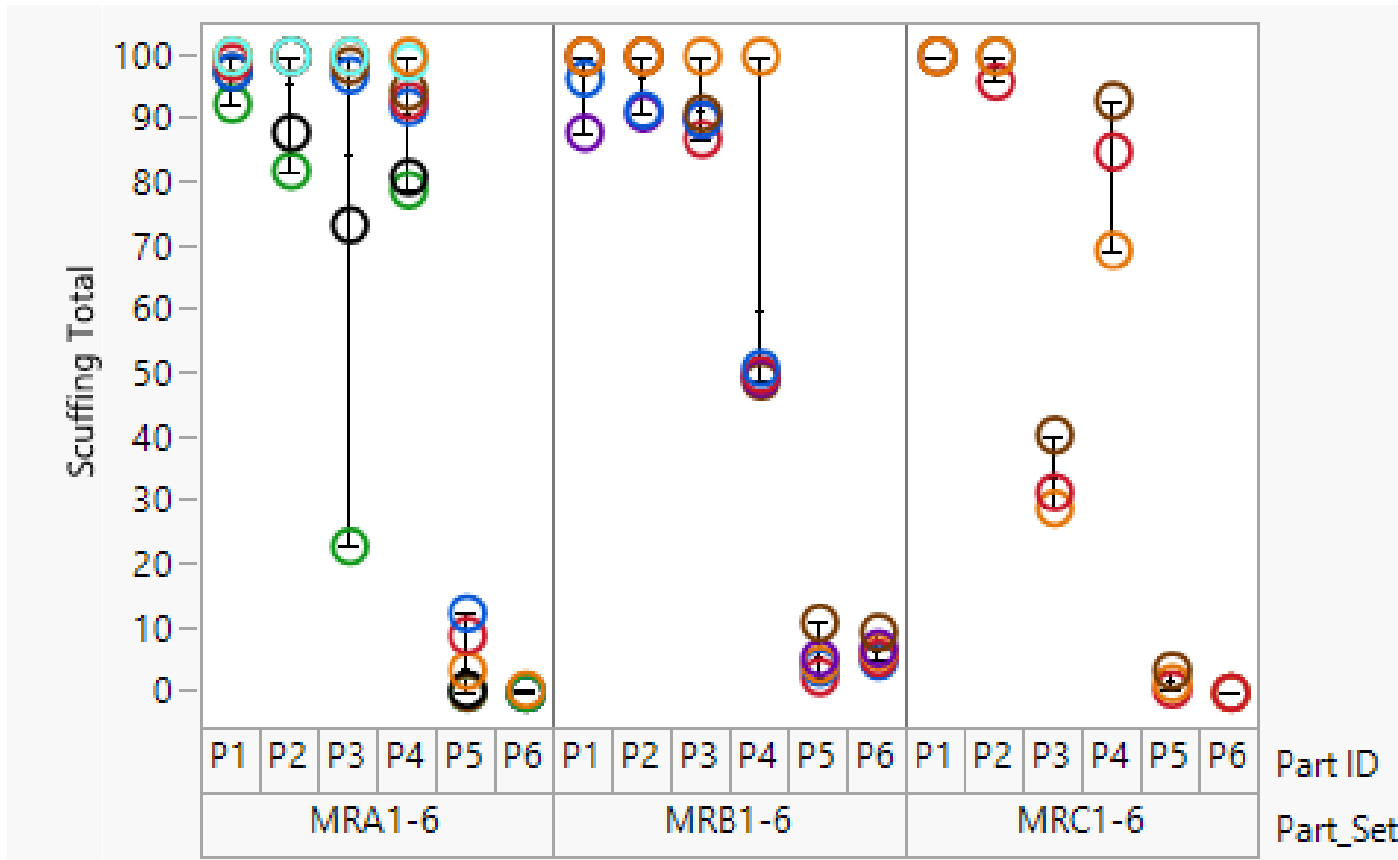
2nd Rings

Colors represent different raters

“O” Indicates a High Volume Rater

“+” Indicates Not a High Volume Rater

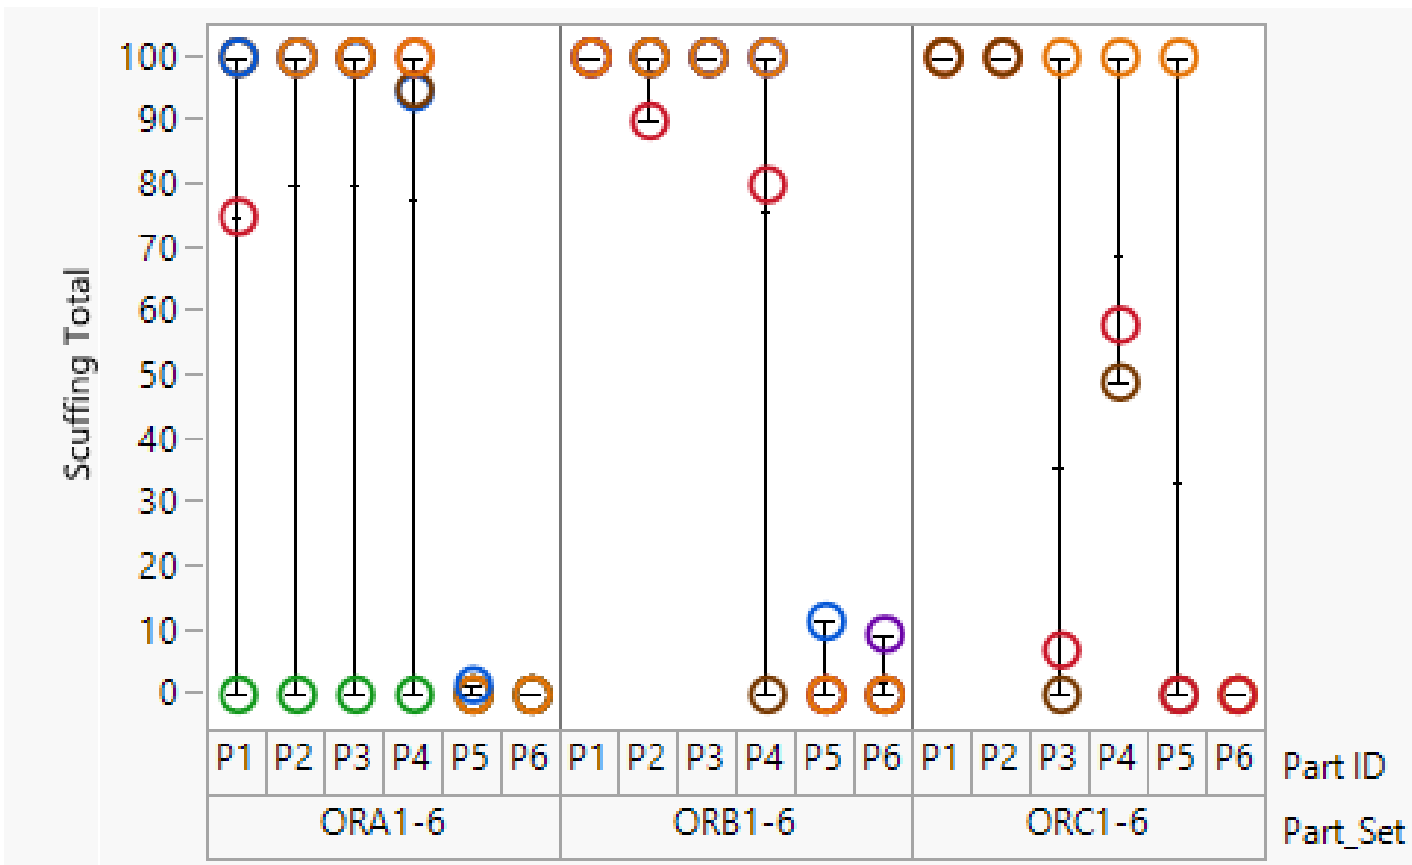
Oil Rings

Colors represent different raters

“O” Indicates a High Volume Rater

“+” Indicates Not a High Volume Rater

The oil control ring scuffing data also shows a very large variation. It was brought up that the surface area to be rated on the oil control ring is extremely small and very difficult to rate which is likely causing the difference in results. This rating parameter could be removed since data doesn't seem to be useful, however the panel was asked to reconsider additional training instead as perhaps the data may be useful in the future.
