M11 EGR Test Matrix Status

**Presentation to
HDEOCP
May 25, 2001
David M Stehouwer**

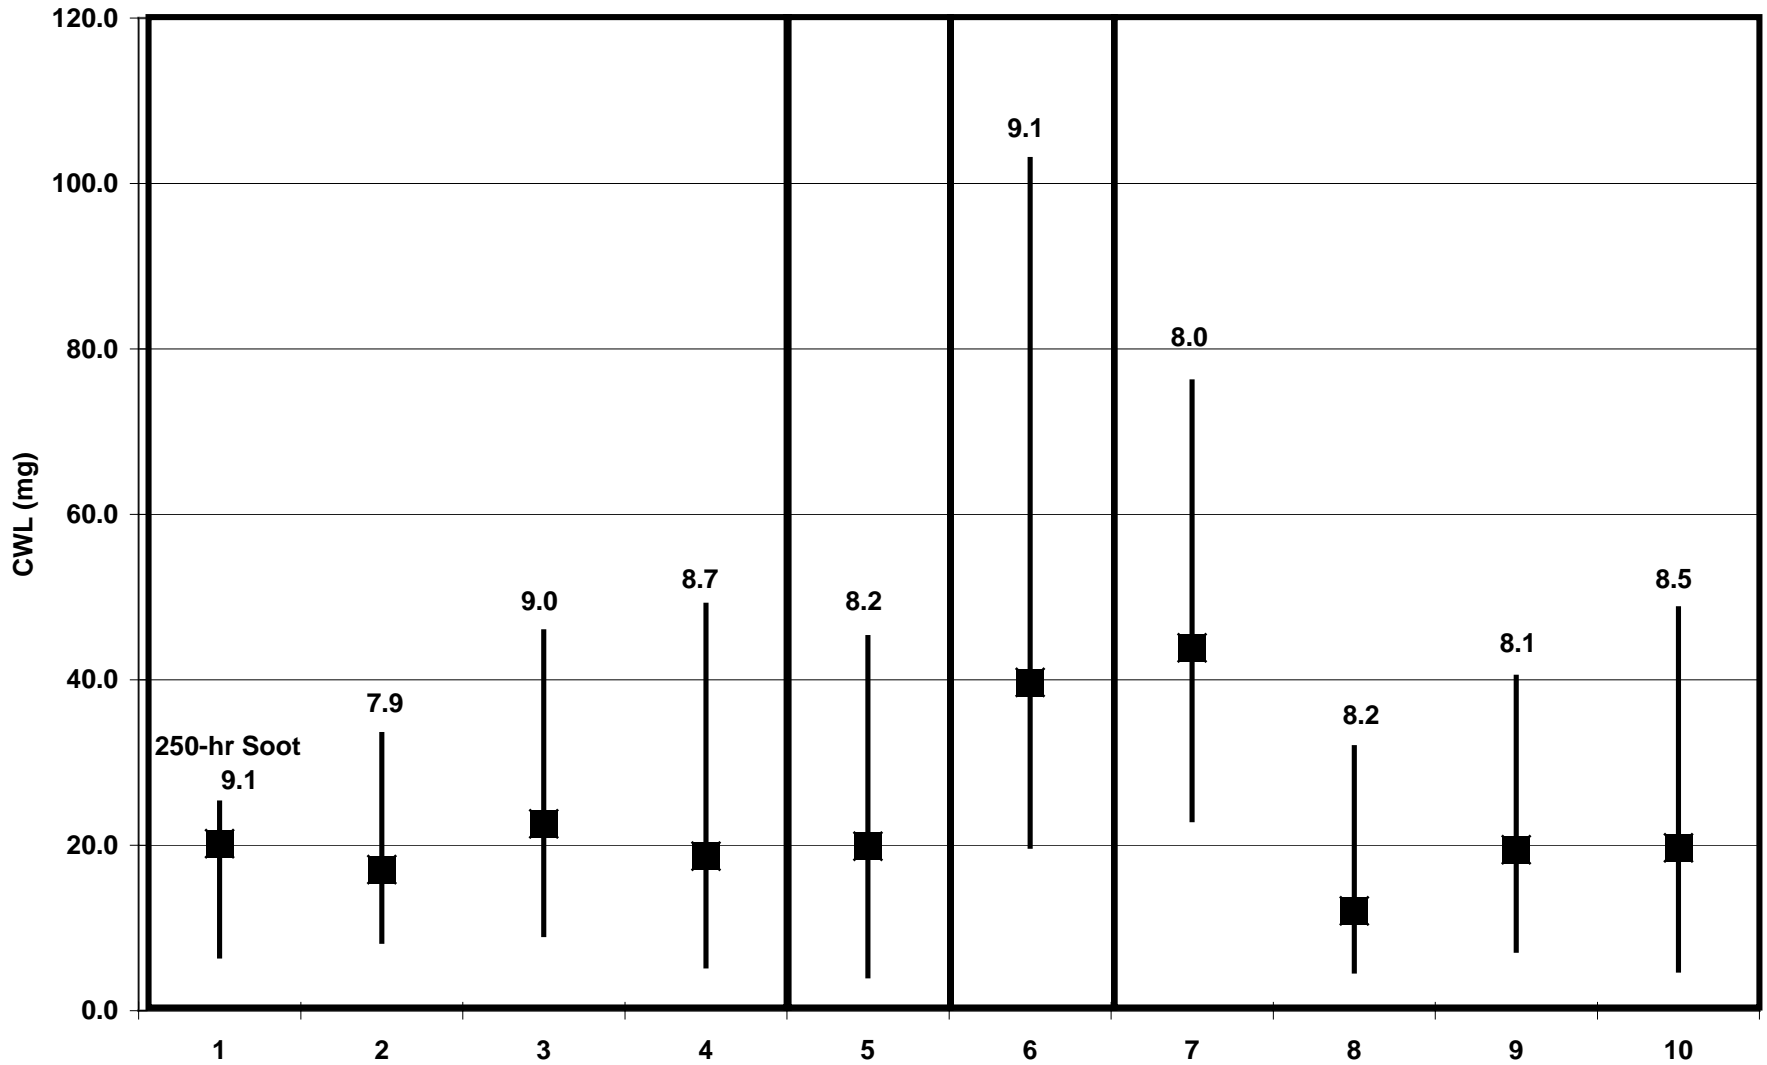
Crosshead Weight Loss - Matrix Oil E

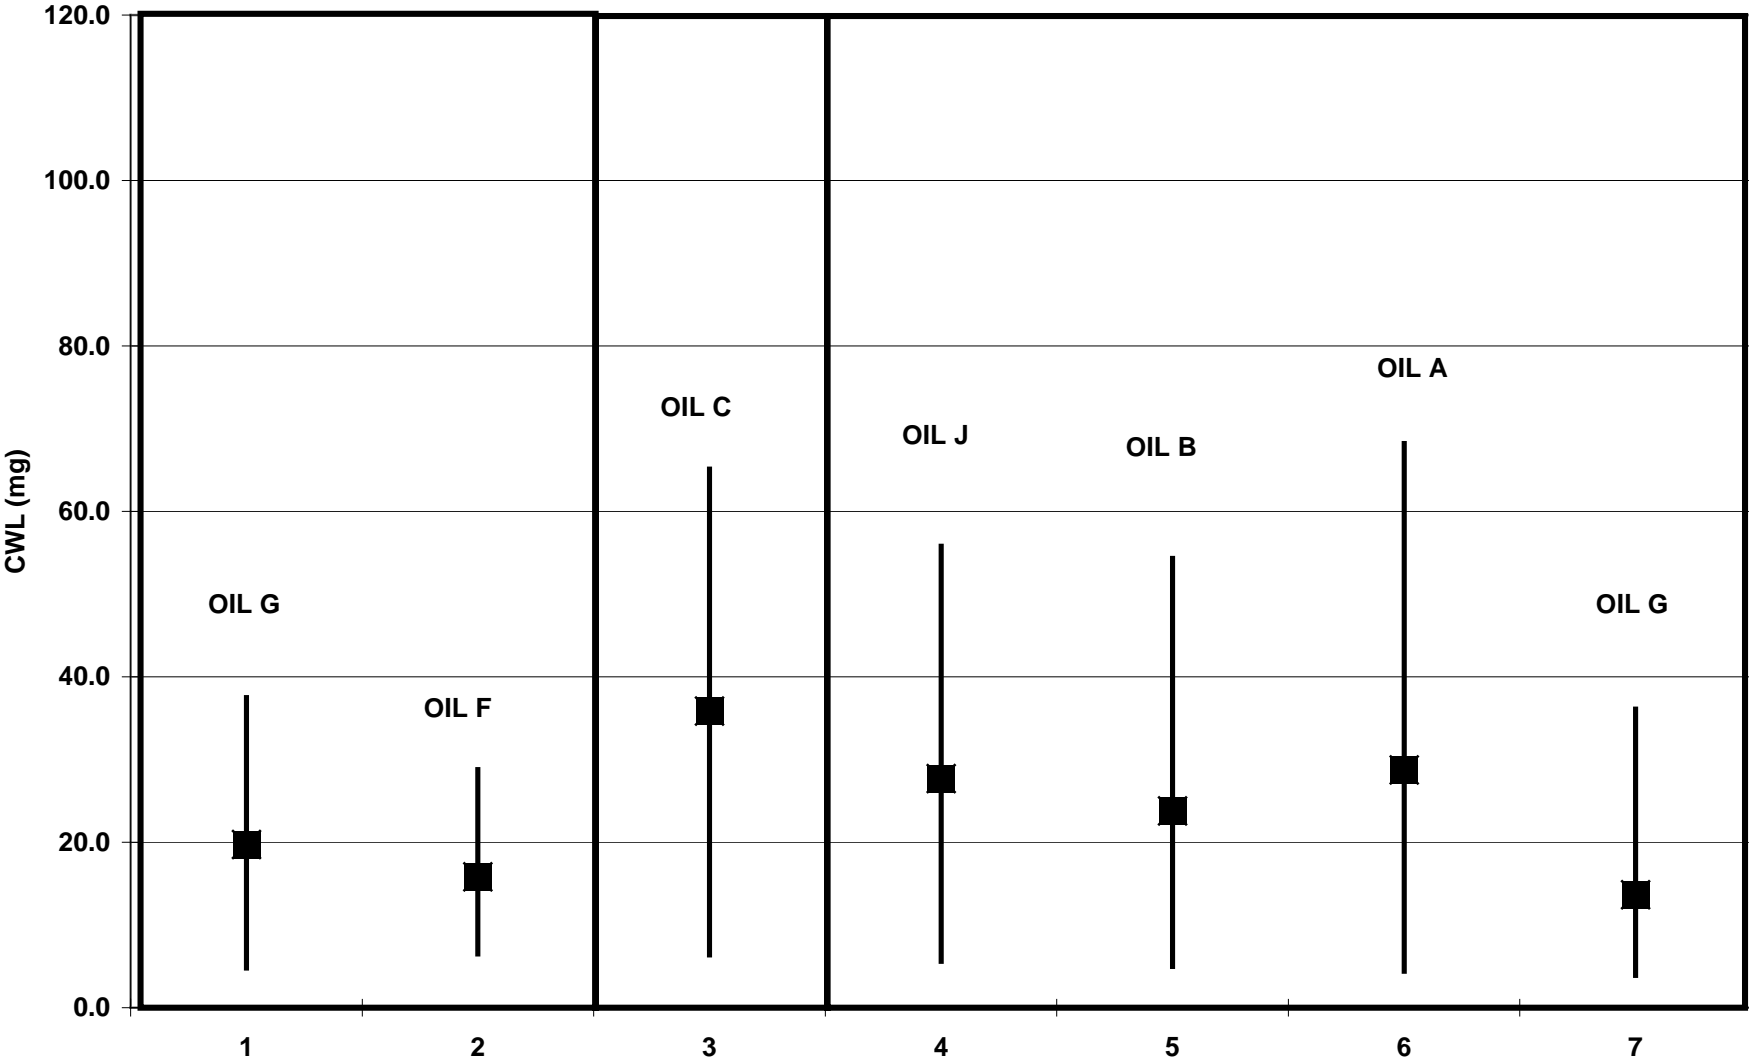
Crosshead Weight Loss

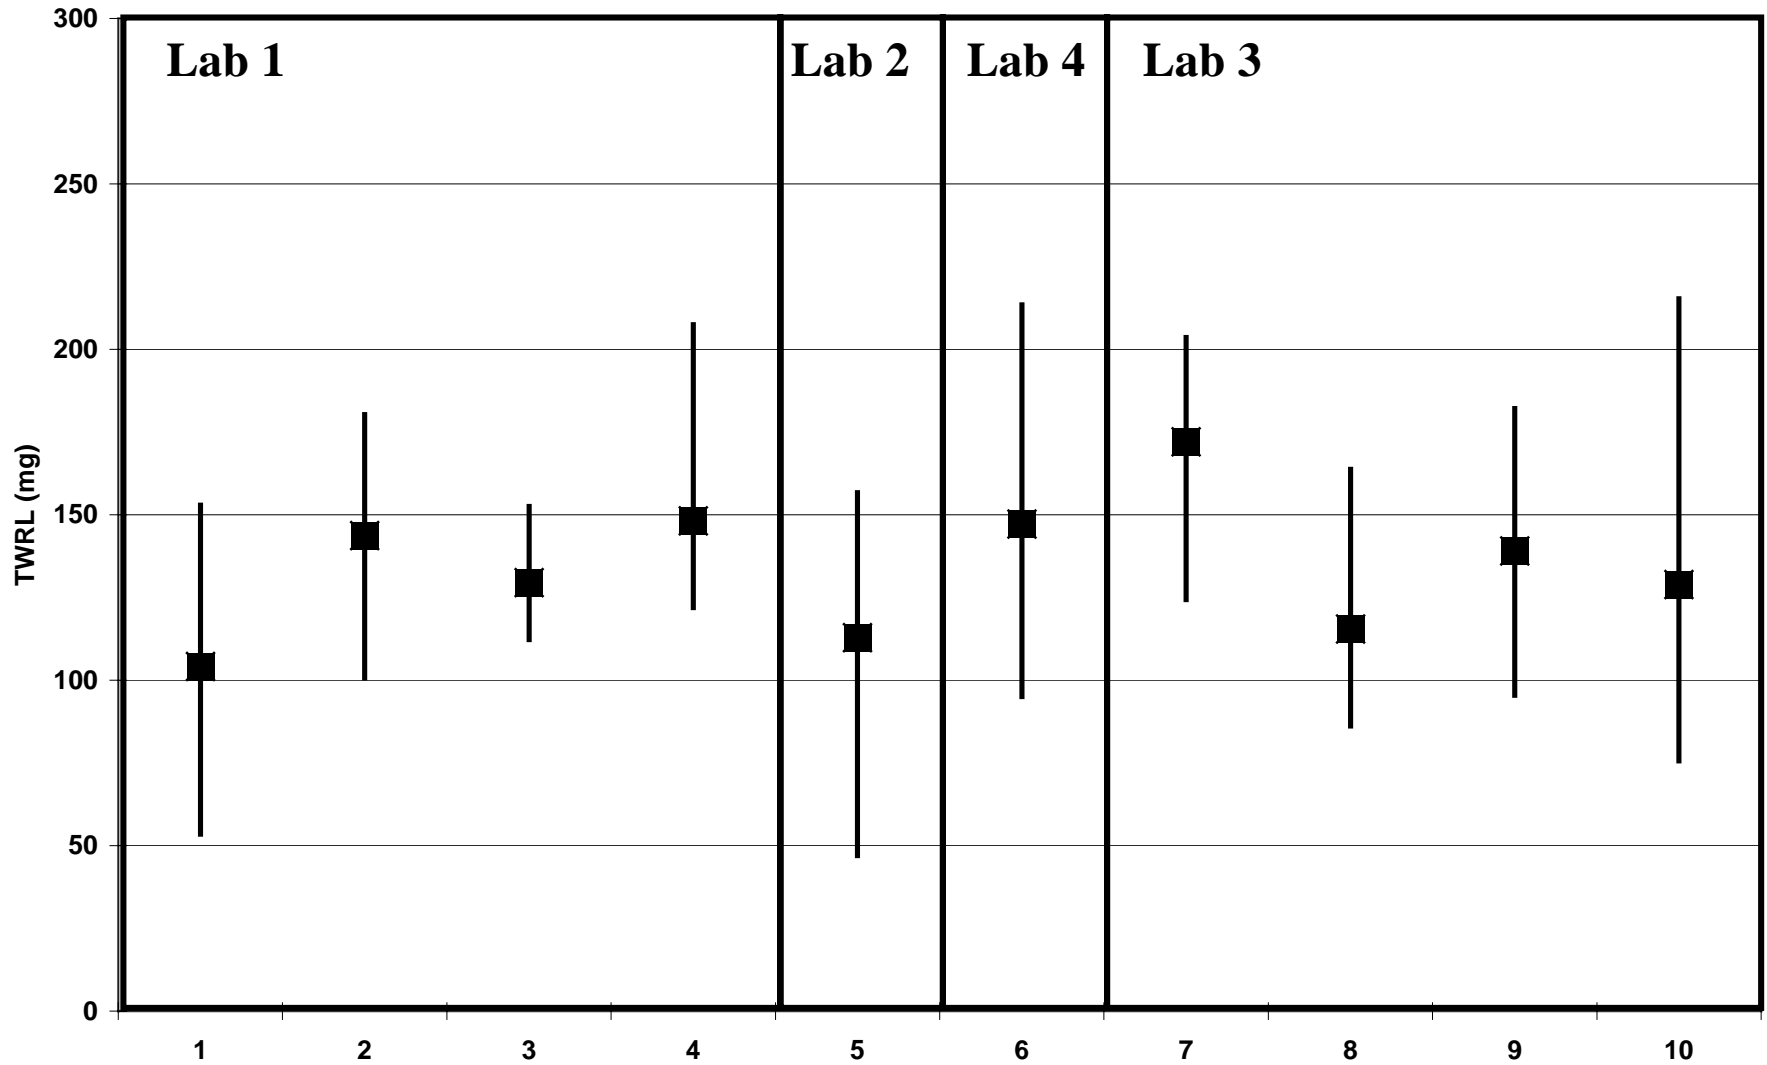
Top Ring Weight Loss - Matrix Oil E

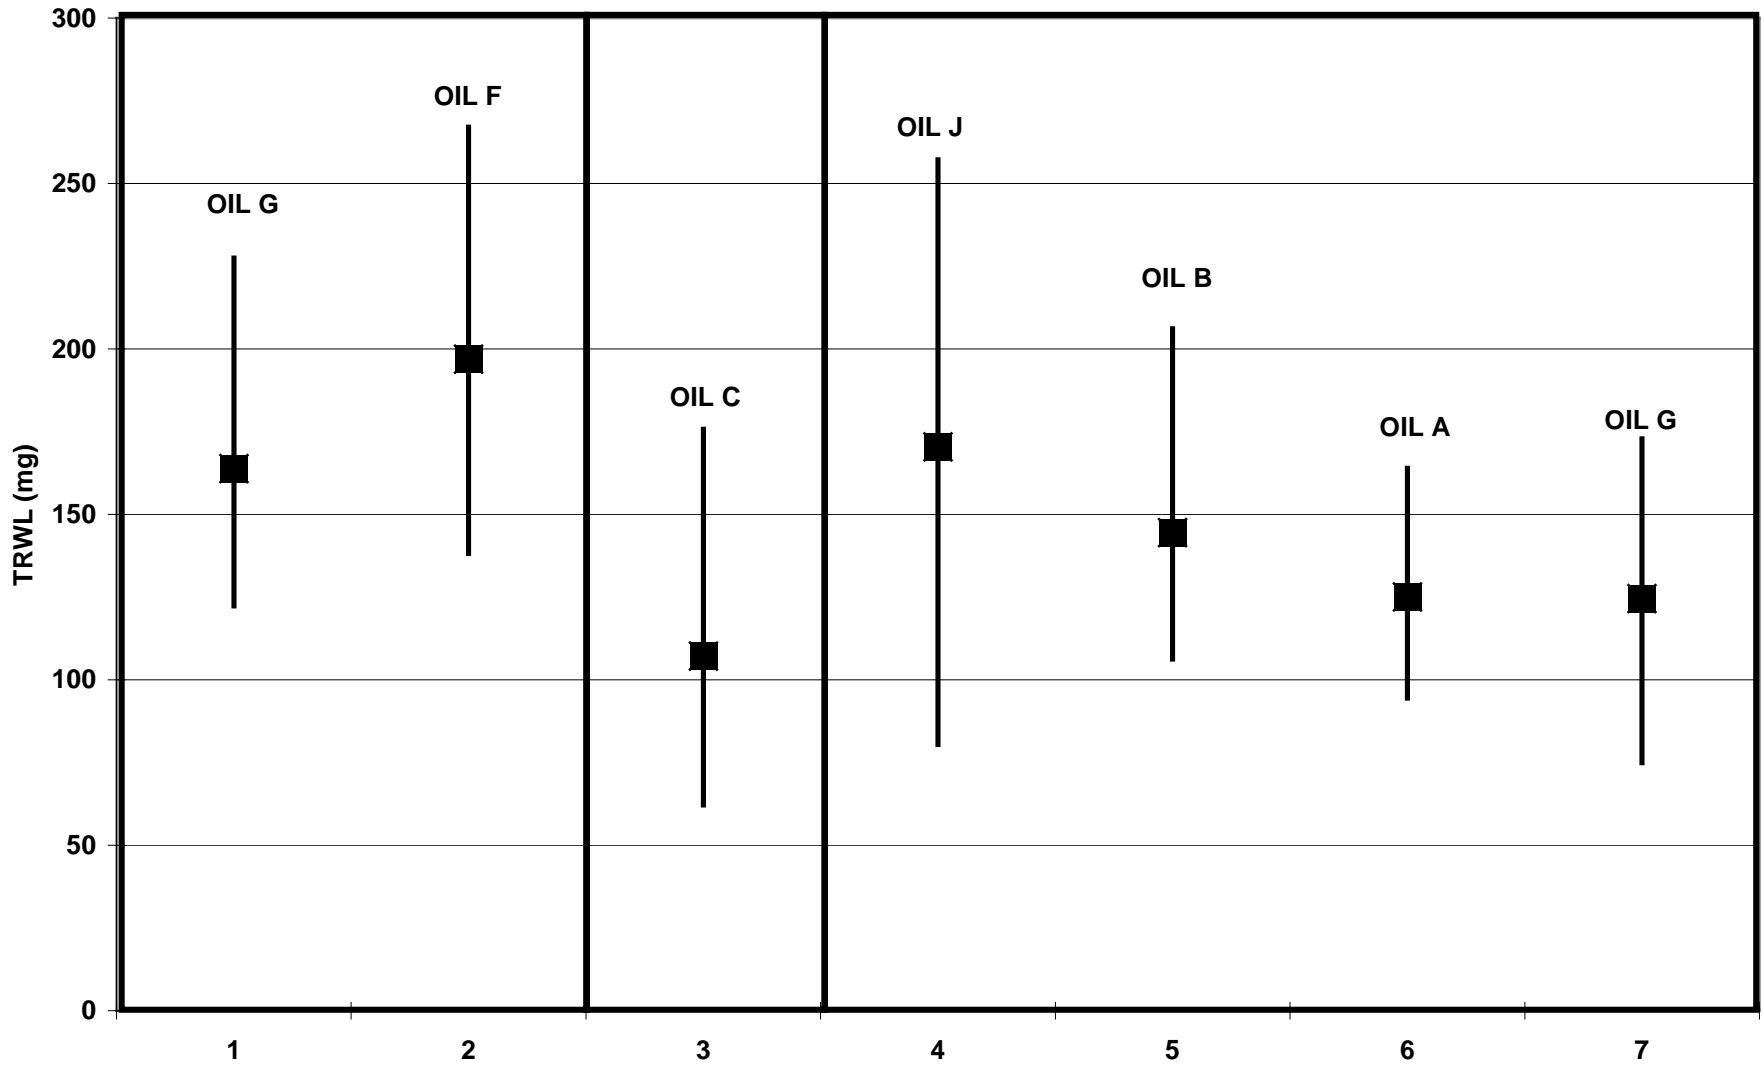
Top Ring Weight Loss

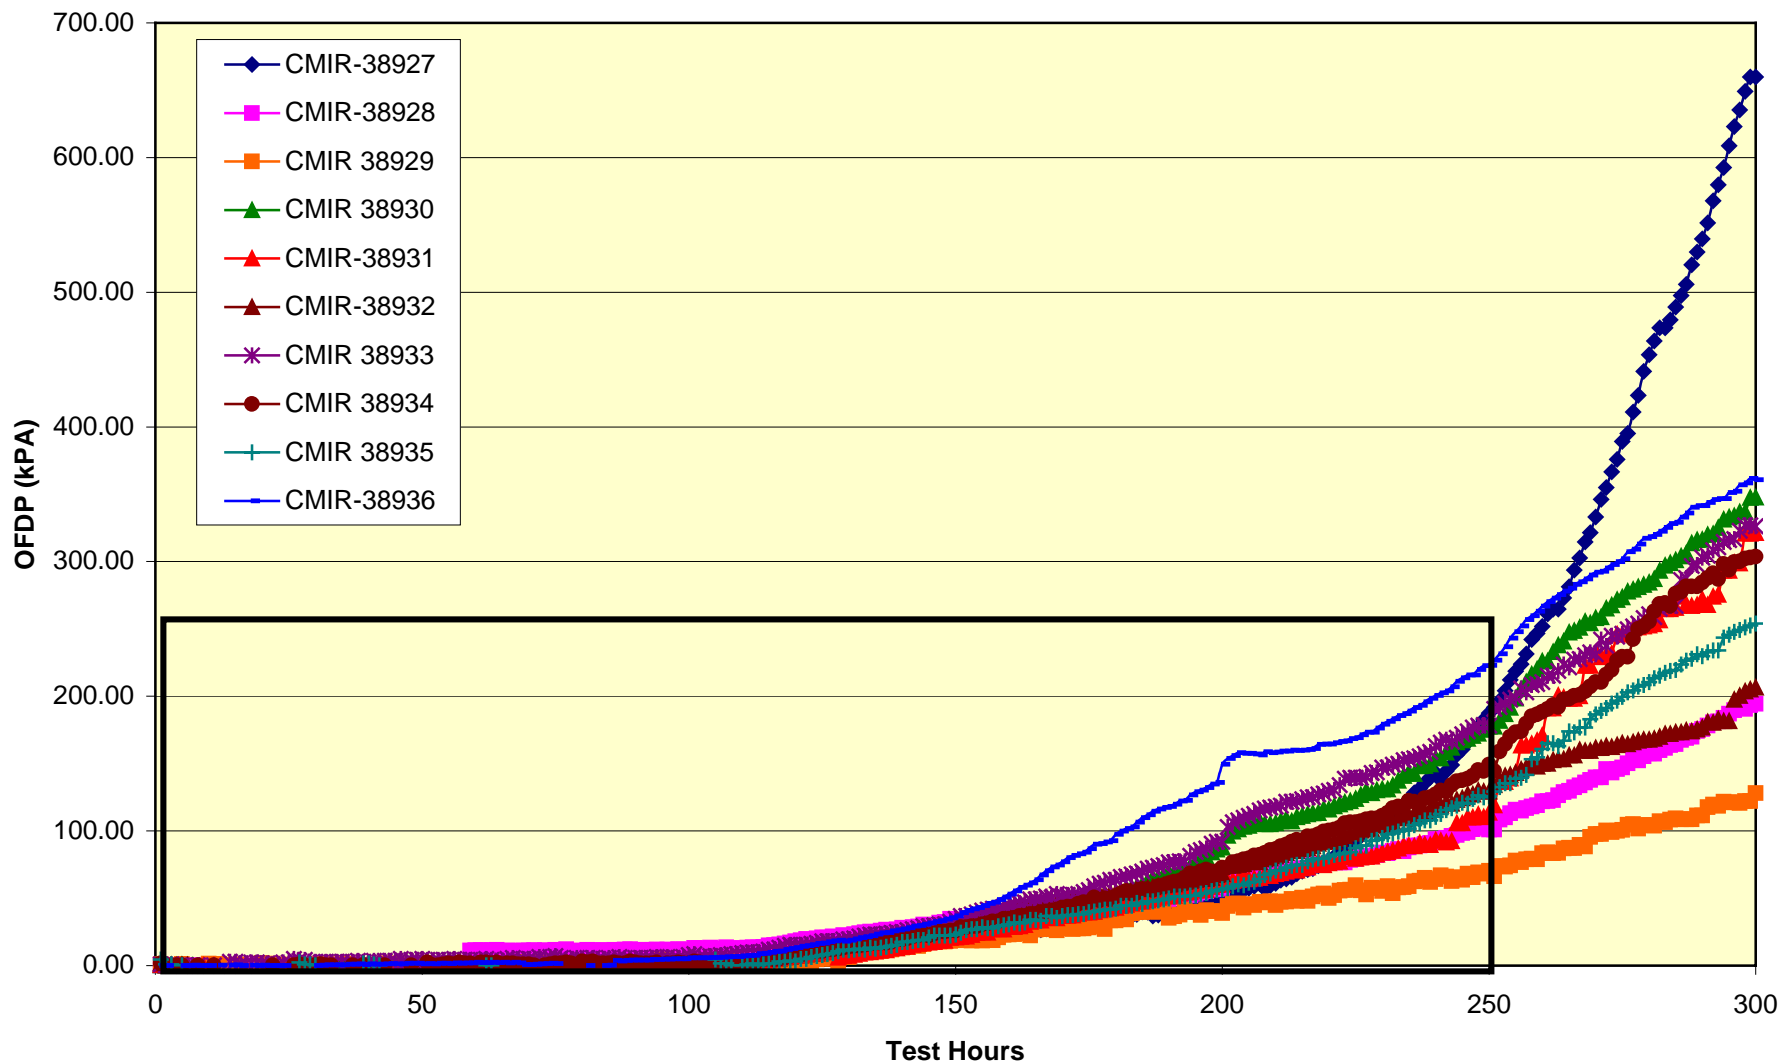
PC9 Matrix Data Oil E, Corrected & Normalized

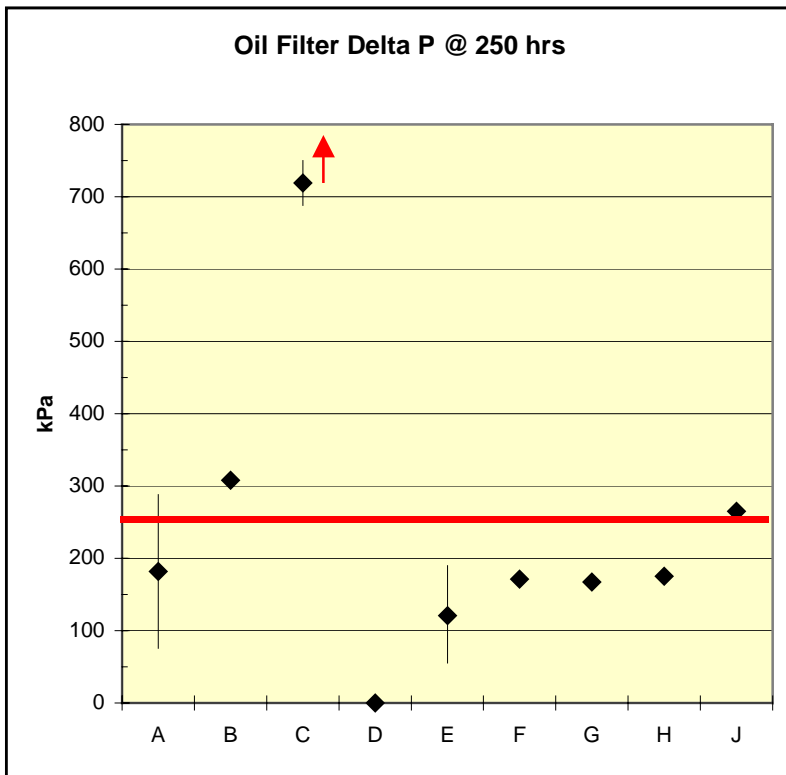
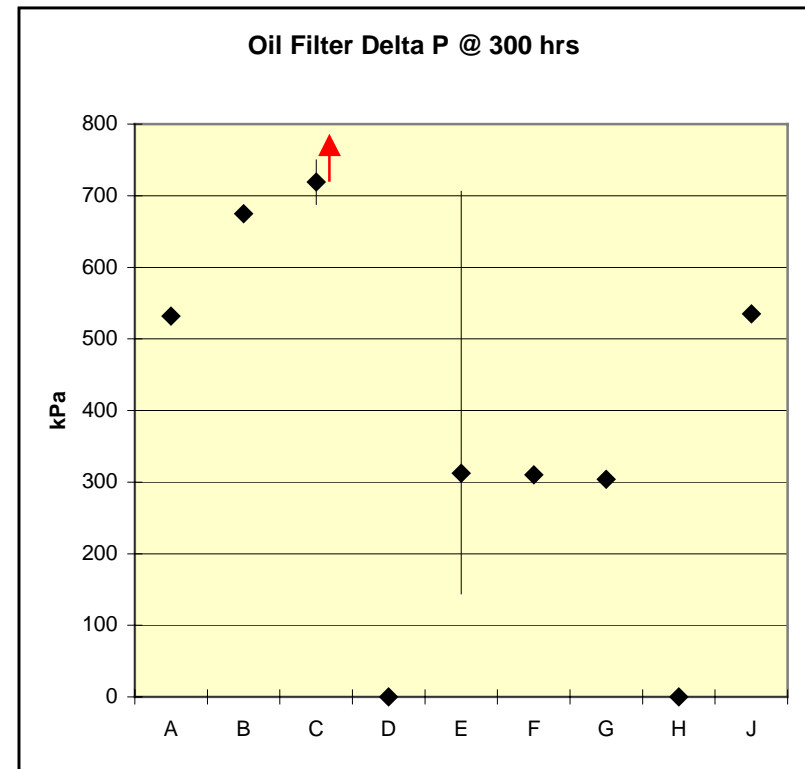
M11 EGR: Filter Delta P Matrix Results

- Apply HST correction factor
- Report 250 hr and 300 hr corrected DP
- Plots show range and mean
- Set limit at 250 hr

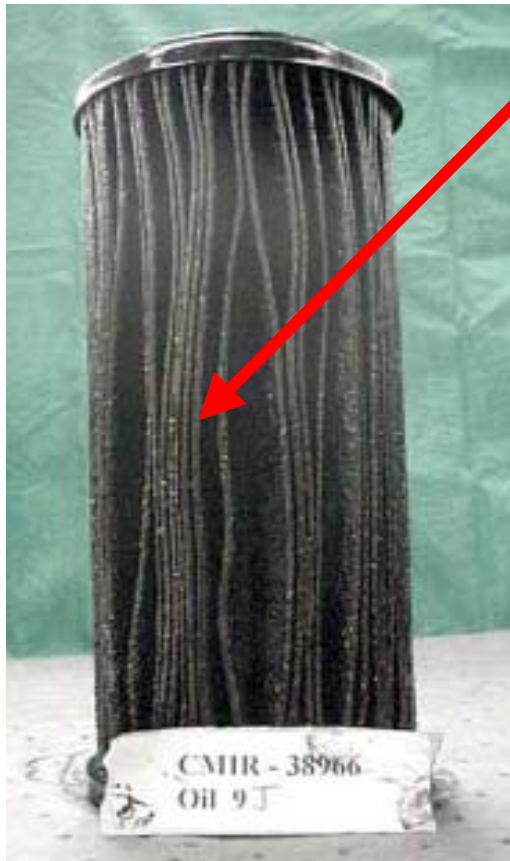
Shifting pleats cause loss of flow area

Filter Modification

- SWRI will run oil E with modified filter
- Surveillance Panel to review proper action

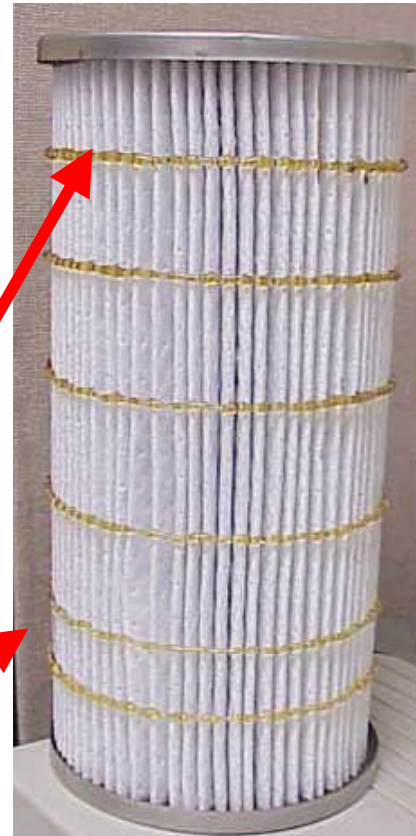
Hot-melt beads stabilize pleats
