M11 EGR Test Matrix Status

**Presentation to
HDEOCP
June 19, 2001
David M Stehouwer**

M-11 EGR Test Matrix Status

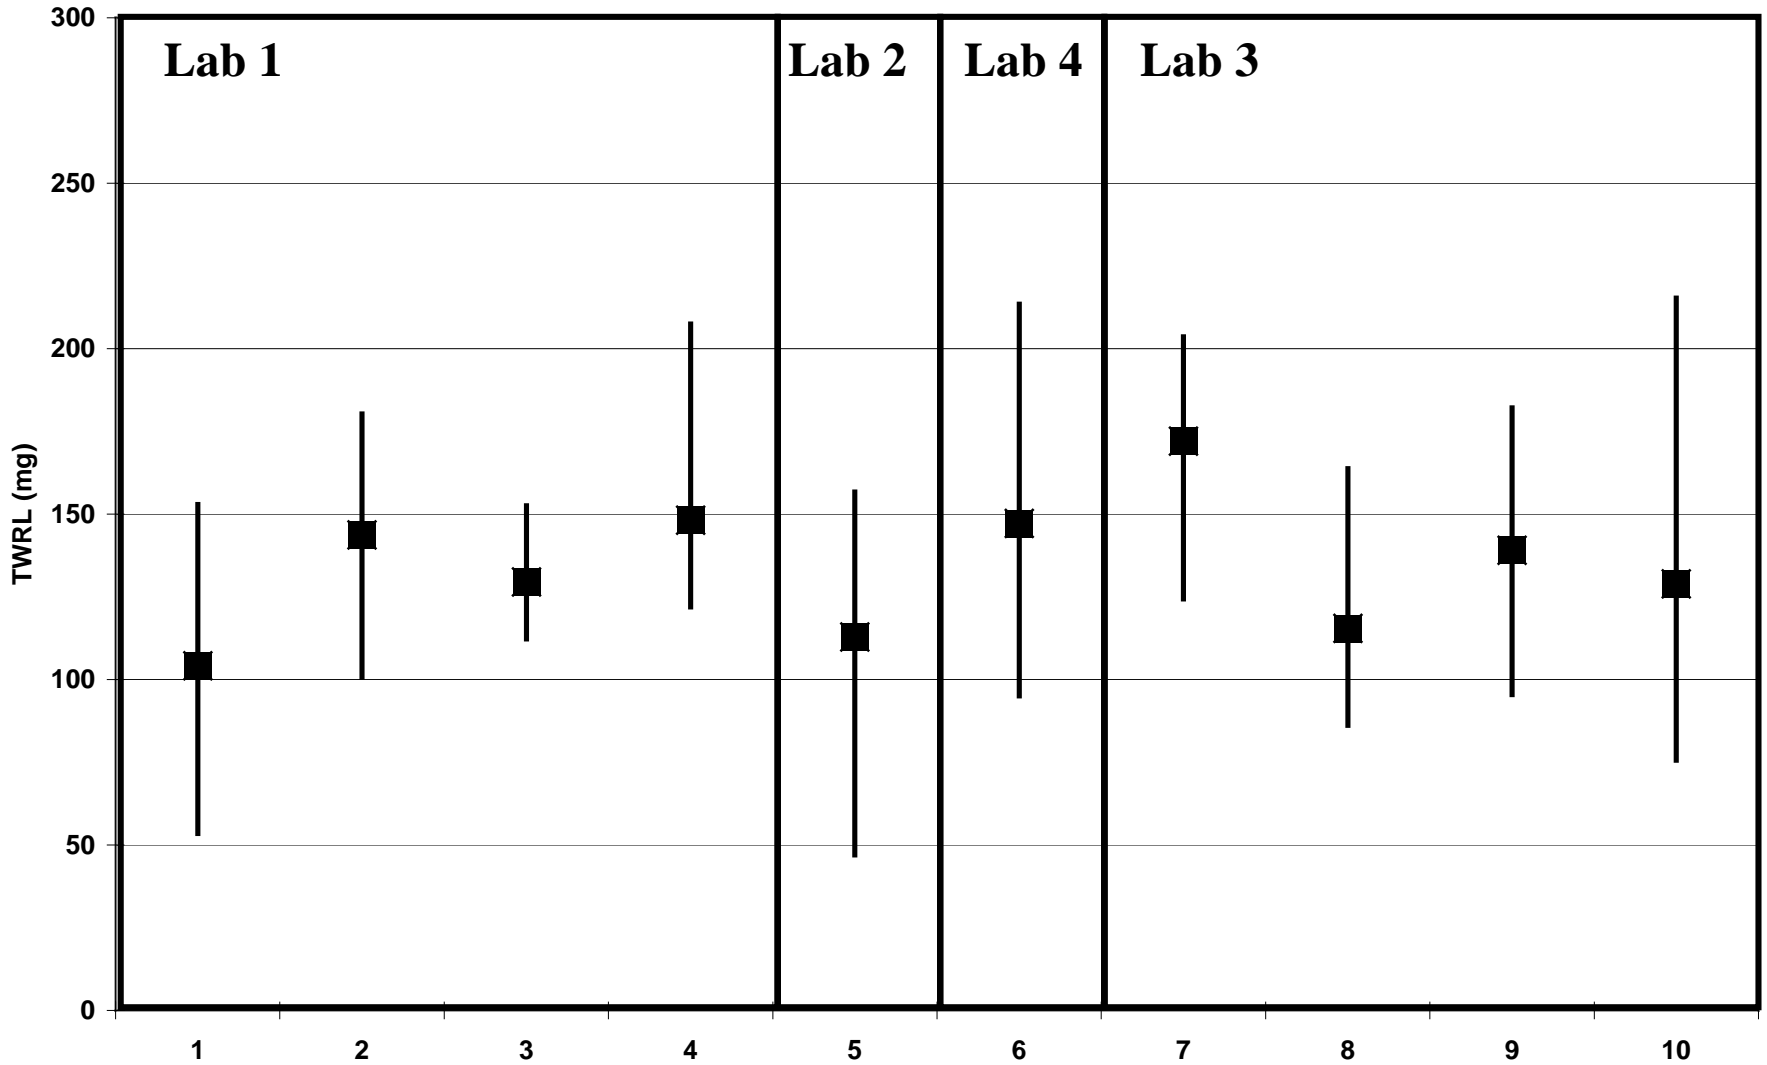
Top Ring Weight Loss - Matrix Oil E

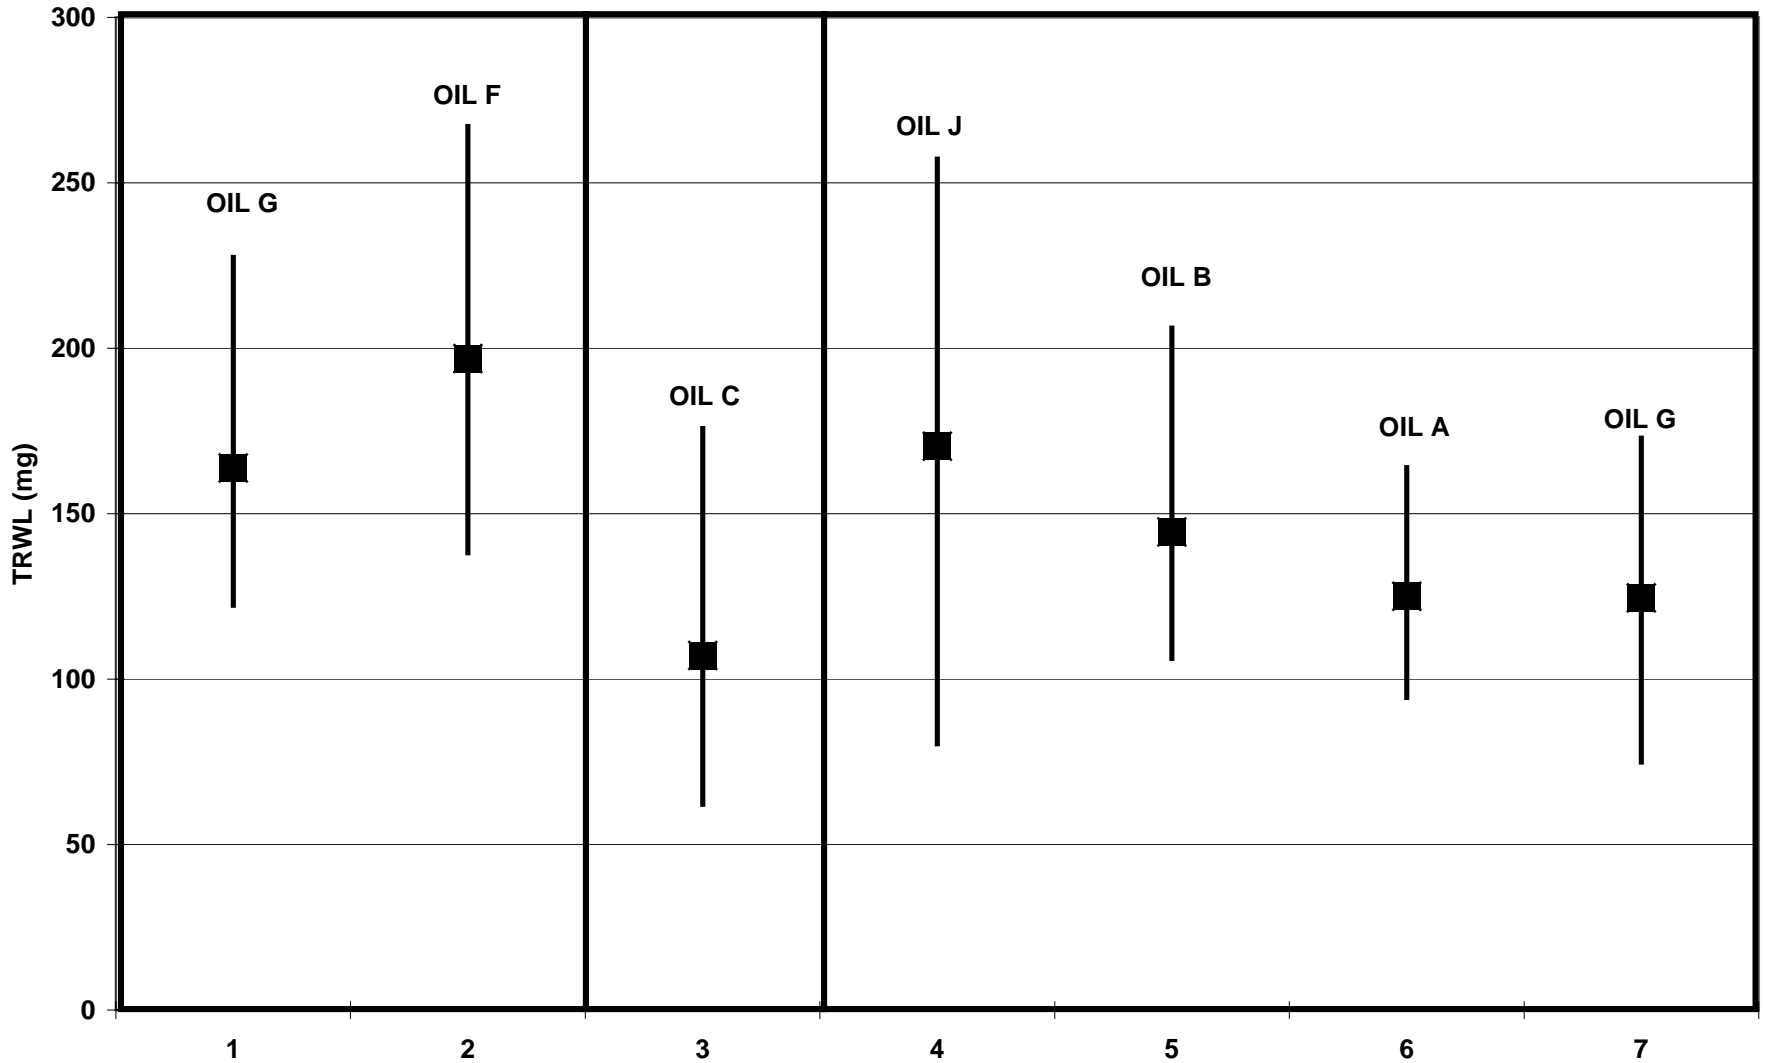
Top Ring Weight Loss

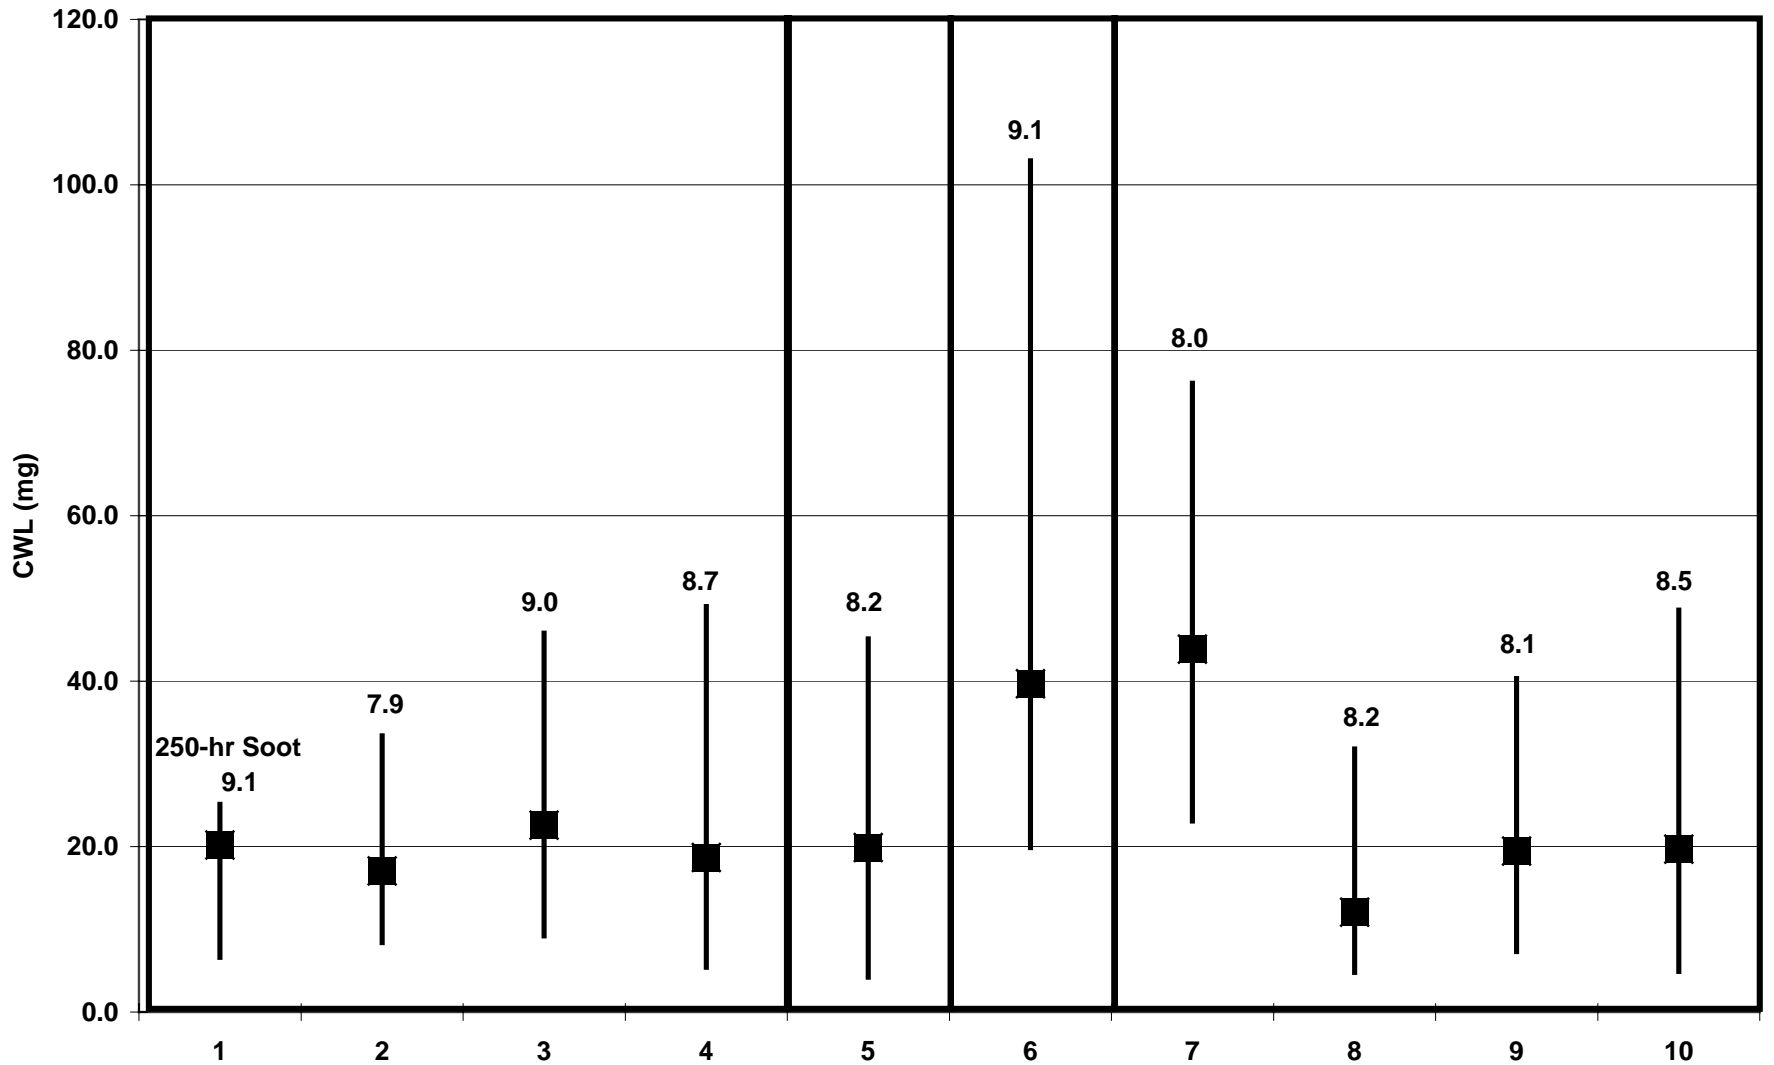
Crosshead Weight Loss - Matrix Oil E

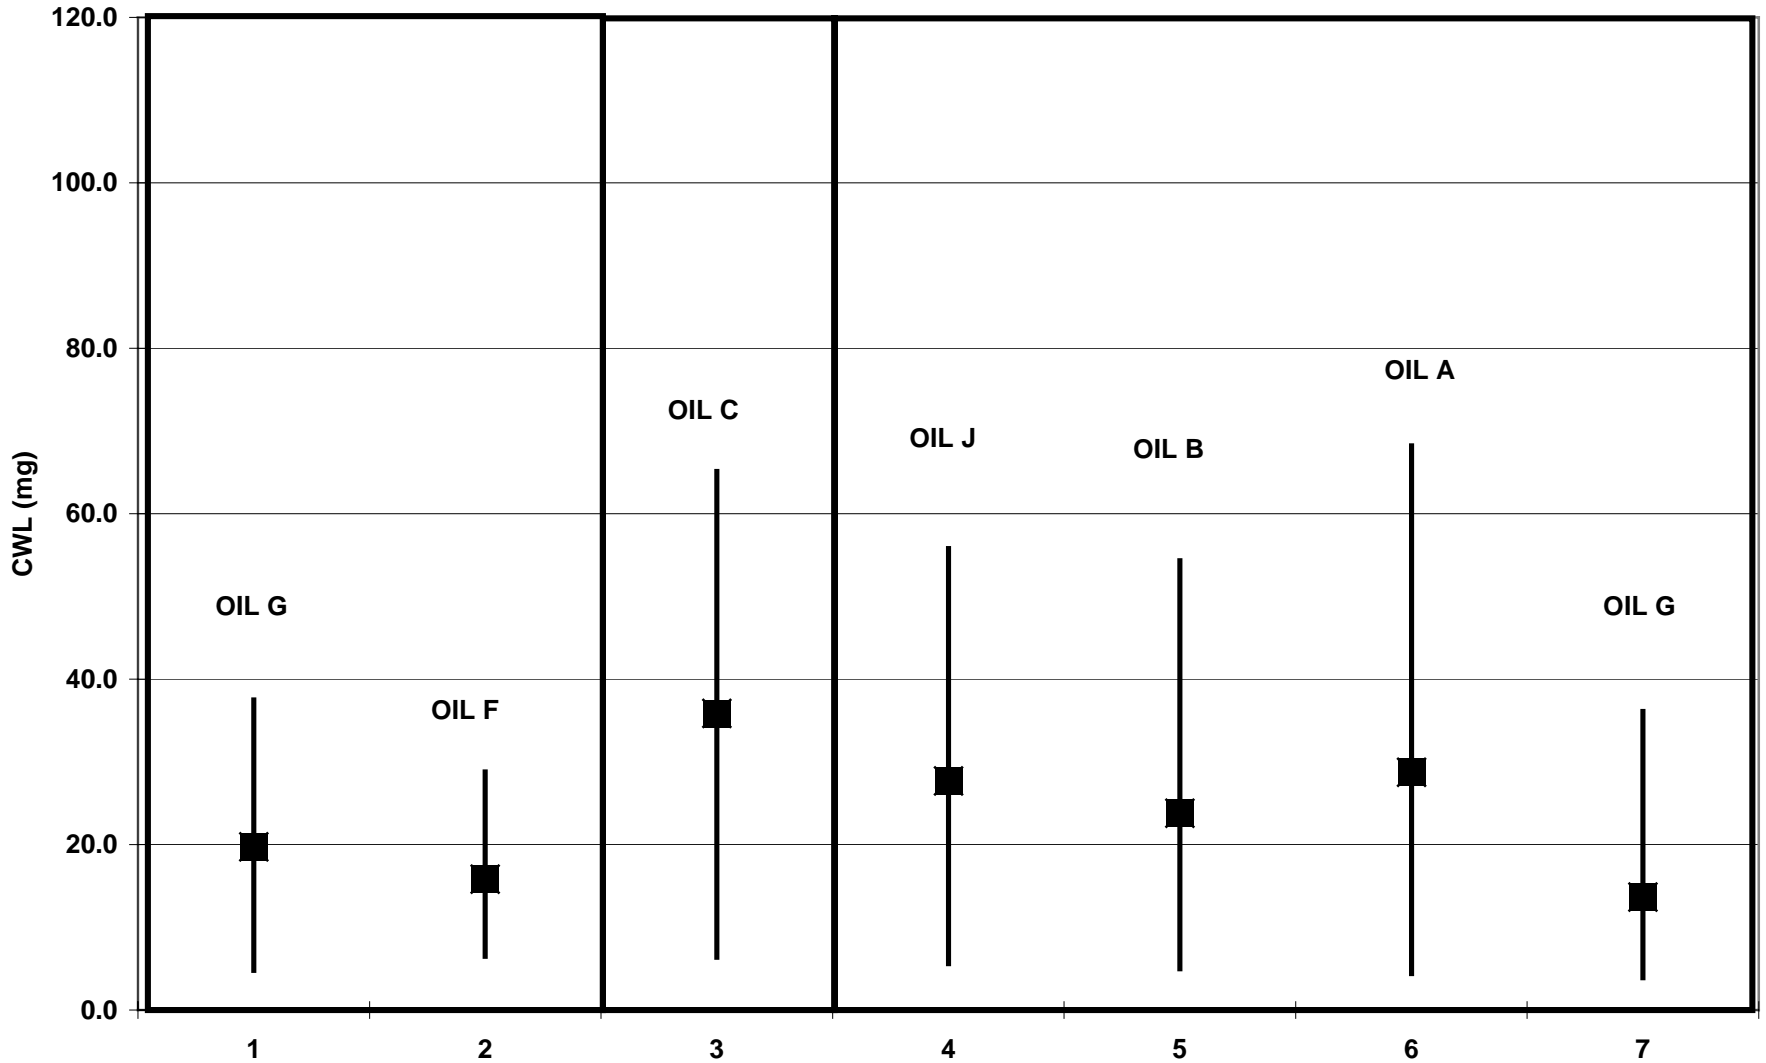
250-hr Soot

Crosshead Weight Loss

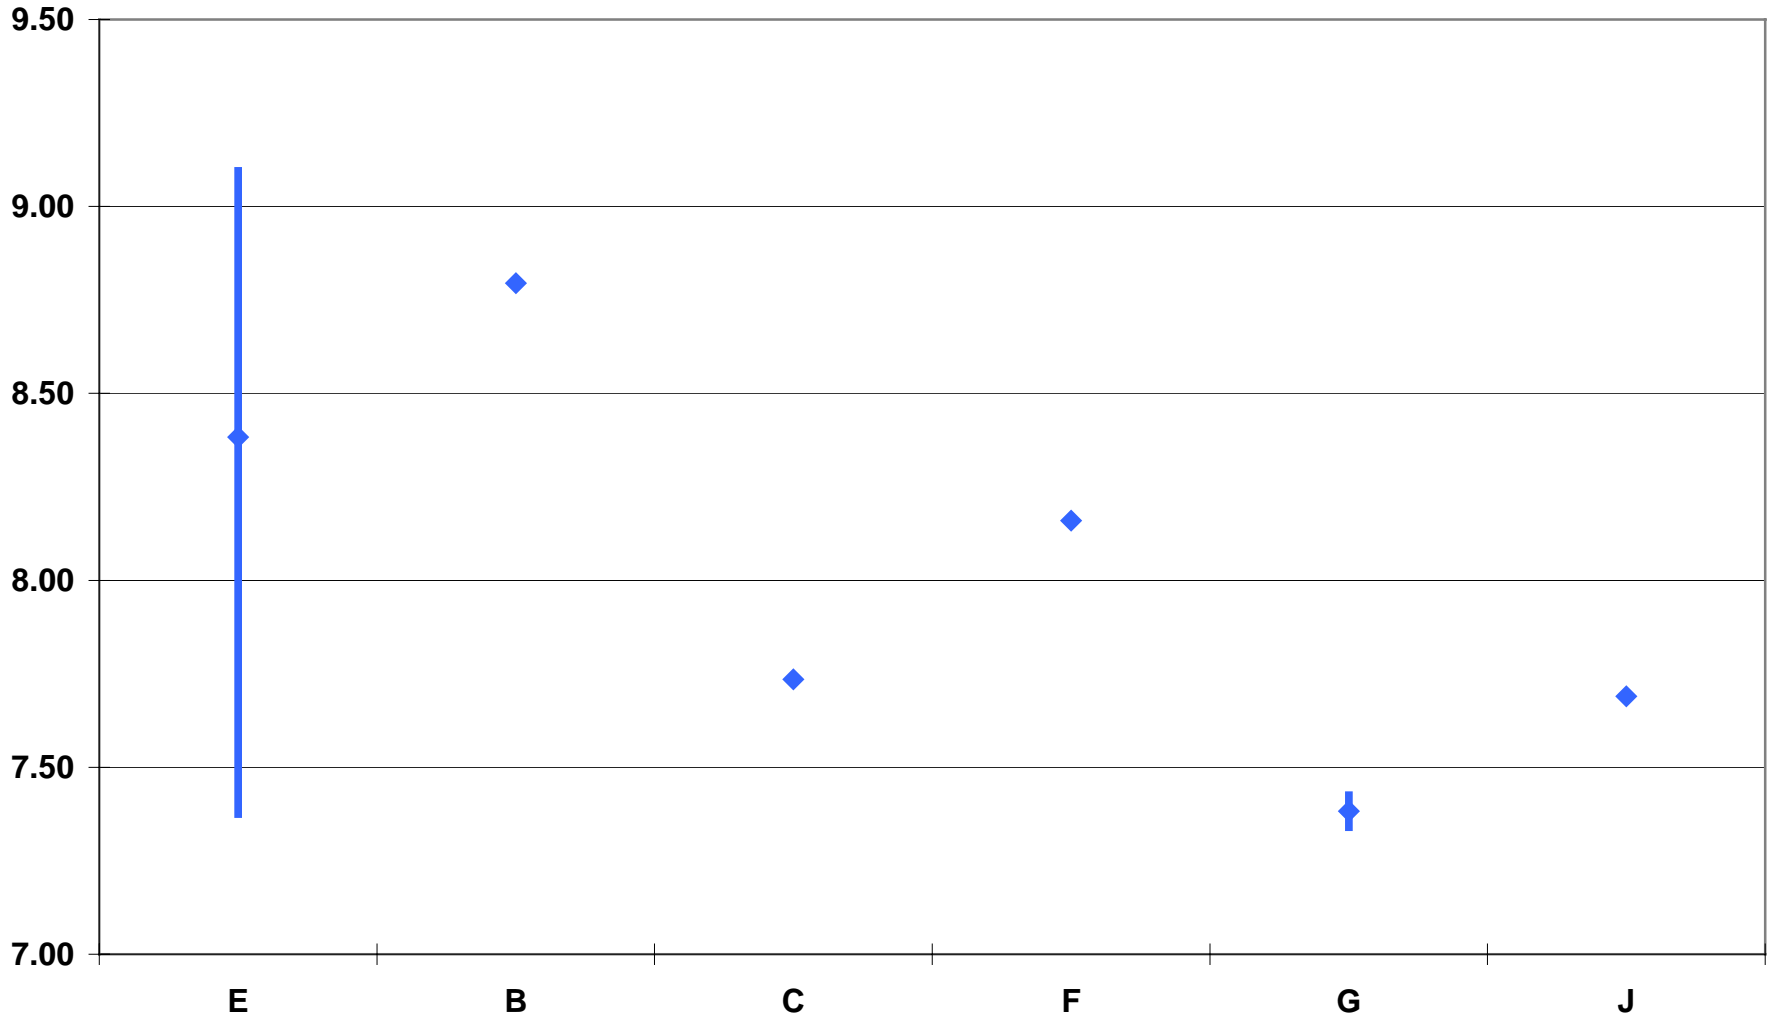
M11 EGR Sludge Ratings

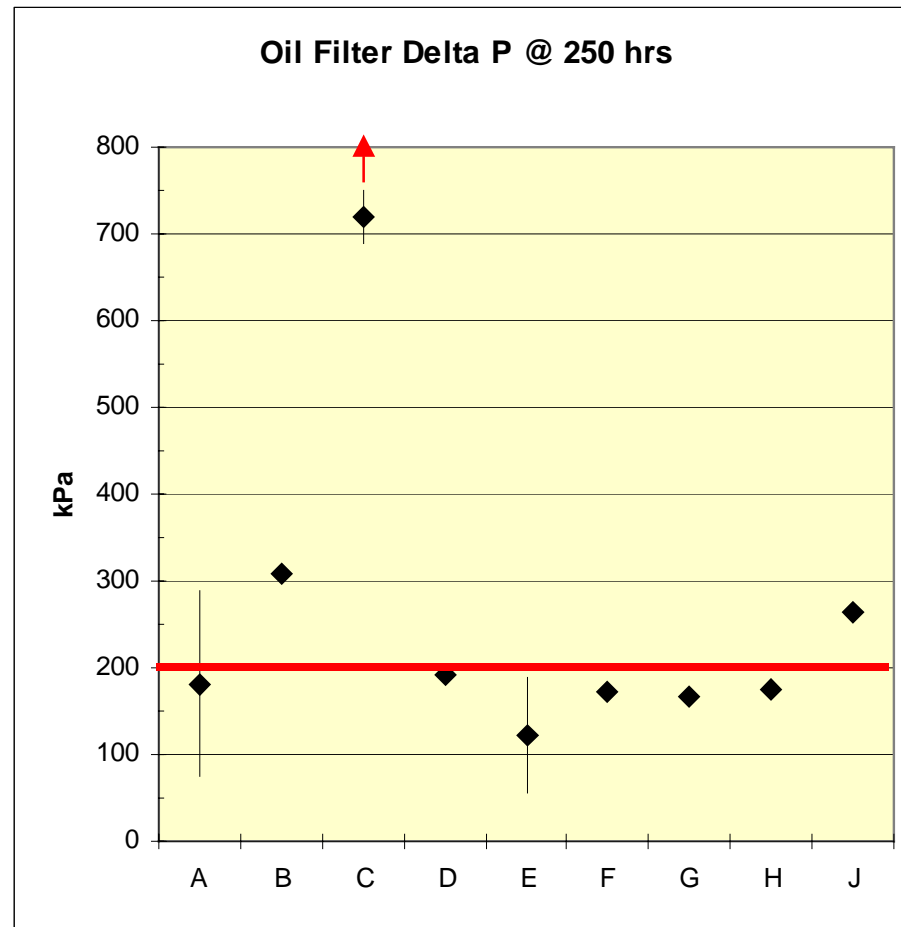
M11 EGR: Filter Delta P Matrix Results

- Apply HST correction factor to delta P
- Plots show range and mean
- Set limit at 250 hr

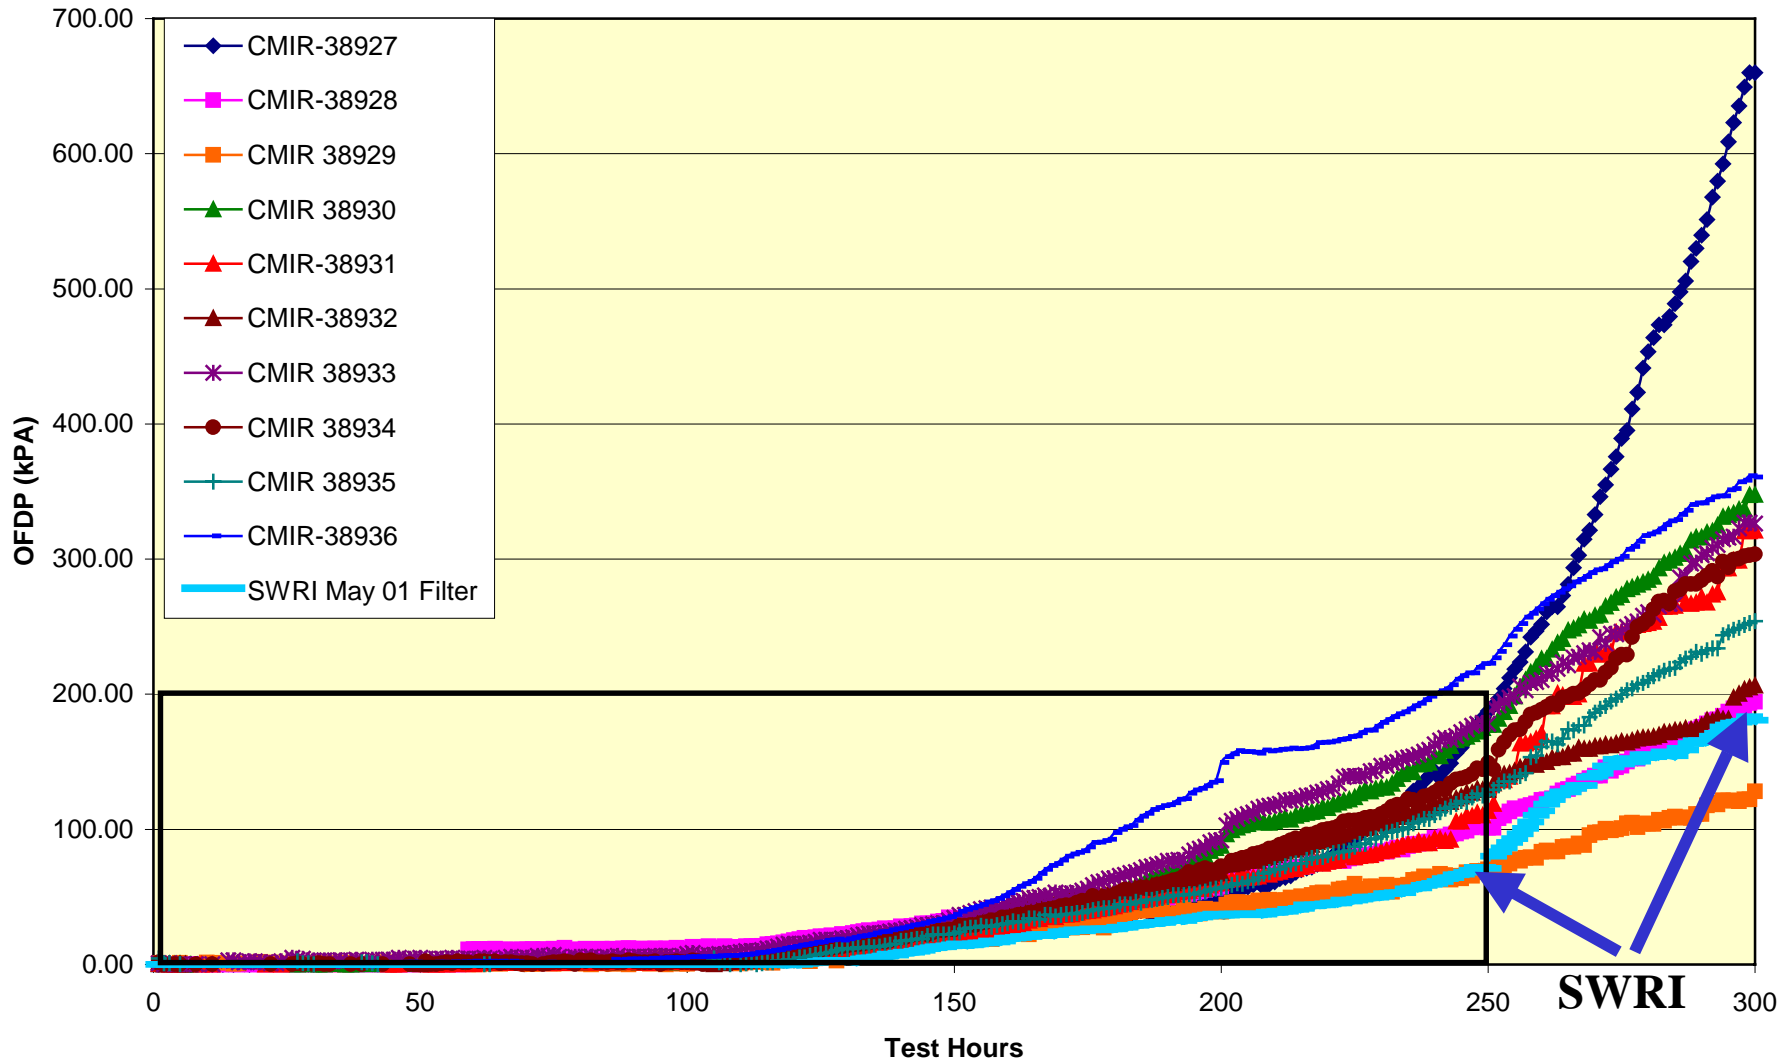
PC9 Matrix Data Oil E, Corrected & Normalized

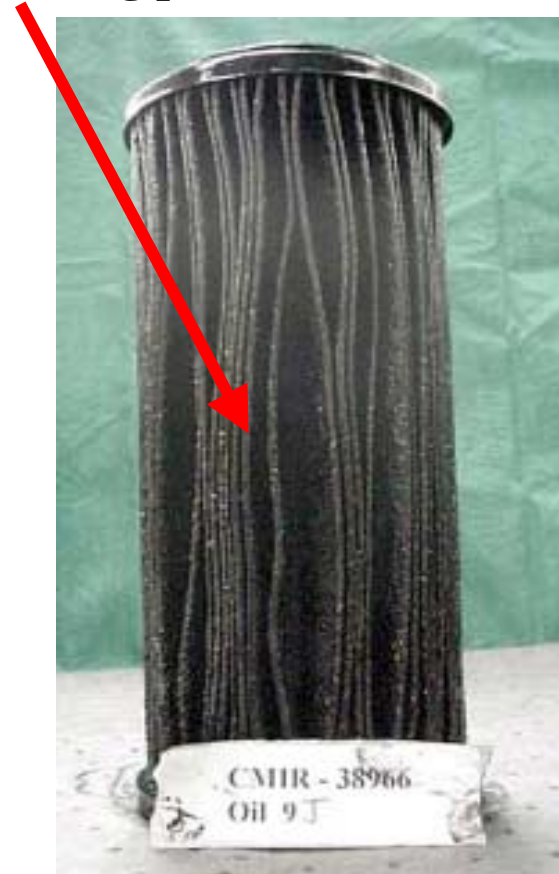
Shifting pleats cause loss of flow area

Filter Modification

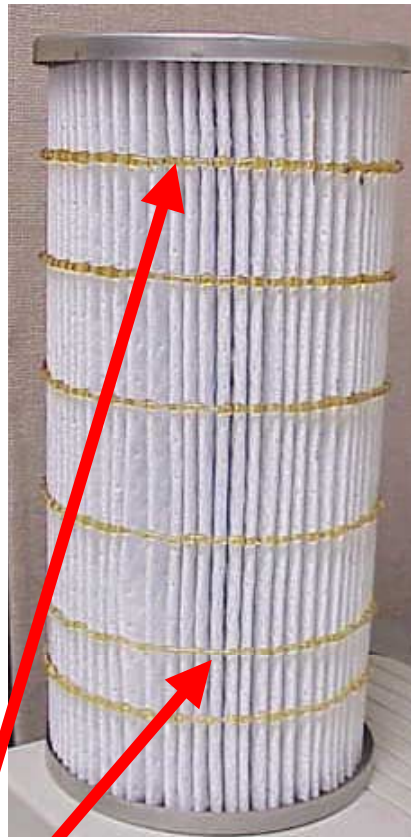
Hot-melt beads stabilize pleats

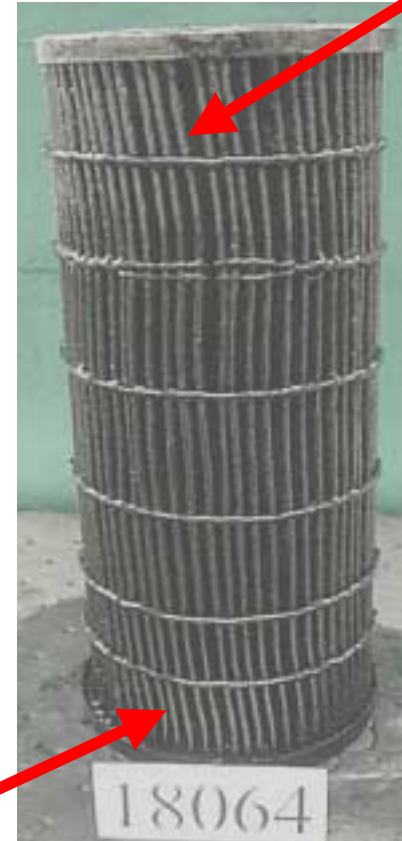
Used Filter shows stable pleats

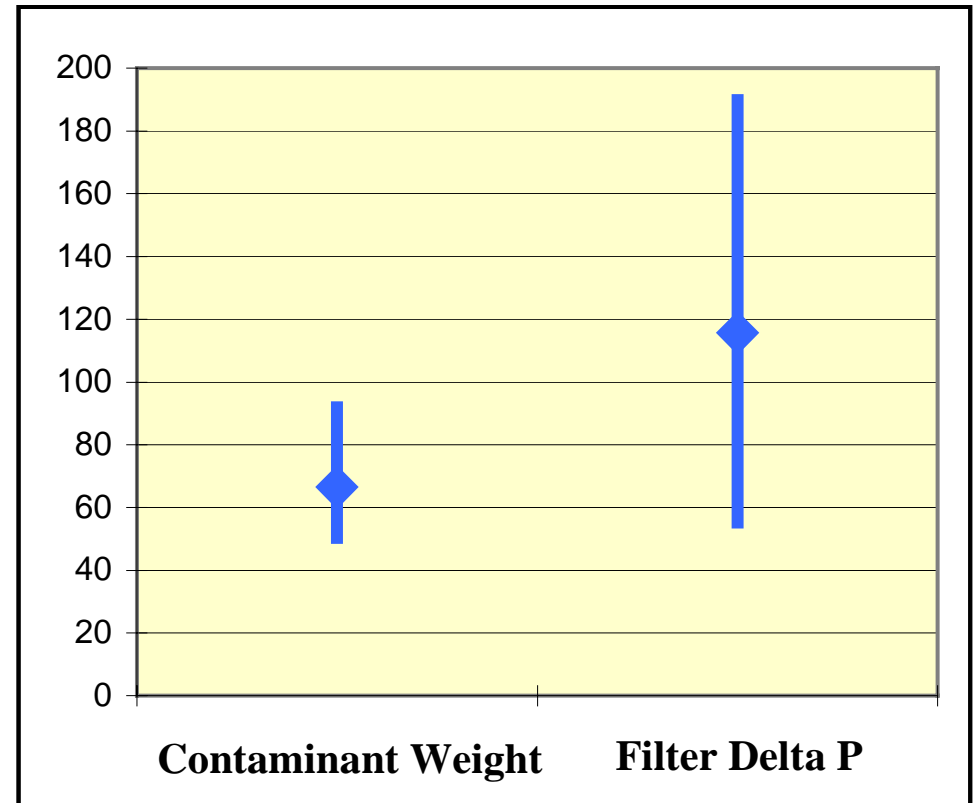
M11 EGR Used Filter Properties: Oil E

- **Delta P variation caused by filter structure**
- **Filter contaminant more repeatable than delta P**
- **Engine test generating same contaminant each run**
- **Filter removing same contaminant each run**

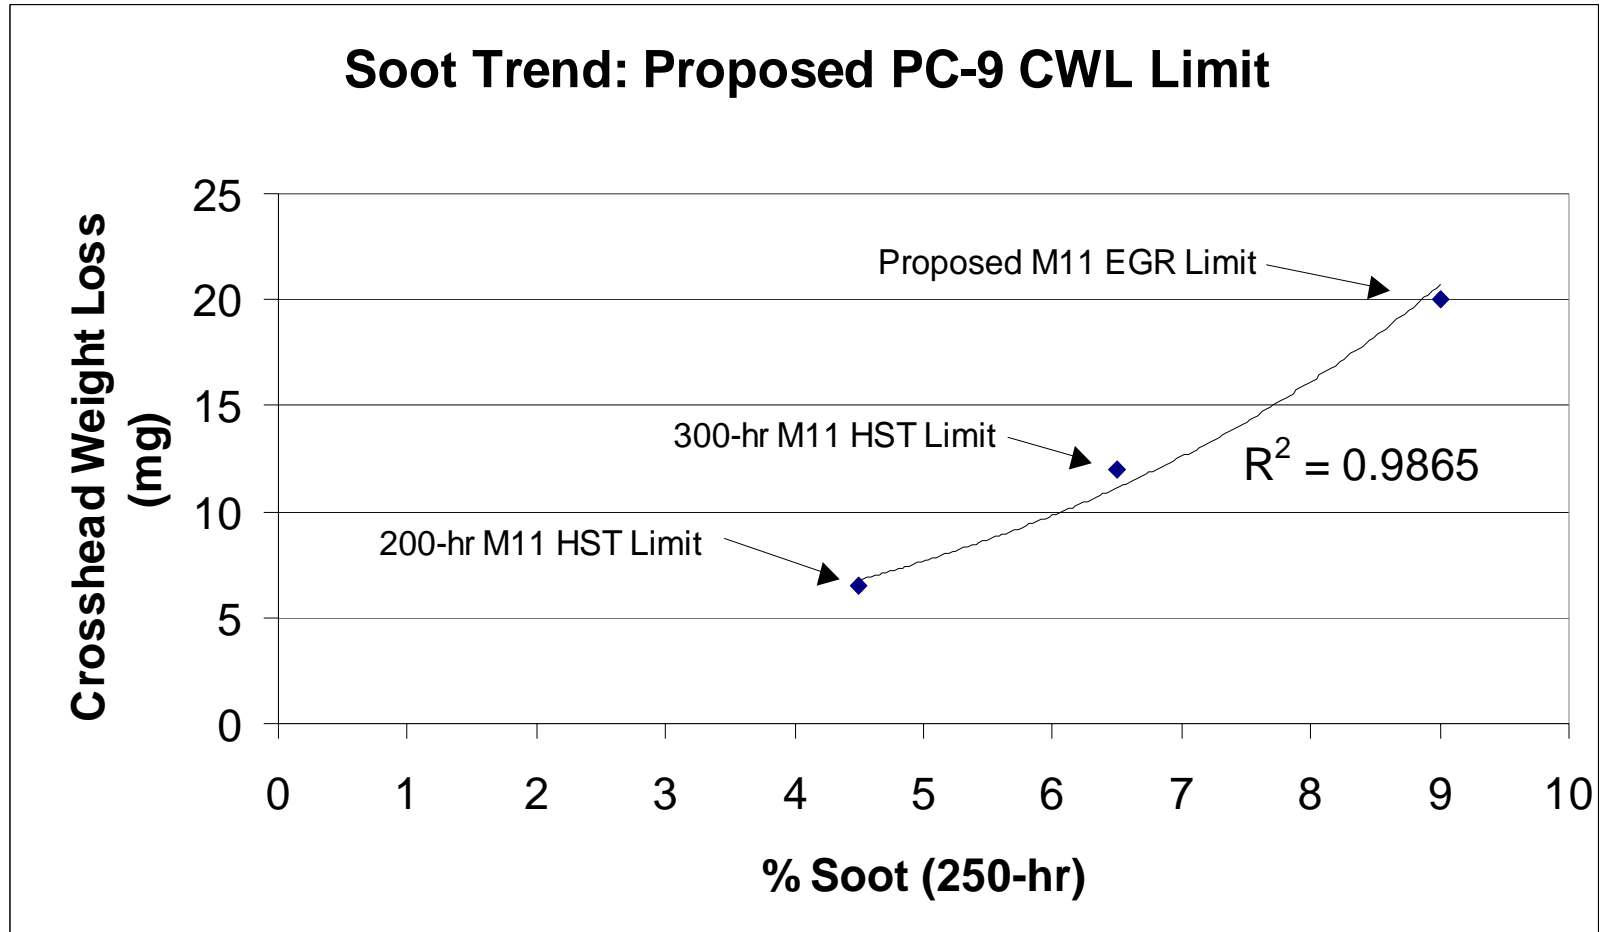
Soot vs. Wear in M11 Tests
