T11/T12 Intake Valve

Comparison – July 2014

SwRI – Robert Warden

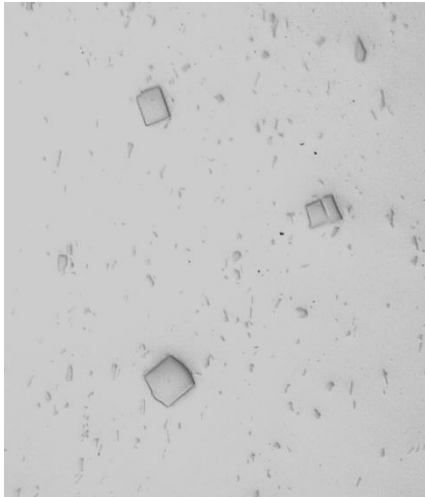
Fractured Valve

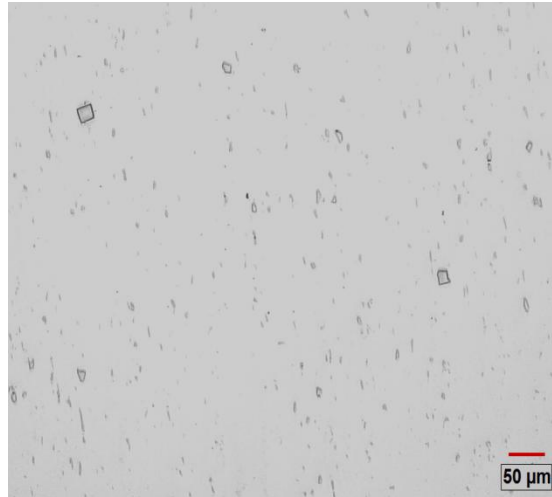
Fractured Batch

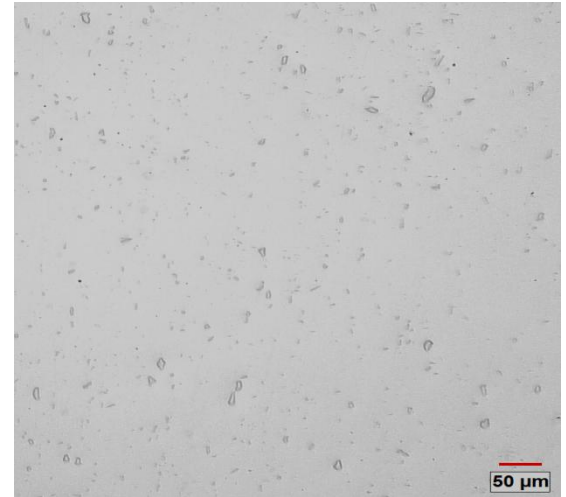
Good Batch

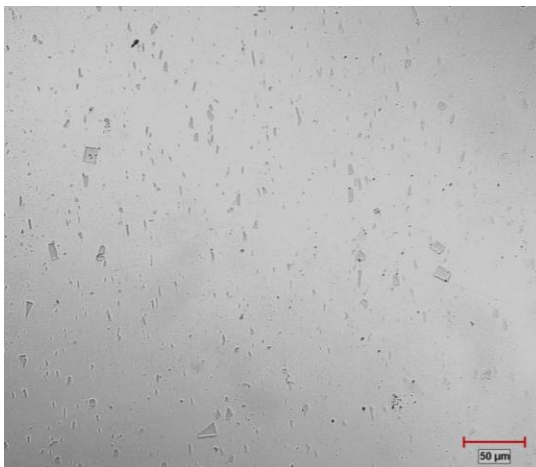
Mack 03-14 B

- Lack of surface carbides on new Mack batch as well as Aftermarket valves
- Some signs of interior carbides and difference in grain structure for new Mack batch
 - Likely a heat treatment effect?
- Some noticeable geometric features on the Aftermarket valves at the transition from stem to tulip, potential for stress raiser
- Minor geometric differences between valves, but still allows head to be built to specs.

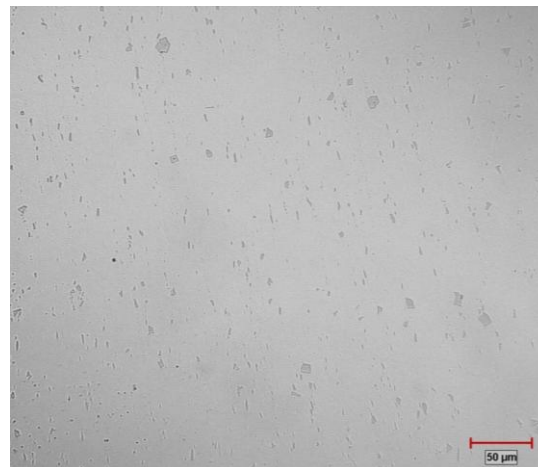
Aftermarket

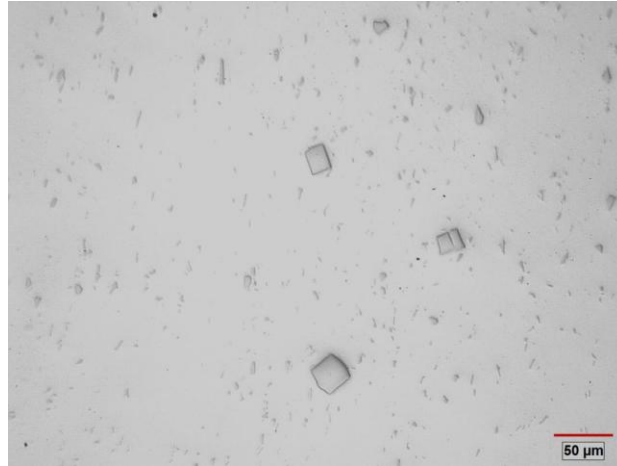
Fractured Valve

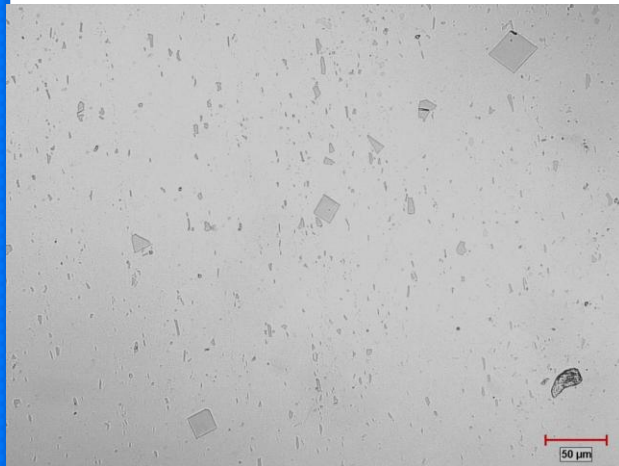
Mack 03-14 B

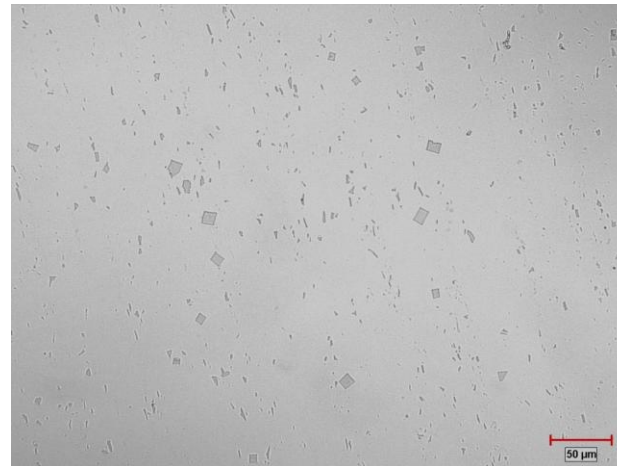
Aftermarket

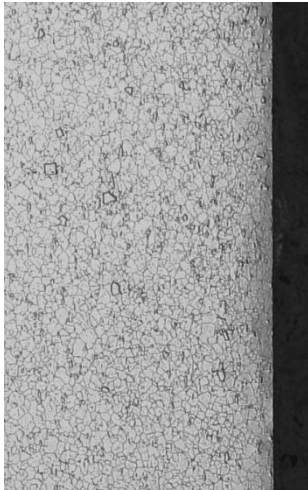
Fractured Valve

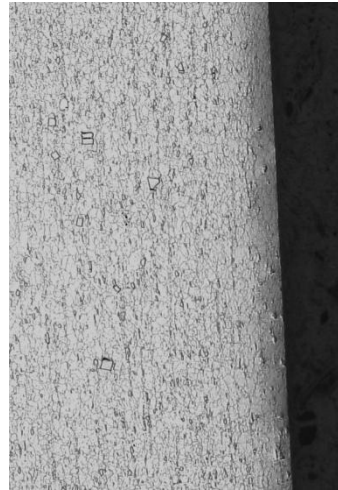
Fractured Batch

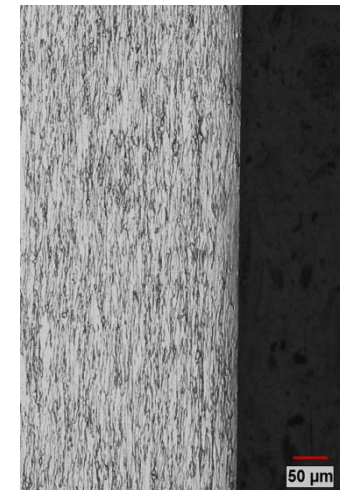
Good Batch

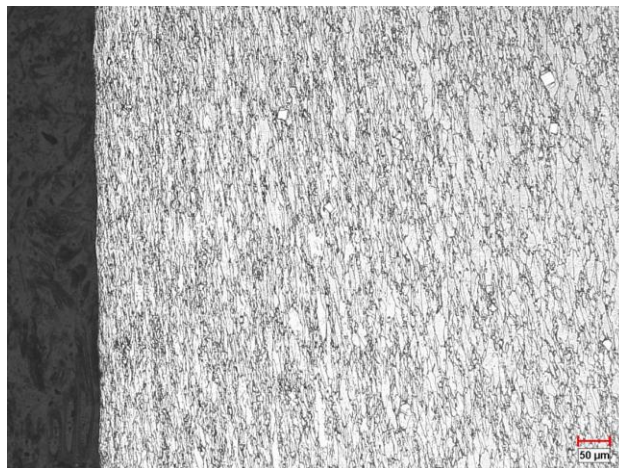
Mack 03-14 B

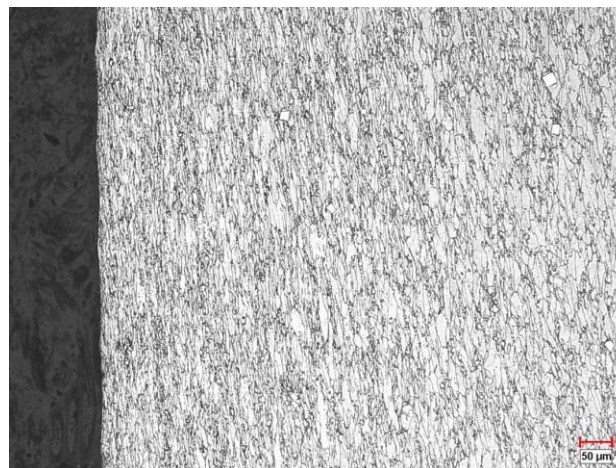
Aftermarket

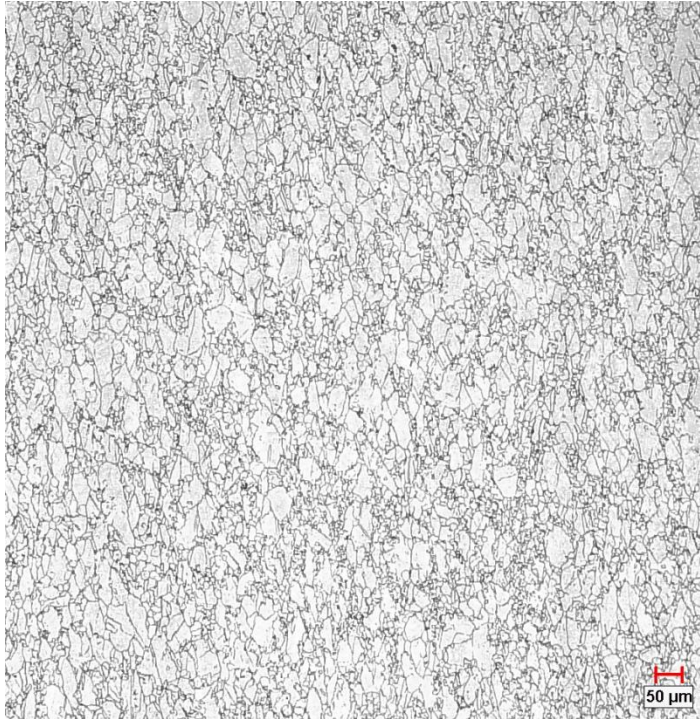
Mack 03-14 B

May still have some heat-treating issue?
Unknown how this will impact durability

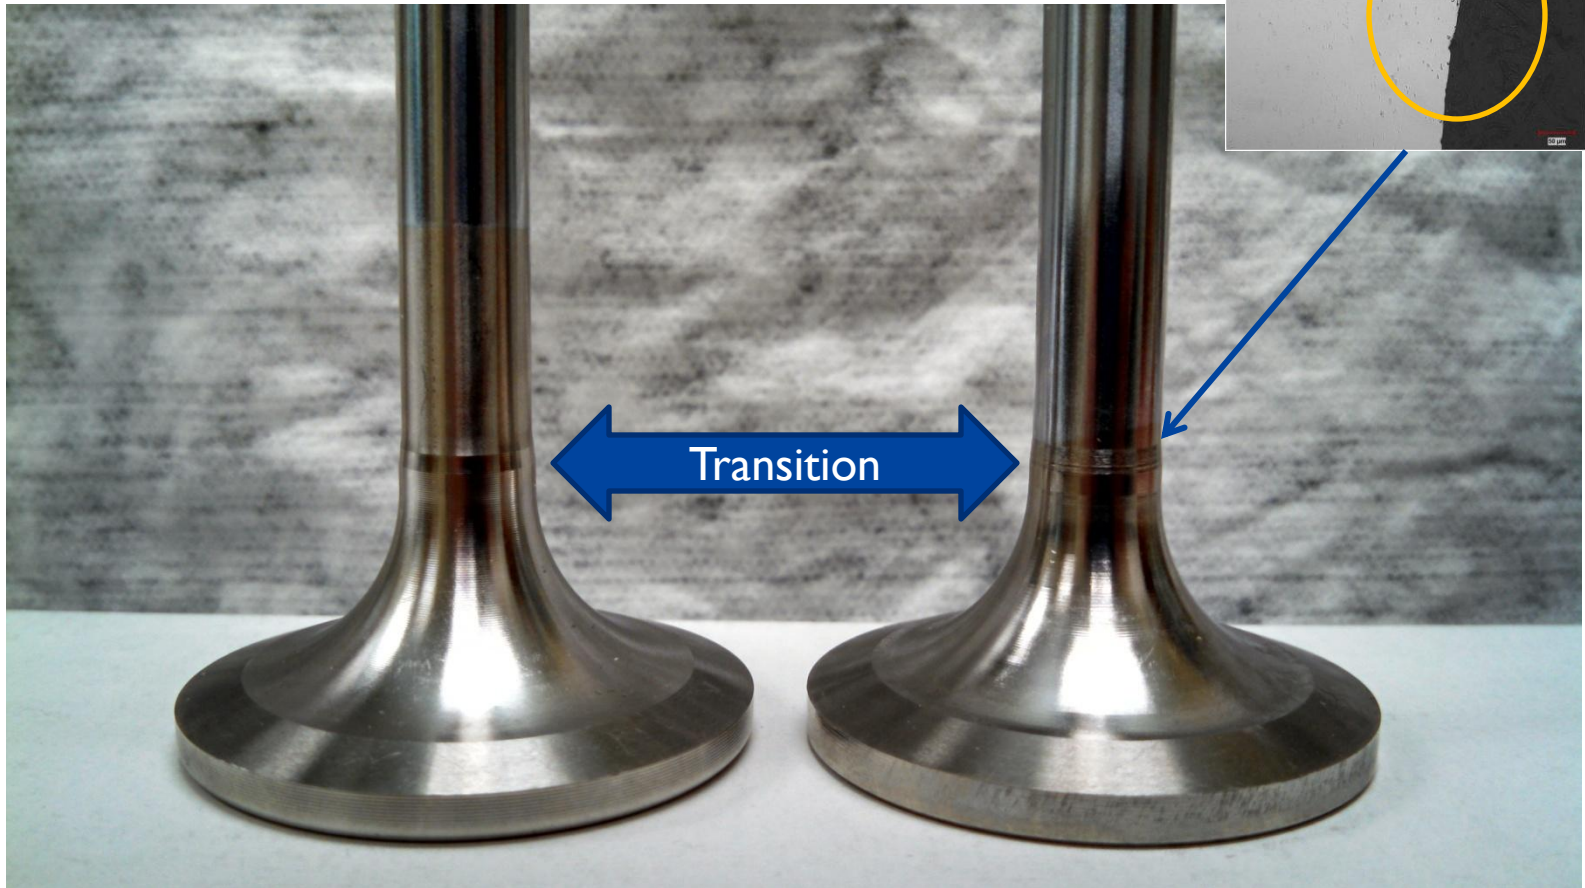
Geometric Differences

Mack 03-14 B

Aftermarket

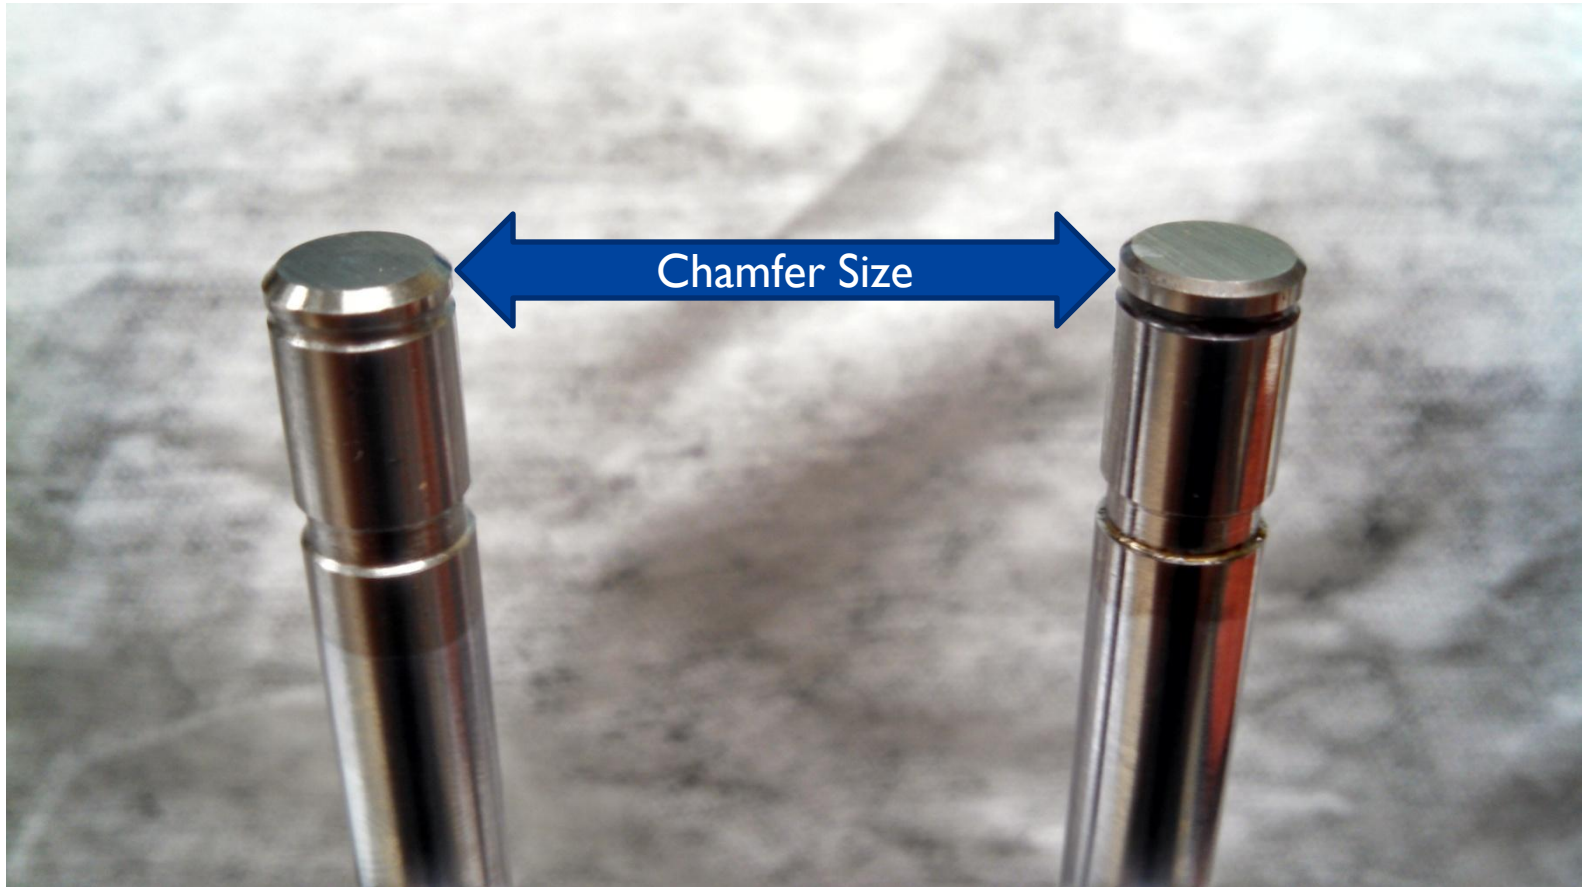
Geometric Differences

Mack 03-14 B

Aftermarket

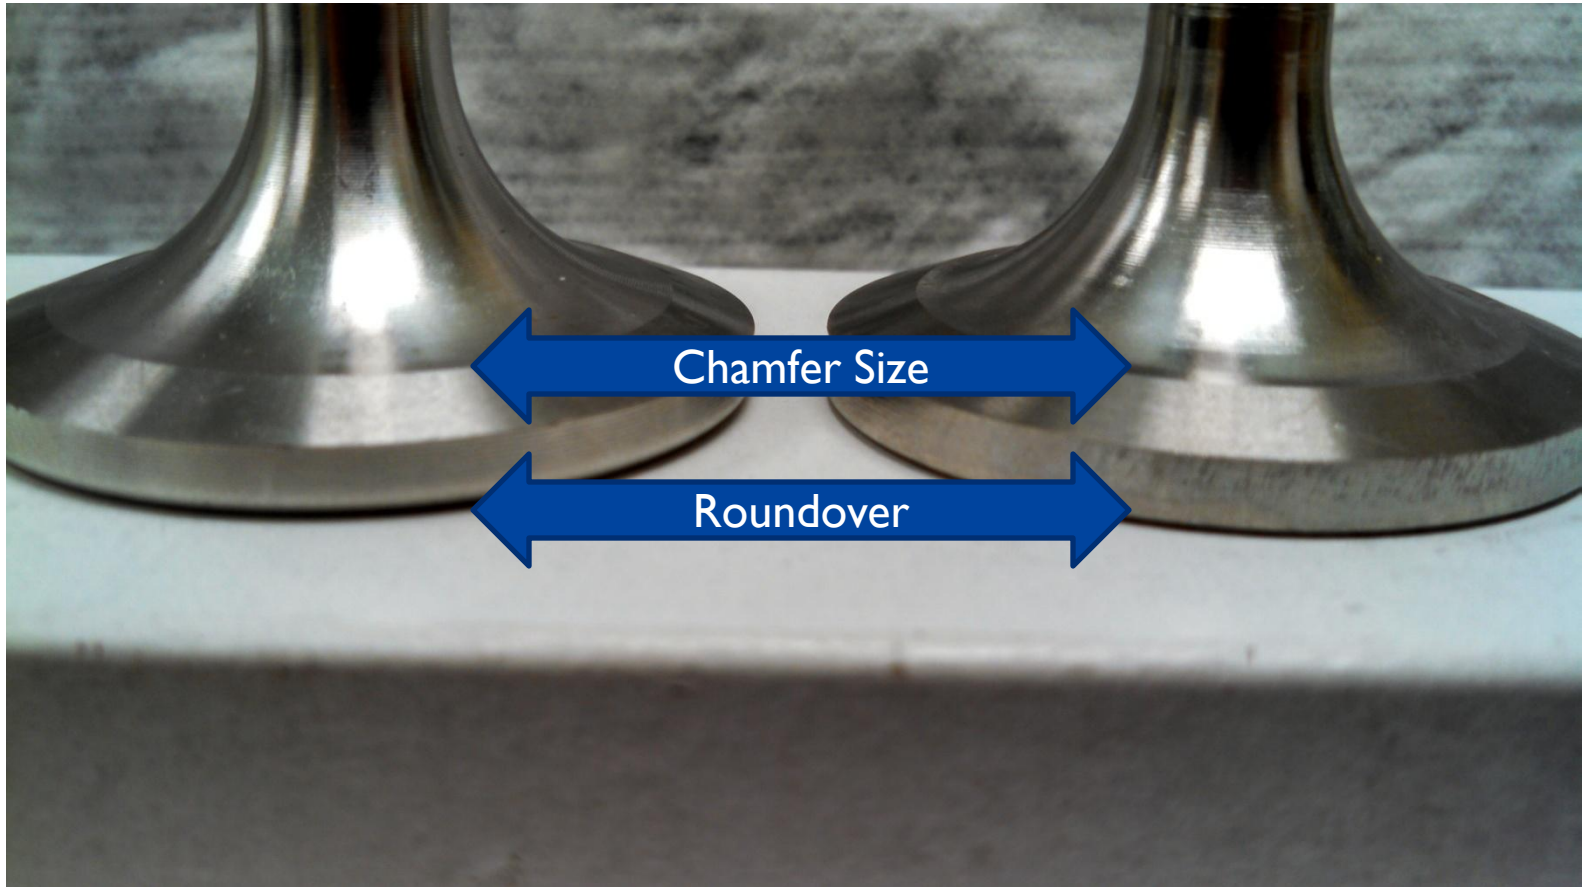
Geometric Differences

Mack 03-14 B

Aftermarket

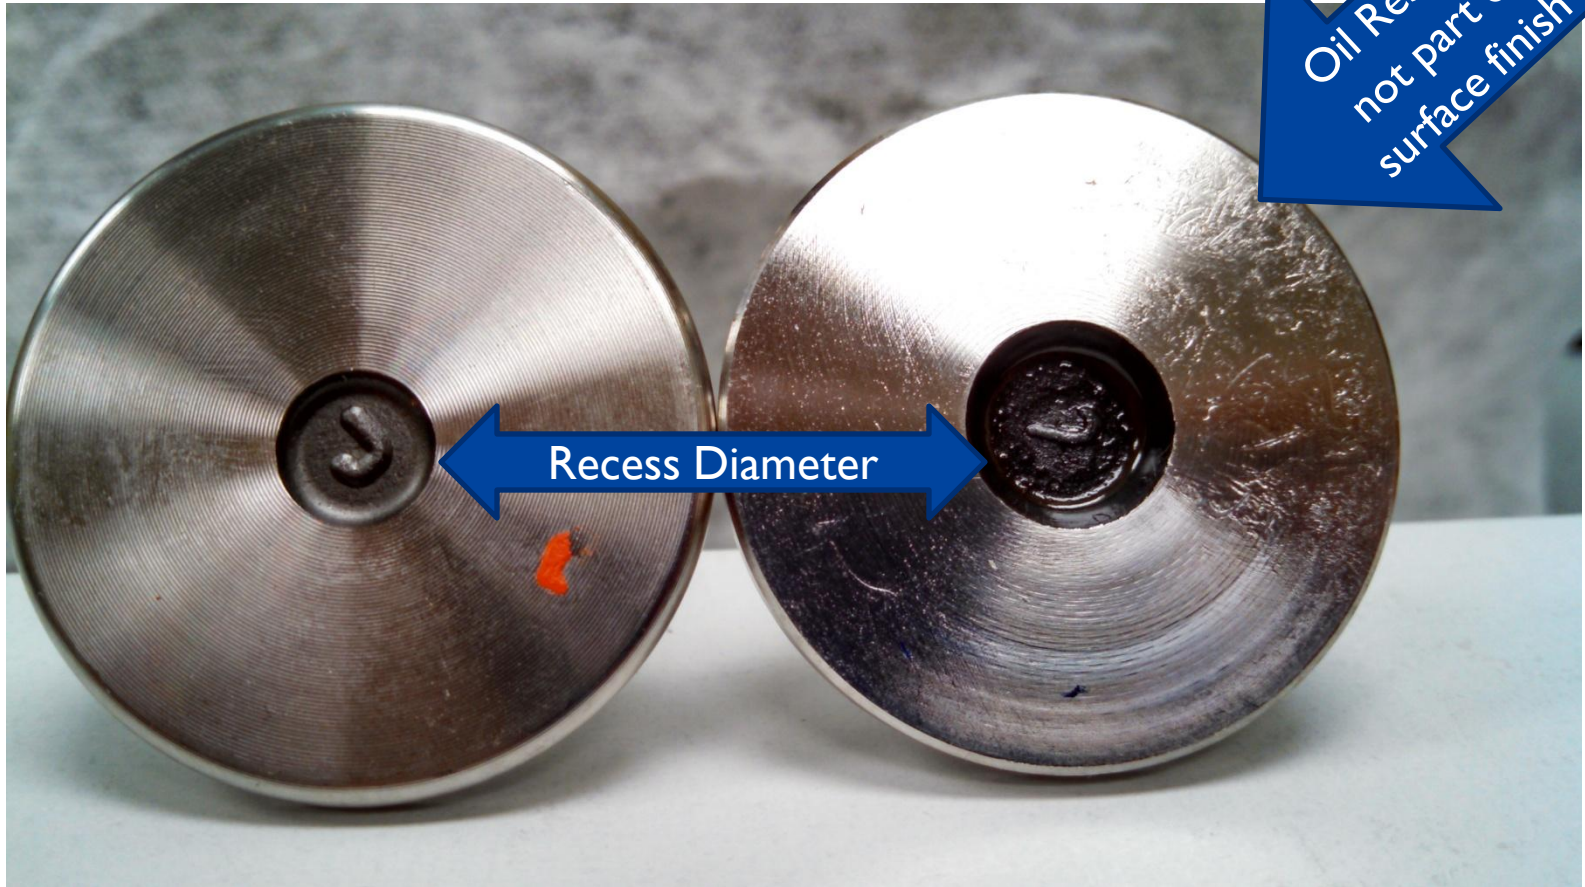
Geometric Differences

Mack 03-14 B

Aftermarket
