Committee D02 on PETROLEUM PRODUCTS AND LUBRICANTS

Sequence III Surveillance Panel Unapproved Meeting Minutes June 2, 2011 GM Technical Center Warren, Michigan

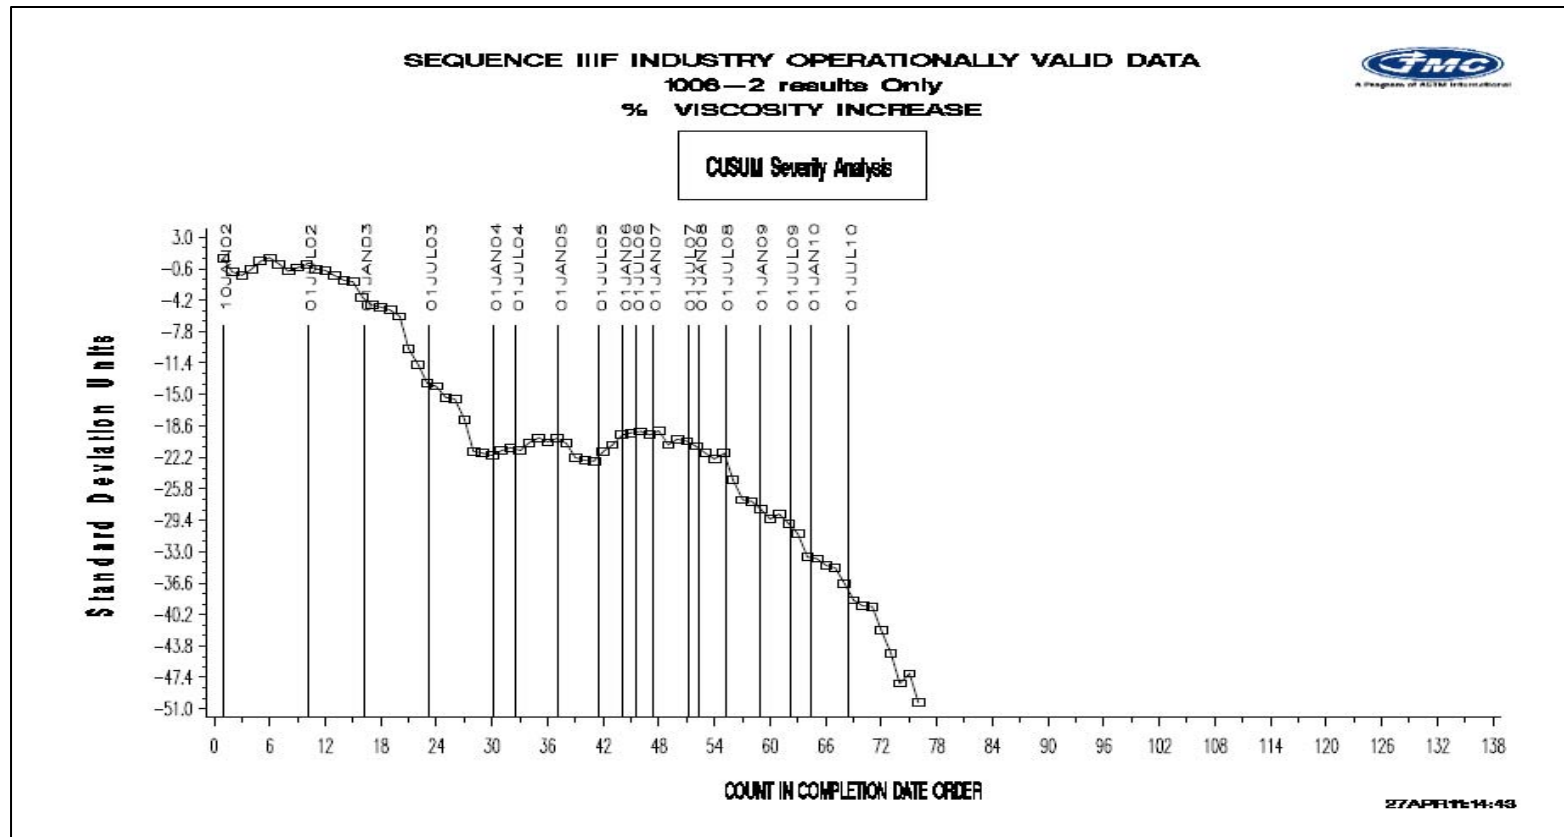
- Plot of reference oil 1006-2 exclusively suggests that the PVIS parameter has been trending severe - since the first quarter of 2007.

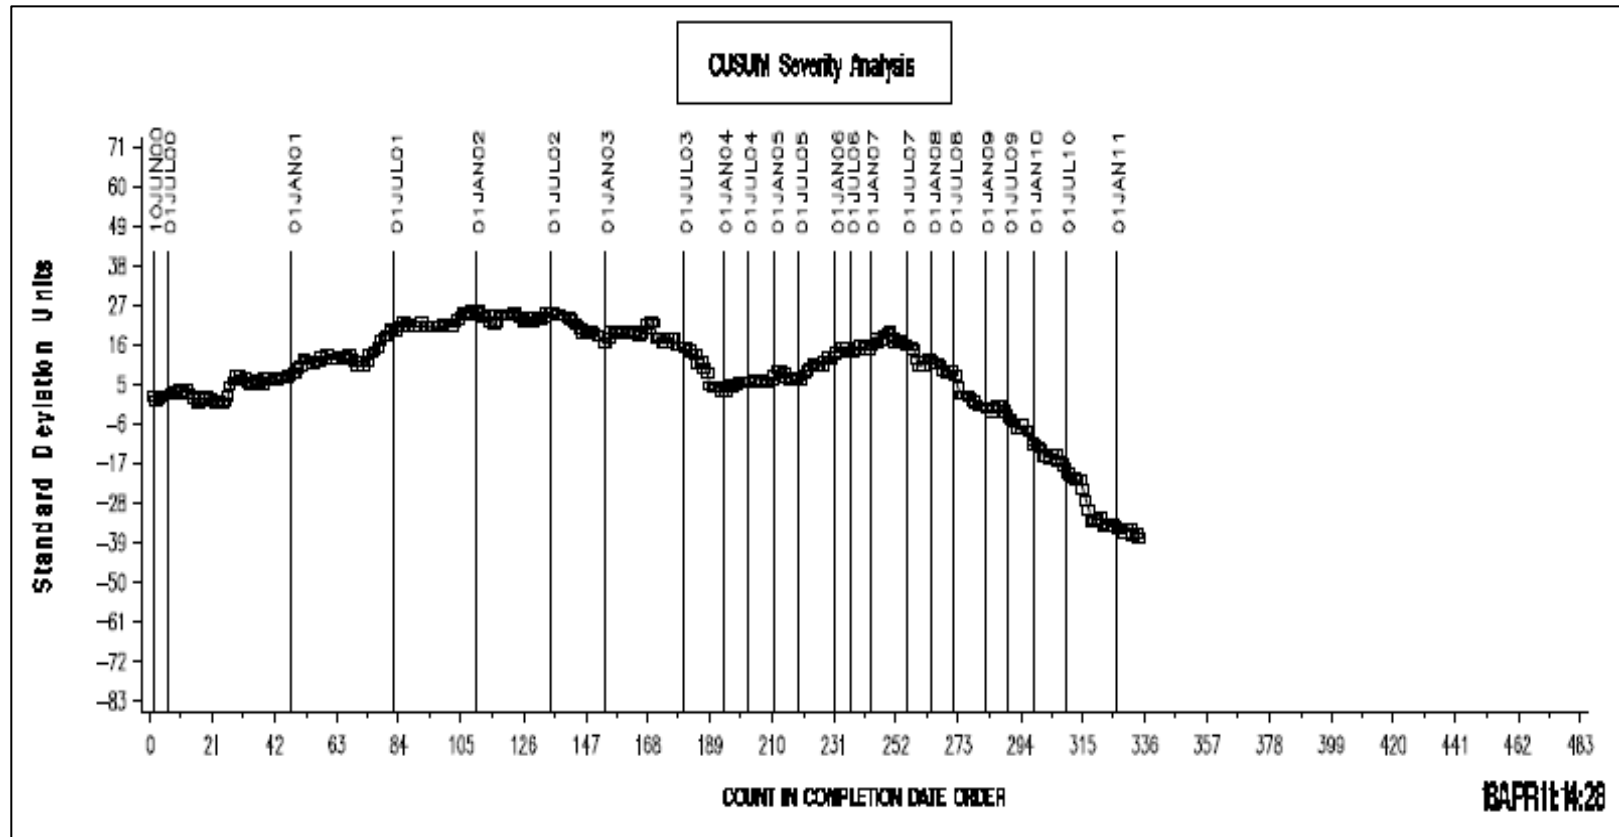
- Plot of reference oil 433-1 exclusively also suggests that the PVIS parameter has been trending severe - since the first quarter of 2007.

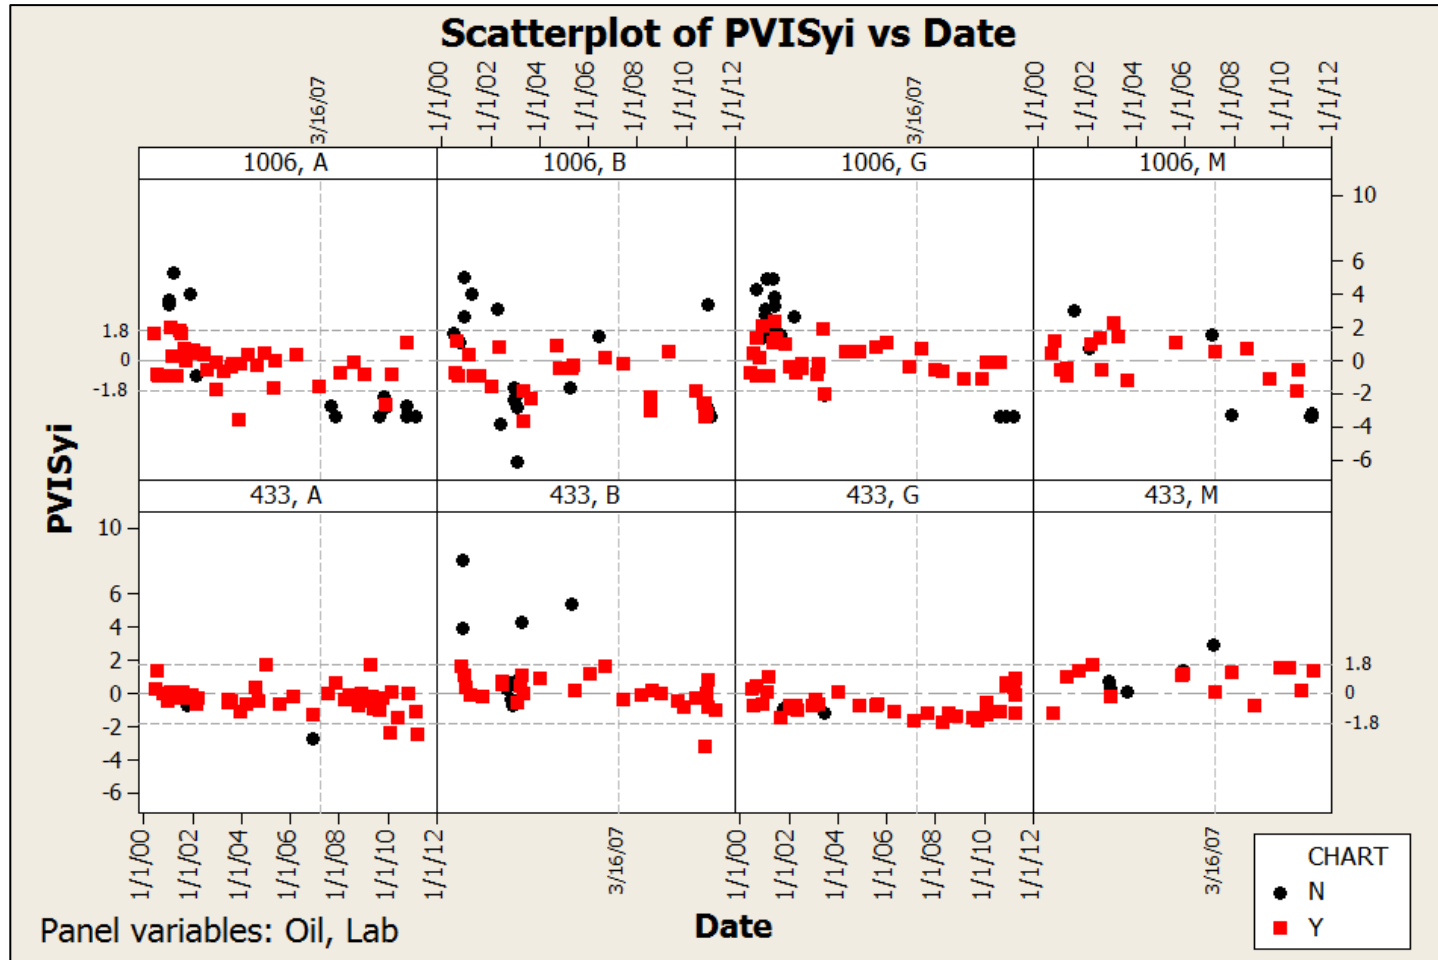
Plot of Chartable & Non-Chartable IIF PVIS Y_i data suggests a similar trend that occurred near the first quarter of 2007.

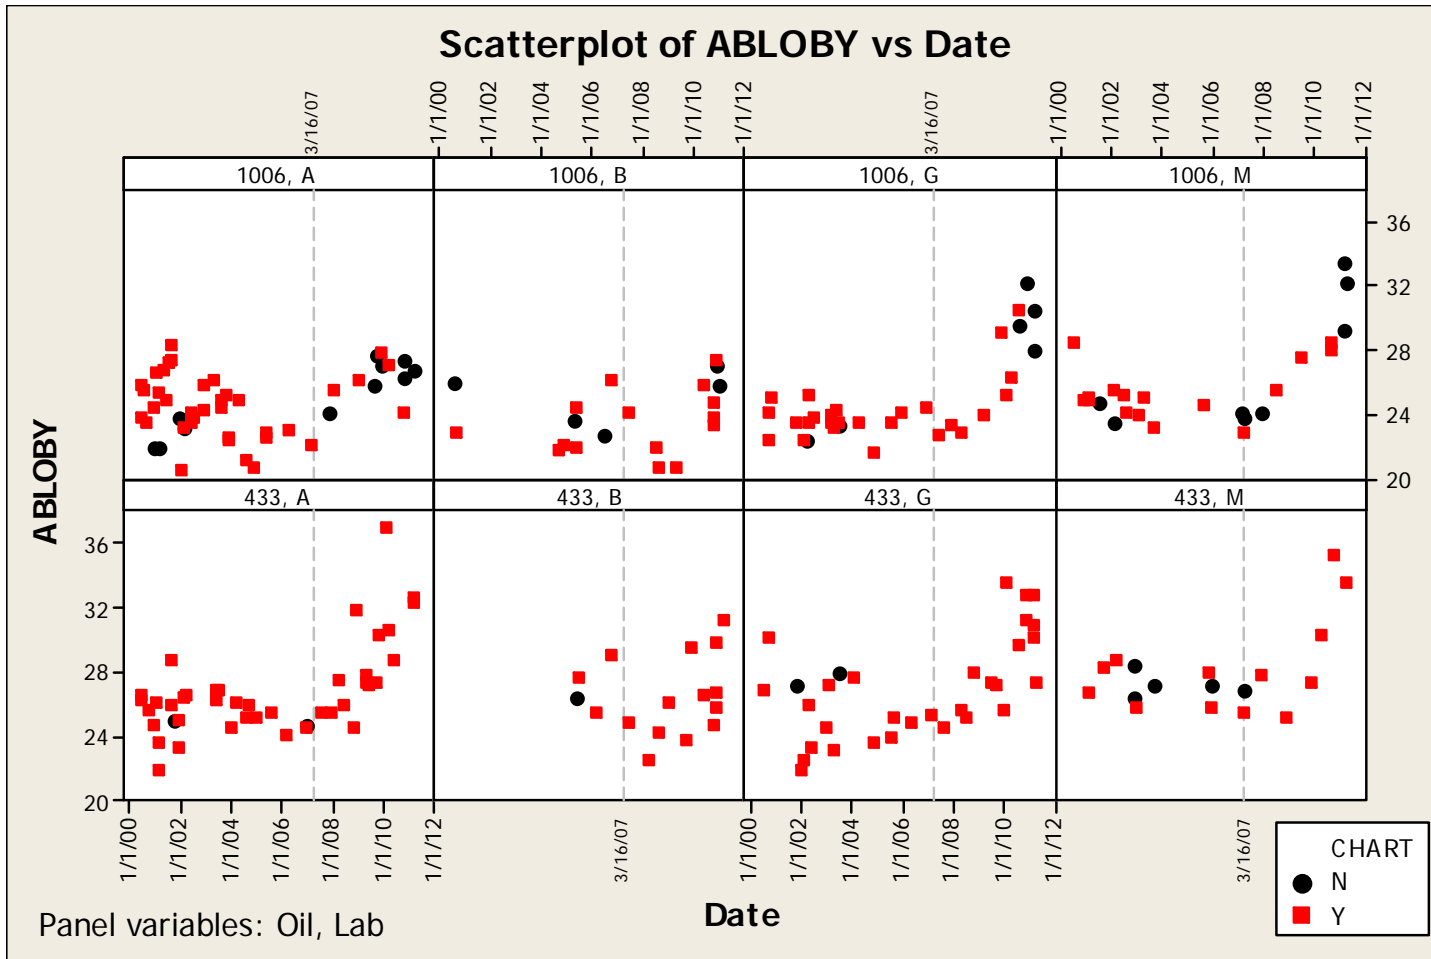
Plot of Chartable & Non-Chartable (Oil 433 & 1006) Avg Blow-by data suggests a similar increasing trend - near the first quarter of 2007.

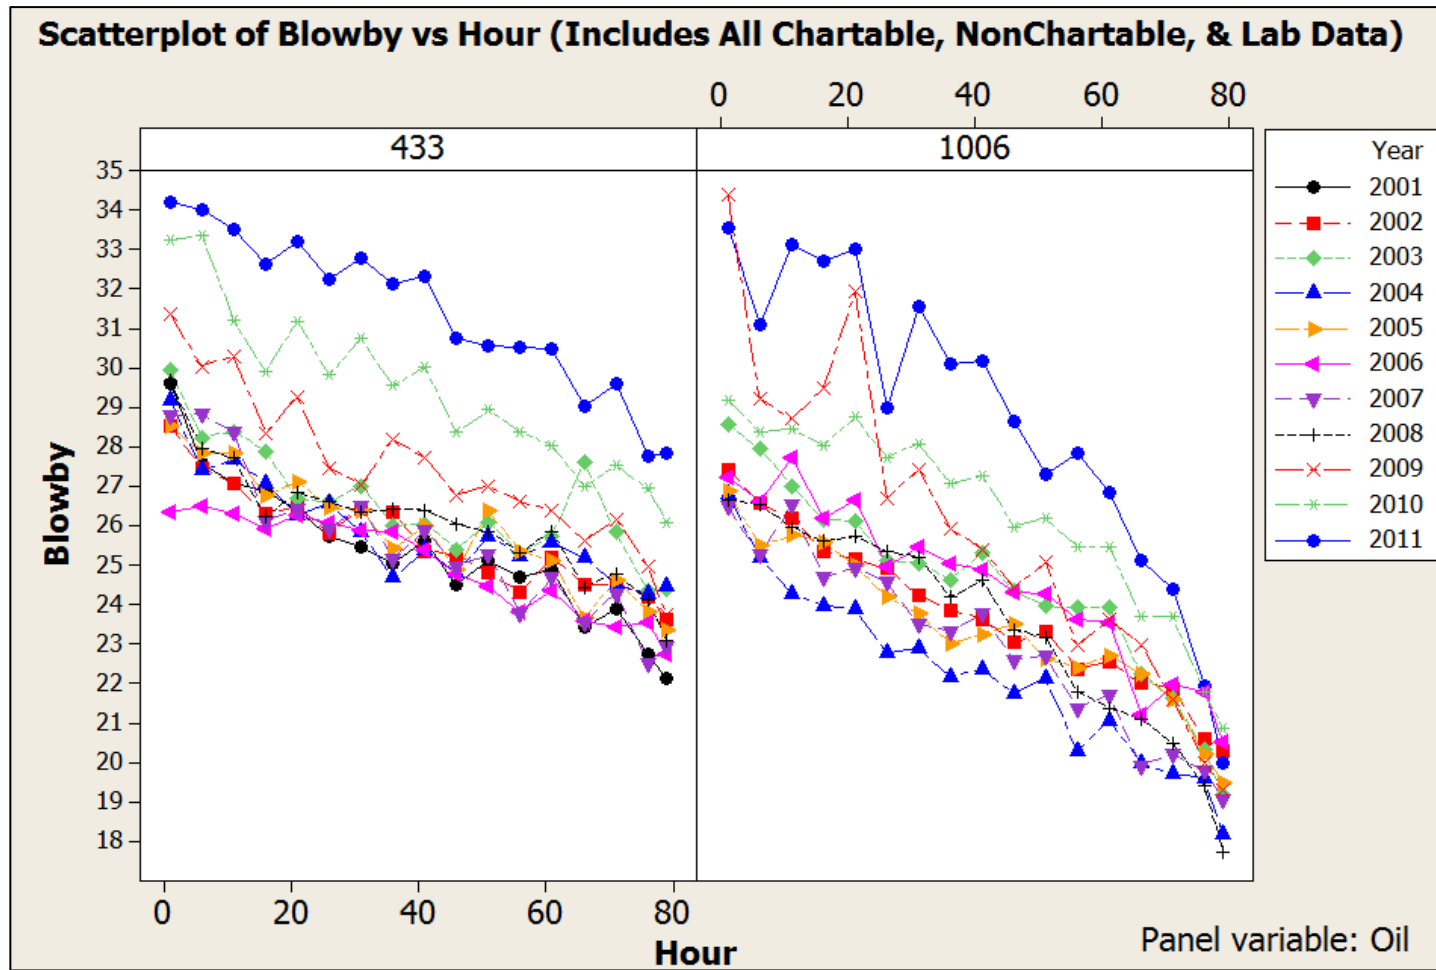
Industry average hourly blow-by for both reference oils (Chart = Y & N and all lab data) suggests an increasing trend - in 2009, 2010, and 2011.

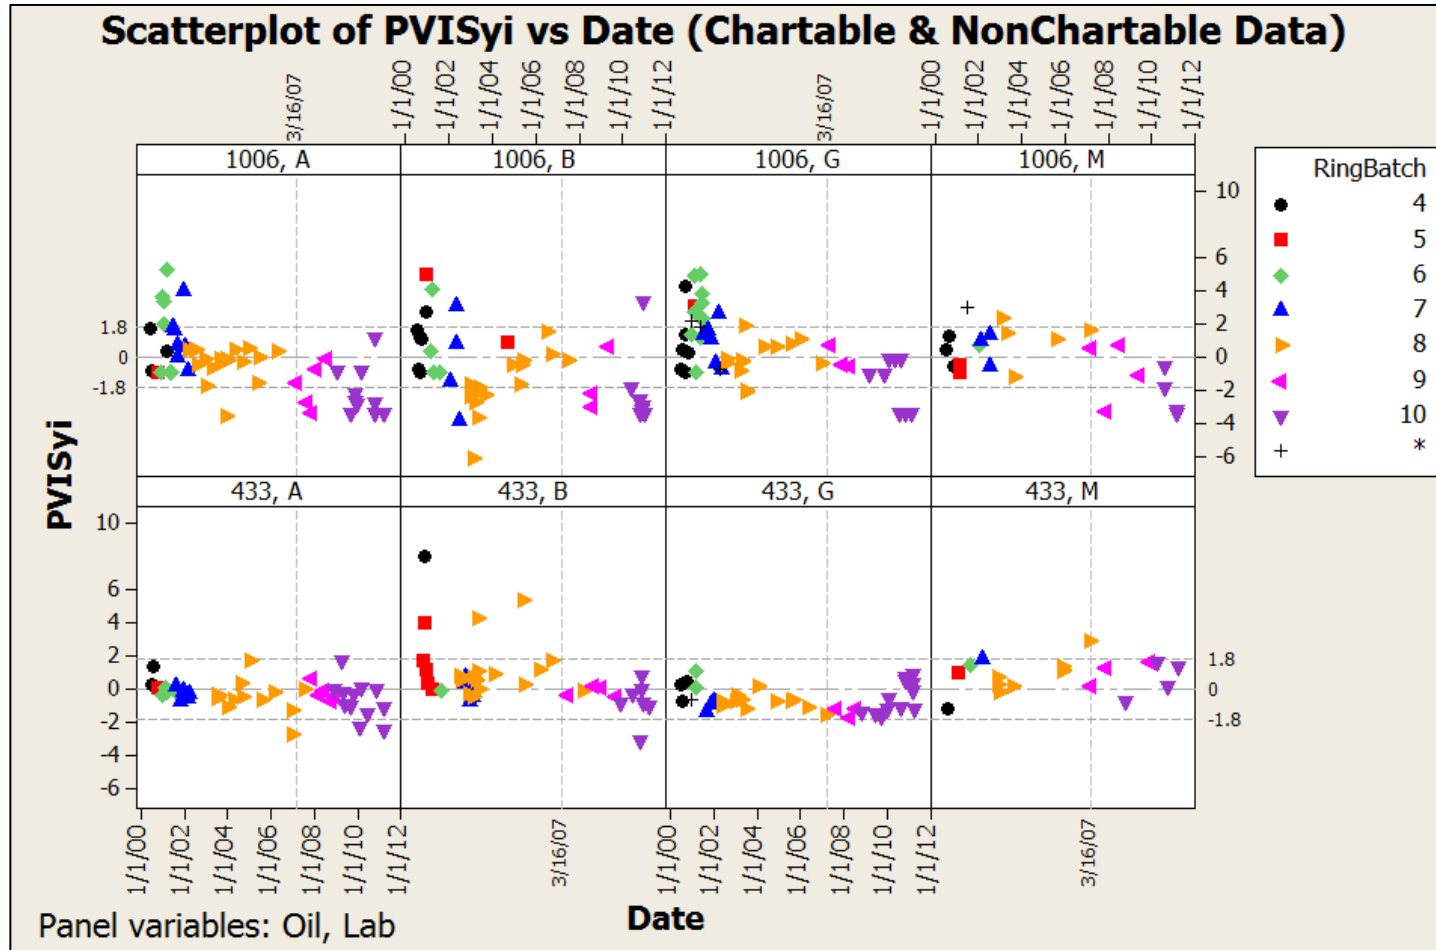
Plot of Chartable & Non-Chartable IIF PVIS Y_i data suggests that Ring batches 9 & 10 may be coincidental with the apparent severity shift

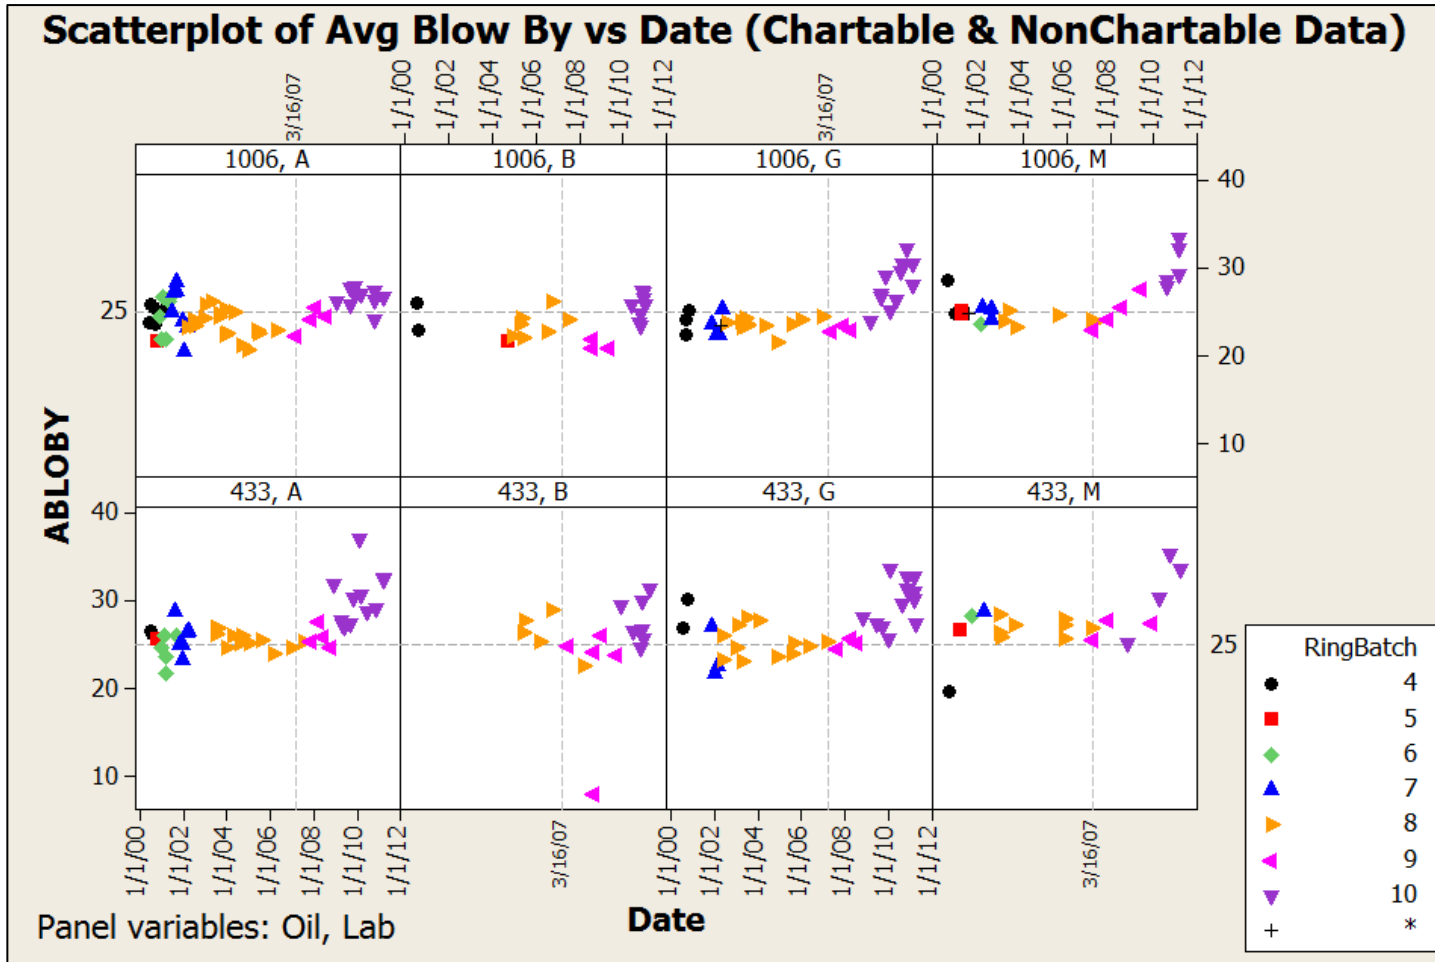
Similar Blow-by trend plot with ring batch identification

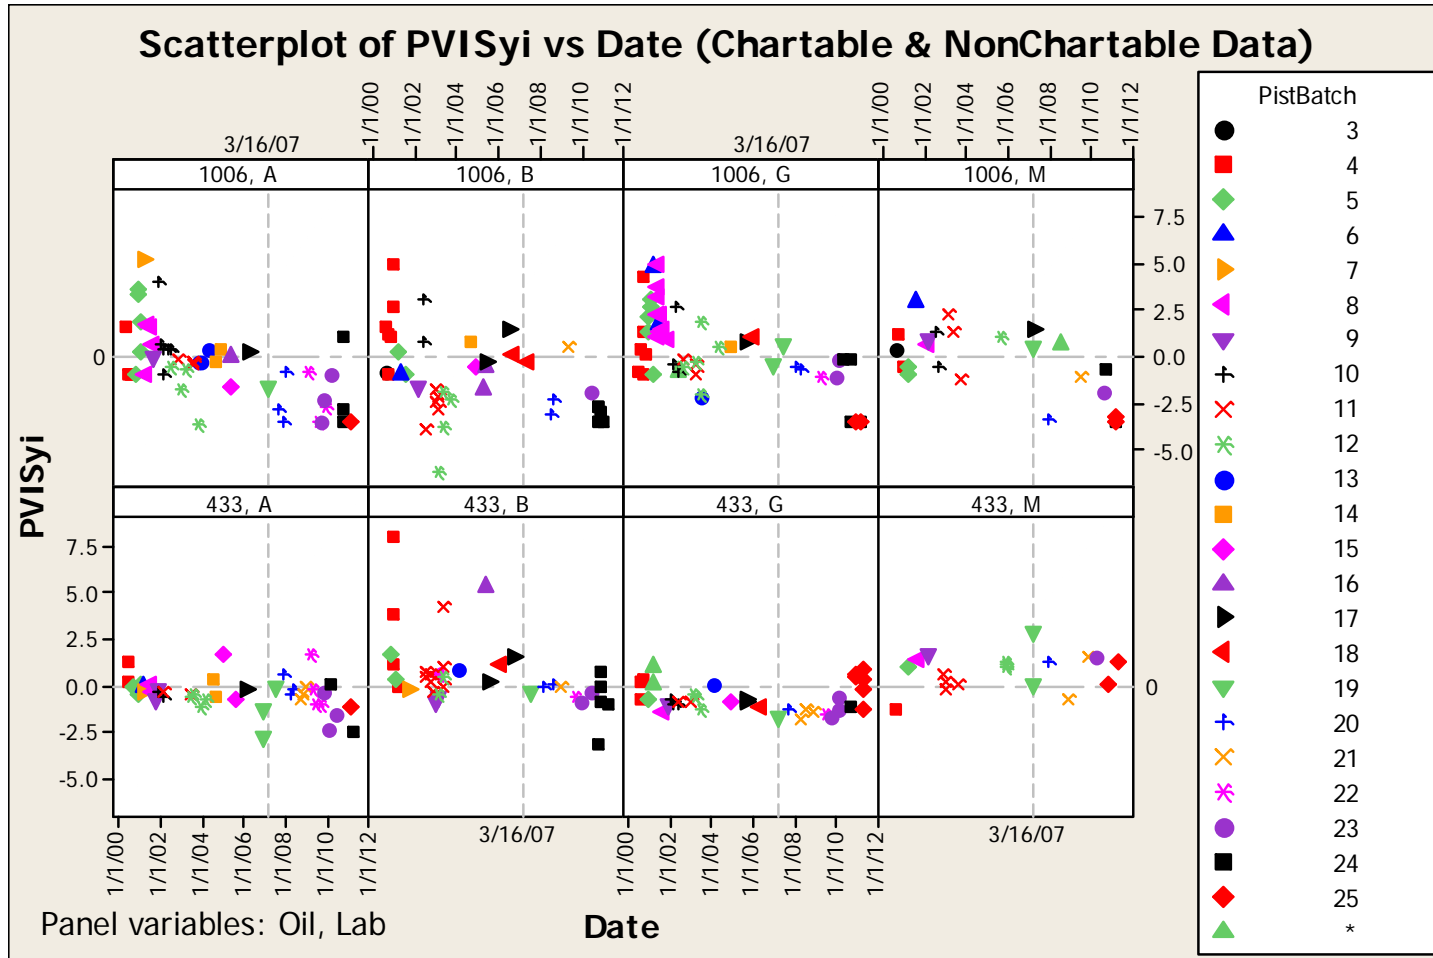
Similar PVIS Y_i plot with piston batch identification

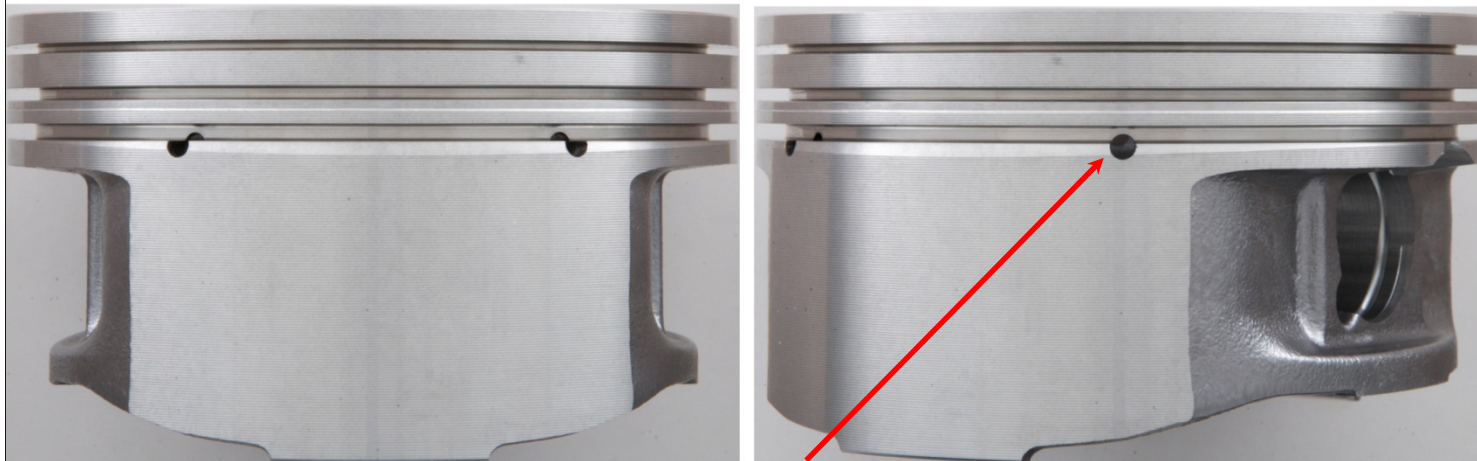
Oil return hole locations on piston (BC13 vs. BC25):

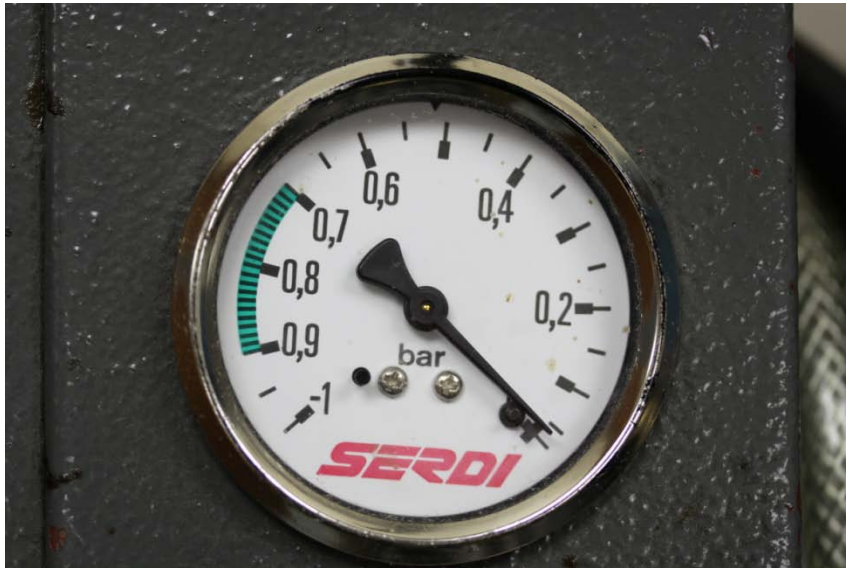
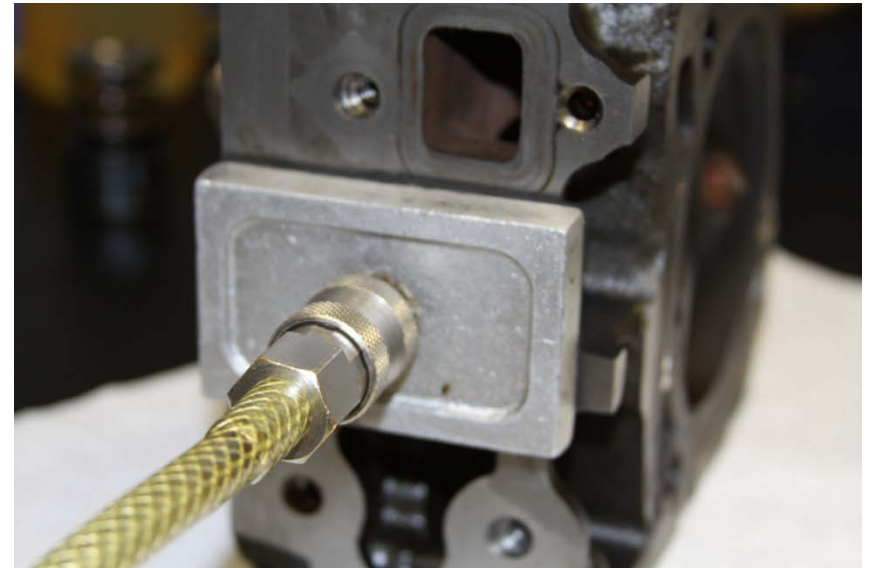
Cylinder Head Valve Seat Seal Checking Apparatus

- Although valve recession is very undesirable and needs to be corrected it may not be the worst of the problems that we have with Sequence III cylinder heads.
- Studies at SwRI have identified that the intake valve seats are losing their sealing ability as the test is running.

Cylinder	SOT Intake Valve Vacuum Check	SOT Exhaust Valve Vacuum Check	EOT Intake Valve Vacuum Check	EOT Exhaust Valve Vacuum Check
1	0.9	0.9	0.25	0.70
3	0.9	0.9	0.05	0.80
5	0.9	0.9	0.60	0.80
2	0.9	0.9	0.70	0.85
4	0.9	0.9	0.30	0.85
6	0.9	0.9	0.05	0.80

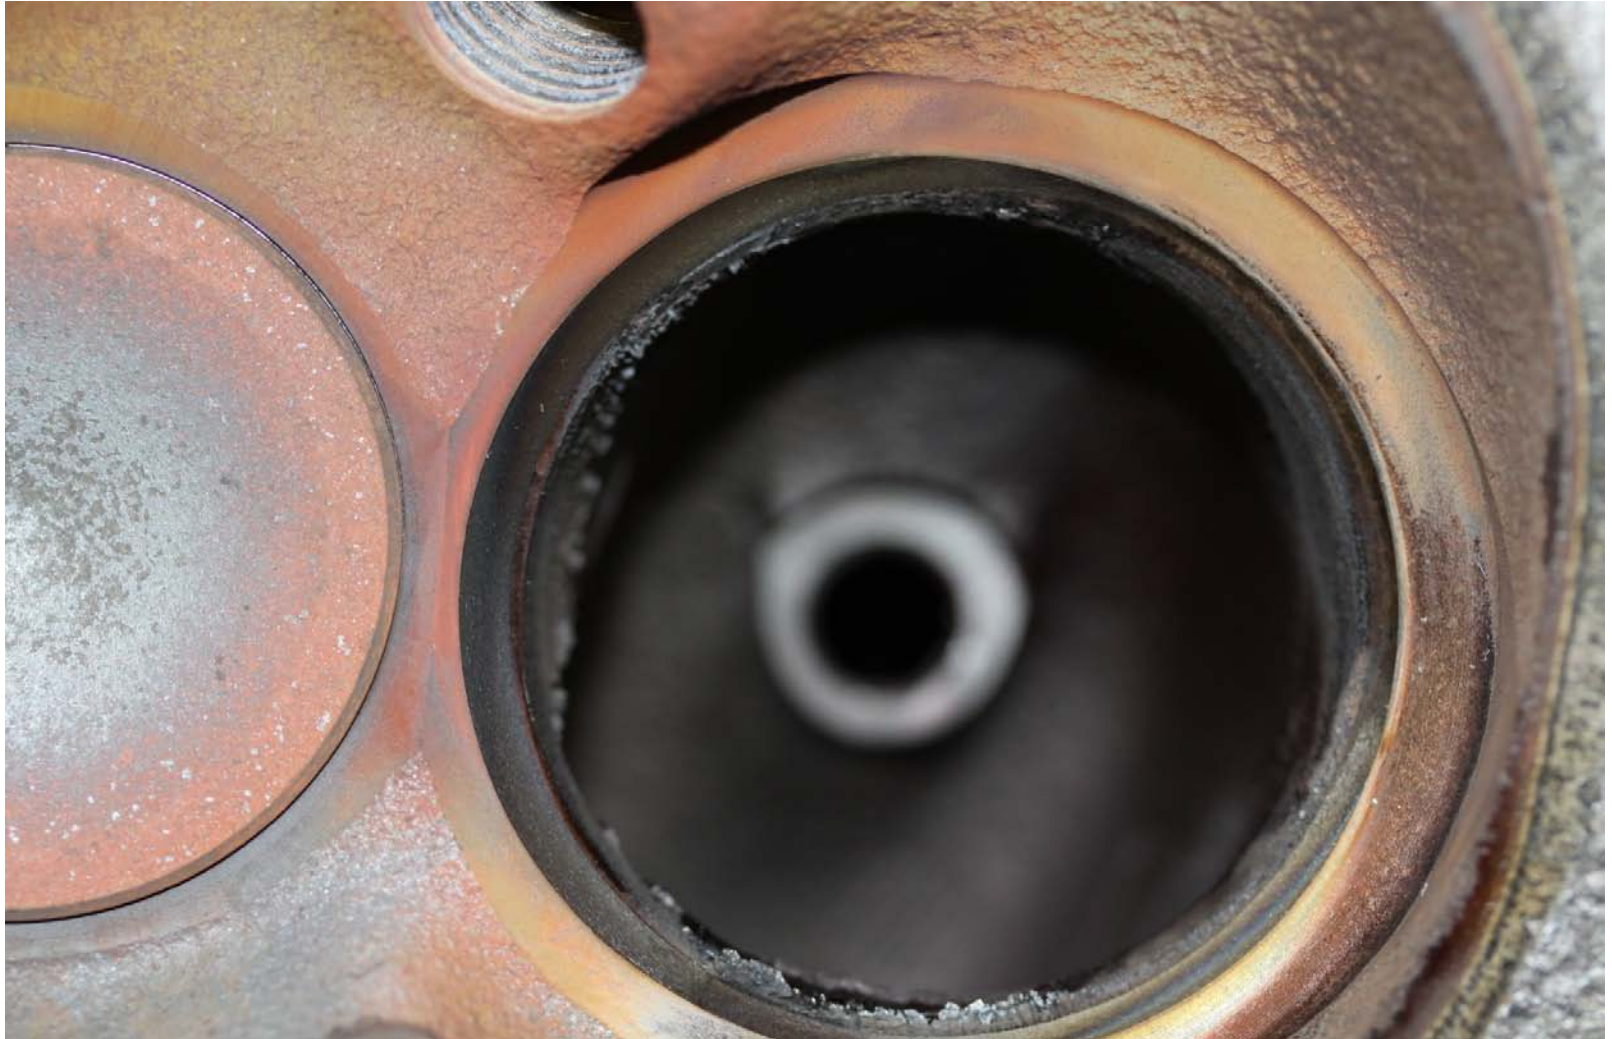
Culprit for Compression Loss - Intake Seat Widening

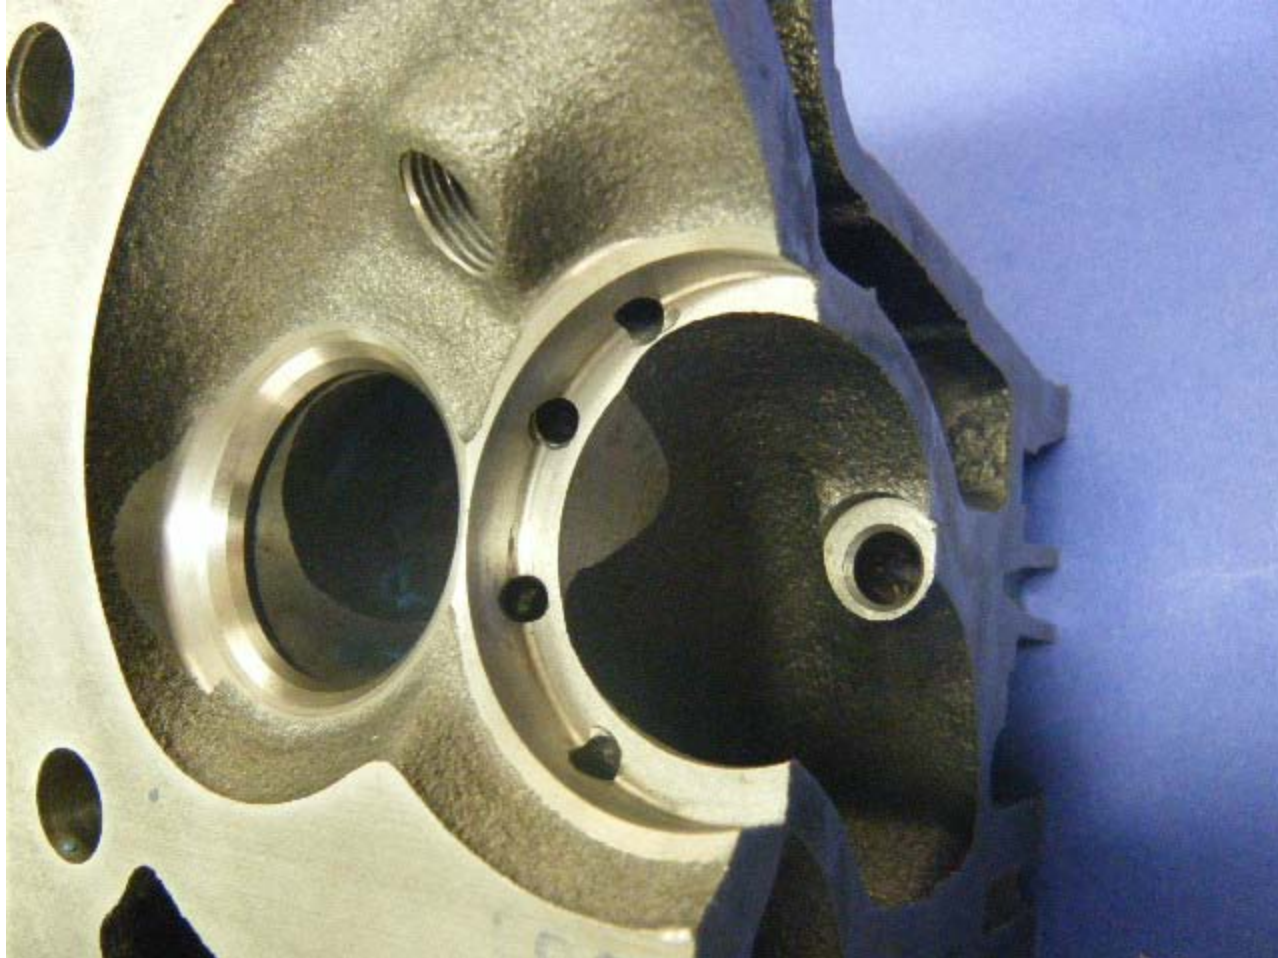
Scoping Work Done to Determine max Seat Insert Depth

- SwRI investigated having seat inserts installed in the intake valve position.
- A seat material of heat treated, hardened nodular iron used for exhaust seats in top fuel drag racing applications was chosen based on input from an experienced cylinder head machinist.
- Intake valve seat inserts were installed in a set of new cylinder heads.

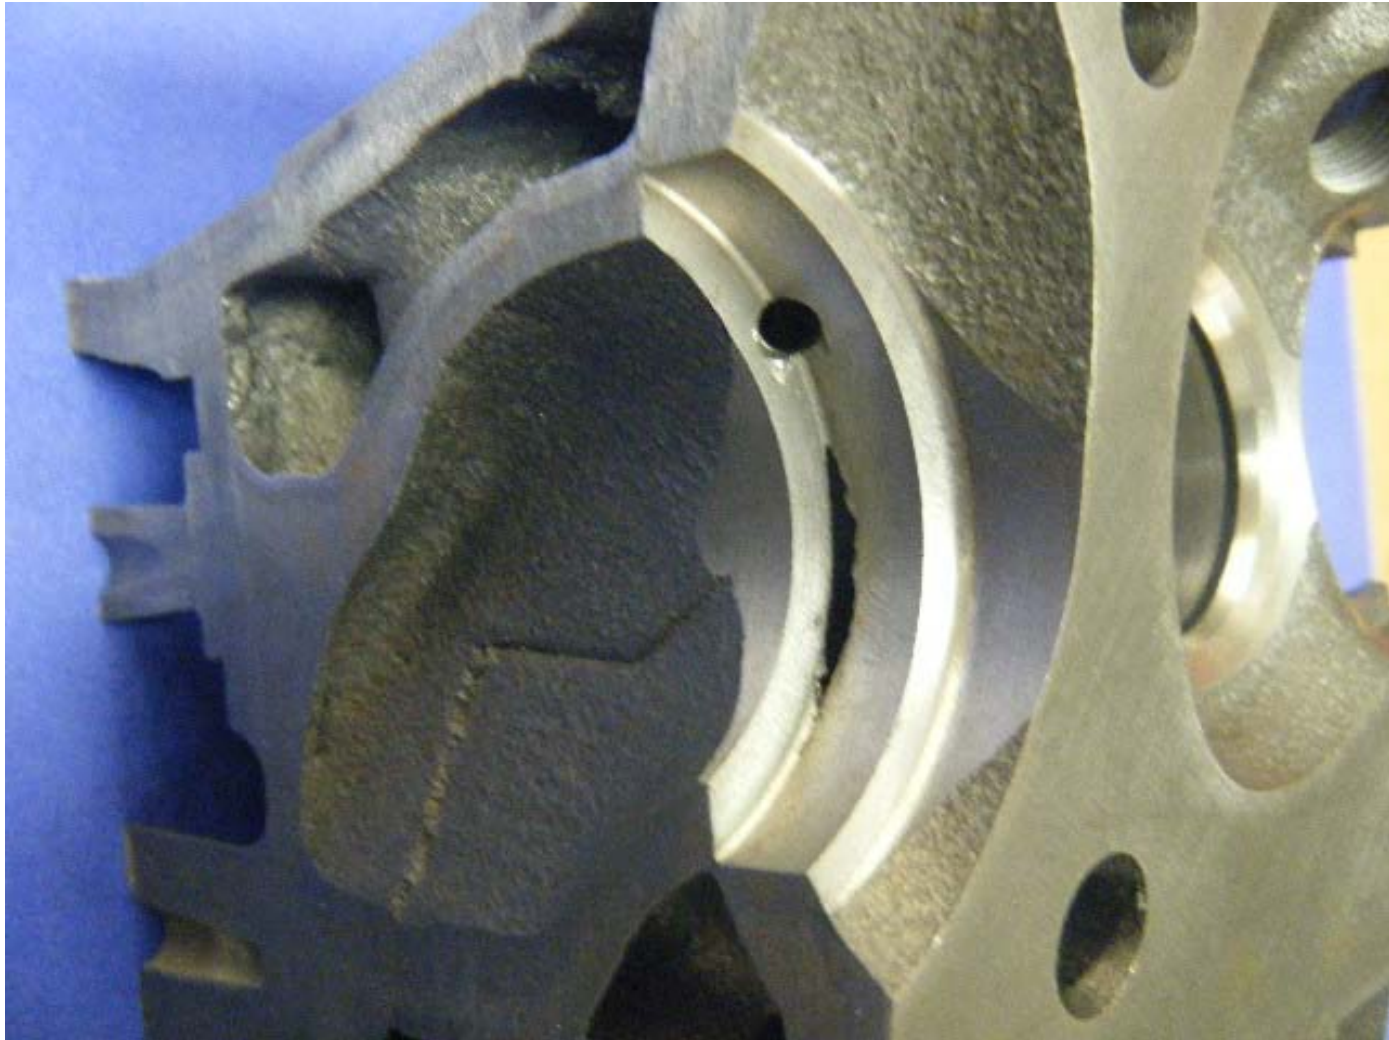
Break Through into Water Jacket

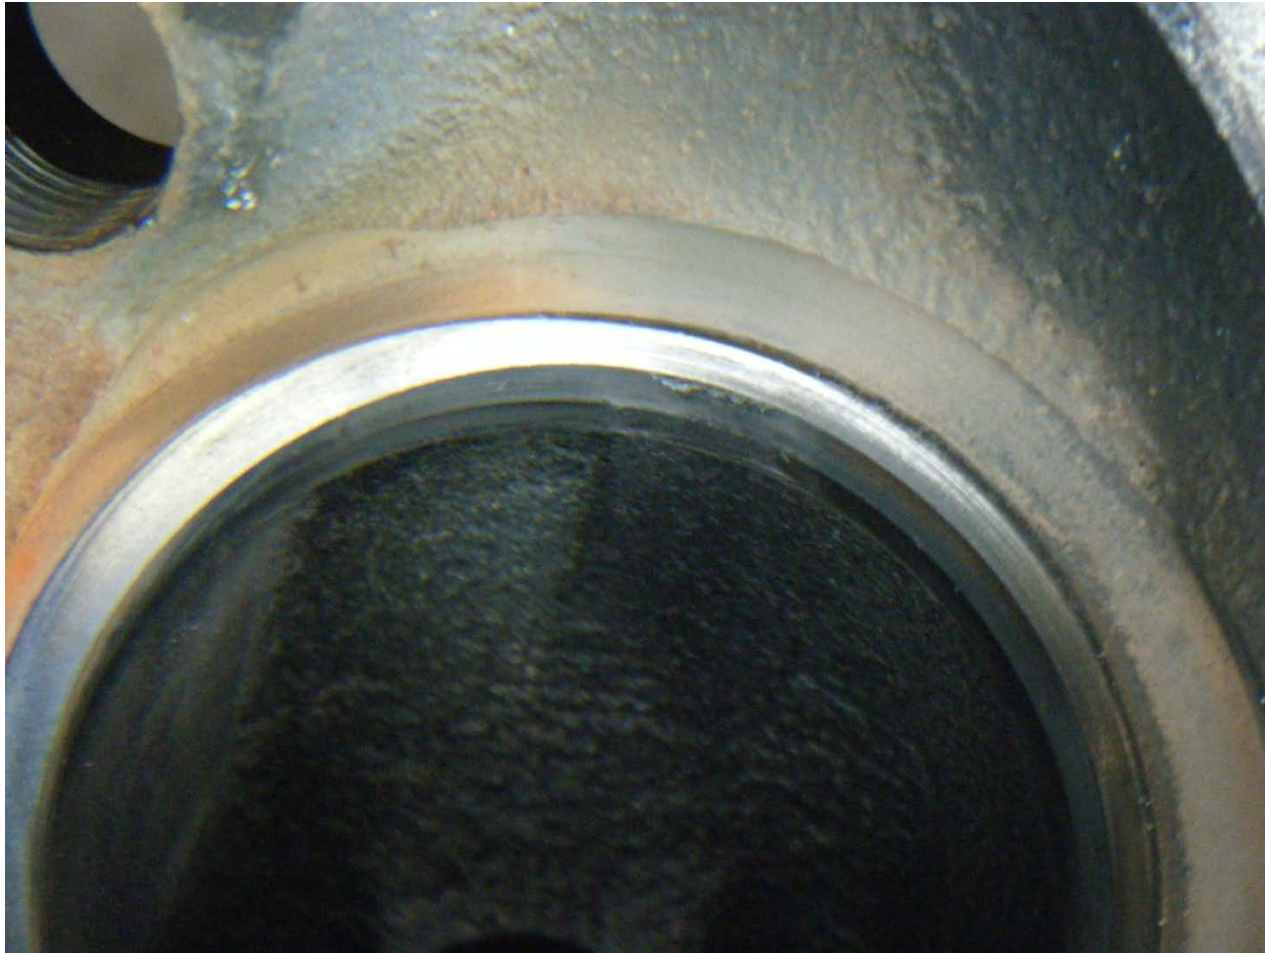
Intake seat burnout (widening) between exhaust & intake

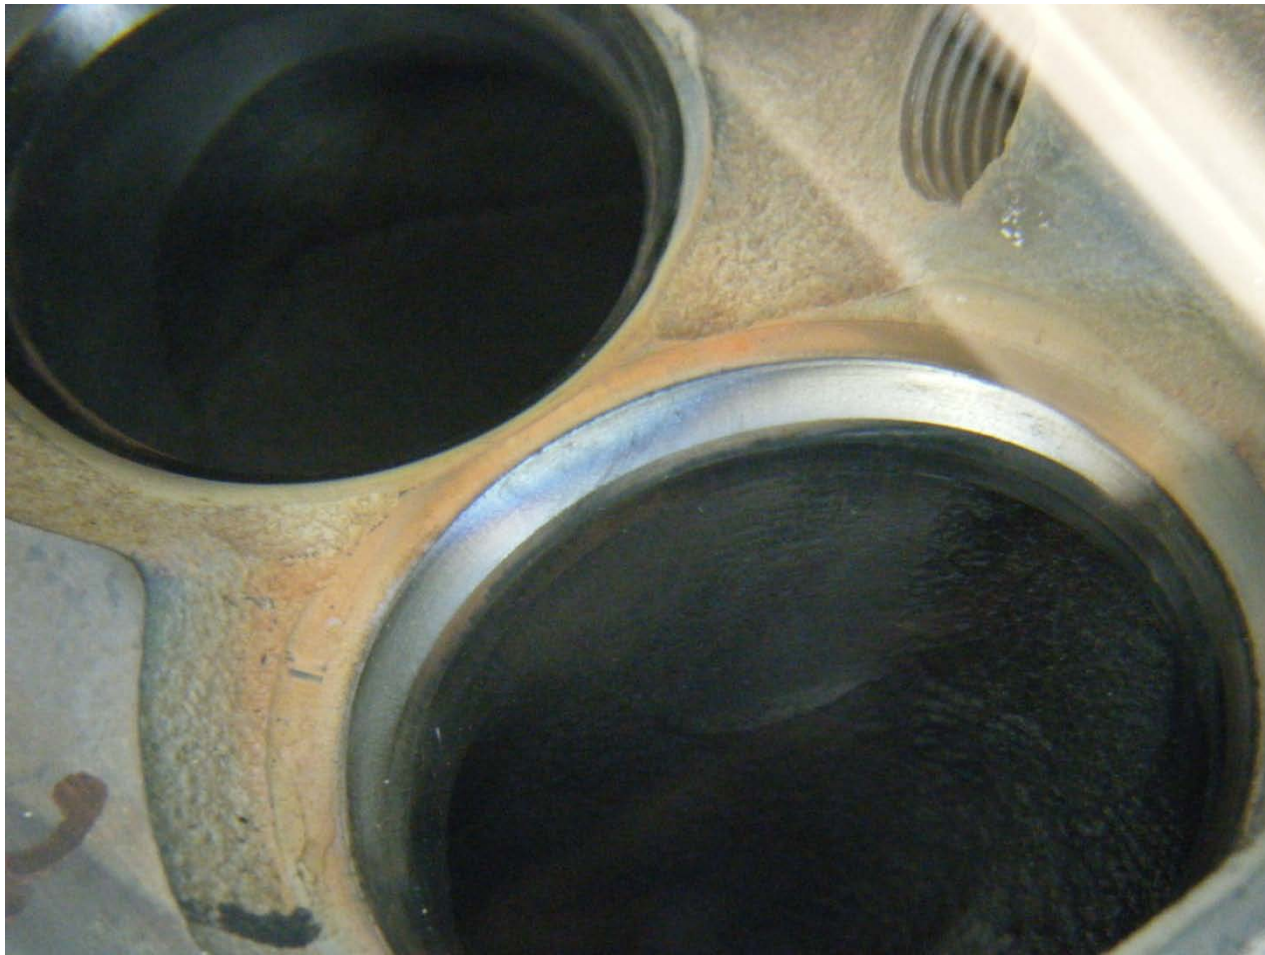
Heat affect from exhaust showing in intake seat

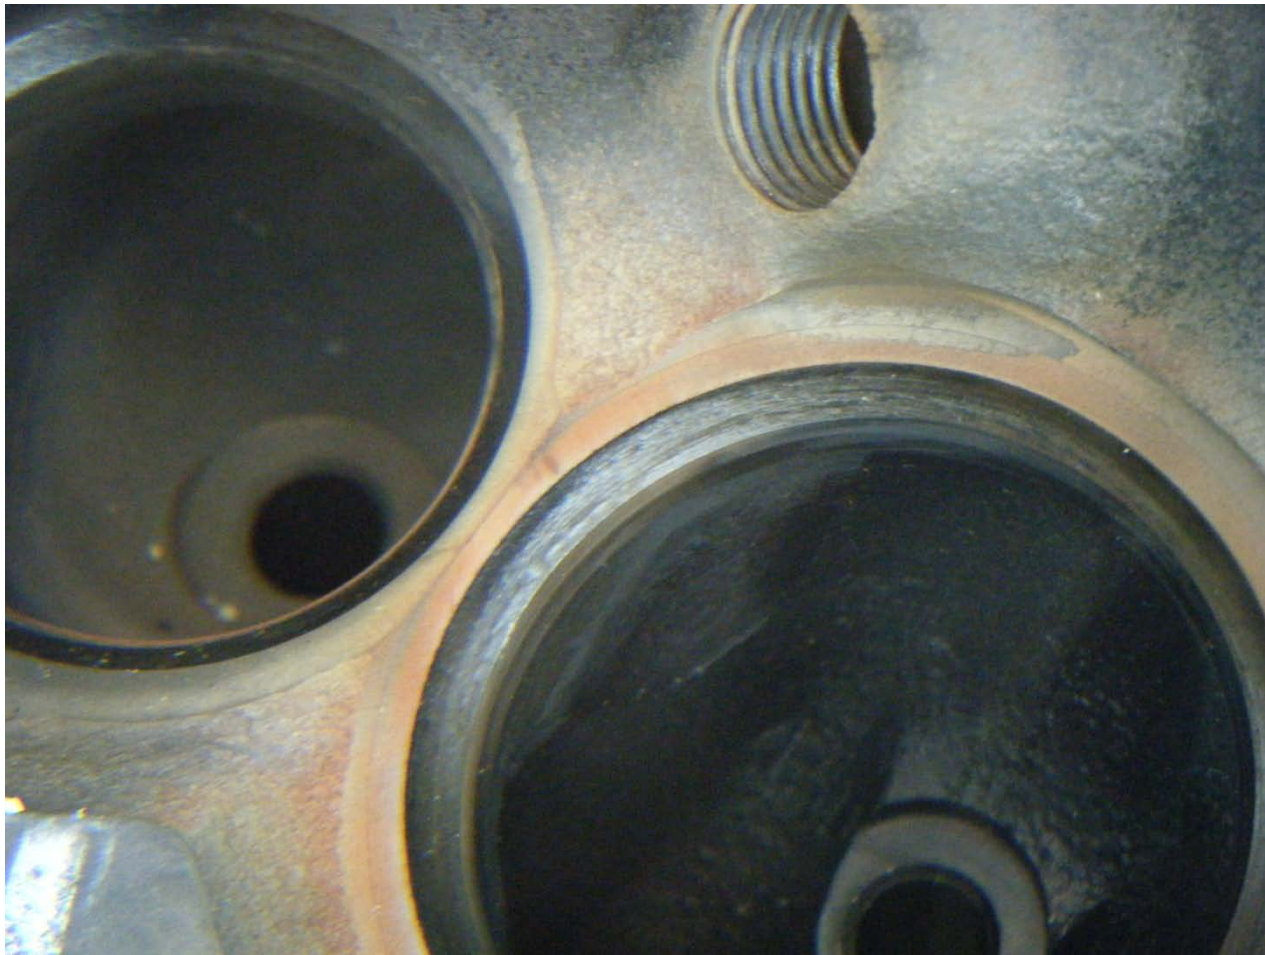
Burnt up pitted seat at heat affect zone between valves

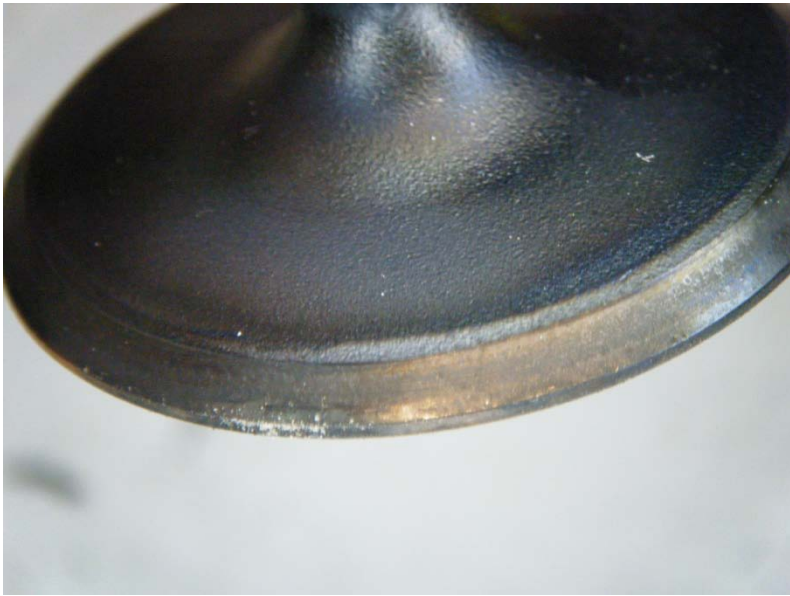
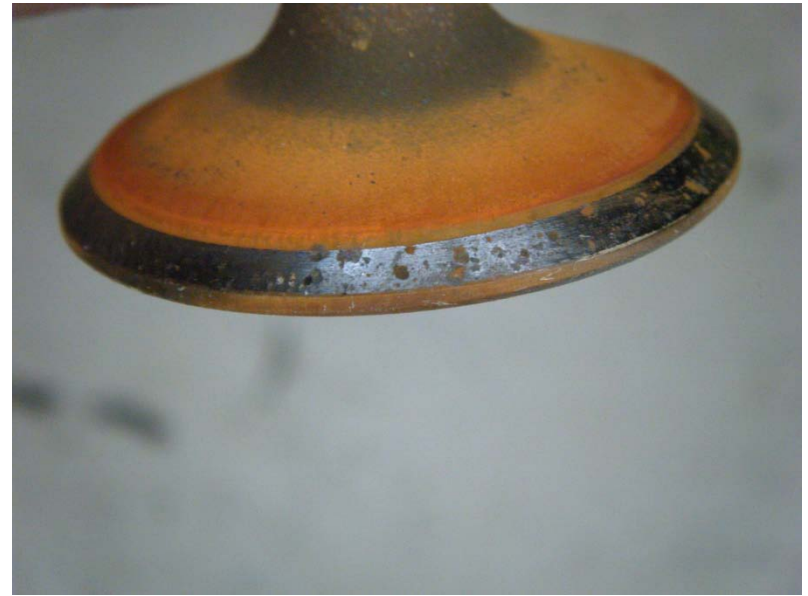
Note both valves run very hot as evidenced by no intake valve-back deposits and micro welding on exhaust
