Unapproved Minutes of the January 24, 2013
Sequence IV Surveillance Panel Meeting held in San Antonio, TX.

DRIVELINE EFFECTS ON DYNAMIC TORSIONAL VIBRATION ON SEQUENCE IVA ENGINE STAND

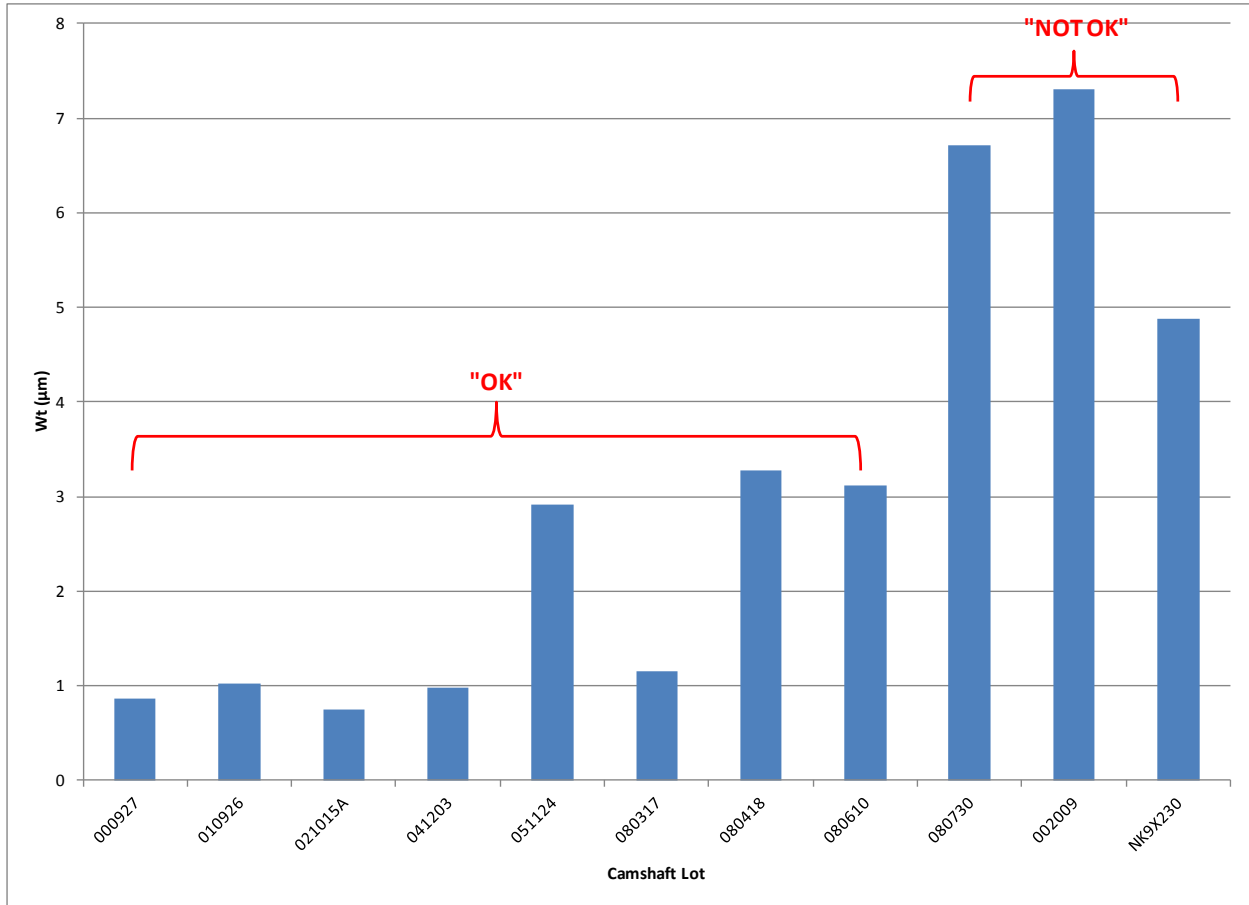
Figure 3: Wt of Camshaft Lobe Surfaces from Multiple Camshaft Lots

The waviness (Wt) of the cam lobe surfaces of multiple camshaft lots are shown in Figure 3. For the purposes of this discussion, Wt is described as the maximum difference between any two points on a surface profile trace of a camshaft lobe. Therefore, Wt represents the distance from the peak of the curve to the edges. As the Wt value increases so does the convexity of a new camshaft lobe surface profile.

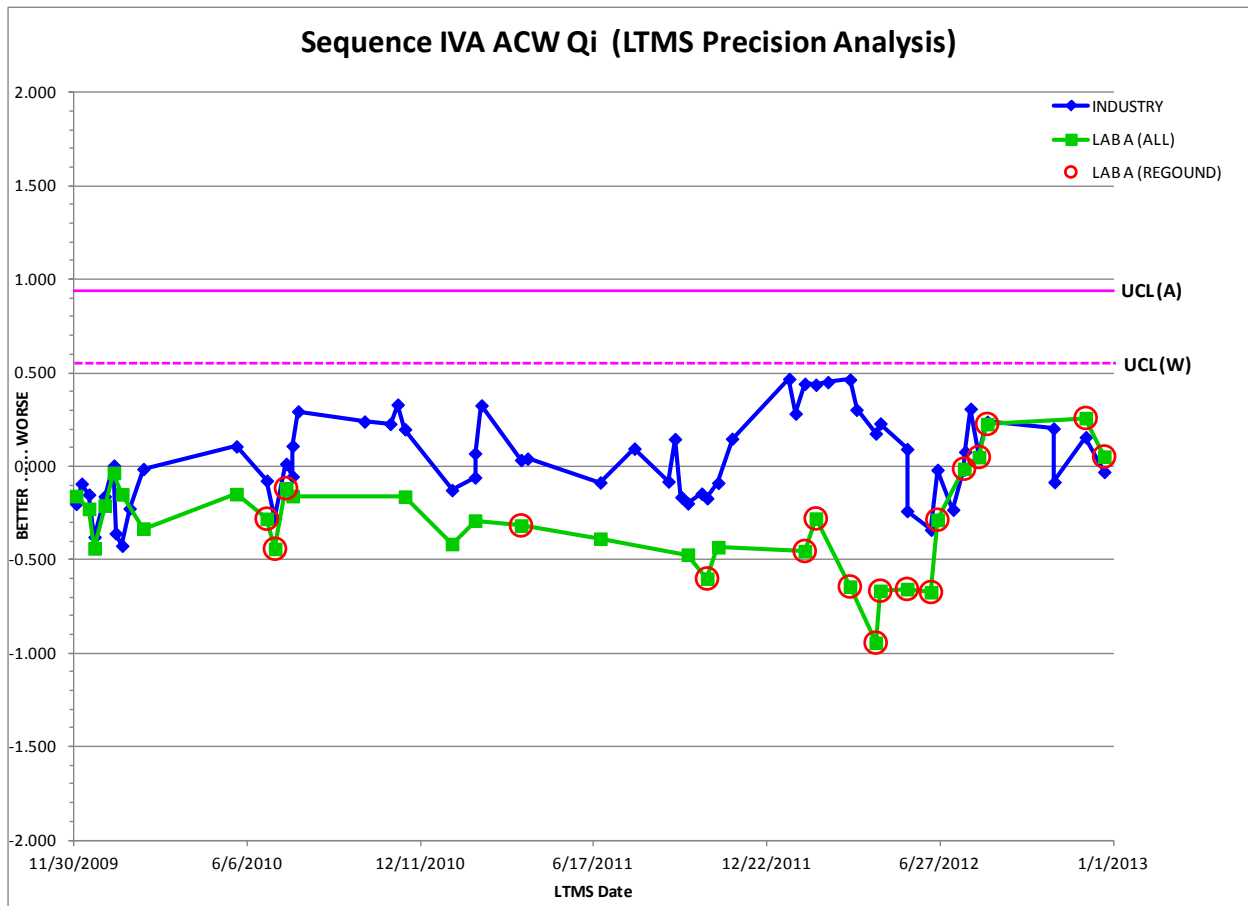
Figure 13: Plot of ACW Q_i vs. Date of Industry and SwRI (Lab A) Reference Oil Tests

The LTMS precision analysis plot of ACW Q_i for industry and SwRI reference test results from December 2009 through January 2013 is shown in Figure 13.

SwRI's lab precision trend is indicated by the green line (any test conducted with a reground camshaft is indicated with a circle around the square). The industry's precision trend is indicated by the blue line. Note that the trends of SwRI's lab precision and the industry's precision, within this timeframe, follow similar patterns. This data indicates that the regrinding had no impact on precision trends.

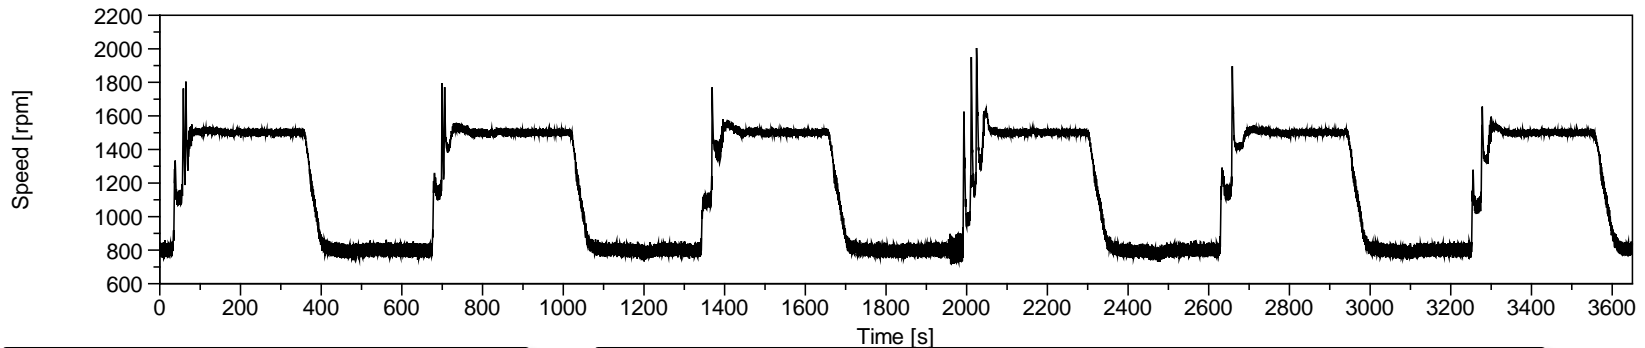
Speed vs. time, shaft 1, data recorded 1/11/13

Flywheel Speed

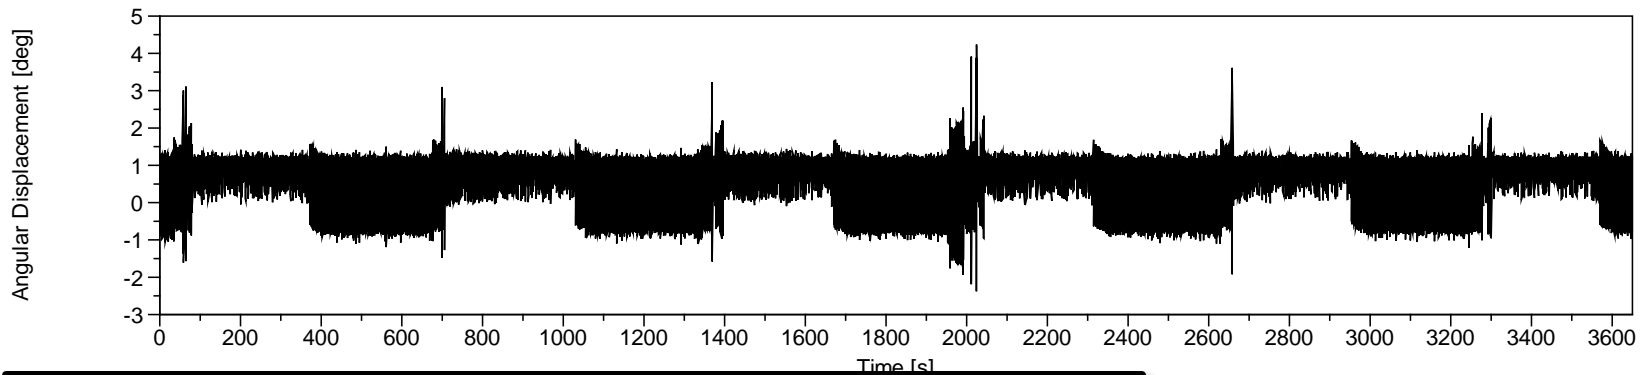
Shaft windup vs. time, shaft 1, data recorded 1/11/13

Flywheel Speed – Dynamometer Hub Speed

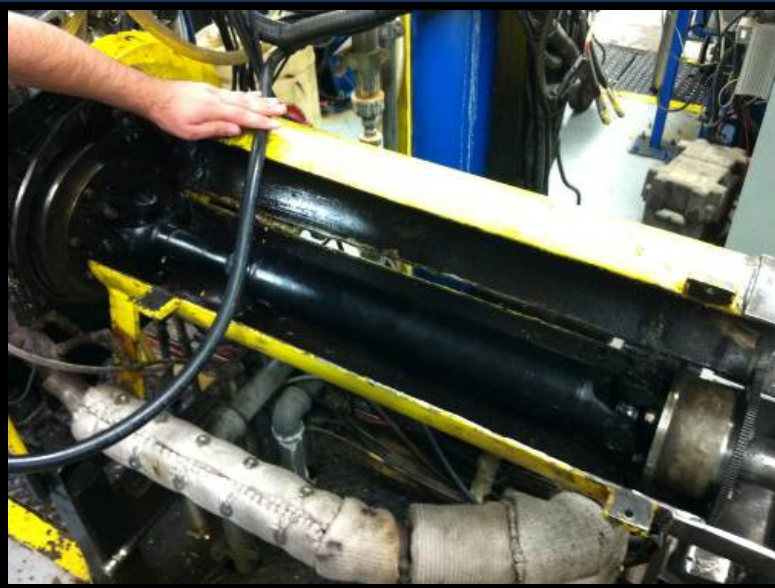
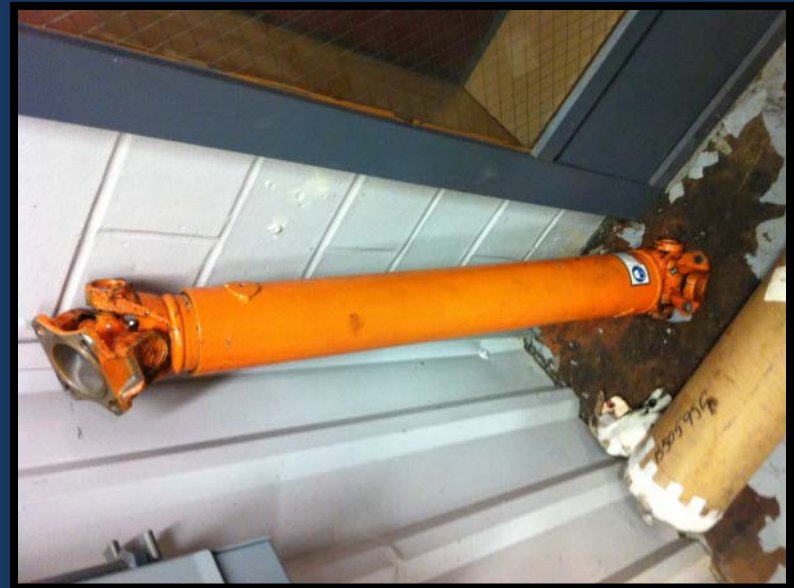
Comparison of ω_n at Different Driveshaft Stiffness

Operation	Observed Resonant Frequency	
	Solid Shaft	Damped Shaft
1-2 Ramp	51Hz	39Hz
2-1 Ramp	44Hz	36Hz

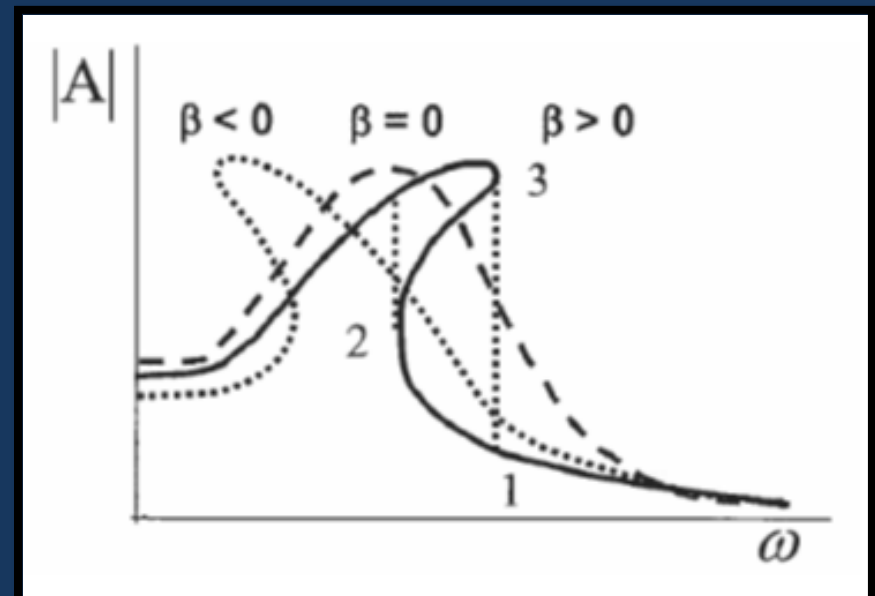
- Duffing equation
 - $m\ddot{x} + c\dot{x} + \alpha x + \beta x^3 = F\cos\omega t$
 - $\beta = 0$, linear spring
 - $\beta > 0$, hardening spring
 - $\beta < 0$, softening spring

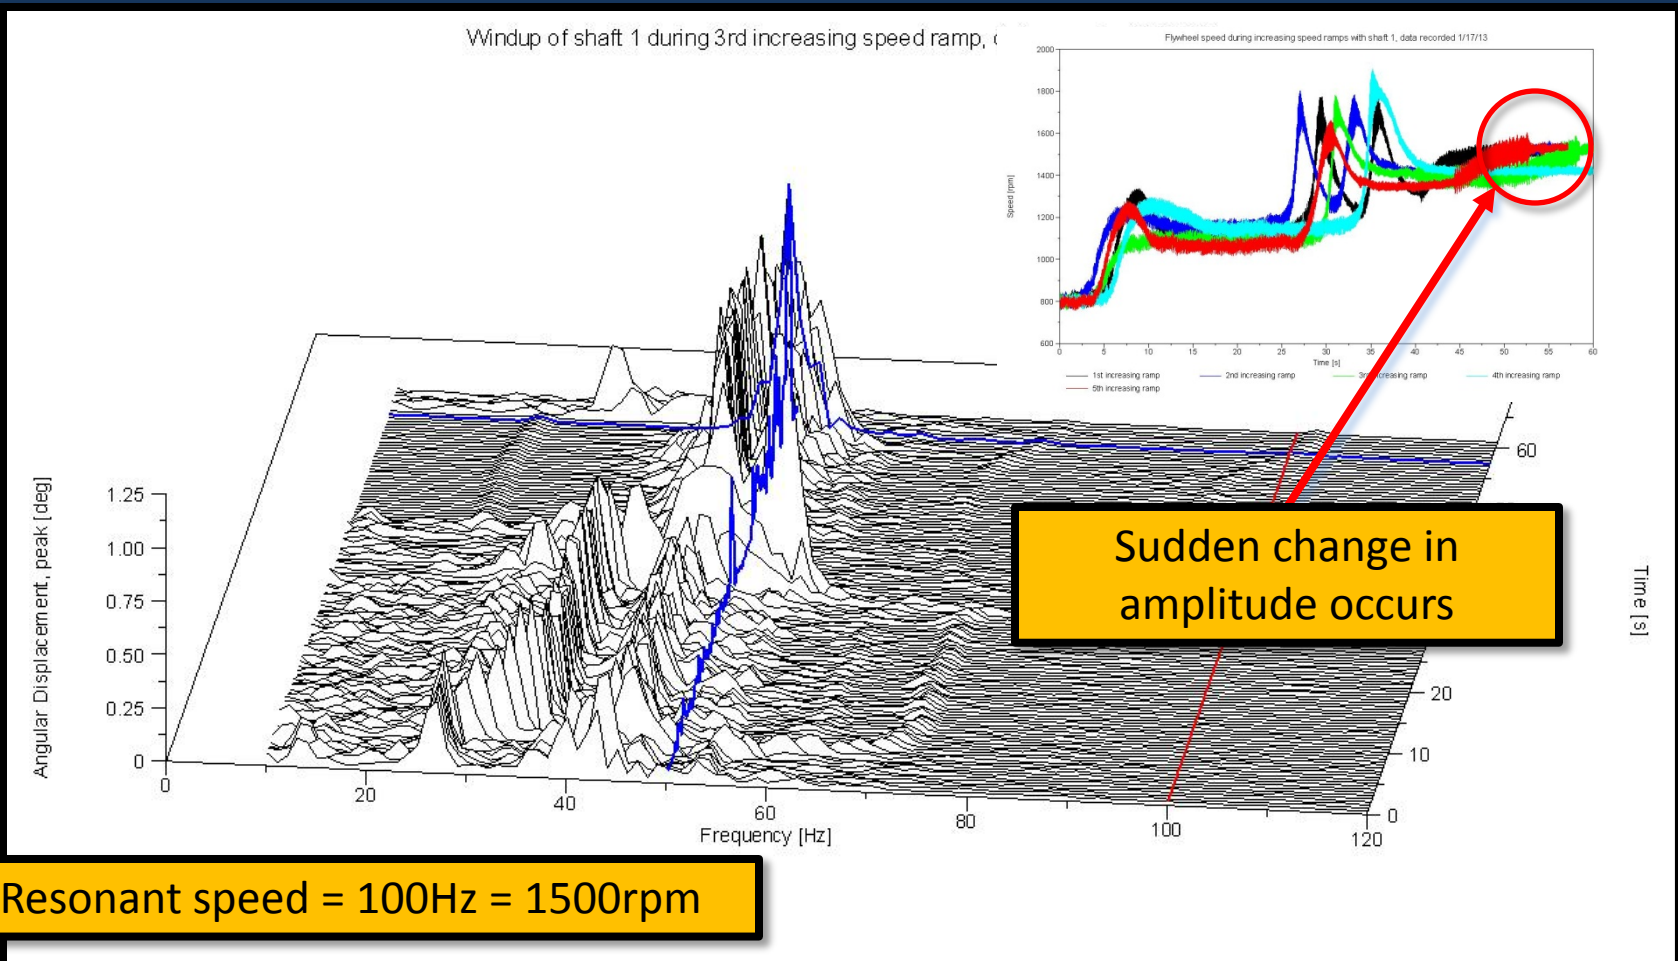
Comparison of ω_n at Different Driveshaft Lengths on Ramp

- 34.5" (Long) Solid Shaft

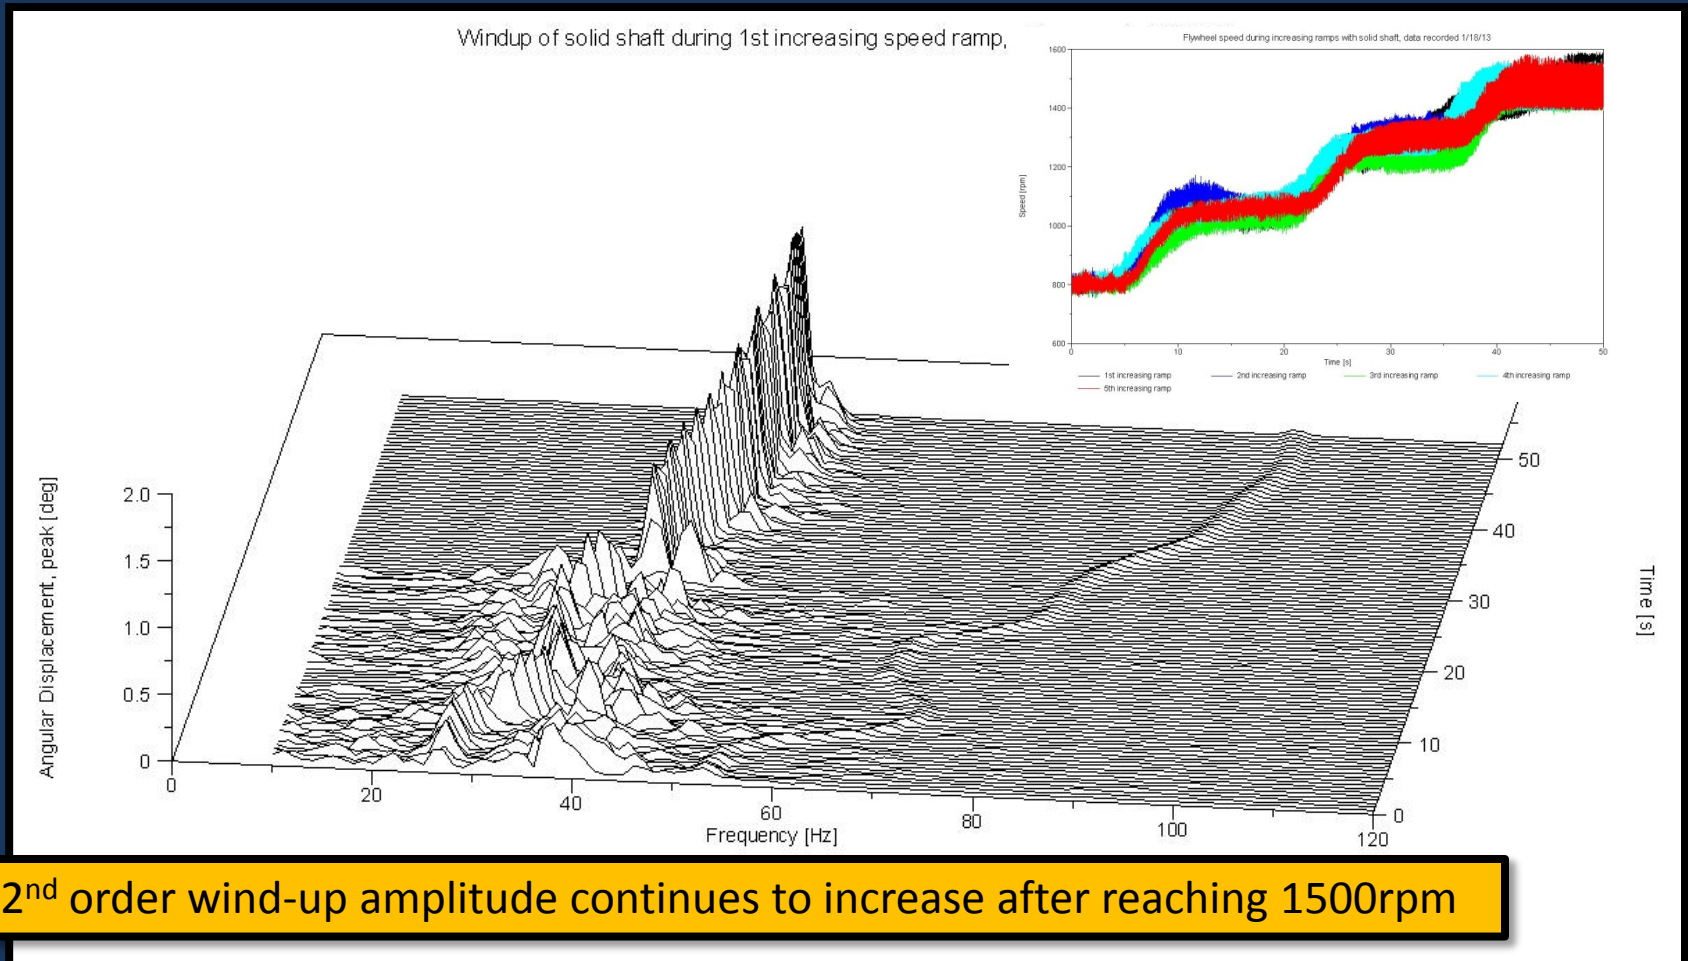
Comparison of ω_n at Different Driveshaft Lengths on Ramp

- 20.5" (Short) Solid Shaft

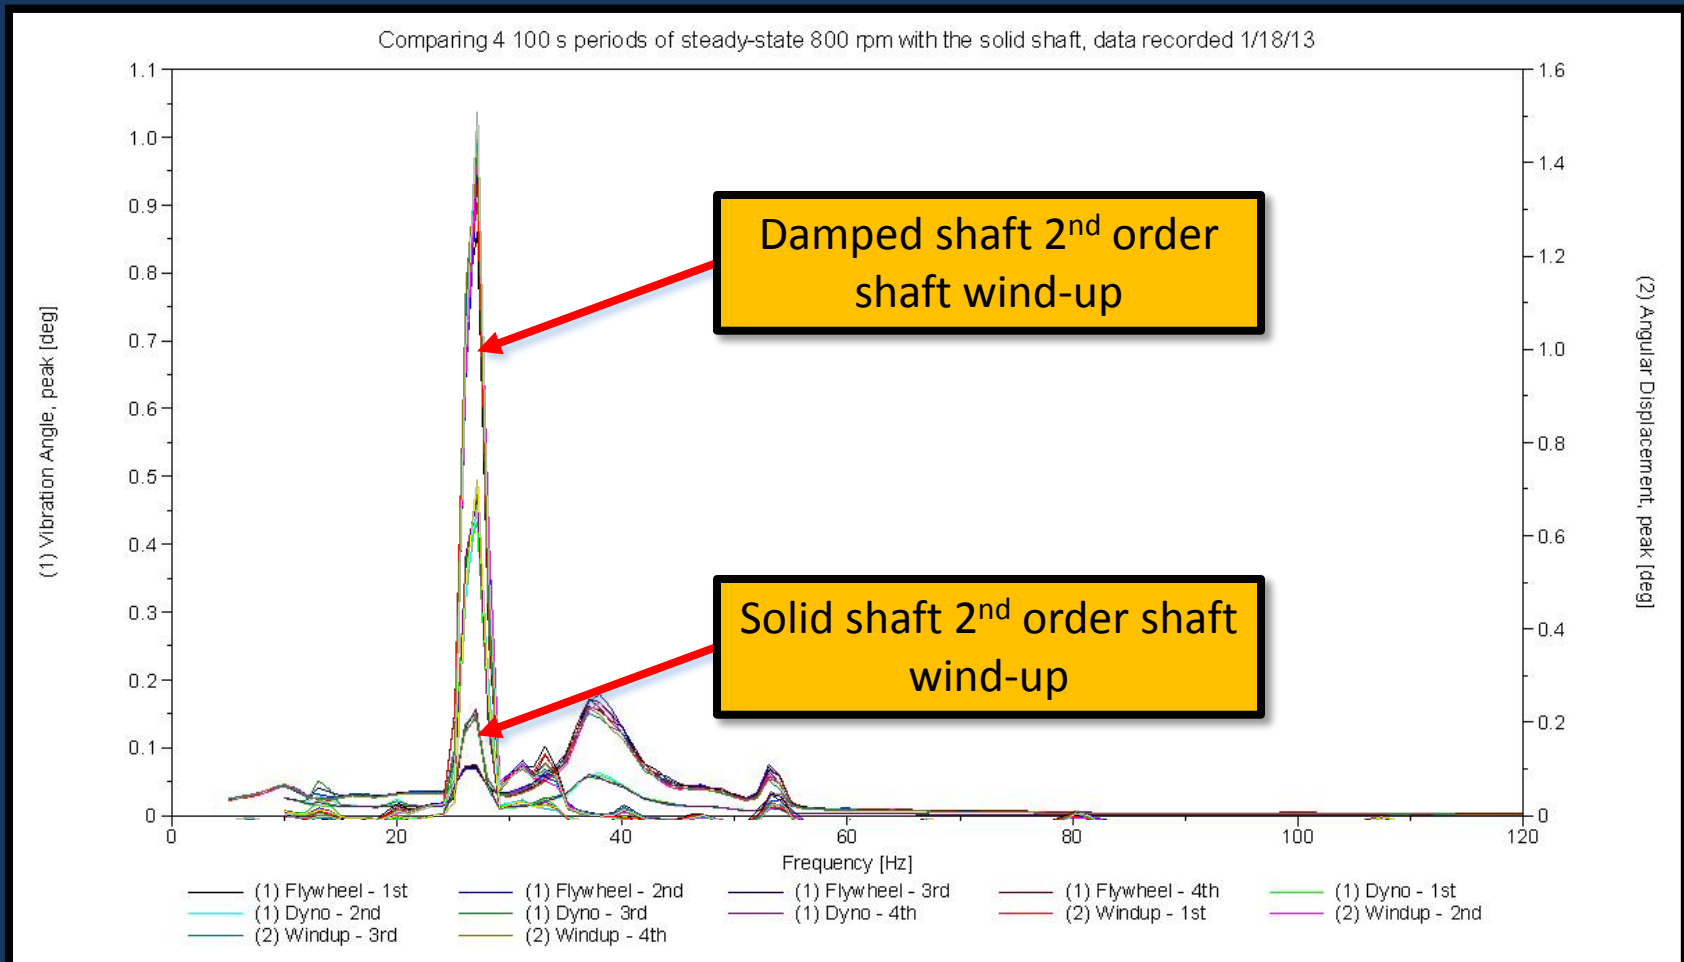
Comparison of ω_n at Different Driveshaft Lengths at 800rpm

- 20.5" Solid Shaft vs. Damped Shaft

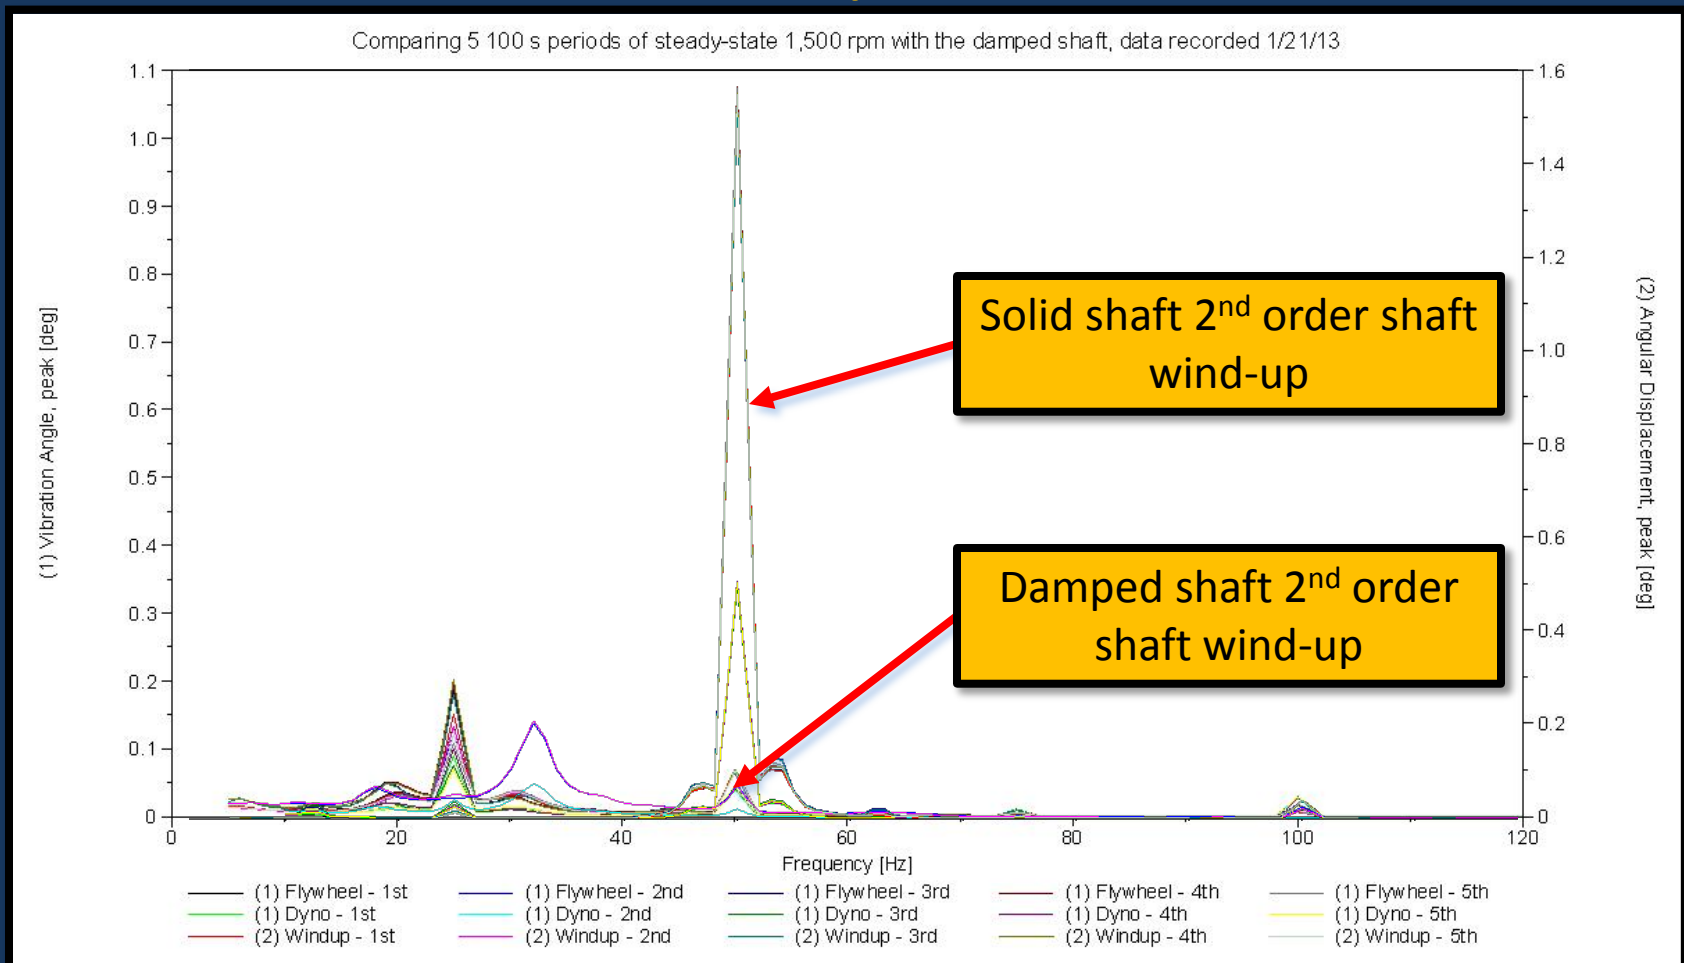
Comparison of ω_n at Different Driveshaft Lengths at 1500rpm

- 20.5" Solid Shaft vs. Damped Shaft

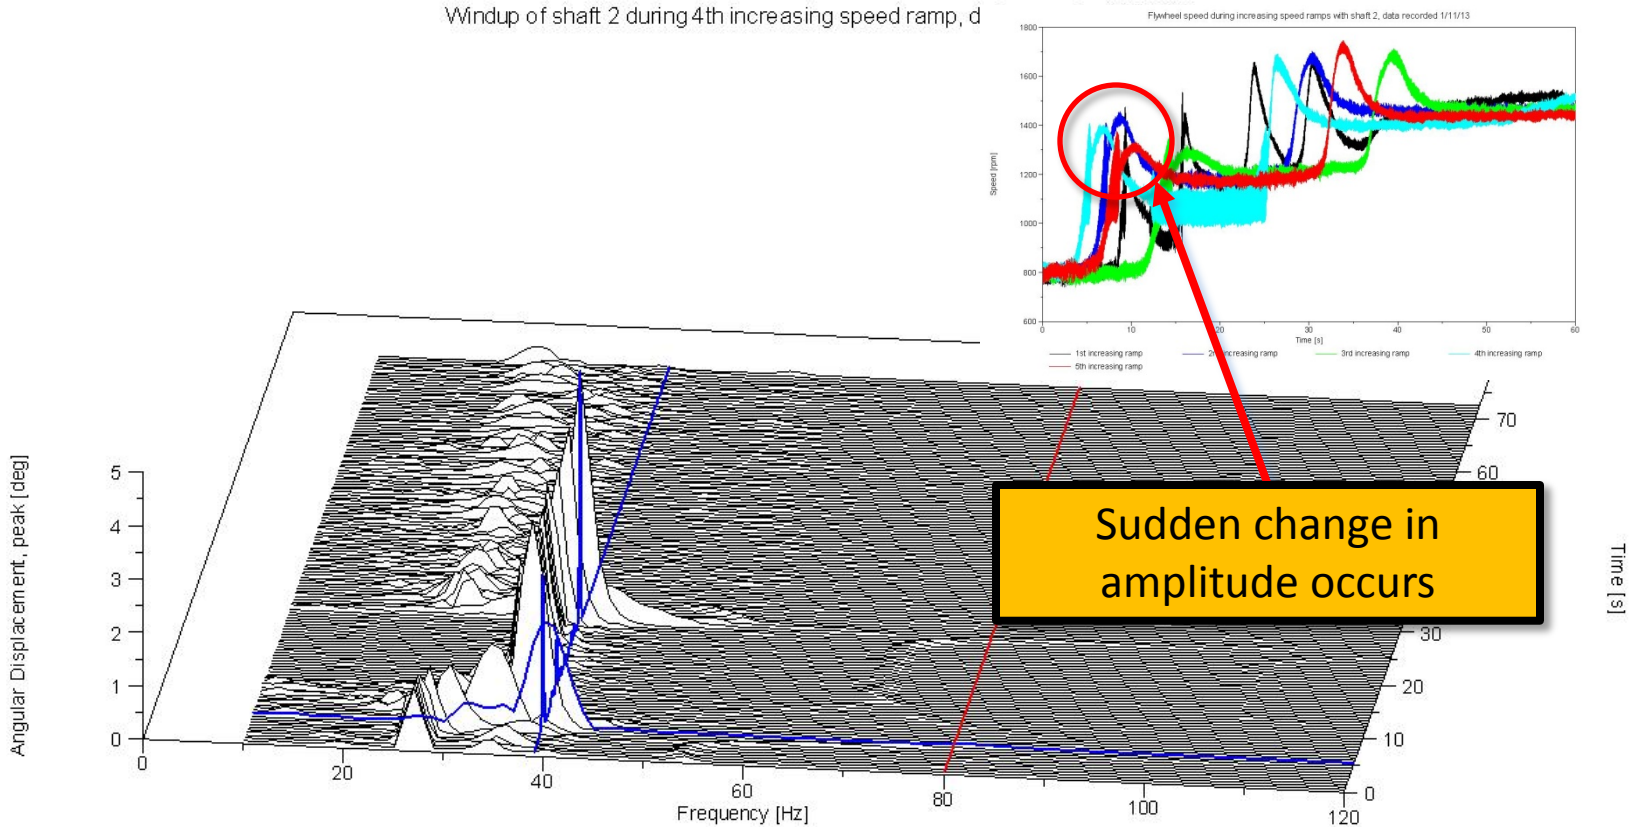
- 34.5" (Long) Damped Shaft

Windup of shaft 2 during 4th increasing speed ramp, d

Resonant speed = 80Hz = 1200rpm

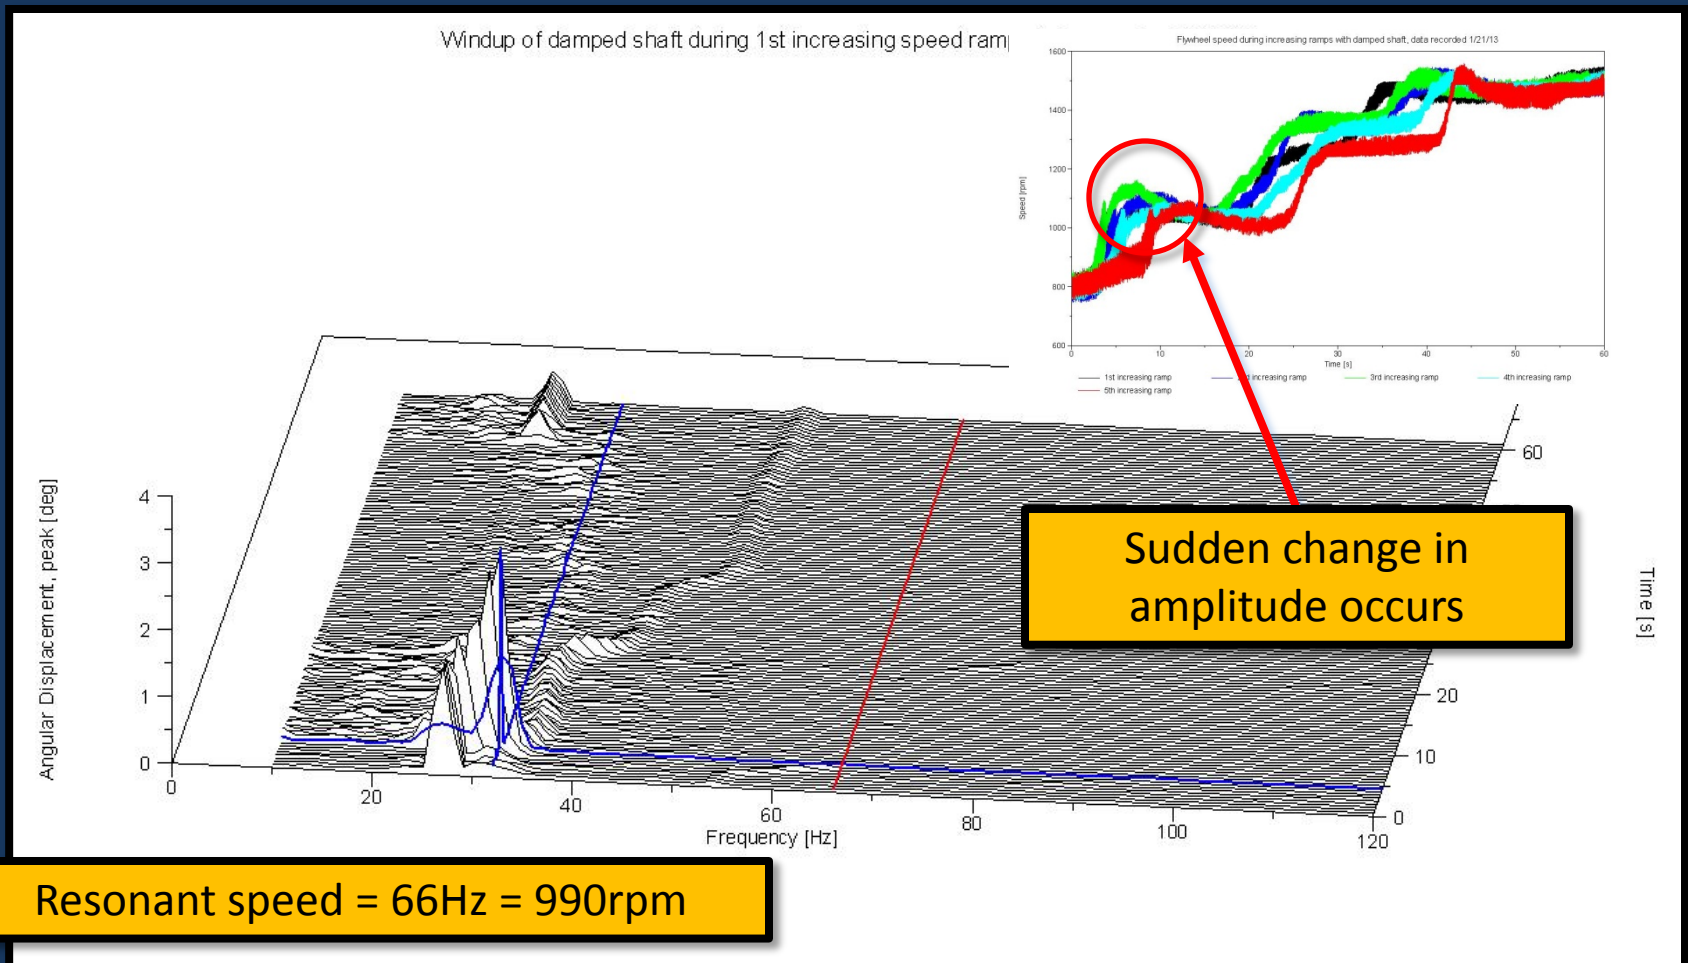
- 20.5" (Short) Damped Shaft

- Natural frequency shifted lower in short driveshaft
- Not expected according to stiffness equation
- Still shows driveshaft length has significant effect on vibrational response
