**Committee D02 on PETROLEUM PRODUCTS AND LUBRICANTS**

Unapproved Minutes of the January 24, 2013  
Sequence IV Surveillance Panel Meeting held in San Antonio, TX.

# **DRIVELINE EFFECTS ON DYNAMIC TORSIONAL VIBRATION ON SEQUENCE IVA ENGINE STAND**

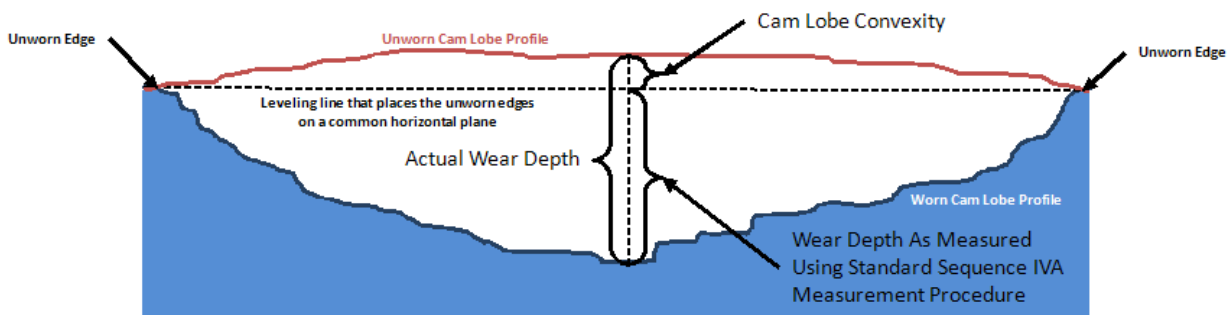
Figure 1: Explanation of Anomaly

The manufacturing anomaly that SwRI identified is described as convexity on the camshaft lobe surface. This surface is supposed to be flat. The convex lobes exhibit a crown that protrudes up to  $7\mu\text{m}$  above the flat surface that normally is used as the baseline to calculate the wear value. A convex camshaft lobe that is undetected and/or uncorrected would lead to an incorrect wear measurement that is milder than the actual wear on a camshaft lobe, because the crown material that is worn off above the baseline is not accounted for when the standard Sequence IVA camshaft wear measurement method is applied. A visual example is shown in Figure 1.

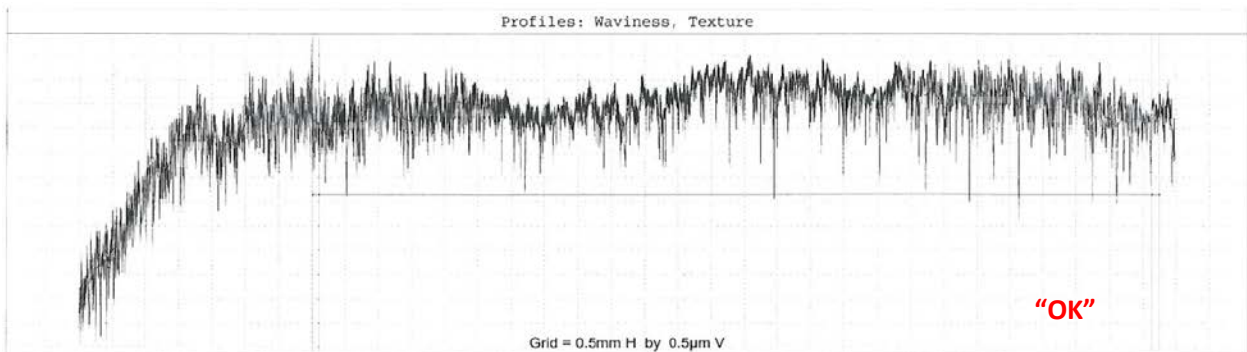
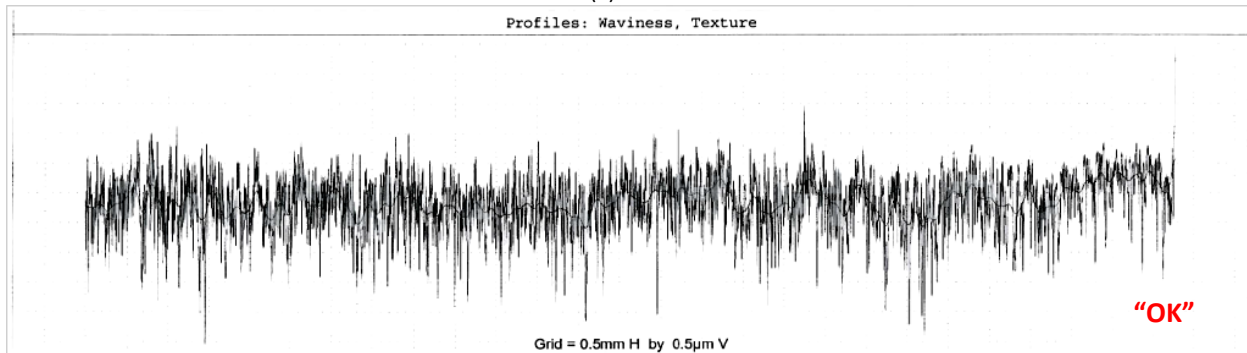
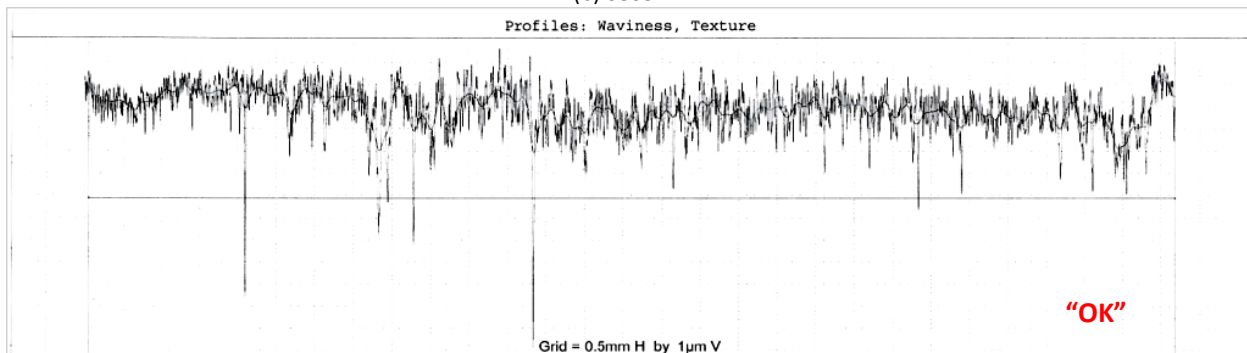
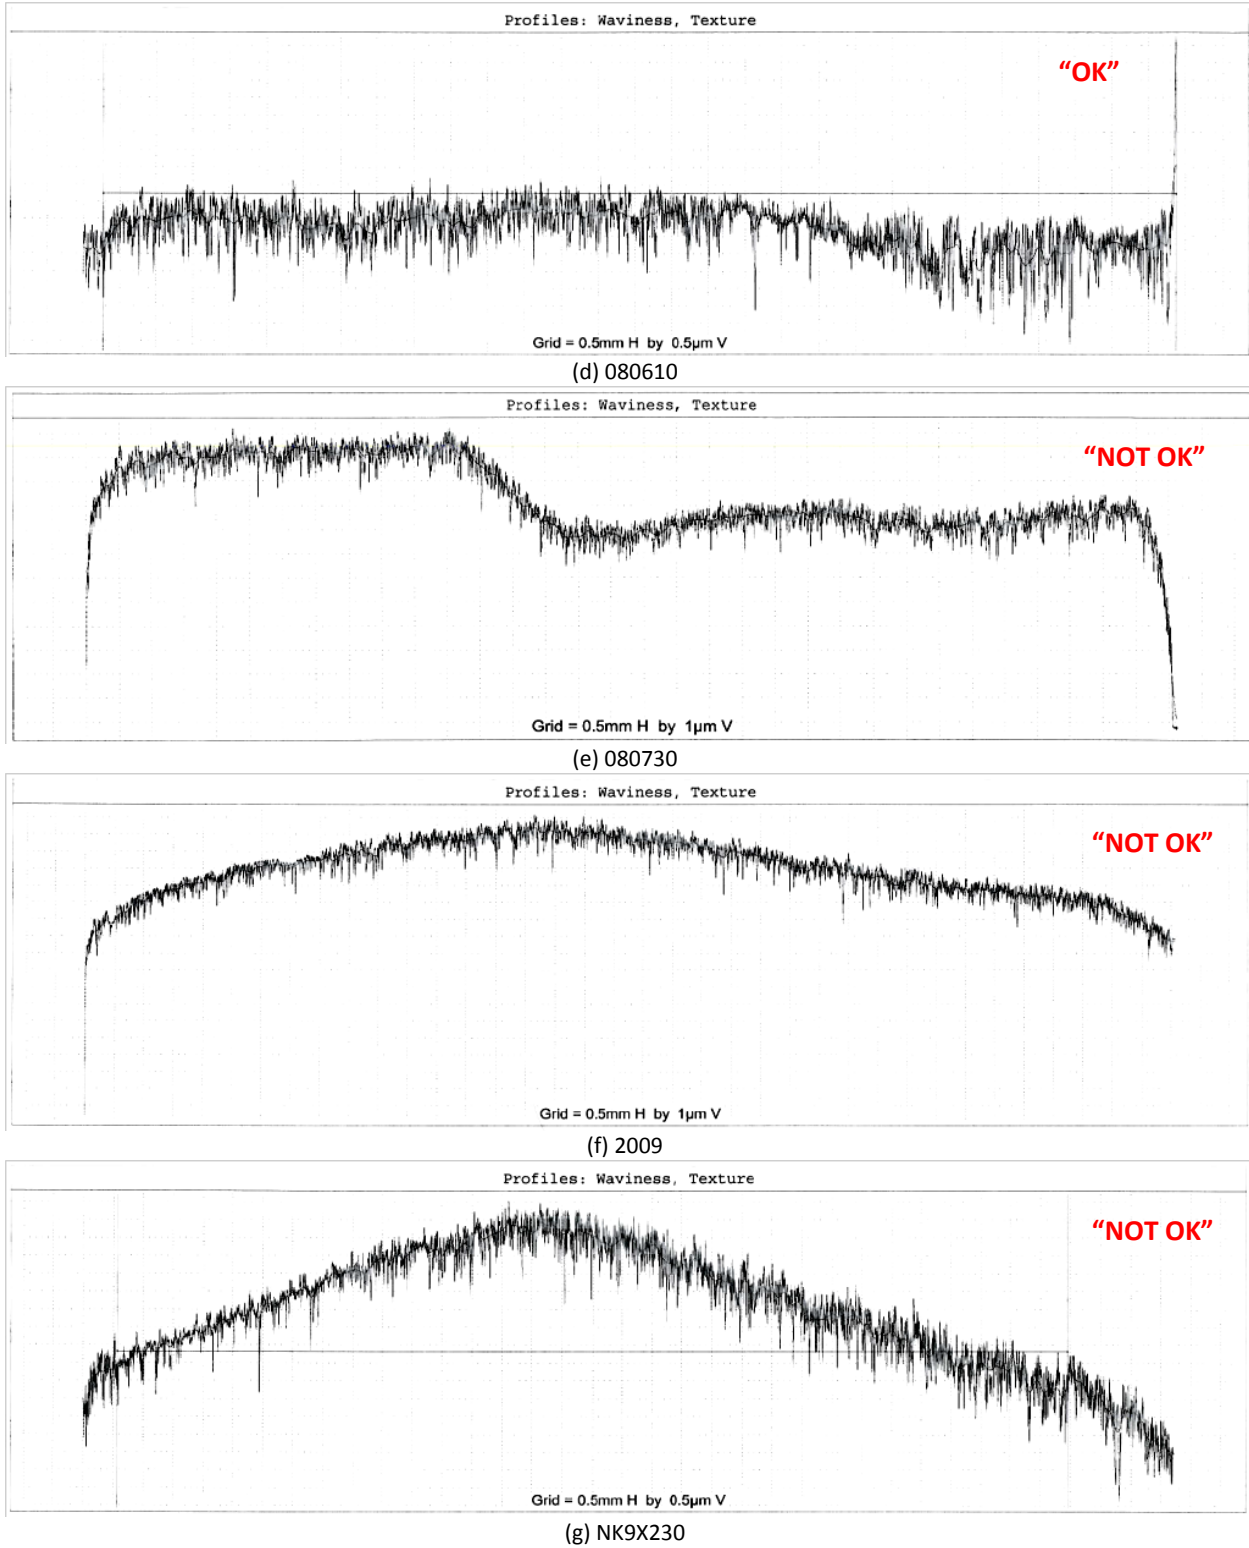
Figure 2: Progression of Camshaft Lobe Surface Curvature Over Seven Camshaft Lots; (a) 051124, (b) 080317, (c) 080418, (d) 080610, (e) 080730, (f) 2009, (g) NK9X230

Starting with camshaft lot 080730, the camshaft lobe surfaces, on intermittent camshafts from some lots and on all camshafts from other lots, were found with this condition. For these camshafts, the lobe surface was found to be a convex curve, whose peak was above the horizontal line that connected the two edges of the camshaft lobe. Figure 2 shows the pre-test lobe measurements over time for the various camshaft batches received by SwRI for testing. As shown in Figure 2, this anomaly was not observed on any camshaft lobe surfaces prior to the 080730 lot. This was first discovered while taking traces of the base circle profile in the case where a post-test lobe is missing a discrete non-worn edge (as per the no-form method in Section 11.5.3.6 of the Sequence IVA Test Method ASTM D 6891). It was also noted that camshaft lobe surfaces from lots manufactured in 2008 and later were progressively non-linear, and the peak of the curve progressively increased, as shown in Figure 2.

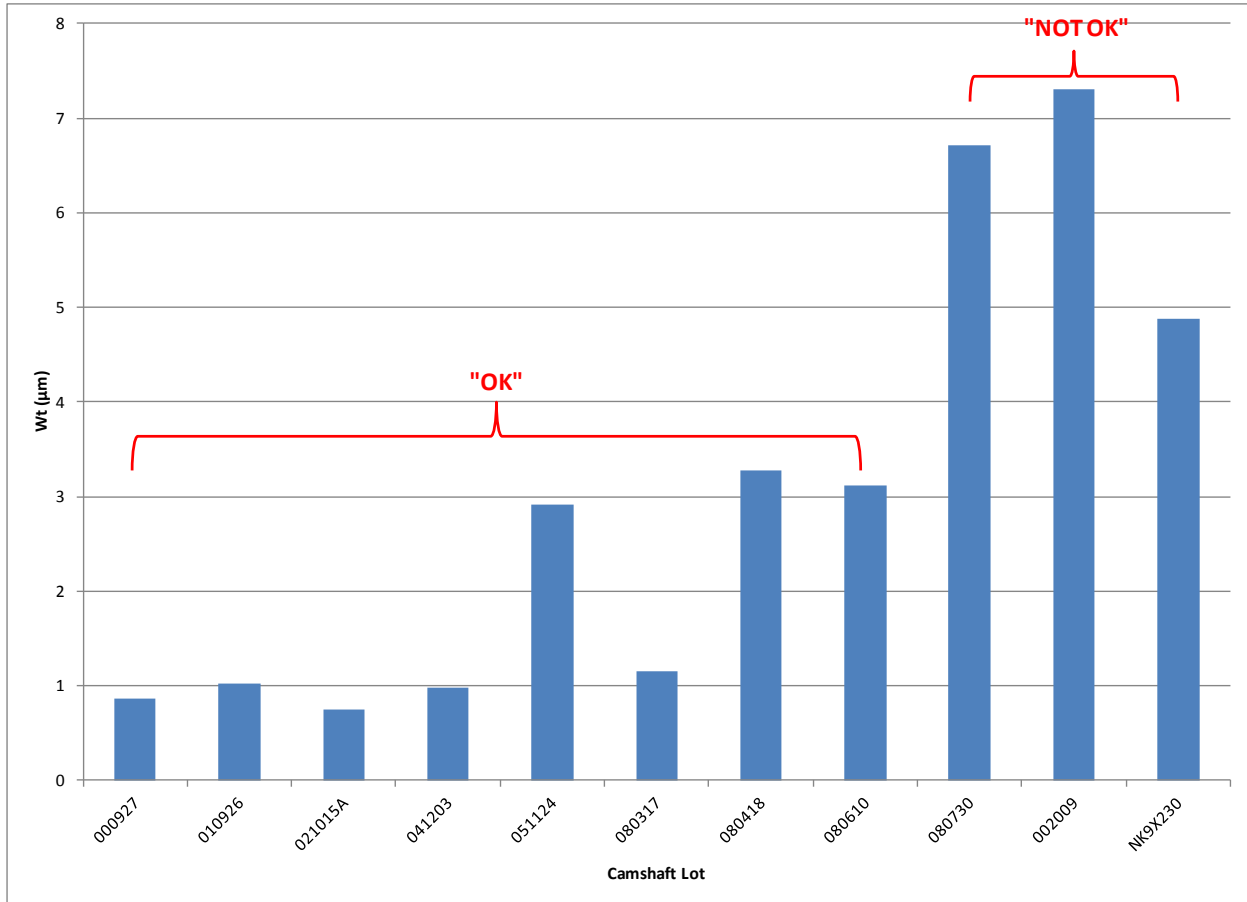
Figure 3: Wt of Camshaft Lobe Surfaces from Multiple Camshaft Lots

The waviness (Wt) of the cam lobe surfaces of multiple camshaft lots are shown in Figure 3. For the purposes of this discussion, Wt is described as the maximum difference between any two points on a surface profile trace of a camshaft lobe. Therefore, Wt represents the distance from the peak of the curve to the edges. As the Wt value increases so does the convexity of a new camshaft lobe surface profile.

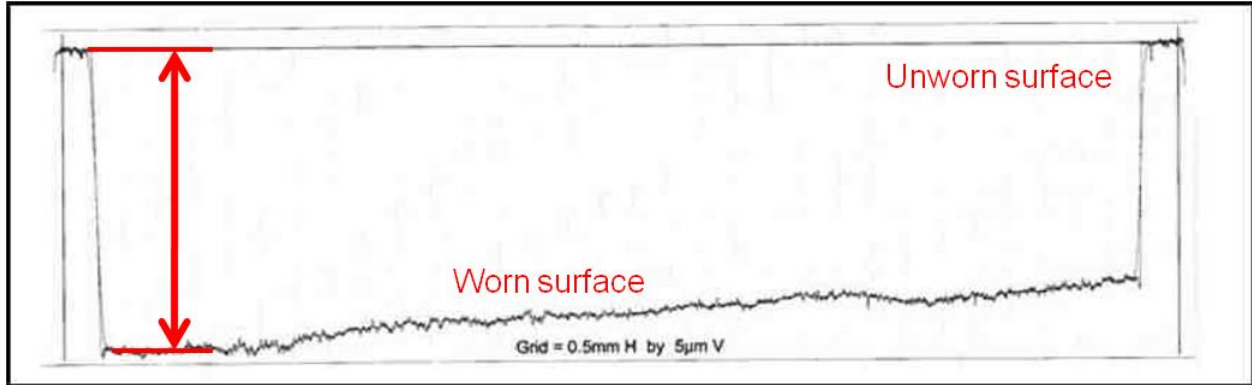
Figure 4: Standard Procedural Measurement of the Maximum Wear Depth Seen at a Camshaft Lobe Position

The curvature of the camshaft lobe surface ultimately affected the wear depth measurement conducted at each position of the camshaft lobe (7 per lobe, 84 per camshaft). The standard wear measurement method, described in Section 11.5.3.3 of ASTM D 6891, states that the unworn edges found on each camshaft lobe are to be used “to define a two-point reference line” from which to measure the maximum depth of wear. A diagram describing the standard measurement method for determining the maximum wear depth is shown in Figure 4.

The maximum wear depth, by definition, is the greatest distance between the unworn surface and the worn surface of the camshaft lobe. Therefore, the accuracy of the measurement method described in the test procedure was based on the assumption that the original surface of the camshaft lobe could be properly represented by a flat line that connected the two unworn surfaces at the edge of each camshaft lobe; the assumption being that the original camshaft lobe surface was flat, not curved.

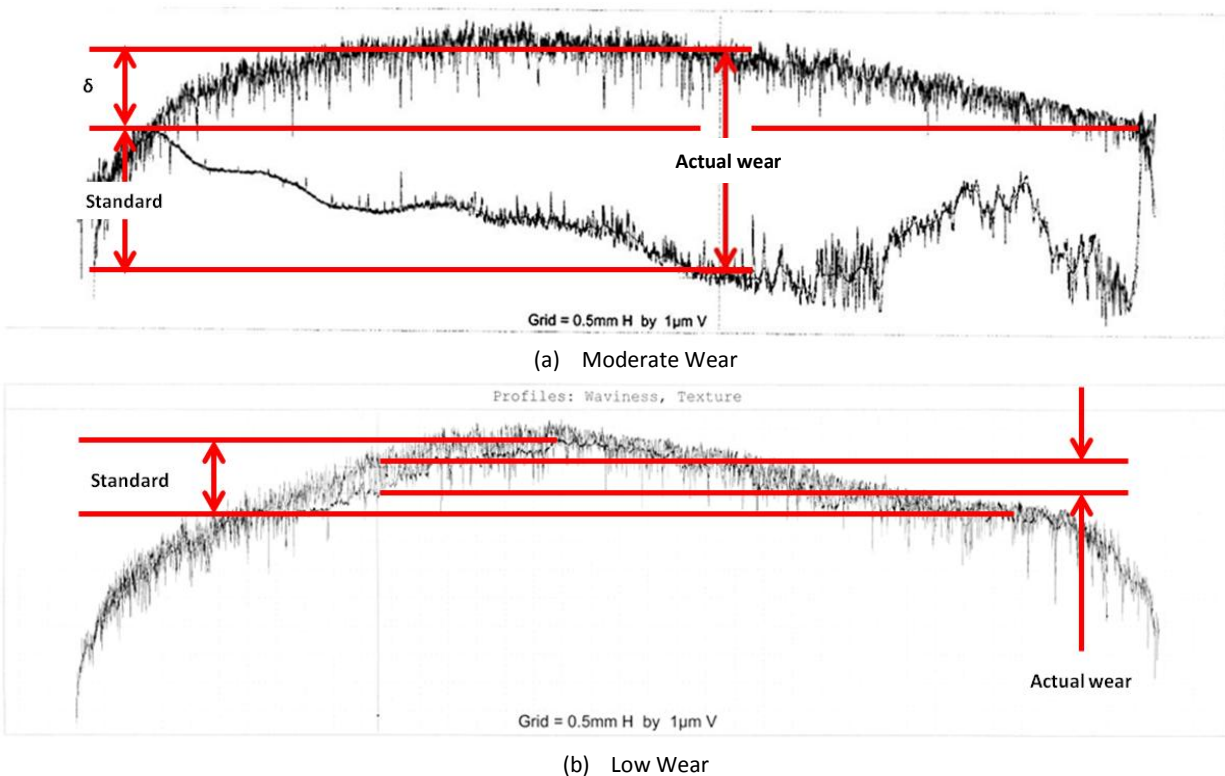
Figure 5: Comparison of Overlay Method and Standard Sequence IVA Method for Measurement of Camshaft Lobe Wear; (a) Moderate Wear, (b) Low Wear

While conducting post-test camshaft lobe measurements, the pre-test camshaft lobe profile was overlaid with the post-test camshaft lobe profile as illustrated in Figure 5. The maximum wear depth was determined by taking the largest difference between the pre- and post-test camshaft lobe profiles. This is indicated by “Actual wear” in Figure 5. In all instances where this wear measurement method was used to determine test results, comments were added to all the final test reports, reflecting that action.

It is shown in Figure 5 that by overlaying the pre- and post-test camshaft lobe profiles, the average camshaft wear (ACW) was higher than the ACW obtained using the standard measurement method. Figure 5b illustrates that, in actuality, if only the standard Sequence IVA ACW measurement method is applied, the convexity of the cam lobe is measured in the case of a low wear cam lobe instead of the actual wear depth.

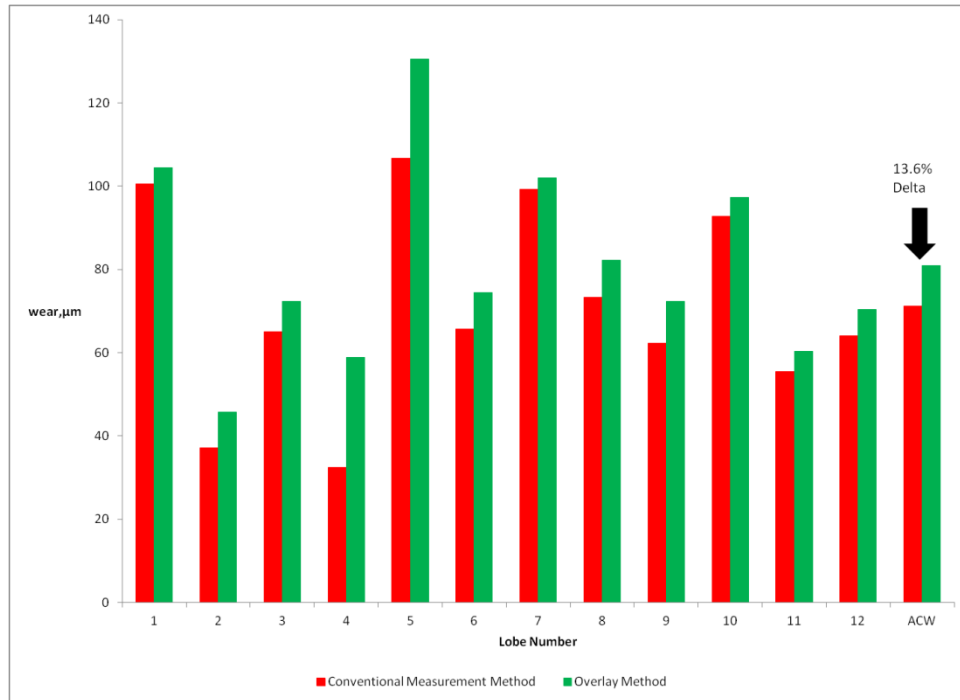
Figure 6: Comparison of ACW Result Using Overlay Method and Standard Sequence IVA Method for Measurement of Camshaft Lobe Wear<sup>1</sup>

An example of a post-test camshaft measured by both ACW measurement methods is shown in Figure 6. The conventional method produces an average wear of 71.23 $\mu\text{m}$  and the overlay method produces an average wear of 80.89 $\mu\text{m}$ . The discrepancy between the average camshaft wear values obtained from each measurement method is 13.6% for this example, and has the potential to be even greater depending on the height of the convexity and the severity of the wear.

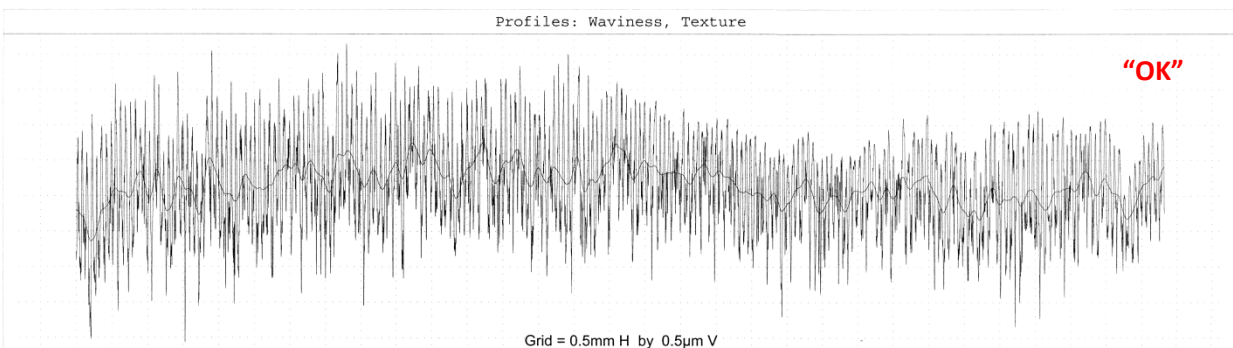
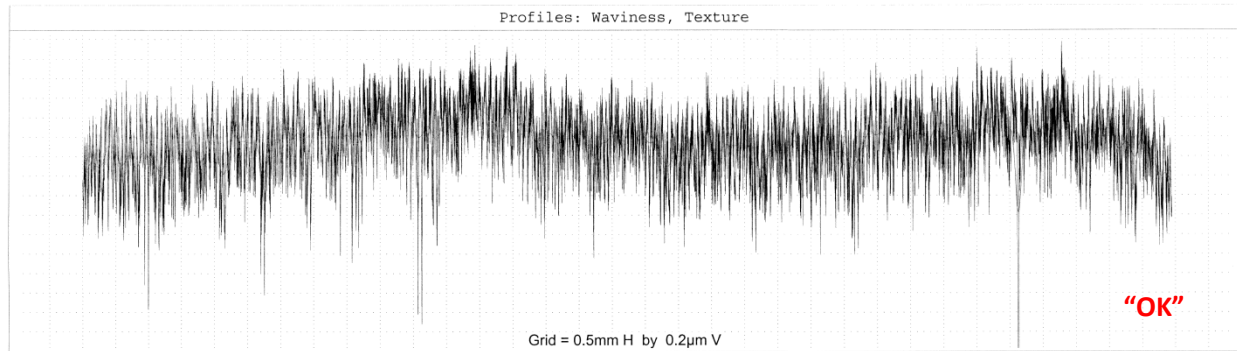
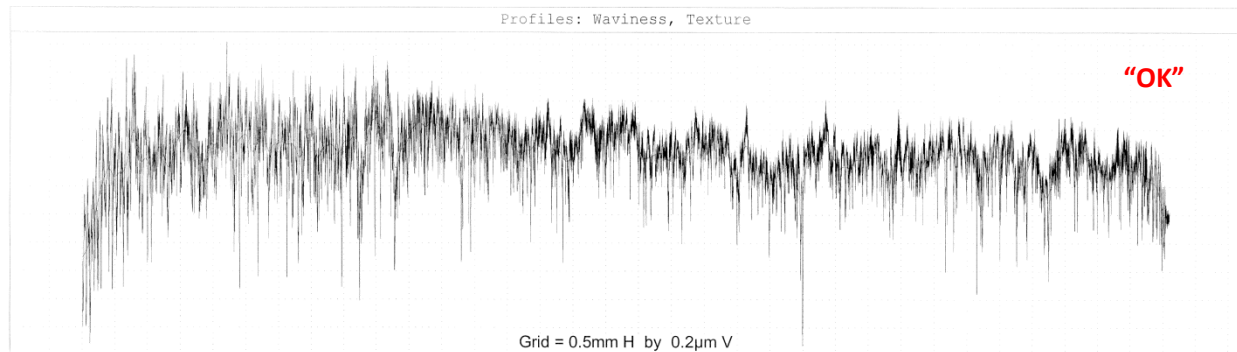
Figure 7: Camshaft Lobe Surfaces of Reground Camshafts, Including Three Camshaft Lots;(a) 080730, (b) NK04120, (c) NK05190<sup>2</sup>

For comparison, the reground camshaft lobes had an average Ra, Rsk, and Wt of  $0.26\mu\text{m}$ ,  $-0.14$ , and  $0.79\mu\text{m}$ , respectively. An example of the final reground camshaft lobe surface from each of the reground camshaft lots are shown in Figure 7.

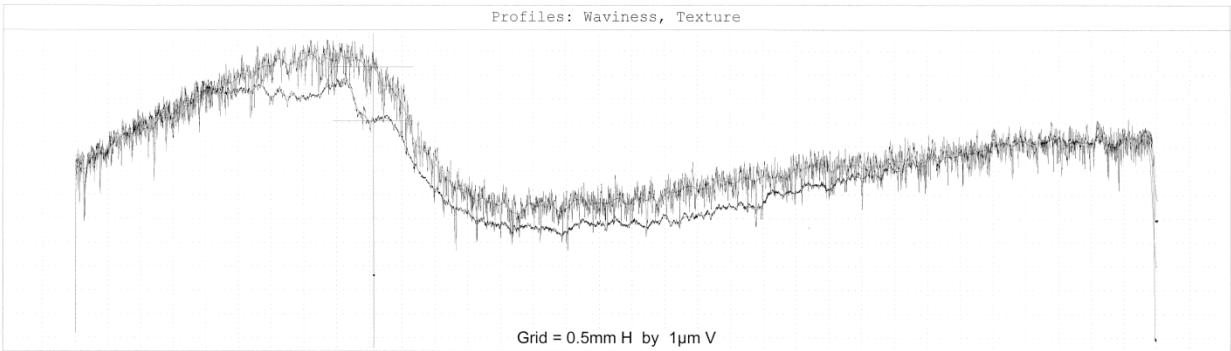
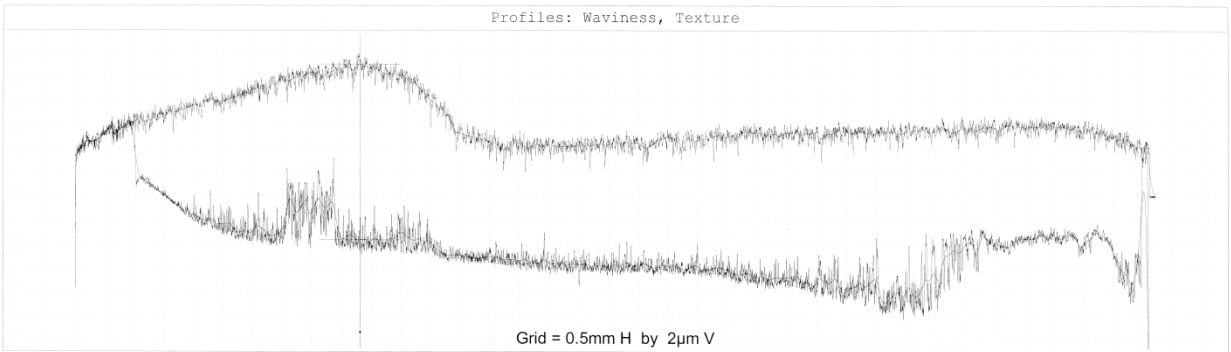
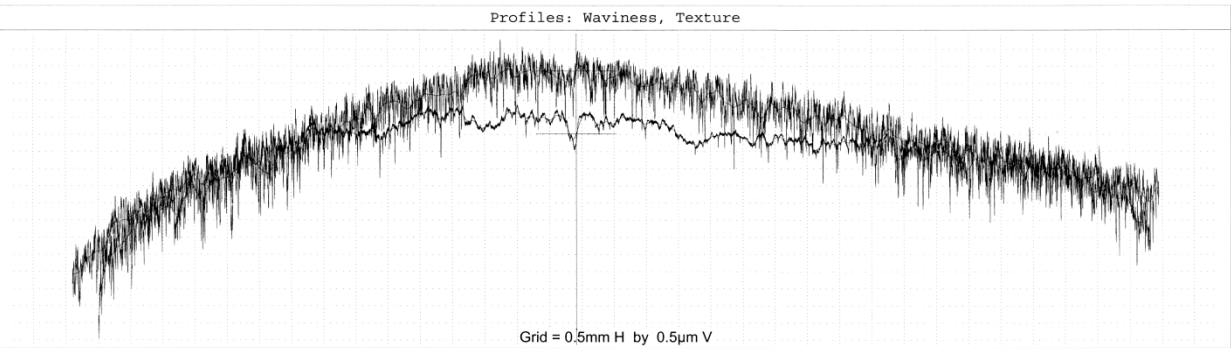
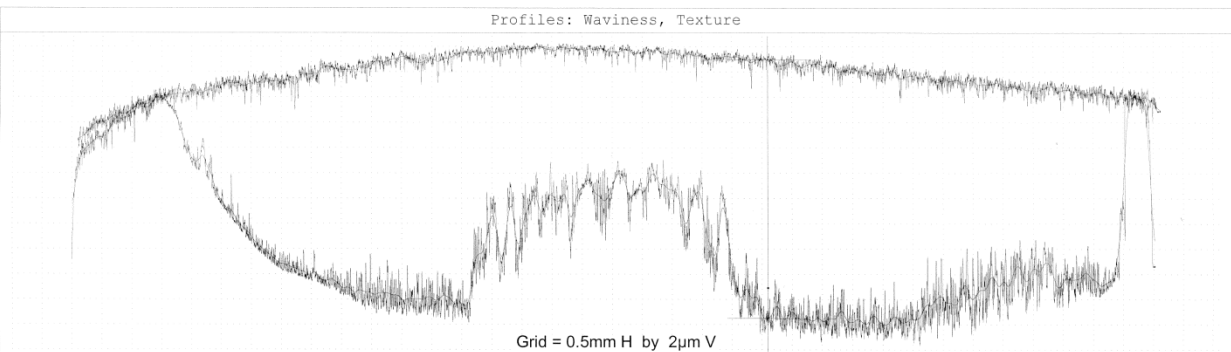
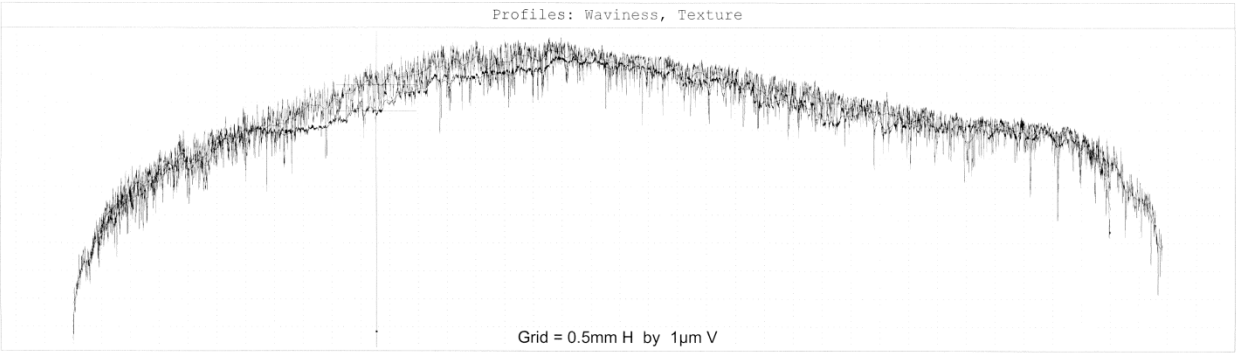
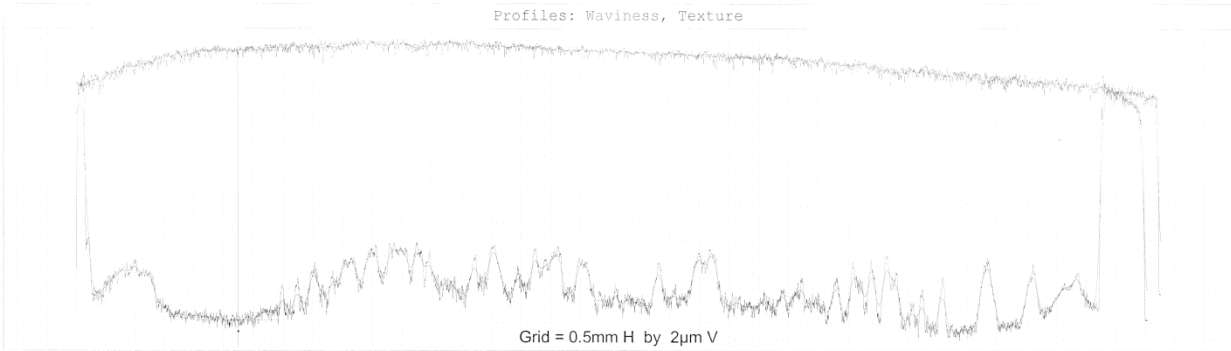
Figure 8: Examples of Low and High Wear Using Pre-Test and Post-Test Profile Trace Overlays for Camshaft Lots 080730 (a) & (b), 2009 (c) & (d), NK9X230 (e) & (f)

Examples of pre-test and post-test profile trace overlays for all three camshaft lots, 080730, 2009 and NK9X230, are shown in Figure 8. Low wear and high wear examples are included for each camshaft lot. The necessity for this measurement method is extremely evident in the low wear examples, and without it, a lab would measure the convexity instead of wear from the baseline.

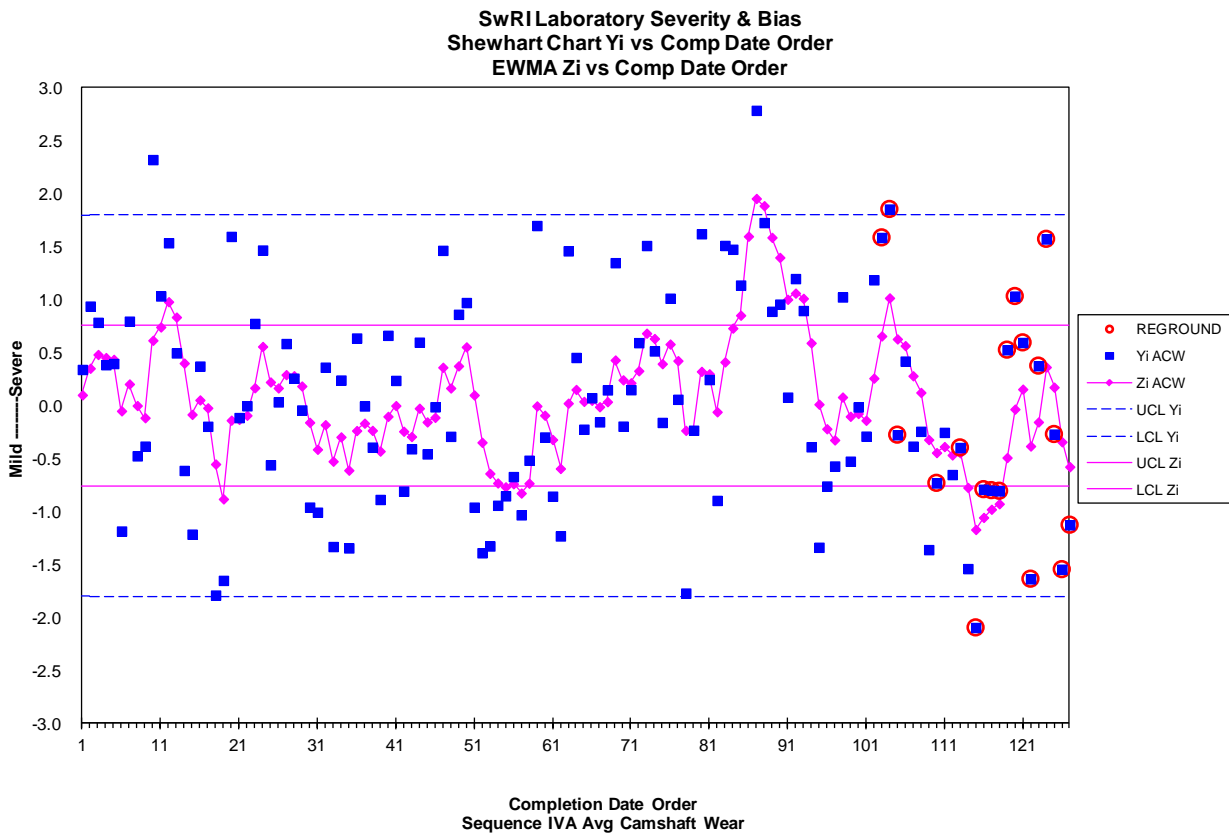
Figure 9: Plot of ACW  $Y_i$  and ACW  $Z_i$  for SwRI Reference Tests

The plot of ACW  $Y_i$  and ACW  $Z_i$  from reference test results vs. completion date is shown in Figure 9. Any test conducted with a reground camshaft is indicated with a circle around the square. This data indicates that the introduction of the reground camshafts did not shift the severity of the test.

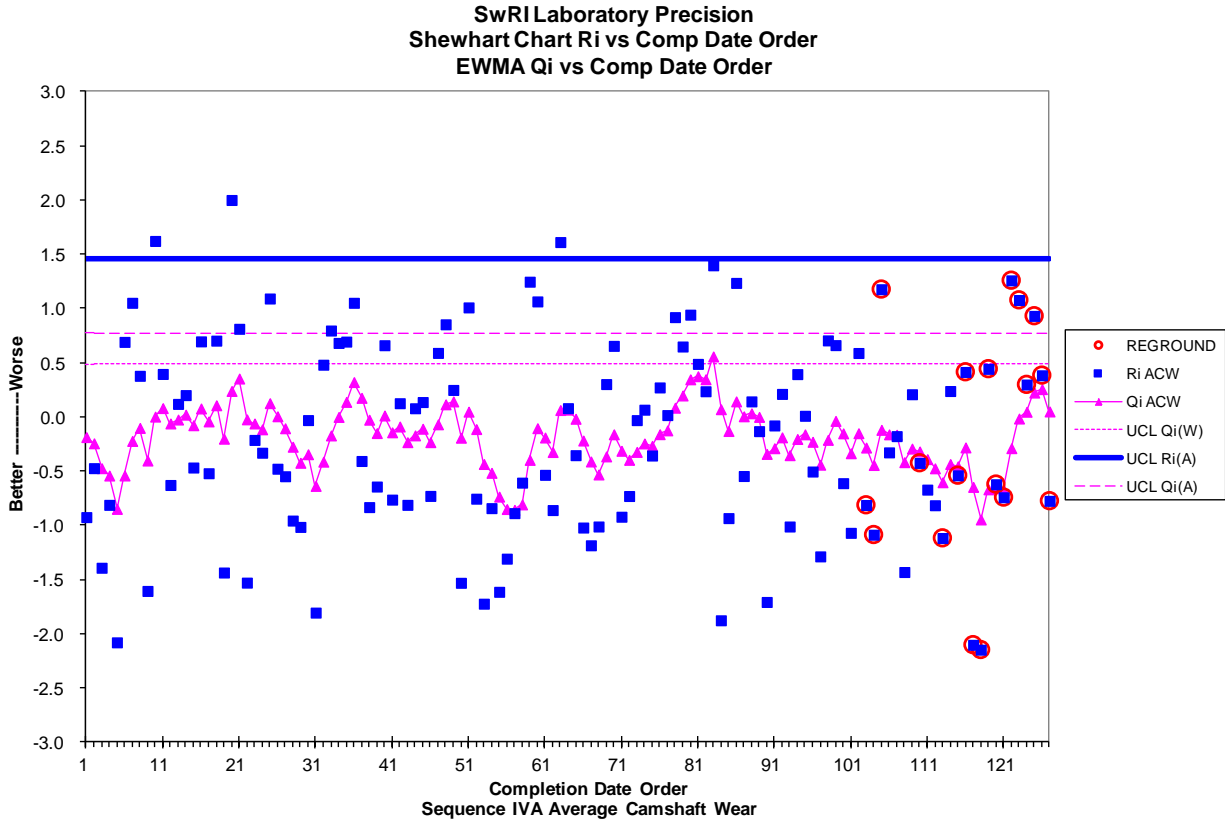
Figure 10: Plot of ACW  $R_i$  and ACW  $Q_i$  for SwRI Reference Tests

The plot of ACW  $R_i$  and ACW  $Q_i$  from reference test results vs. completion date is shown in Figure 10. Any test conducted with a reground camshaft is indicated with a circle around the square. This data indicates that the introduction of the reground camshafts did not shift the precision of the test.

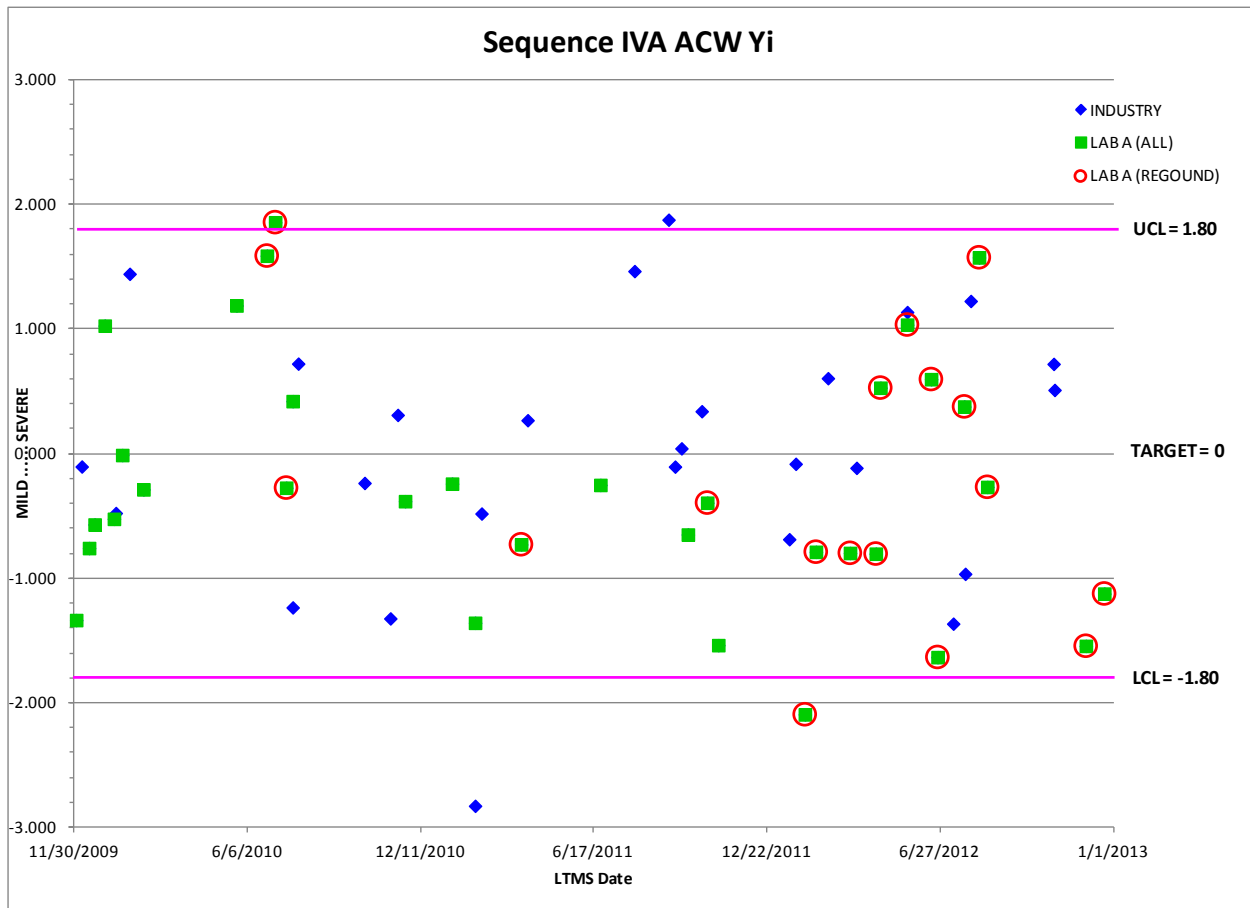
Figure 11: Plot of  $Y_i$  vs. Date of Industry and SwRI (Lab A) Reference Oil Tests

The plot of ACW  $Y_i$  for industry and SwRI reference test results from December 2009 through January 2013 is shown in Figure 11.

SwRI reference tests are indicated by the squares, and any test conducted with a reground camshaft is indicated with a circle around the square. Results from other labs within the industry are indicated by the diamonds. Note that the scatter for all data within this timeframe falls within similar boundaries. This data indicates that the regrinding had no impact on the reference oils performance.

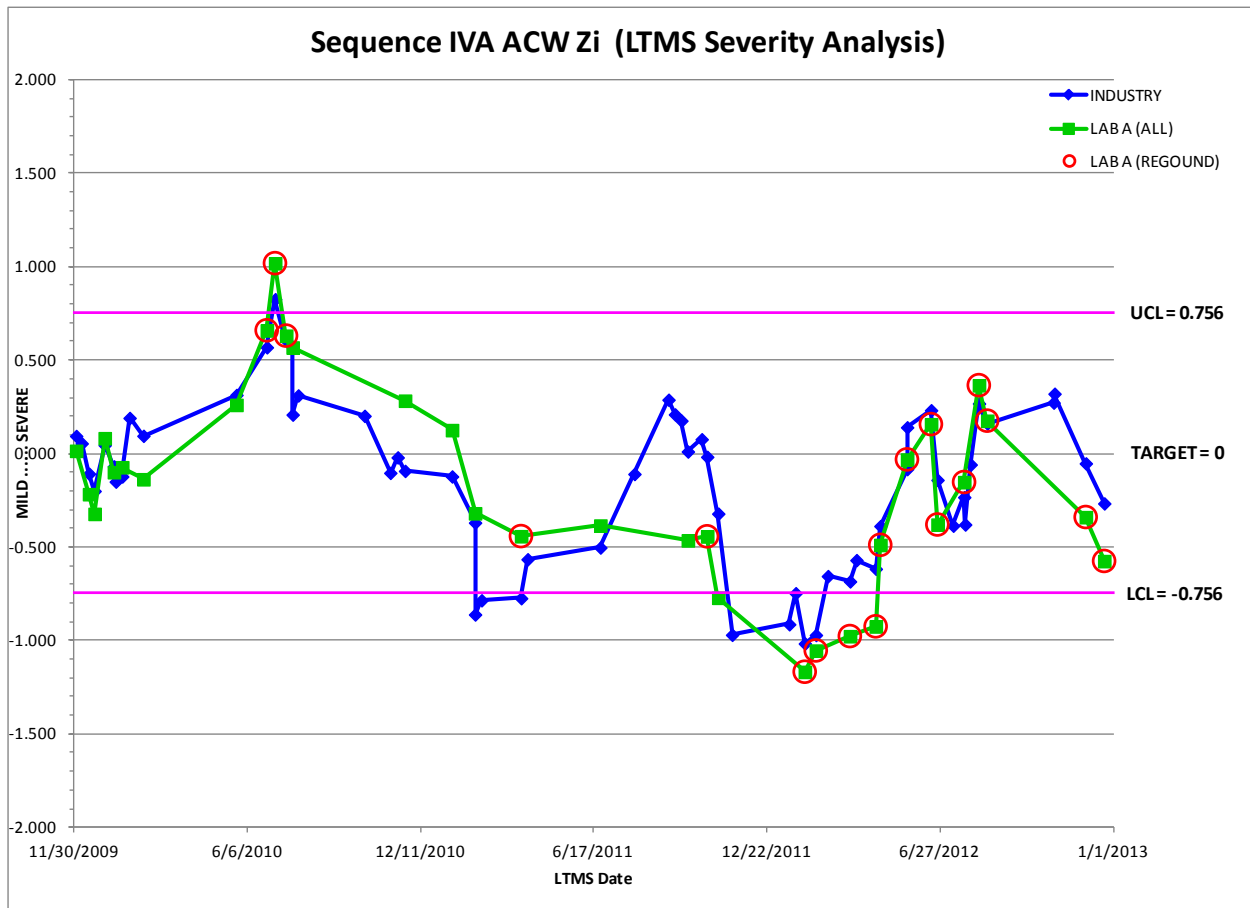
Figure 12: Plot of ACW  $Z_i$  vs. Date of Industry and SwRI (Lab A) Reference Oil Tests

The LTMS severity analysis plot of ACW  $Z_i$  for industry and SwRI reference test results from December 2009 through January 2013 is shown in Figure 12.

SwRI's lab severity trend is indicated by the green line (any test conducted with a reground camshaft is indicated with a circle around the square). The industry's severity trend is indicated by the blue line. Note that the trends of SwRI's lab severity and the industry's severity, within this timeframe, follow similar patterns. This data indicates that the regrinding had no impact on severity trends.

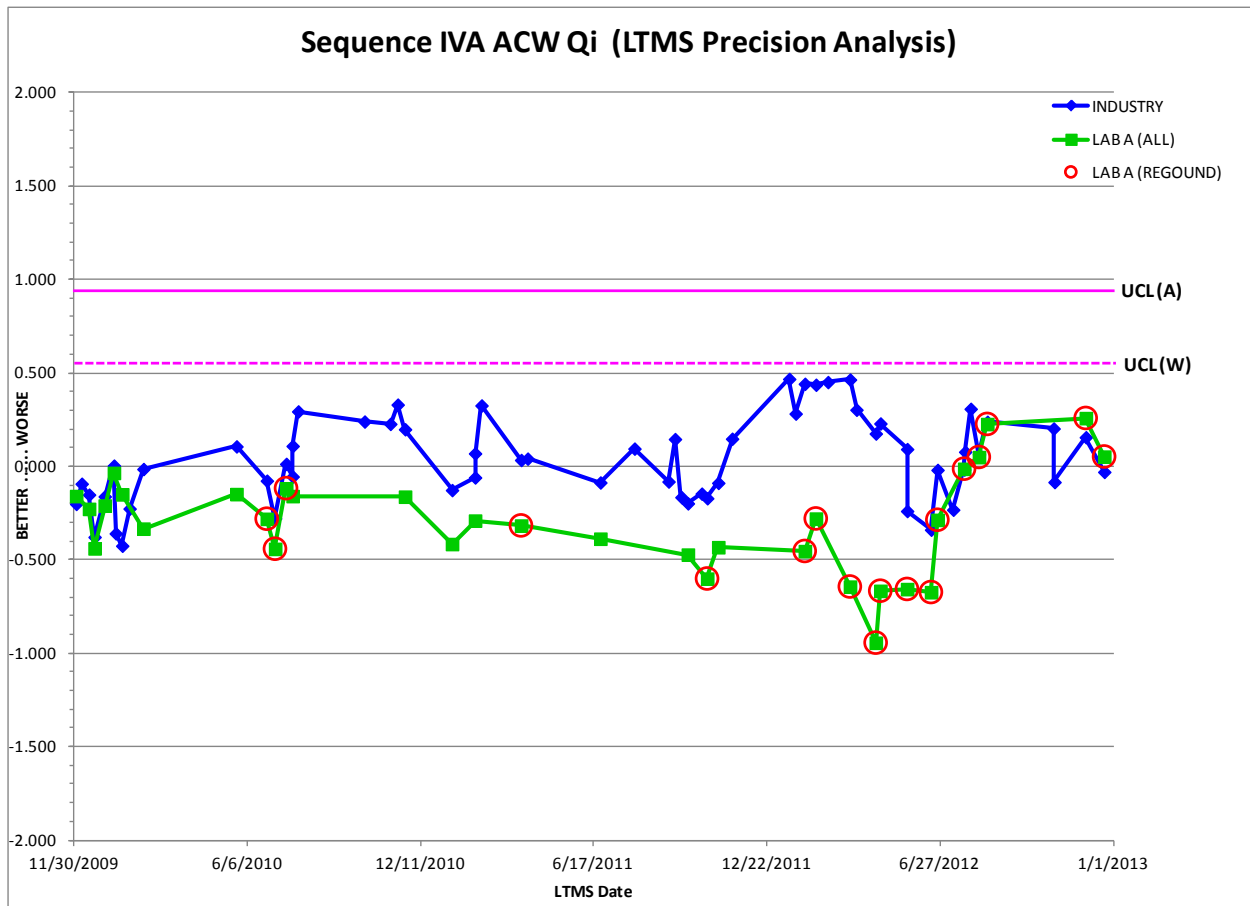
Figure 13: Plot of ACW  $Q_i$  vs. Date of Industry and SwRI (Lab A) Reference Oil Tests

The LTMS precision analysis plot of ACW  $Q_i$  for industry and SwRI reference test results from December 2009 through January 2013 is shown in Figure 13.

SwRI's lab precision trend is indicated by the green line (any test conducted with a reground camshaft is indicated with a circle around the square). The industry's precision trend is indicated by the blue line. Note that the trends of SwRI's lab precision and the industry's precision, within this timeframe, follow similar patterns. This data indicates that the regrinding had no impact on precision trends.

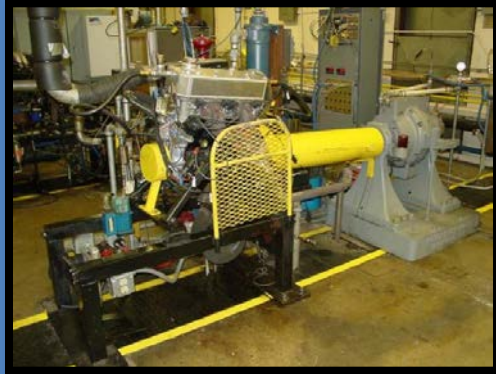
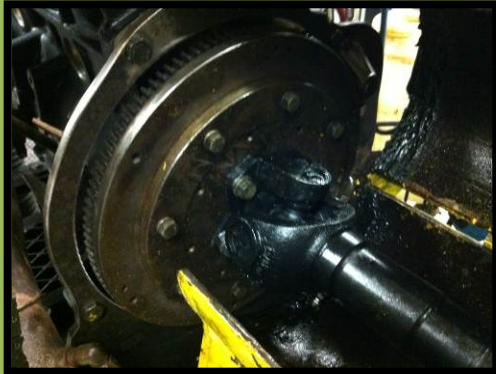
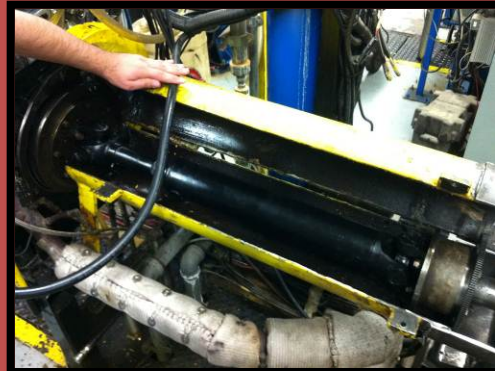
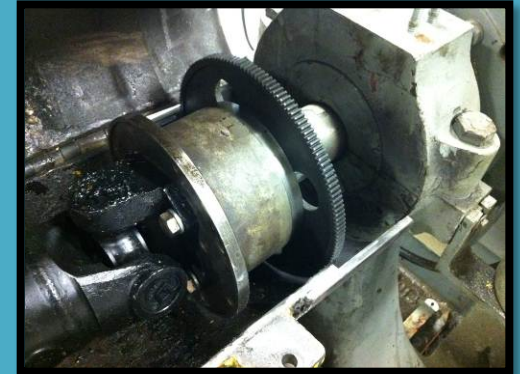
# Experimental Setup

- Demonstration showed different driveline configurations allowed labs to regain discrimination in cam lobe wear
- Driveline of different stiffness changed the torsional vibration dynamics of the test stand
- Torsional vibration dynamics have a direct effect on cam lobe wear

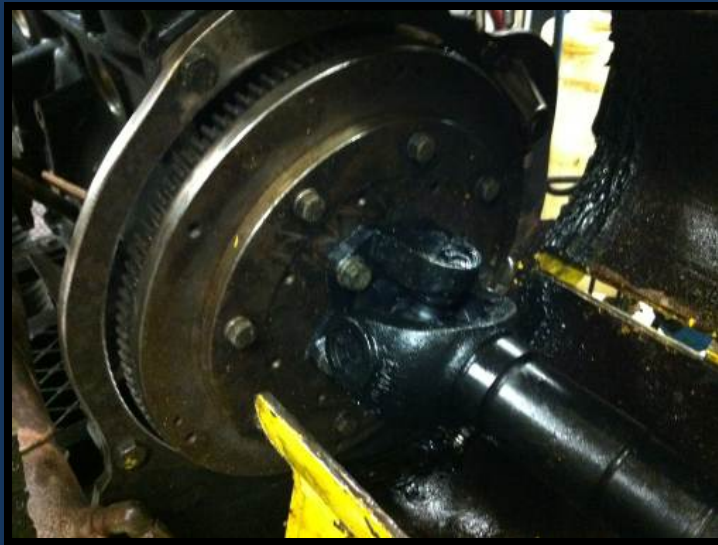
Flywheel

120 teeth  
0.0524 rad/tooth

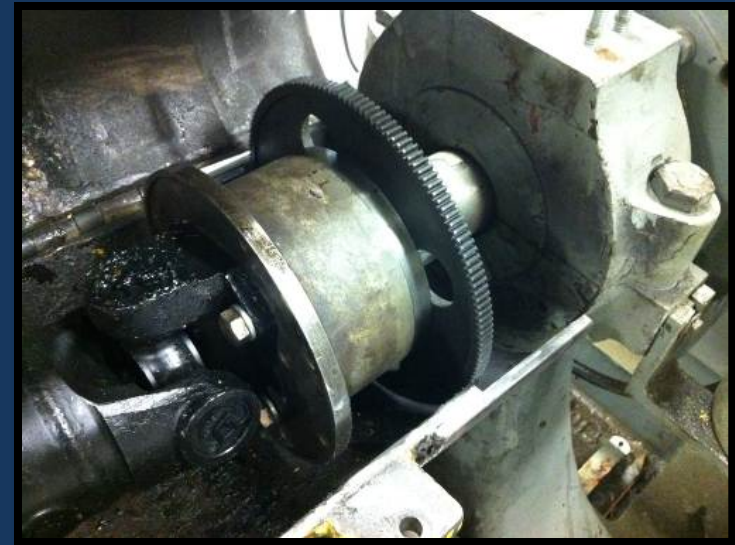
Dyno-Side Gear

160 teeth  
0.0393 rad/tooth

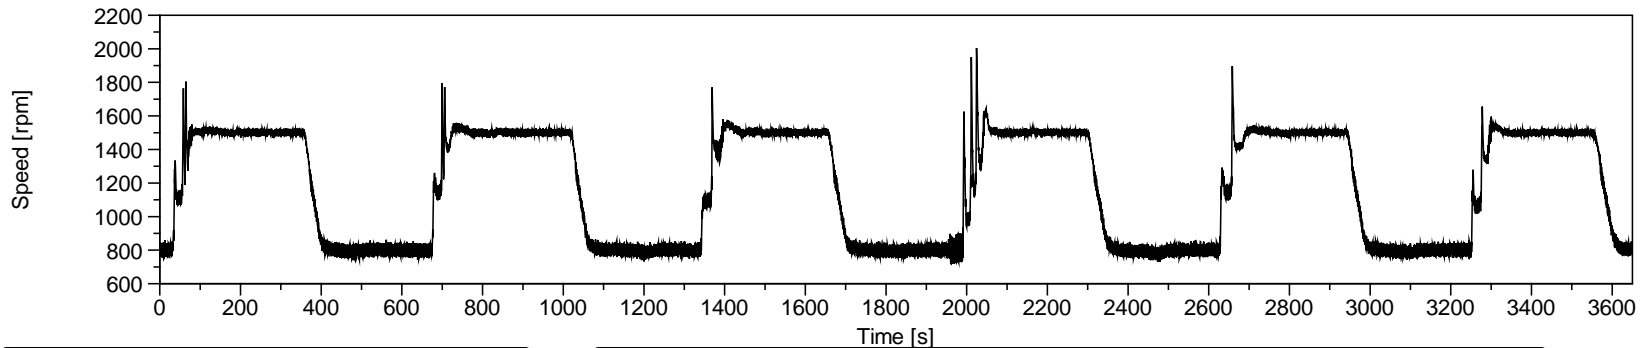
Speed vs. time, shaft 1, data recorded 1/11/13

Flywheel Speed

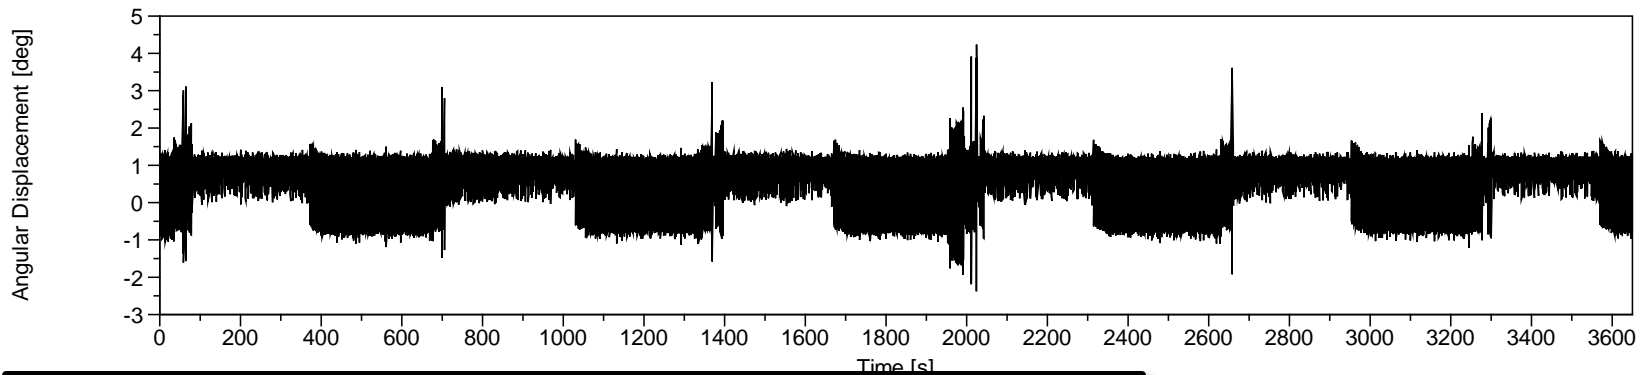
Shaft windup vs. time, shaft 1, data recorded 1/11/13

Flywheel Speed – Dynamometer Hub Speed

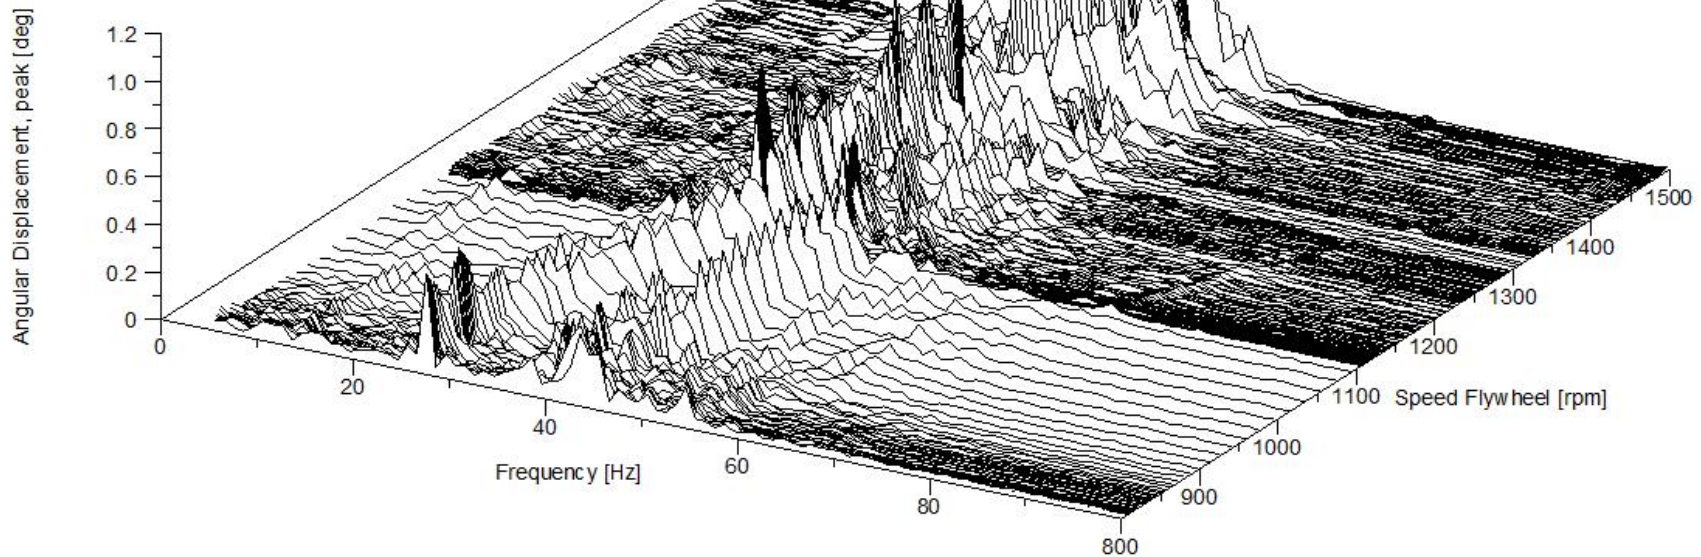
Wind-up of the shaft, shaft 1, first increasing ramp, data recorded 1/11/13
