**Committee D02 on PETROLEUM PRODUCTS AND LUBRICANTS**

Unapproved Minutes of the January 24, 2013  
Sequence IV Surveillance Panel Meeting held in San Antonio, TX.

# **DRIVELINE EFFECTS ON DYNAMIC TORSIONAL VIBRATION ON SEQUENCE IVA ENGINE STAND**

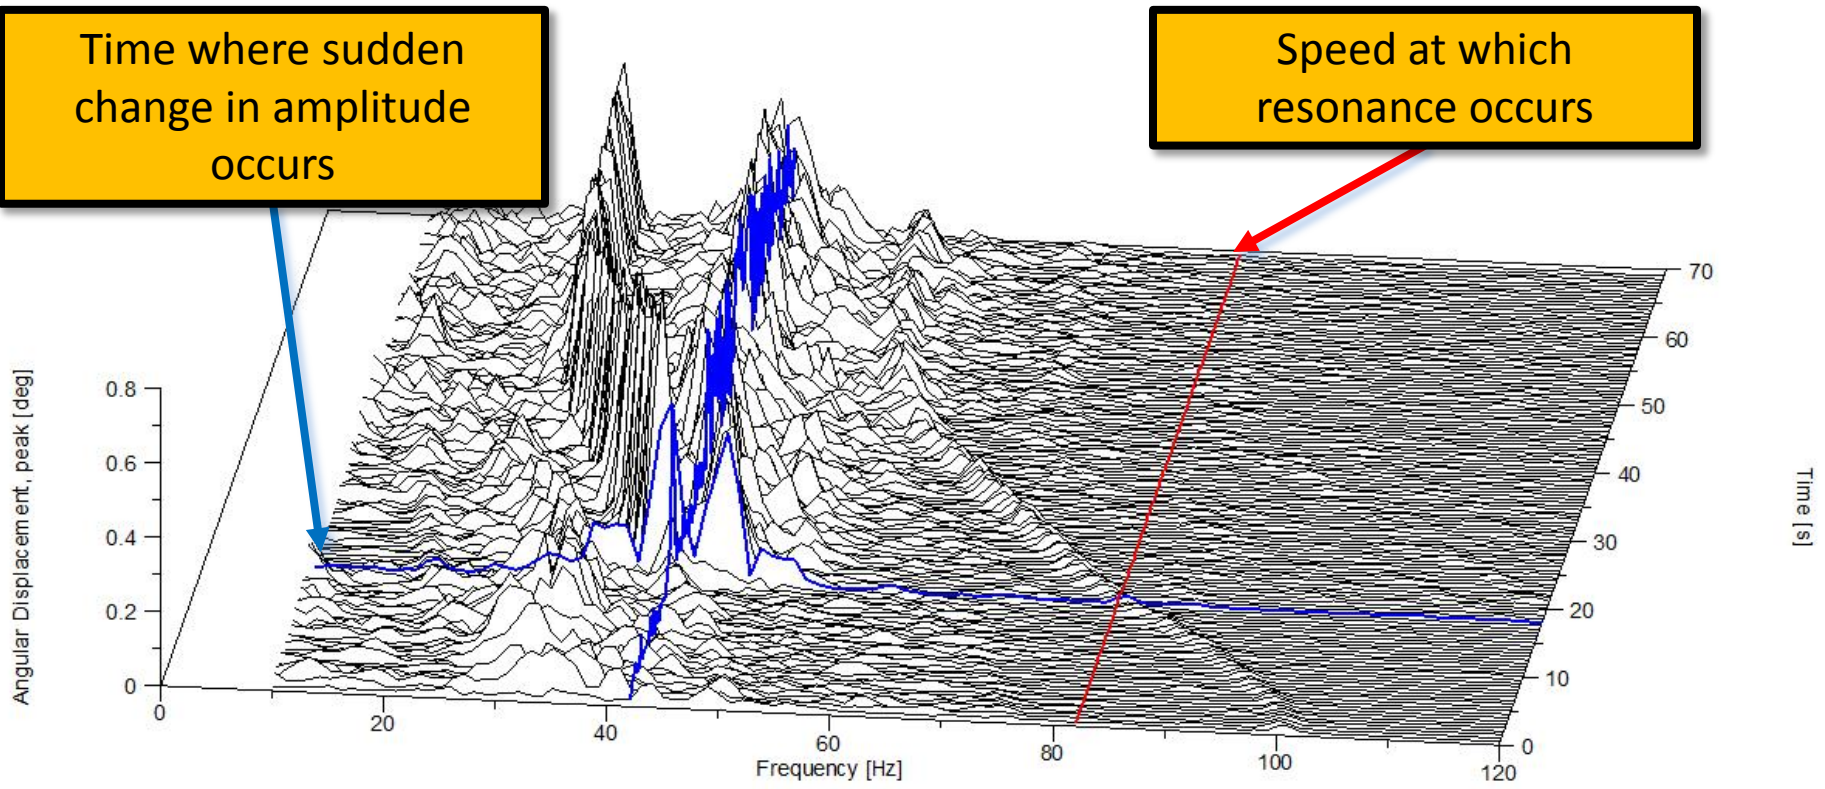
Windup of shaft 1 during 1st decreasing speed ramp, data recorded 1/15/13

Time where sudden change in amplitude occurs

Speed at which resonance occurs

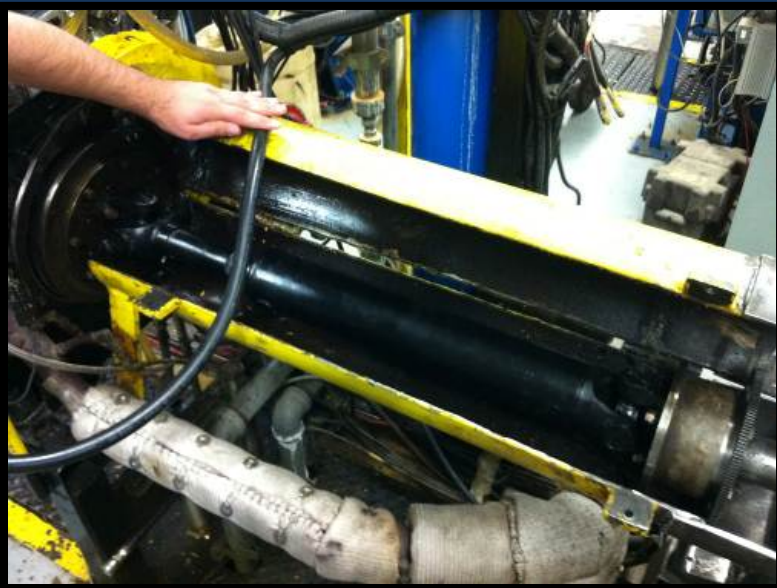
**Solid Shaft**

- To quantify differences in torsional vibration dynamics in the engine test stand system between drivelines of different stiffnesses

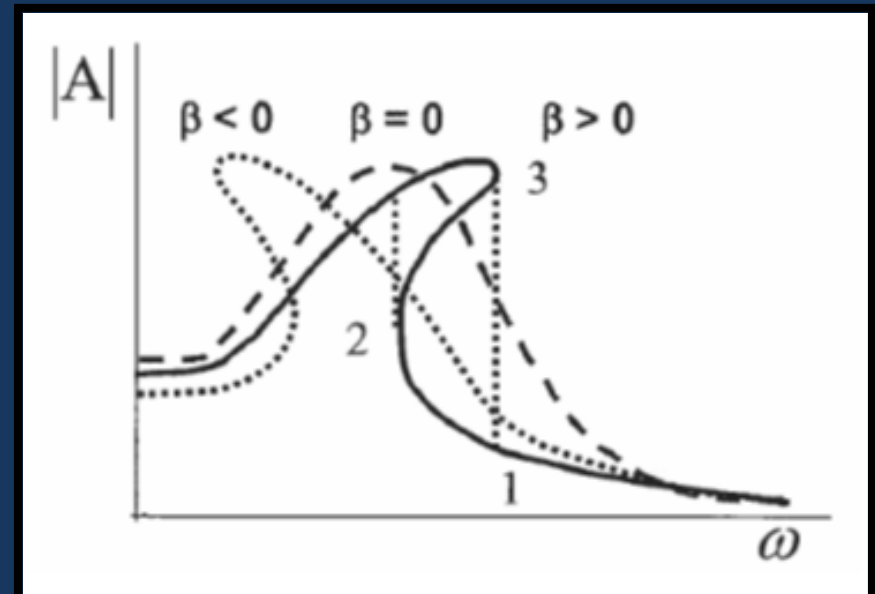
- Duffing equation
  - $m\ddot{x} + c\dot{x} + \alpha x + \beta x^3 = F\cos\omega t$
  - $\beta = 0$ , linear spring
  - $\beta > 0$ , hardening spring
  - $\beta < 0$ , softening spring

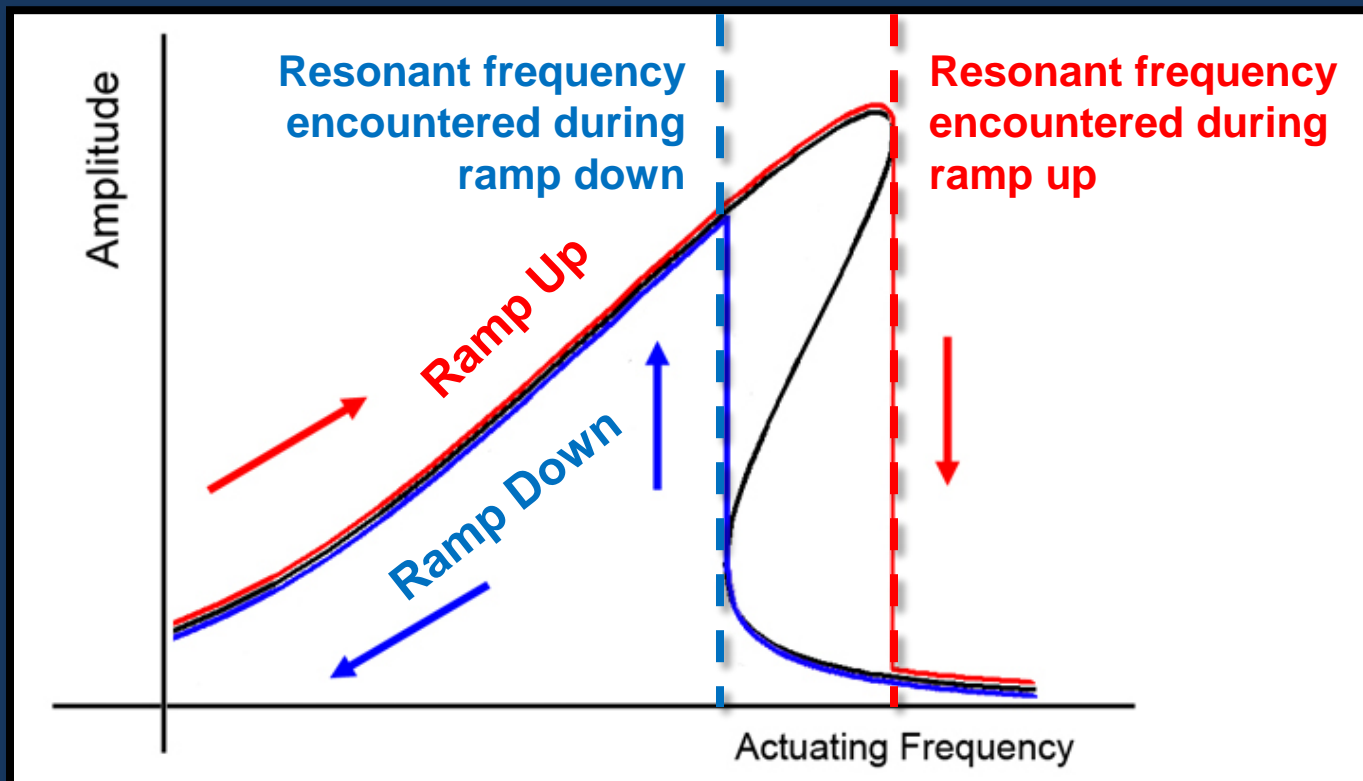
- Driveshaft vibration responses resemble hardening spring ( $\beta > 0$ )

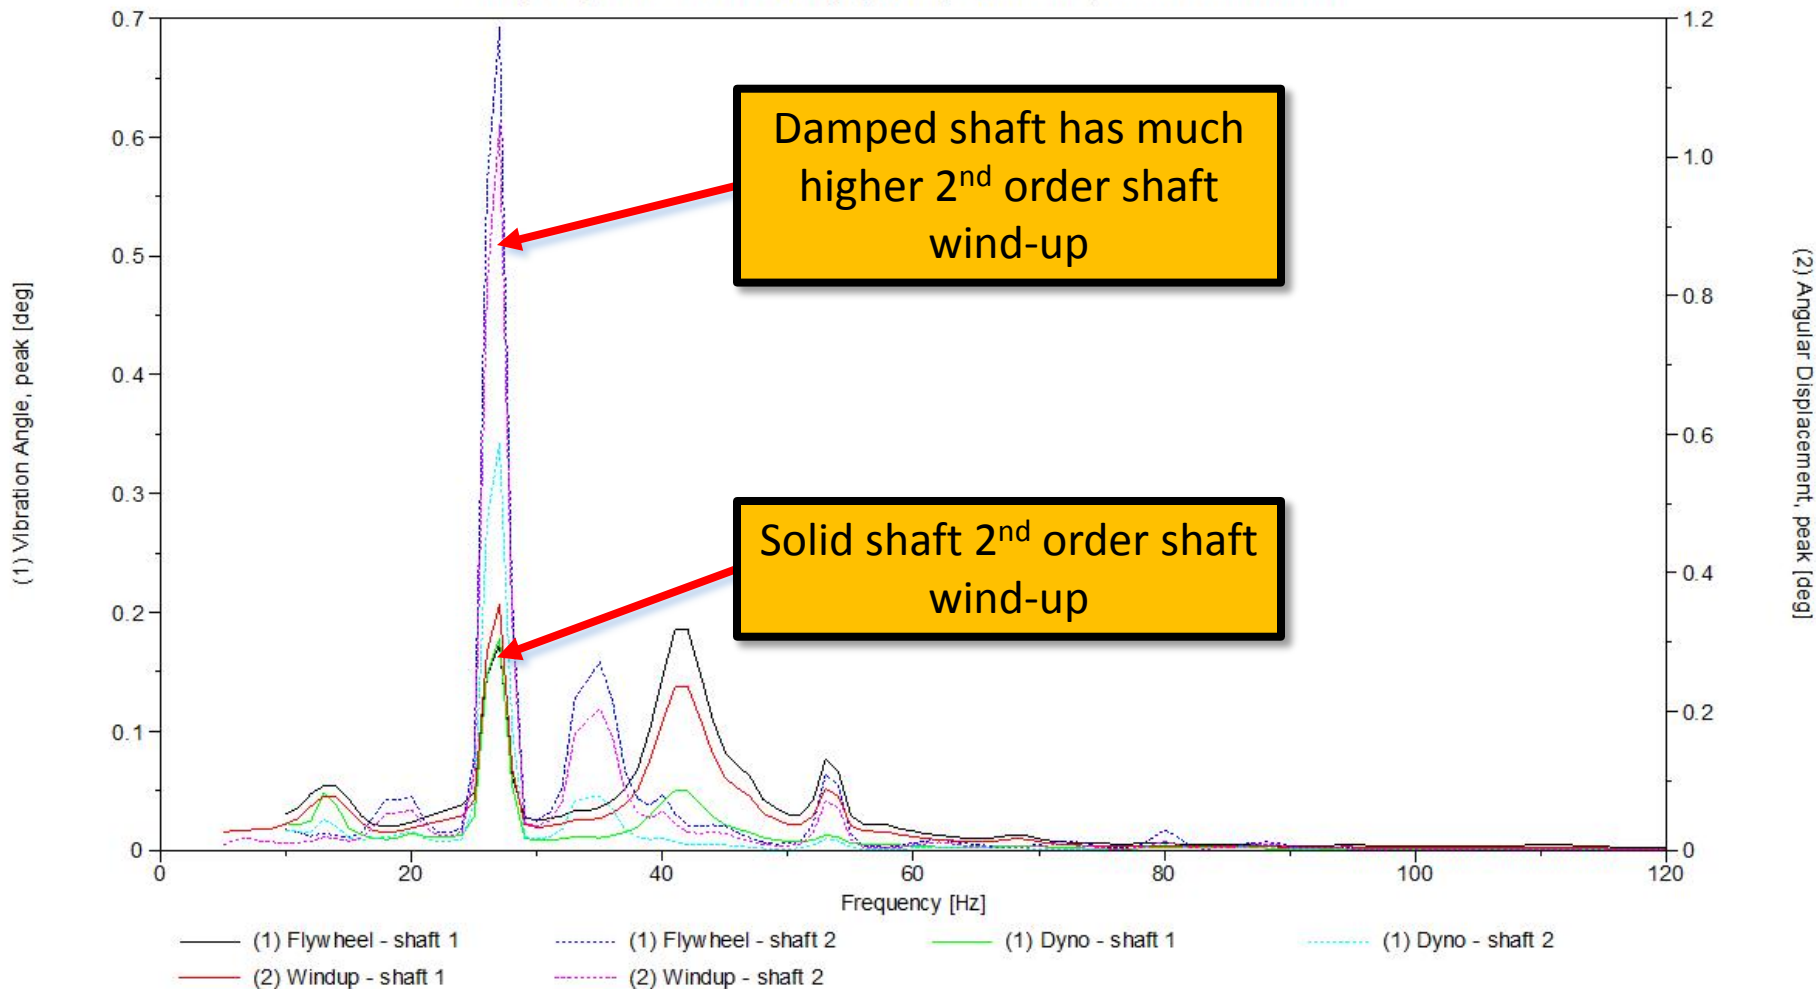
Comparing shafts 1 & 2 at 800 rpm, average over 100 s, data recorded 1/11/13

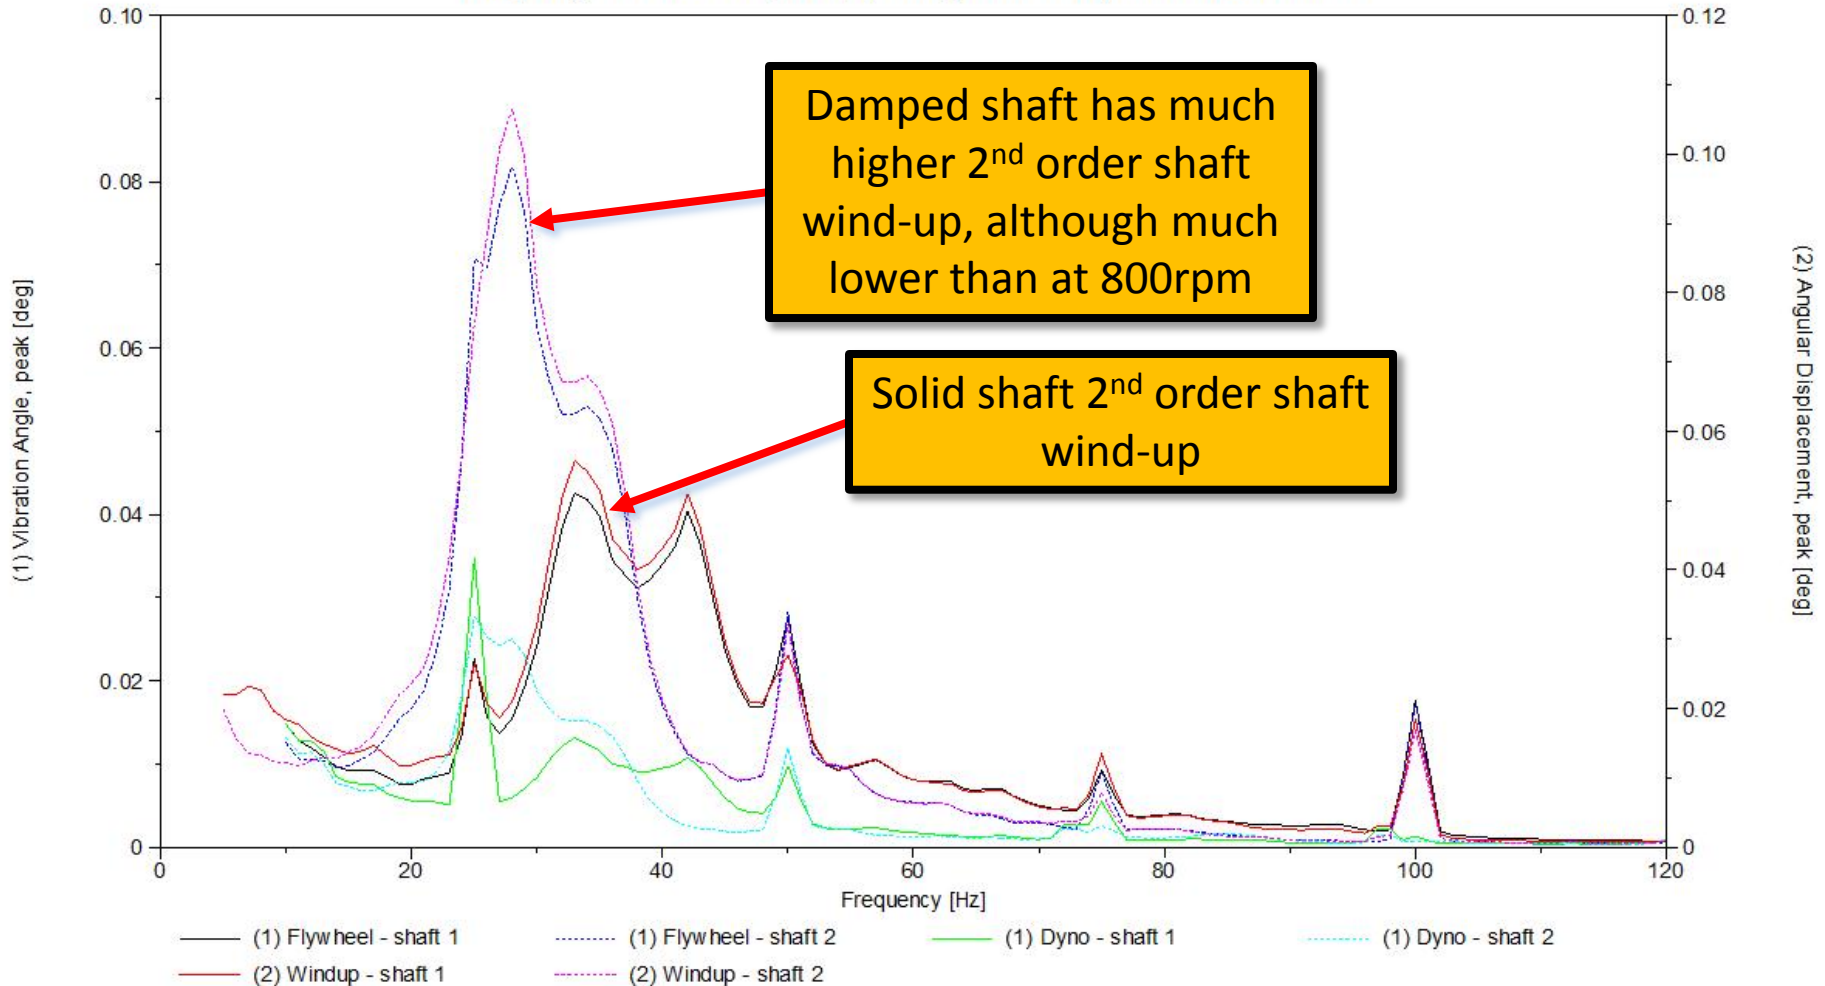
Comparing shafts 1 & 2 at 1,500 rpm, average over 100 s, data recorded 1/11/13

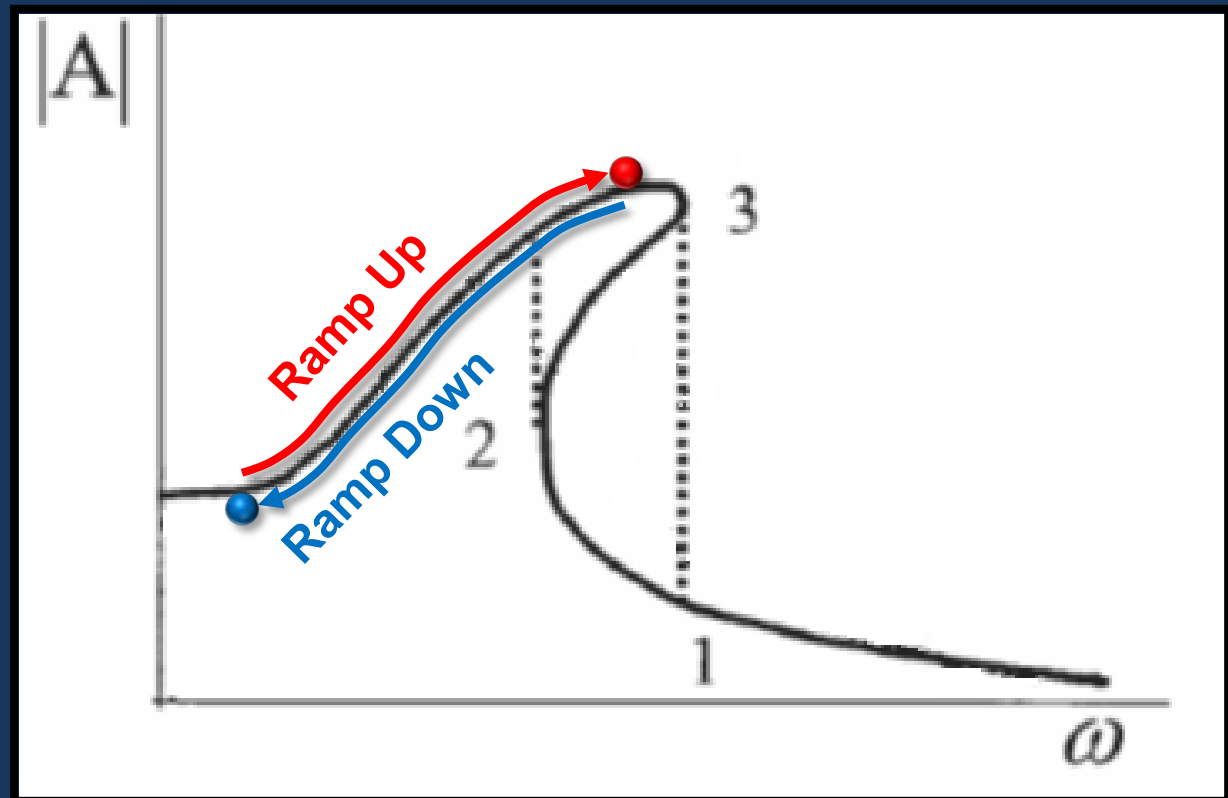
- Excitation frequency did not exceed natural frequency during ramp up (point 3)
- No Jump

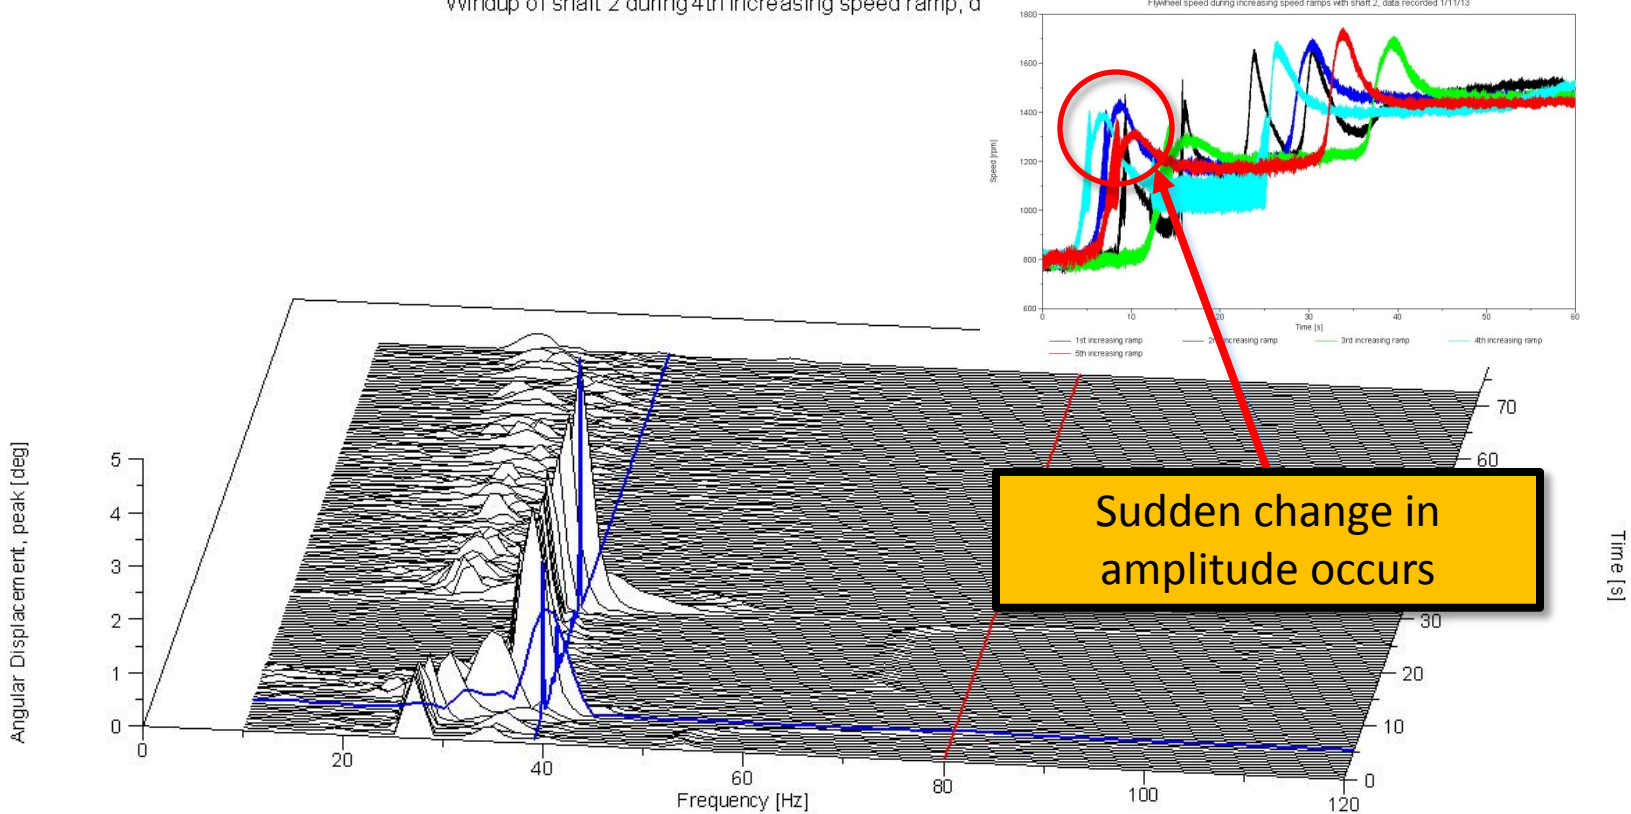
Windup of shaft 2 during 4th increasing speed ramp, d

Resonant speed = 80Hz = 1200rpm

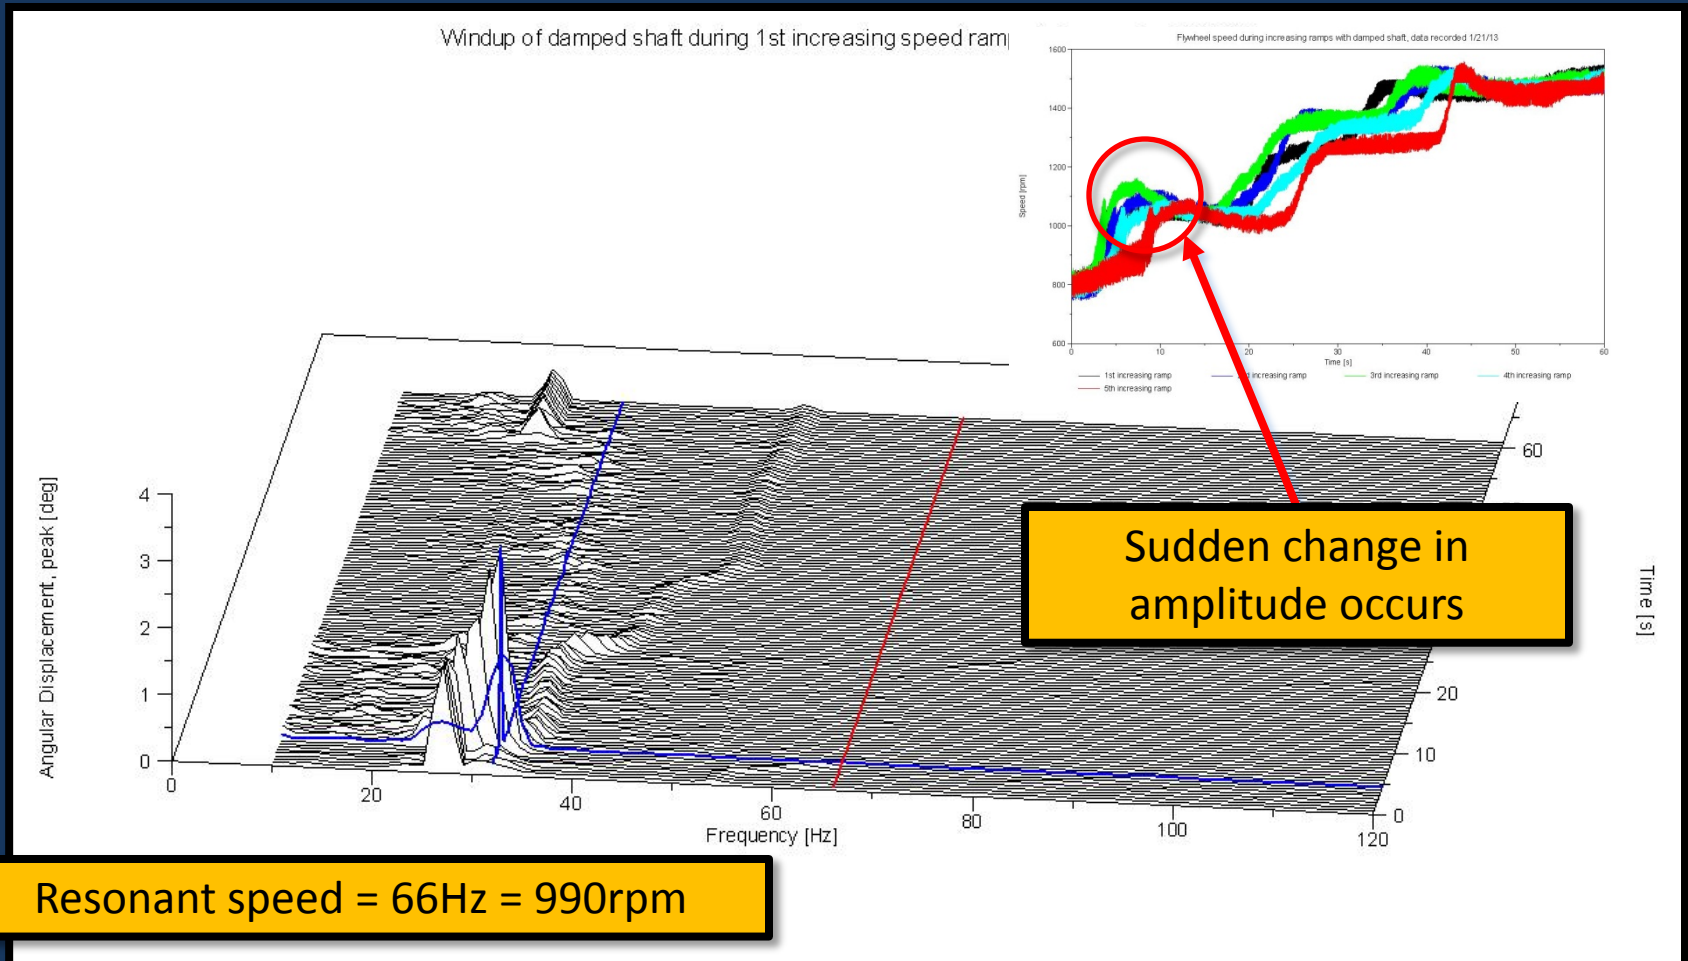
- 20.5" (Short) Damped Shaft

- Natural frequency shifted lower in short driveshaft
- Not expected according to stiffness equation
- Still shows driveshaft length has significant effect on vibrational response
