Sequence X Severity Task Force

Meeting Minutes

01/25/22

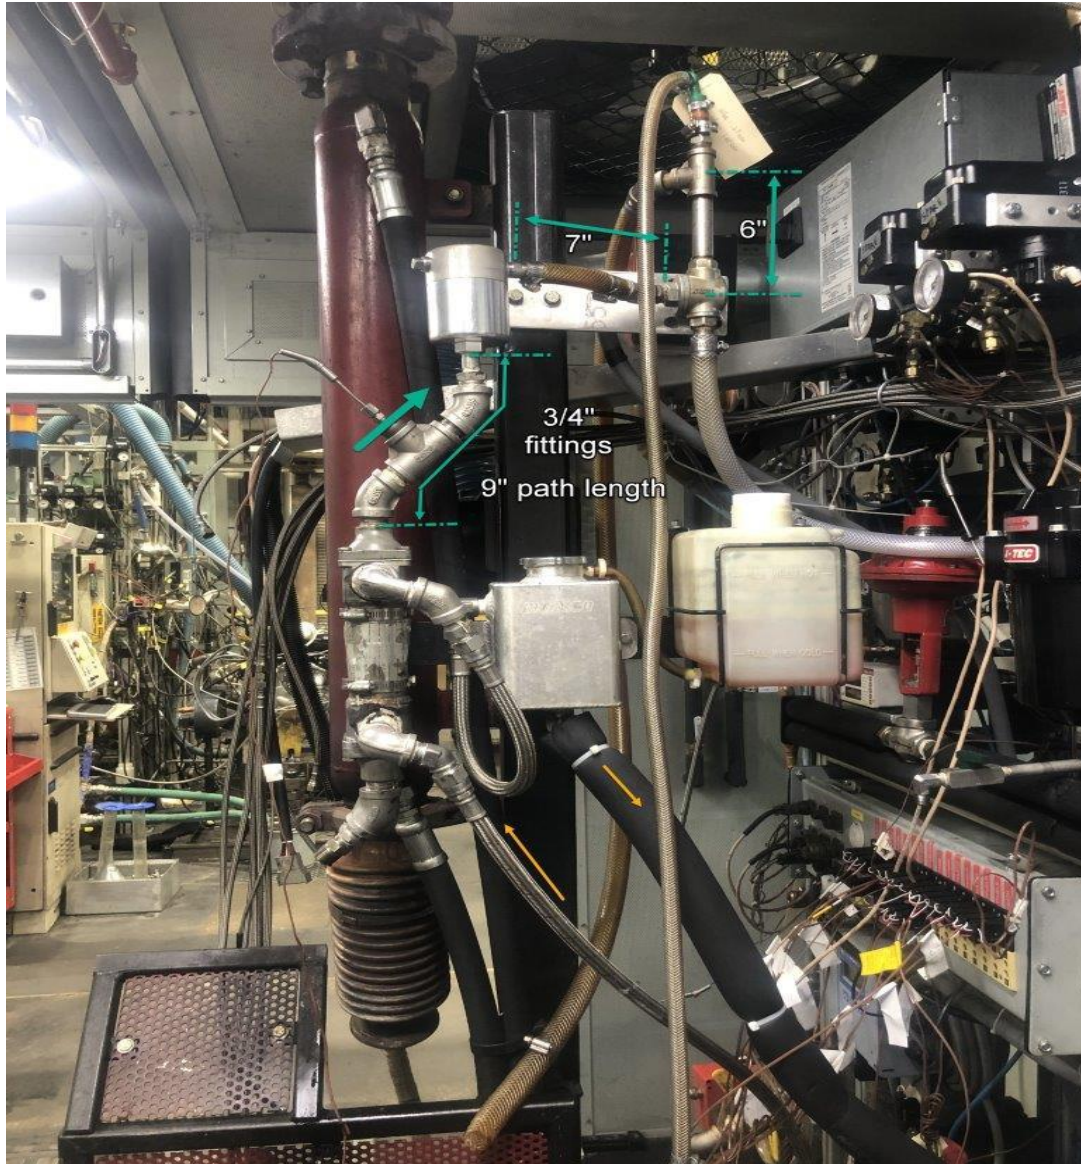
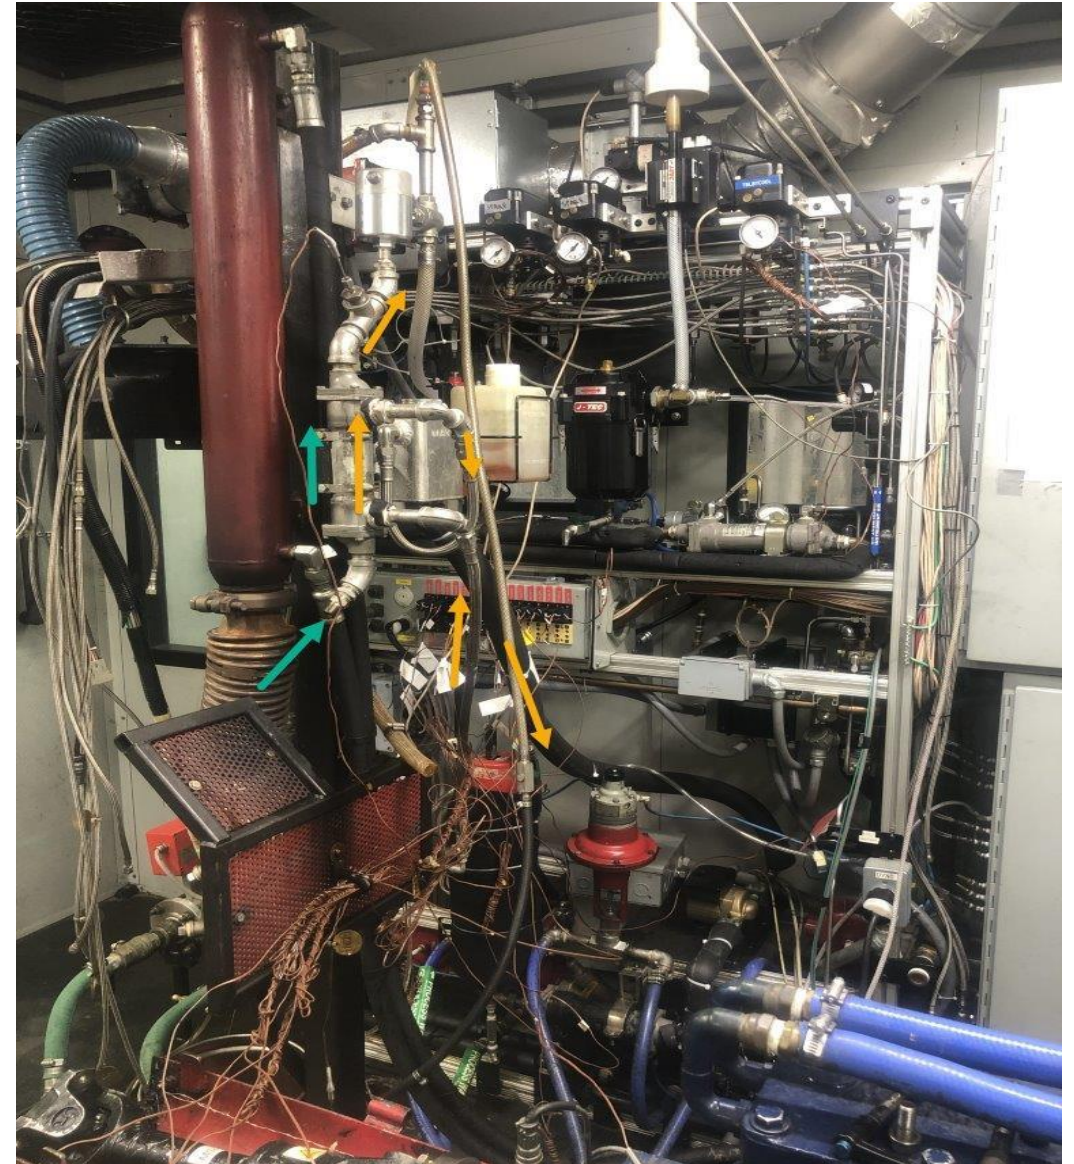
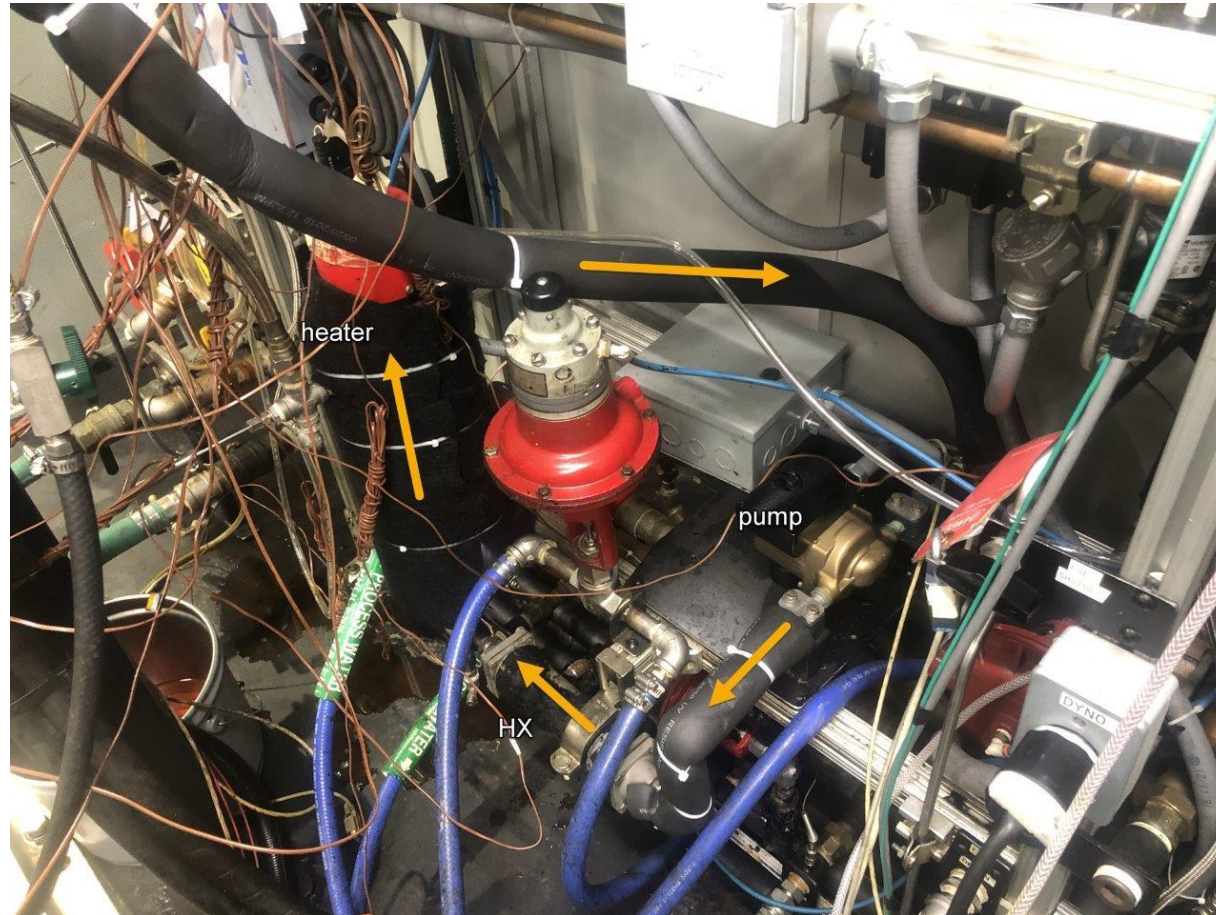
Photo Review LZ

- Photographs of LZ were presented. (See slides below)
 - LZ photo of the blow by stack shows the 45 degree elbows and total length. LZ and Valvoline have this configuration. There was discussion of increased baffling and drain back with the 45 degree elbows. The concern of thermocouple positioning and condensation effects were discussed. With the intent to communize all stands an action item was made for George to change his stack plumbing and install a “y” pipe fitting to eliminate the fittings. This y fitting should eliminate the condensation issue. If successful, all labs to adopt. George will install on his next reference.
 - The LZ coolant flow in the heat exchanger is in parallel flow.

- The BB stand plumbing between the heat exchanger and the oil separator between labs needs to be standardized. Action item for George to install the y pipe and collect data on his next reference.
- The BB stack plumbing after the oil separator is not specified in the procedure. There are lab differences that need to be addressed.
- Afton yet to present stand photos

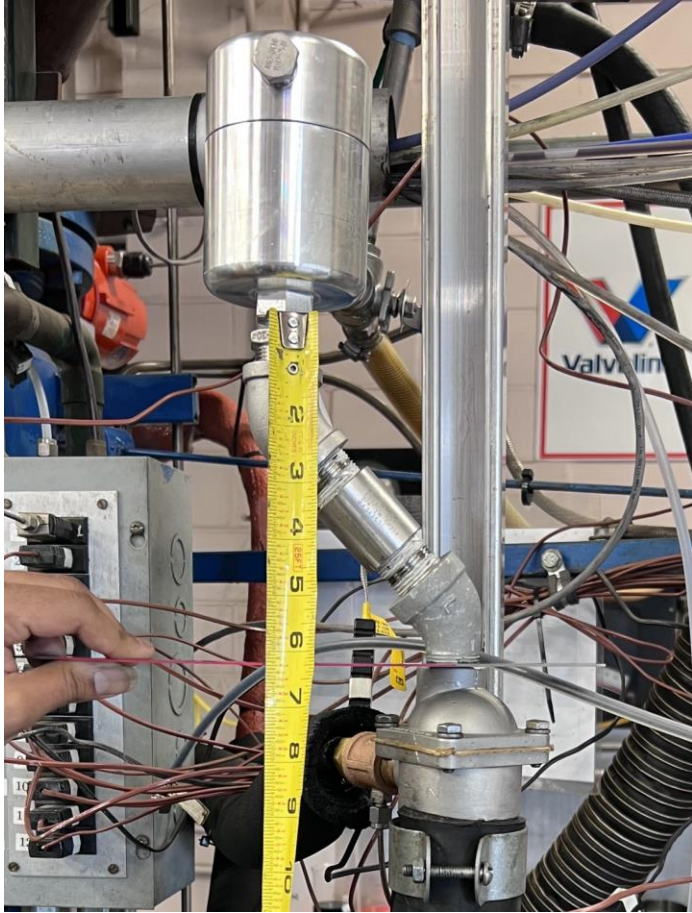
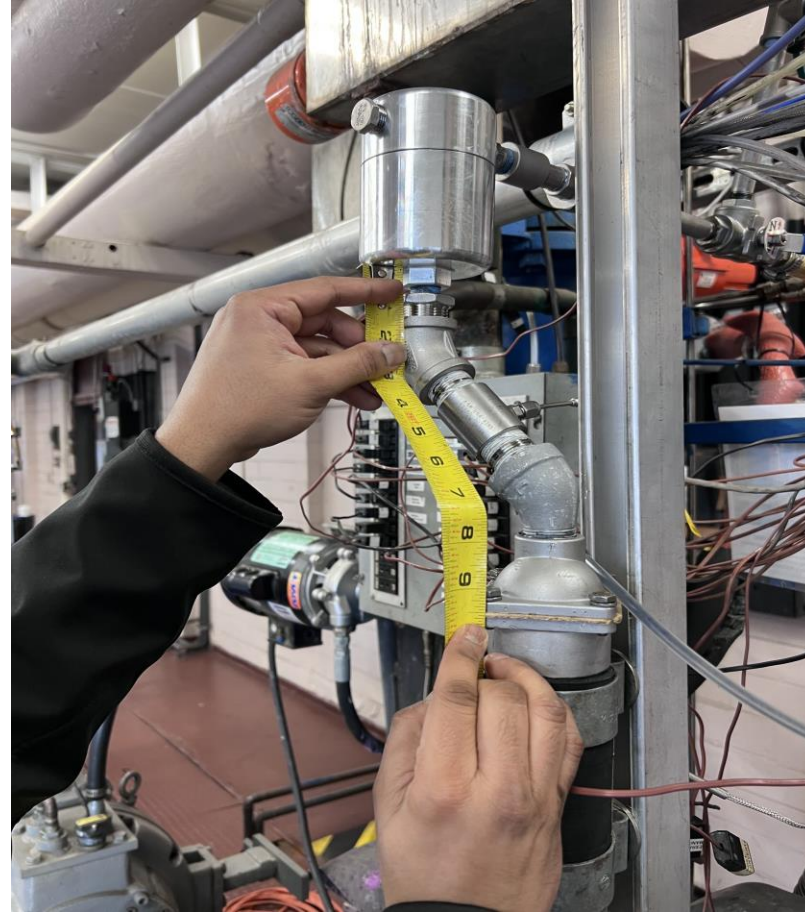
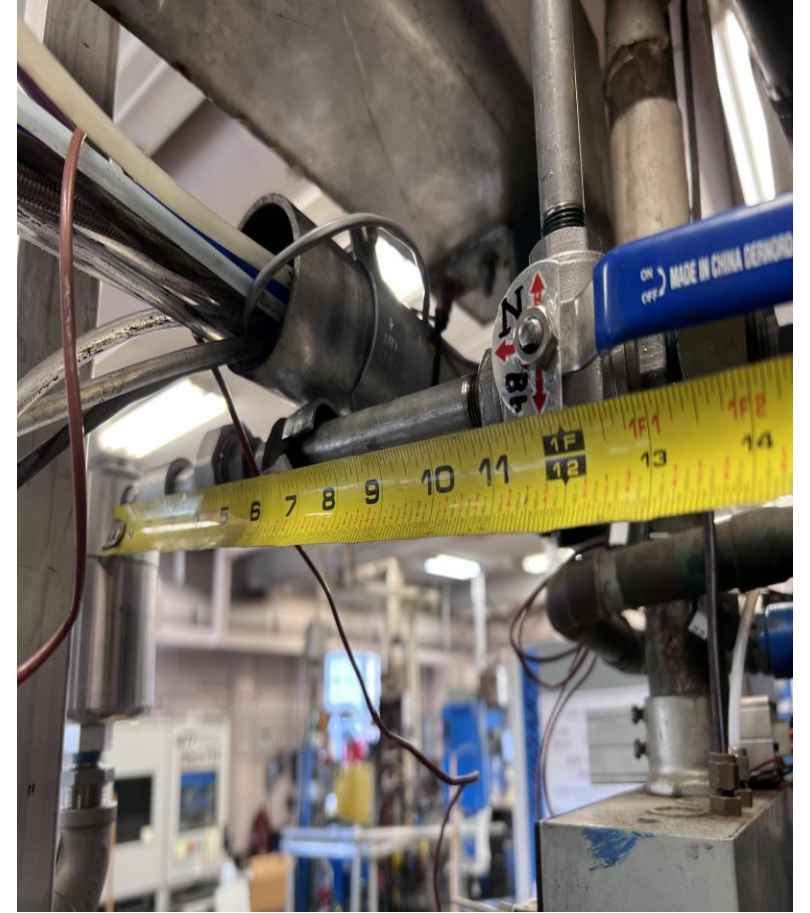
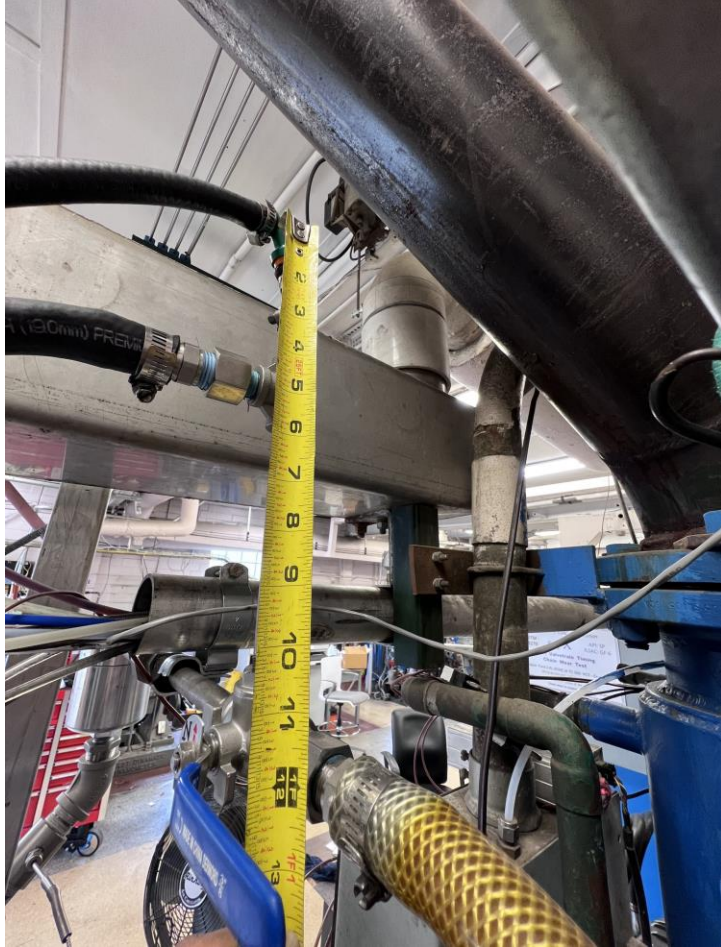
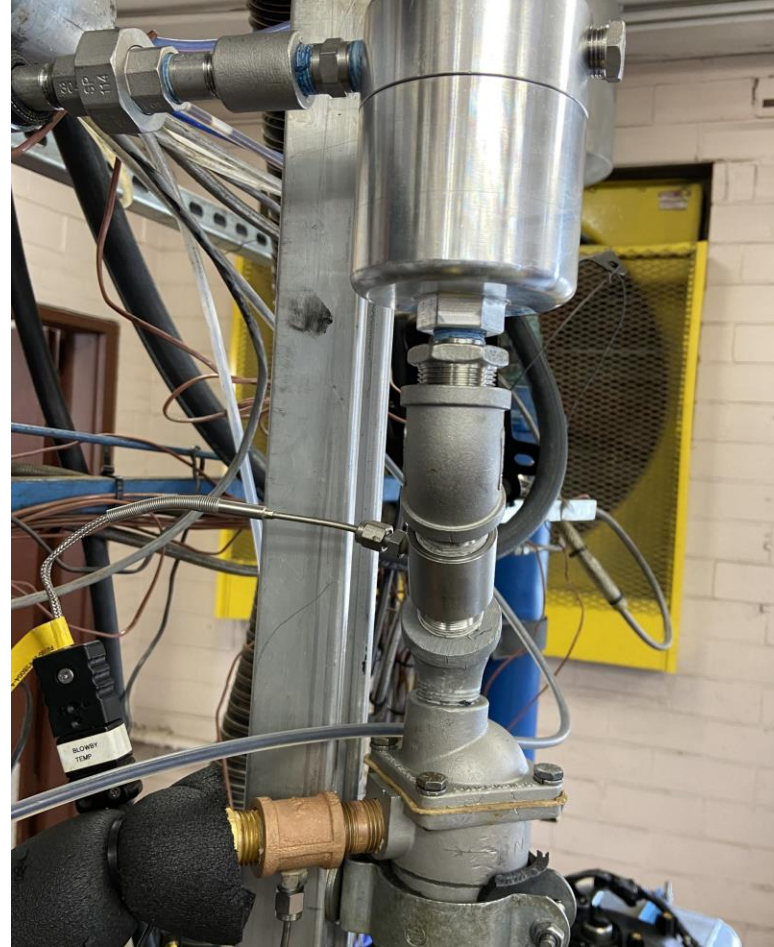
Photo Review - Valvoline

- Photographs of the Valvoline stand were presented (See slides below)
 - This configuration uses the 45 degree elbows and similar in length to the oil separator to the LZ stand
 - The biggest difference seen in these pics is the length of tubing from the oil separator to the PCV valve. There are no length limits or descriptions in the procedure. No discussion was made to communicate this portion of the blowby stack. There are stand configuration constraints at Valvoline that forced them to assemble the stack in this configuration.
 - Coolant through the BB heat exchanger is in counterflow direction.

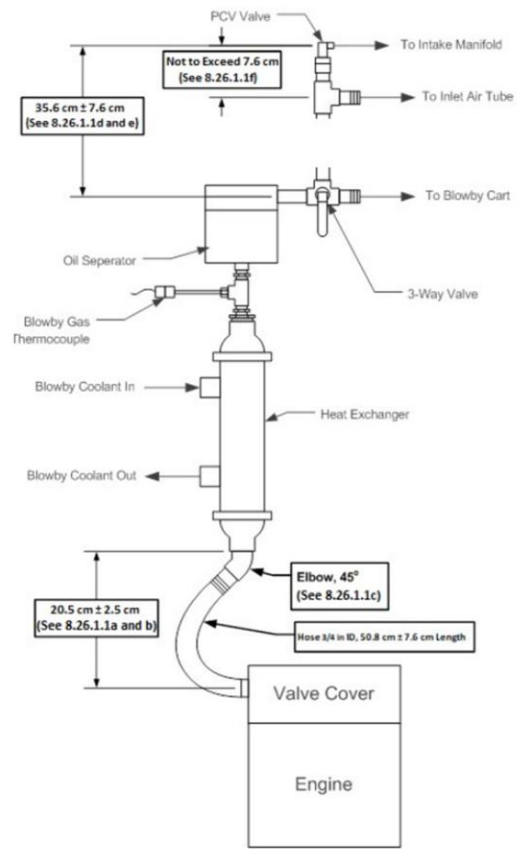
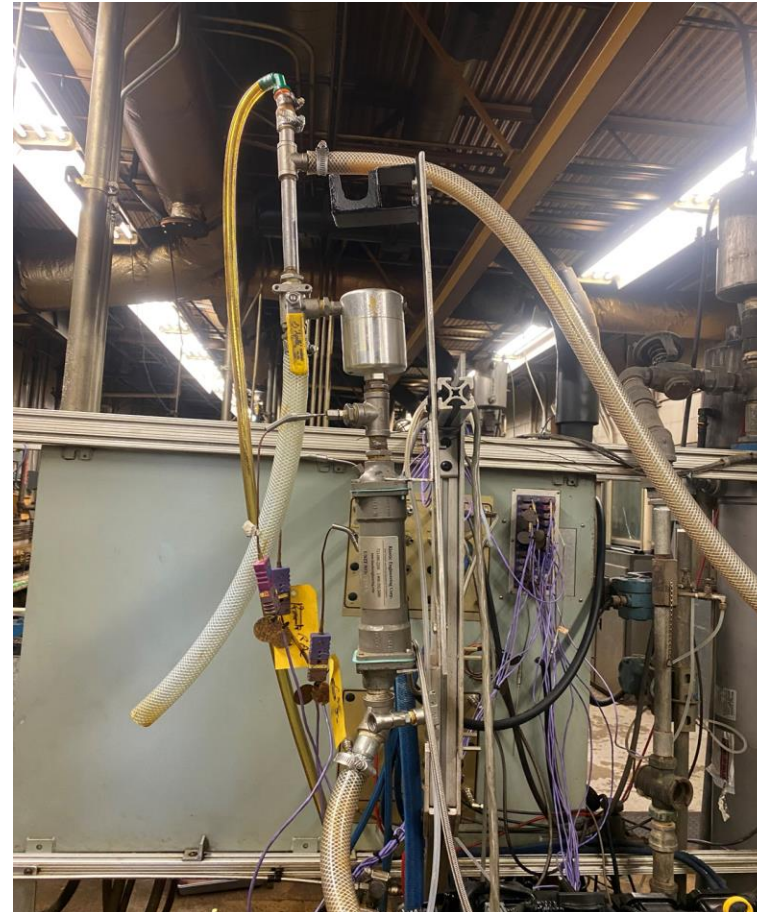
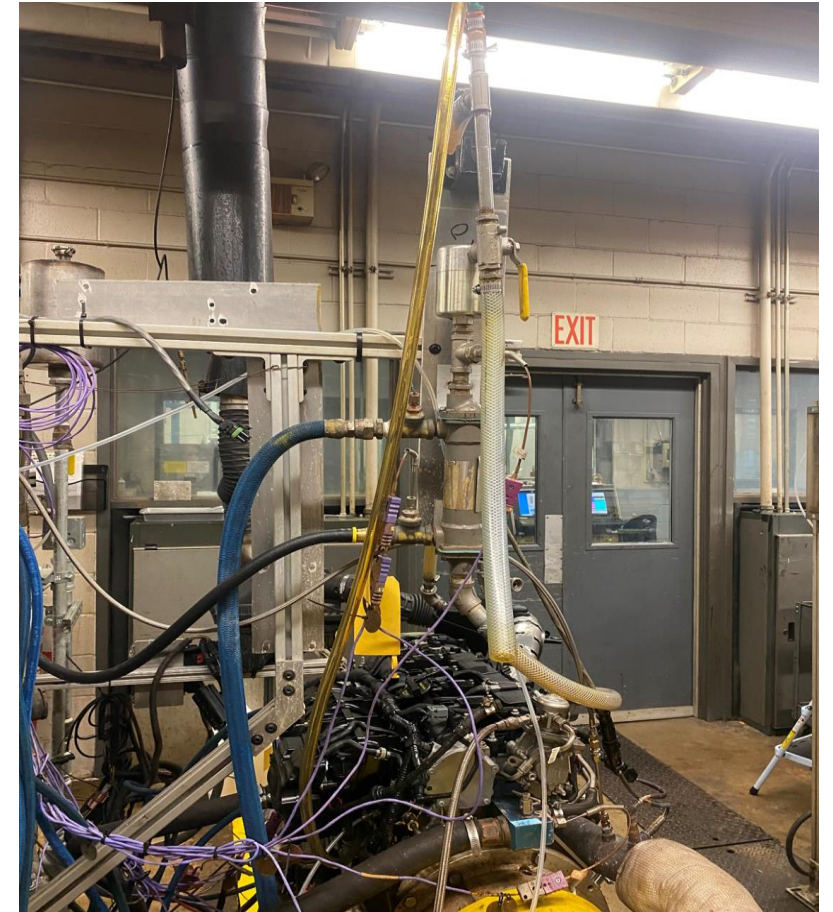
Photo Review - SWRI

- A drawing and photographs of the SWRI stand were presented (see slides below).
- The configuration is similar to Intertek.
- Coolant flow in the BB heat exchanger is in counterflow configuration.

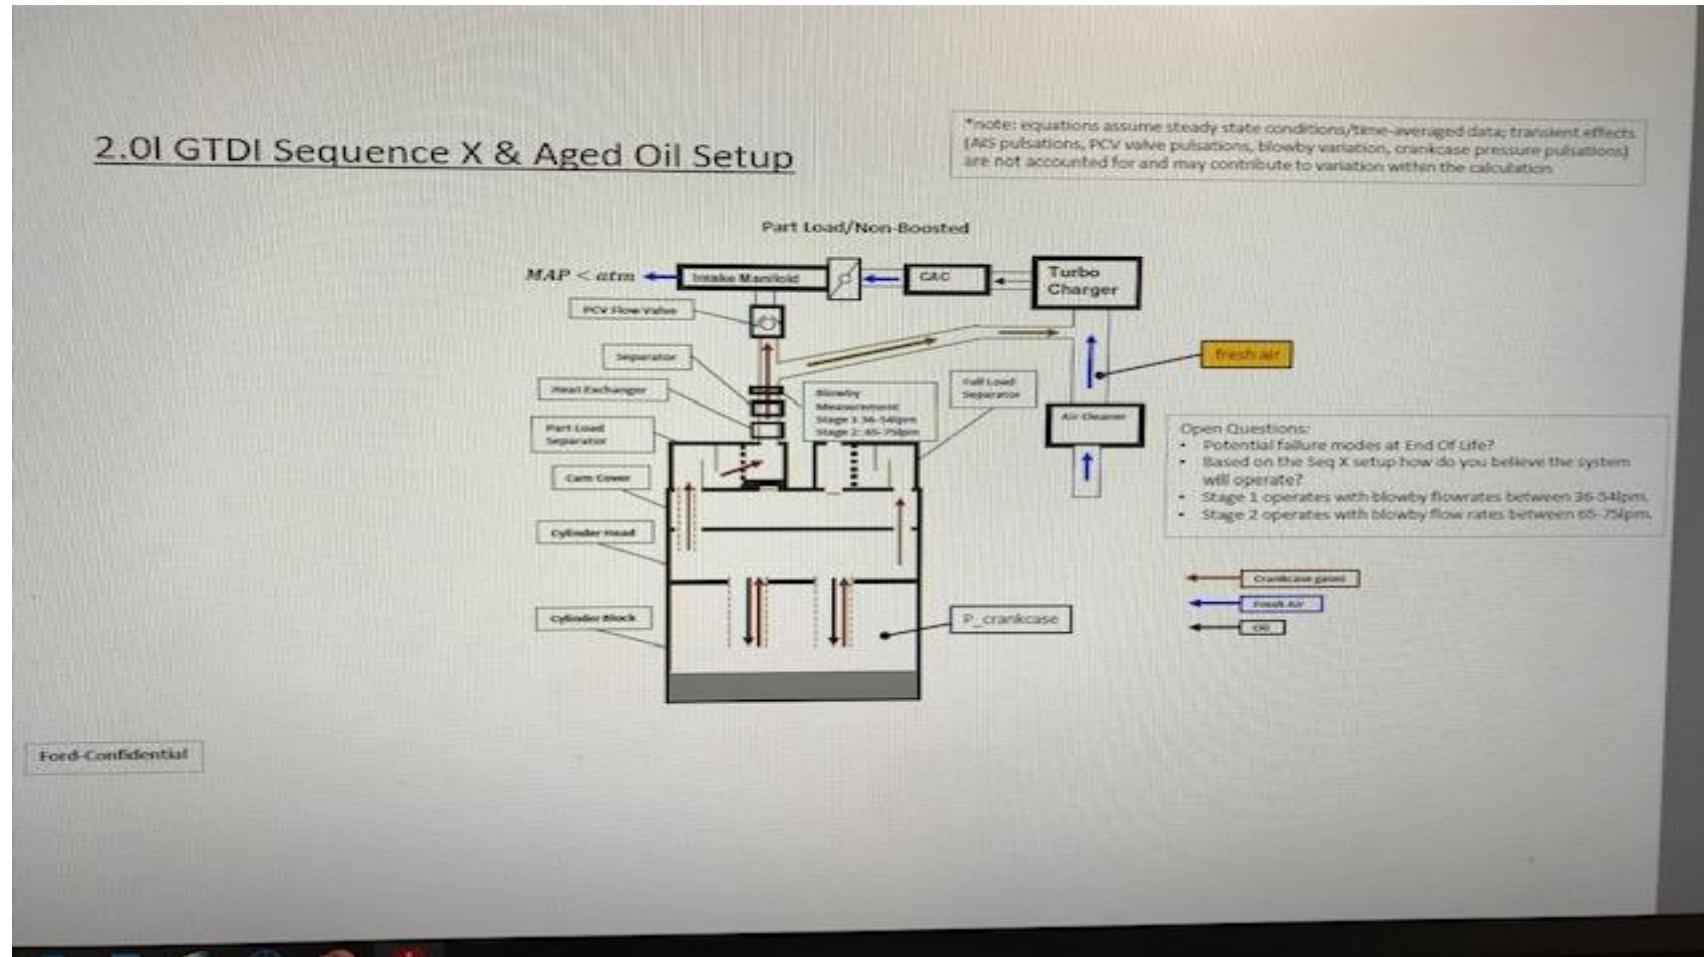
FIG. 4 Crankcase Ventilation System and Blowby Conditioning Critical Dimensions

- A concern was raised that during second stage there may be some amount of boost pressure that closes the PCV valve. At that point, all blowby gas flow would flow through the leg of the system going to the air tube downstream of the air filter box. See crankcase ventilation schematic below.
- An action item was made to study and compare the boost pressure from CAN data of the precision matrix to current tests.
- The flow distribution between the two legs of the crankcase ventilation system was never studied or measured during test development. Knowing the max flow rate of the PCV valve and the limits of manifold pressure to close the valve, we are now realizing that the flow characteristics may be different across labs and stands.

Chain Wear Engine Crankcase Ventilation
