# Sequence X Severity Task Force

Meeting Minutes

07/29/21 and 08/04/21

# Seq X crankcase experiment

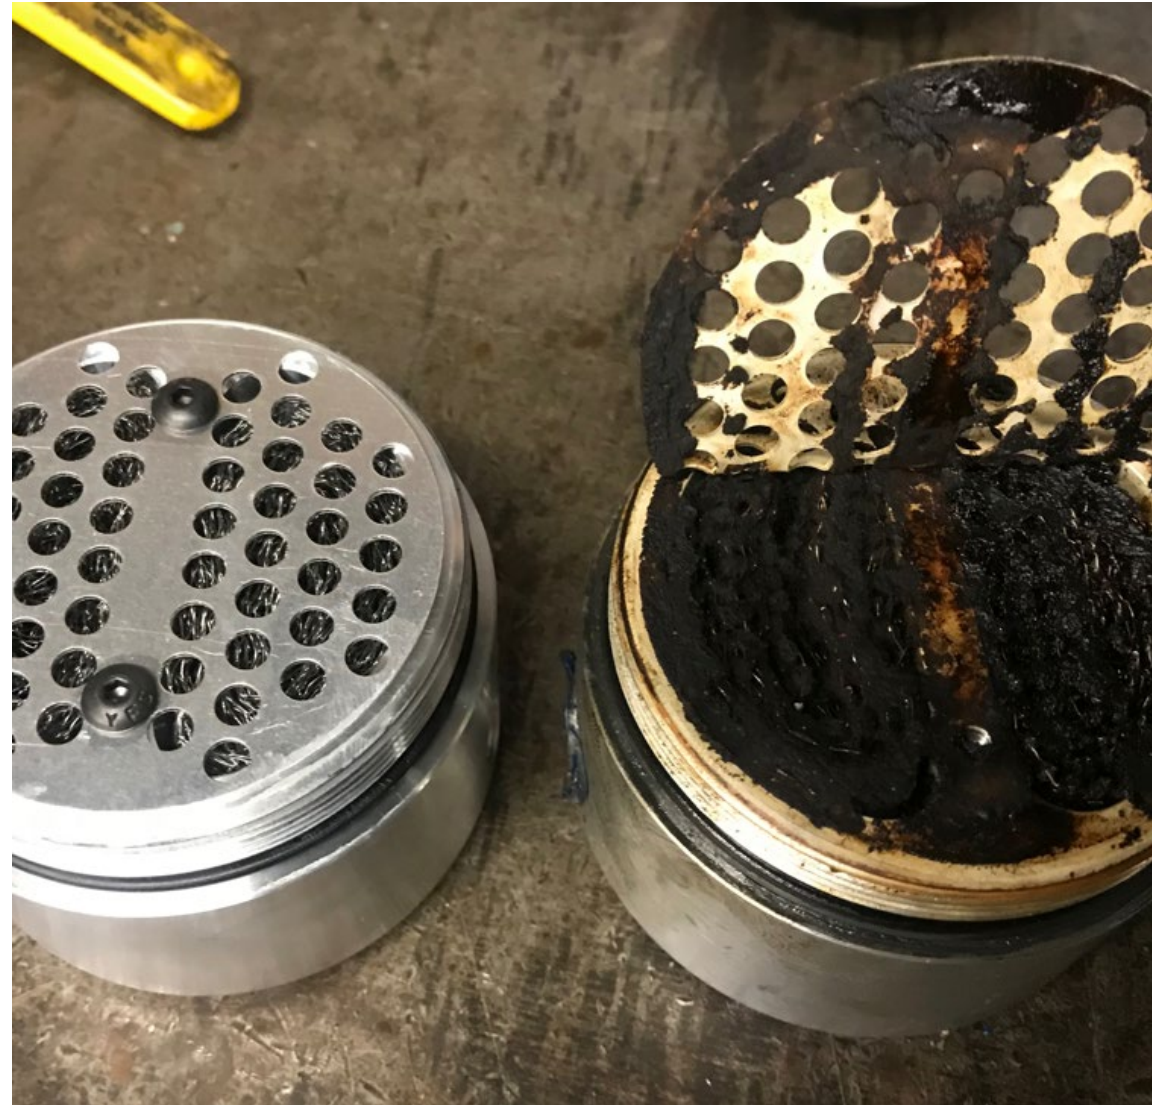
# Crankcase restriction

- Blowby system was being cleaned with a flush cart.
- 07//2018- we tripped a high crankcase alarm. We found that the high crankcase was being caused by the clogged oil separator filter.
- Most of the oil was found in the intercooler.

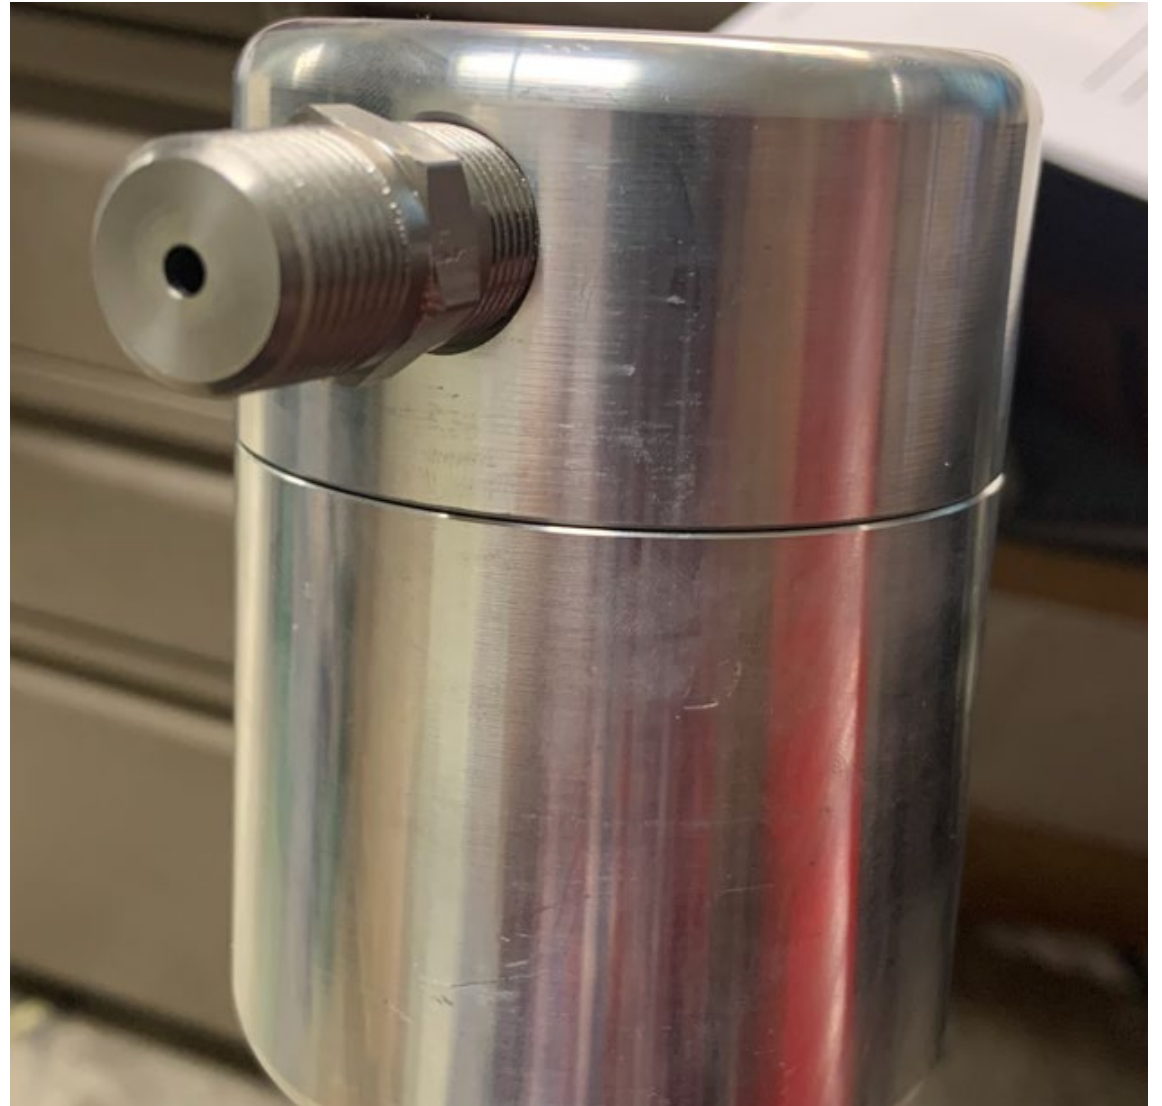
# Crankcase orifice

- A 15/64" orifice was added to the outlet of the oil separator in order to increase crankcase pressure.

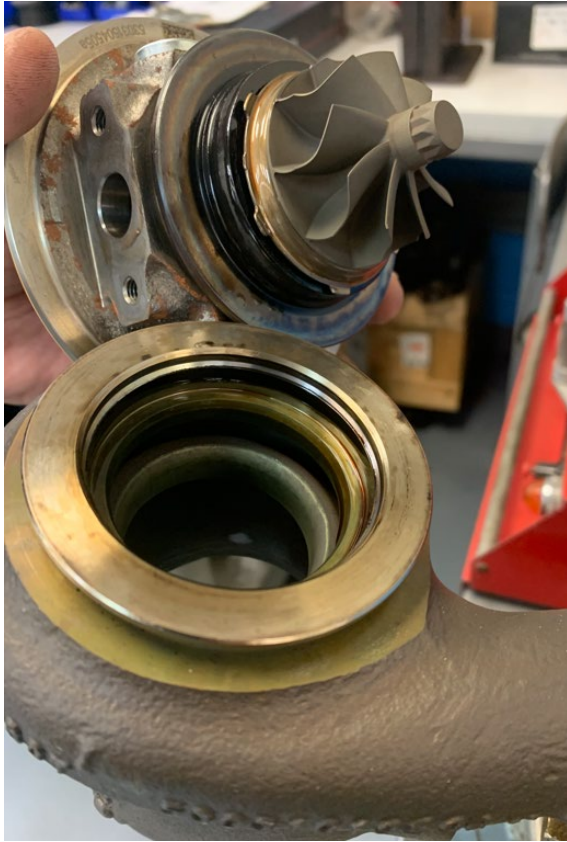
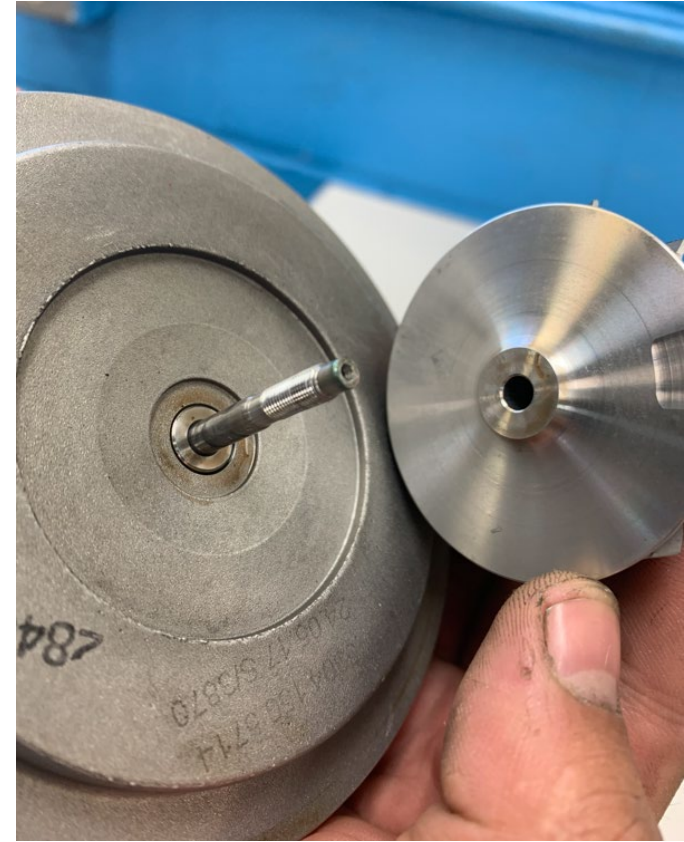
# Turbocharger Oil Drain

Engine oil under pressure enters the bearing housing of the impeller shaft from the oil inlet side. This oil passes bearing and the wheel journal surfaces lubricating and cooling the moving components. Here it depressurize and flows by gravity through the oil drain line and into the engine sump.

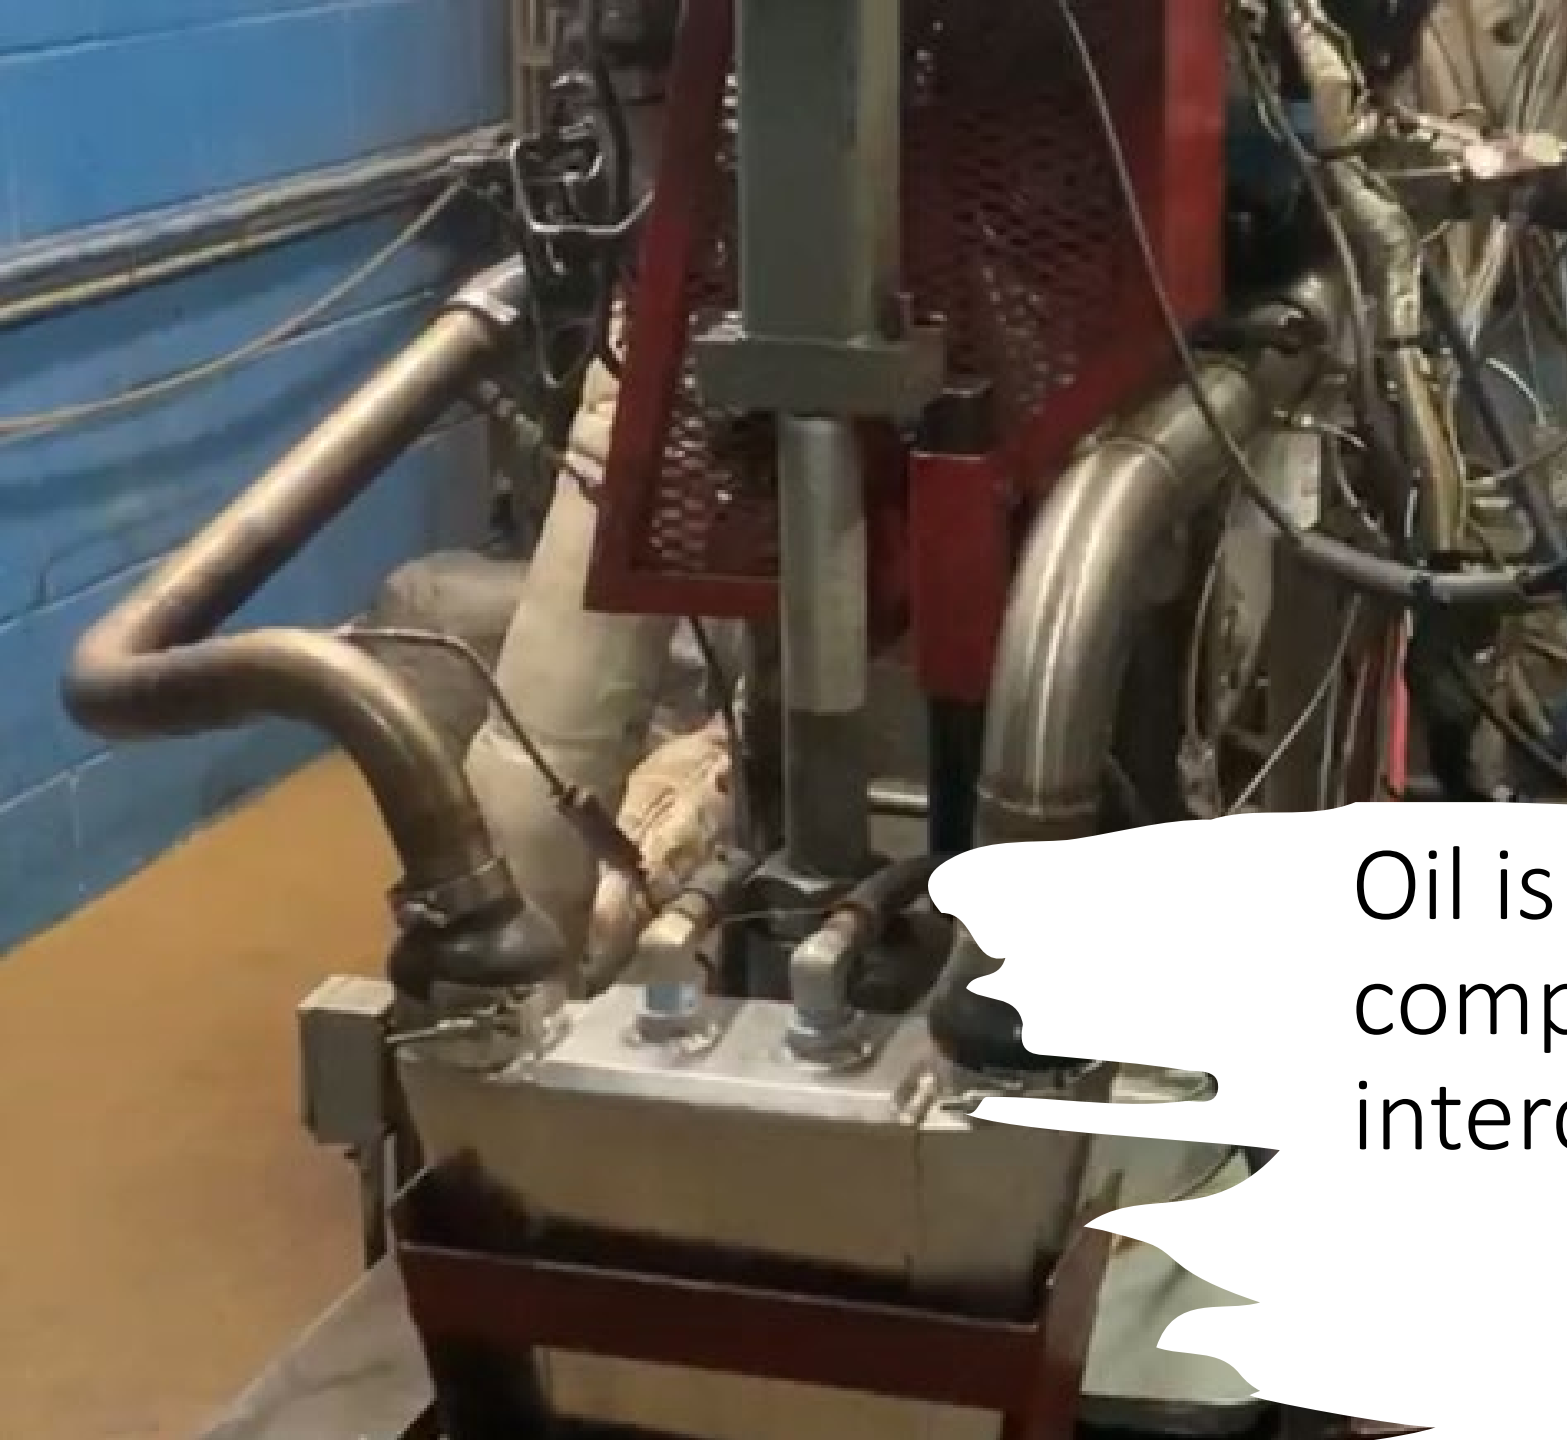
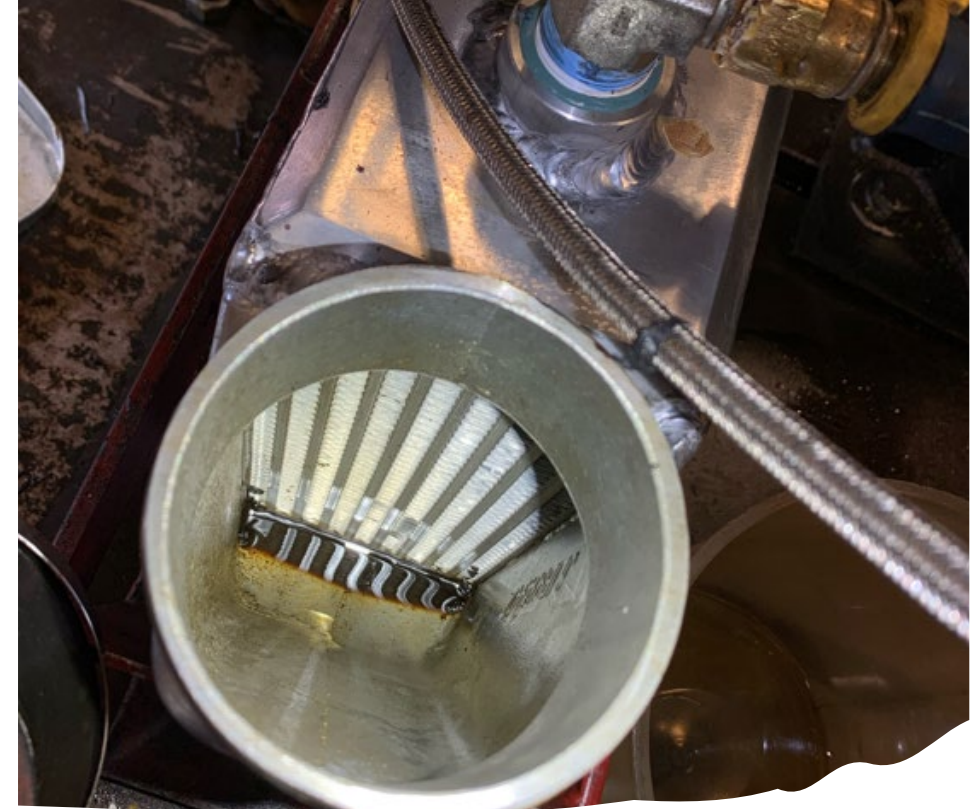
# Turbocharger oil seals

Oil is pushed out of the compressor side into the intercooler.

- The meeting continued with the 07/29/21 agenda
- Jason presented his findings and results of the BB orifice restrictor tests. See slides below.
- Jason has a suspicion that oil is being pushed through the turbo seals
- Oil consumption for the IAR tests has been very low and not at the level seen in the early years of test when IAR was on target.
- The orifice tests at IAR were mild of target for oil 271. IAR did not reproduce the test results seen at Valvoline. One main difference was oil consumption. Valvoline oil consumption was in the 1000 gm range. This level of oil consumption matches what IAR had in the past.
