L-37 Surveillance Panel Teleconference Minutes
Thursday 07/31/2008

P/N 060GA104 X
Model-60 Hypoid Drive Gear Set
ASTM Test Assemblies

Parco Lubrite-2 Coating:
Dana Coating Spec ES-PS-0506
Process Documentation

Henkel Technologies Analytical Services Report

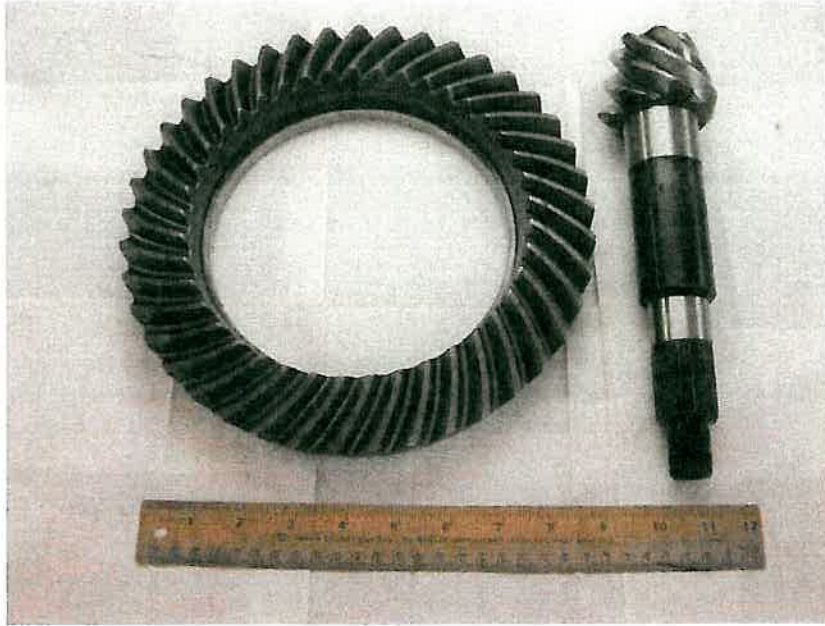
Dana Gear Sets, as received packaging.

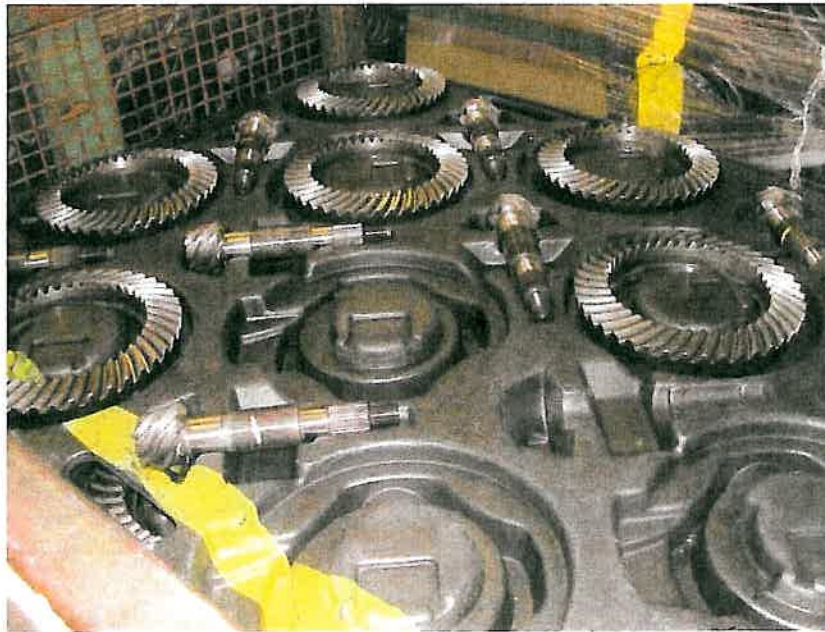
Custom Coating Inc, Gear Set Production Coating Basket Racking.

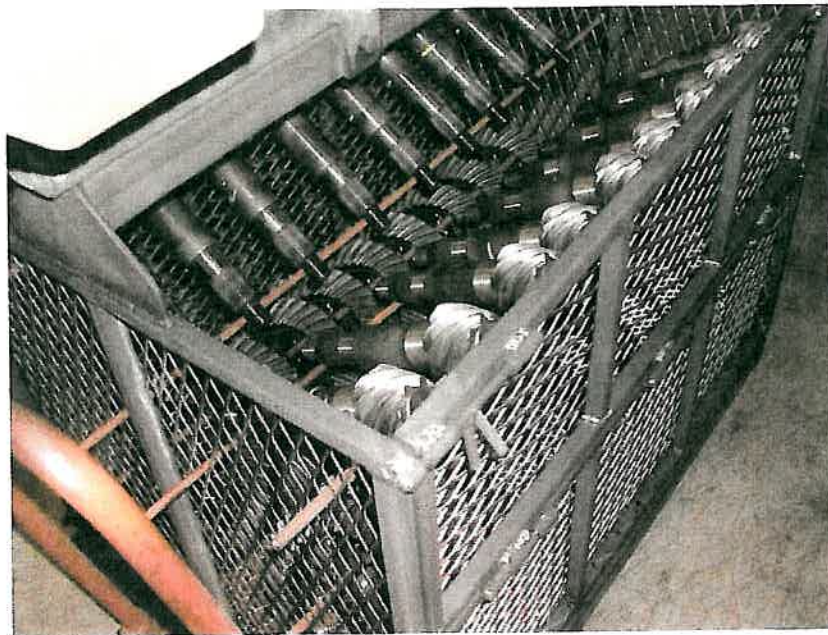
Test Panel Coupons, basket mounting location.

NOTE: Above calculated Lubrite Coating Weights will be slightly higher than normally calculated, due to the coupons (while being Lubrite coating were), hung down inside (see attached photo) production Gear Set holding baskets. I wasn't able to retrieve the coupons prior to the Soluble Oil Rust Preventative bath. Therefore the initial coating calculation weight also includes the Soluble Oil weight. However, Test Panel Coupons were air dried for five days (July 4th Holiday weekend) prior to weighing & stripping panels.
