**Report of Meeting
L-37 Surveillance Panel Meeting
US Army TACOM
Warren, MI**

November 11th, 2009

MATERIALS ENGINEERING LAB REPORT
DANA HOLDING CORPORATION
3939 TECHNOLOGY DR.
MAUMEE, OHIO 43537

REQUEST : EVALUATE FRACTURE ON PINION TOOTH AND PERFORM MATERIAL ANALYSIS ON RING GEAR AND PINION. PHOTODOCUMENT, MAG PARTICLE, AND MATERIAL ANALYSIS.

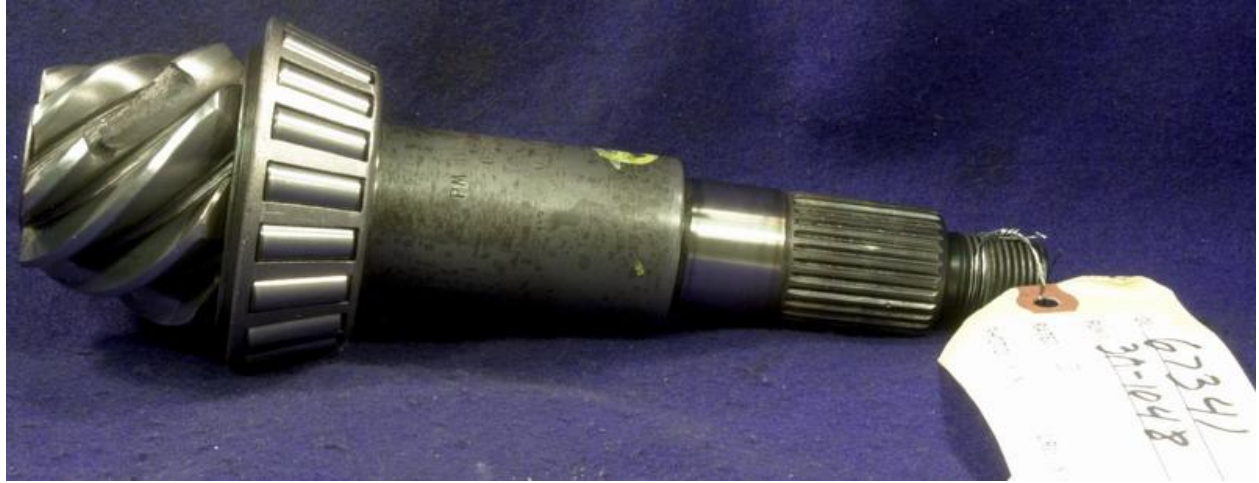
FIGURE 1: PINION AS RECEIVED.

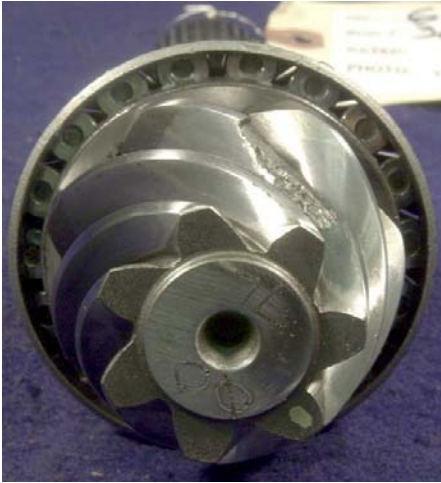
FIGURE 2: END OF PINION.

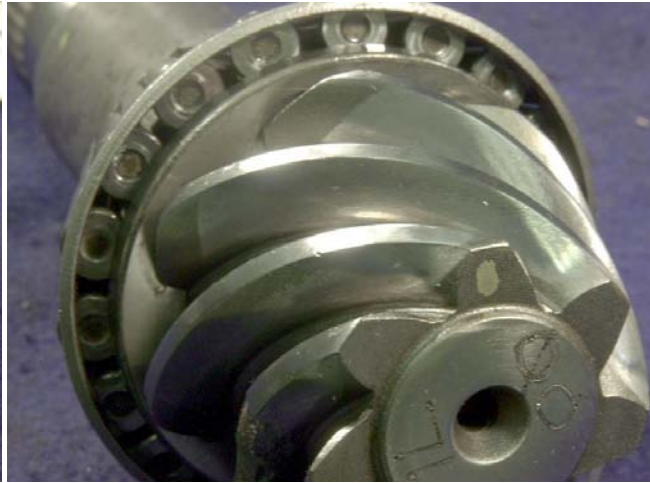
FIGURE 3: ALTERNATIVE VIEW OF PINION SHOWING CONTACT PATTERN.

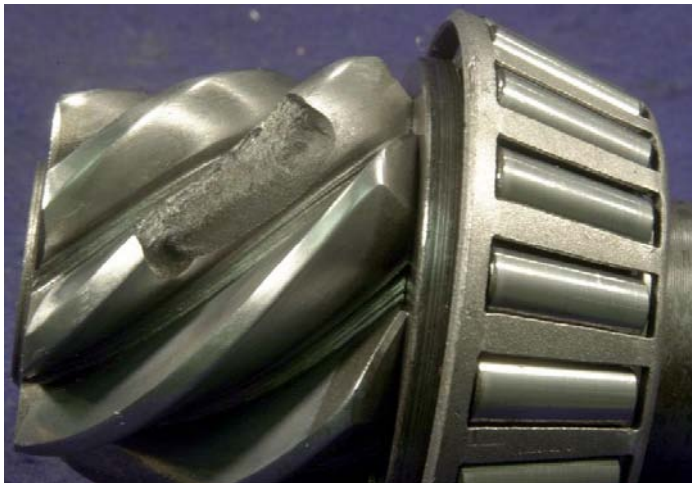
THE PINION WAS RECEIVED WITH ONE BROKEN TOOTH. THE TOOTH FAILED MID TOOTH AT THE ROOT TOWARD THE TOP OF THE TOOTH. THERE WAS A HARD LINE OF CONTACT OBSERVED AT THE BOTTOM OF THE CONTACT PATTERN. PITTING OCCURRED ALONG THIS LINE OF CONTACT AND LED IN TO THE FAILURE ON THE TOOTH. THIS LINE OF CONTACT WAS OBSERVED ON THREE TEETH, FIGURES 8-10.

CONCLUSION : THE PINION IS AT THE MINIMUM CASE DEPTH AT THE ROOT, AND IT MEETS ALL OTHER SPECIFICATIONS. THE FAILURE IS DUE TO PITTING AND SPALLING ON ONE TOOTH. ADDITIONAL TEETH SHOW AN AREA OF HIGH LOCALIZED CONTACT STRESS NEAR THE TOE END AT THE BOTTOM OF CONTACT. A LINE OF PITTING IS PRESENT AT THE TOP OF THIS AREA. THIS IS BELIEVED TO BE THE CAUSE OF THE FAILURE.

FIGURE 4: PINION SHOWING TOOTH FAILURE.

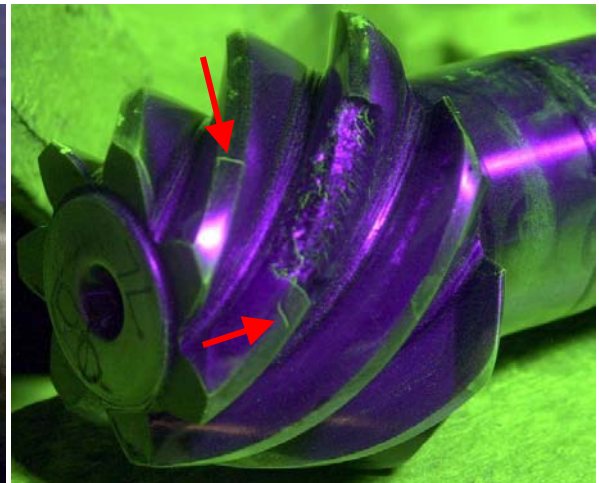
MAGNETIC PARTICLE INSPECTION REVEALED TWO CRACKS ACROSS THE TOP OF THE FAILED TOOTH AND ON THE TOOTH NEXT TO IT, FIGURE 5.

FIGURE 5: MAGNETIC PARTICLE INSPECTION OF PINION, ARROWS INDICATING CRACKS.

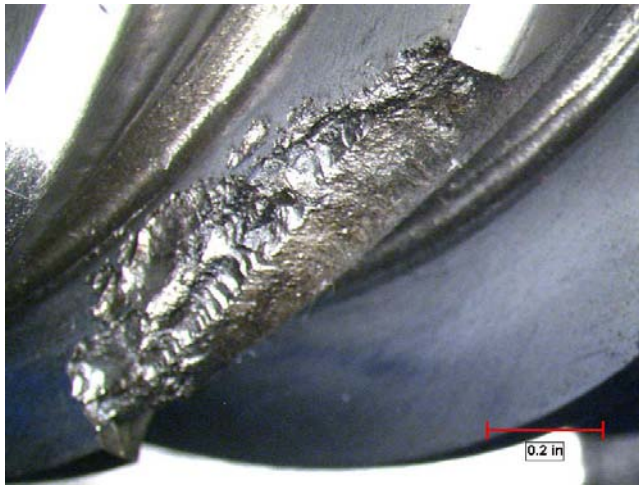
FIGURE 6: CLOSE-UP OF FAILED TOOTH, CONCAVE FACE OF TOOTH.

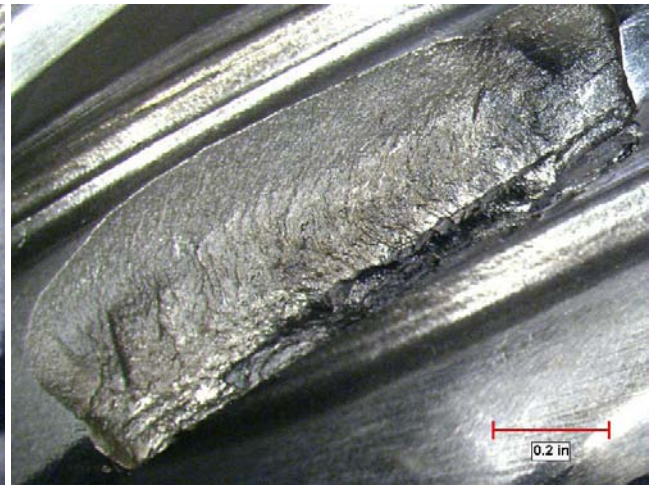
FIGURE 7: CLOSE-UP OF FAILED TOOTH, CONVEX FACE OF TOOTH.

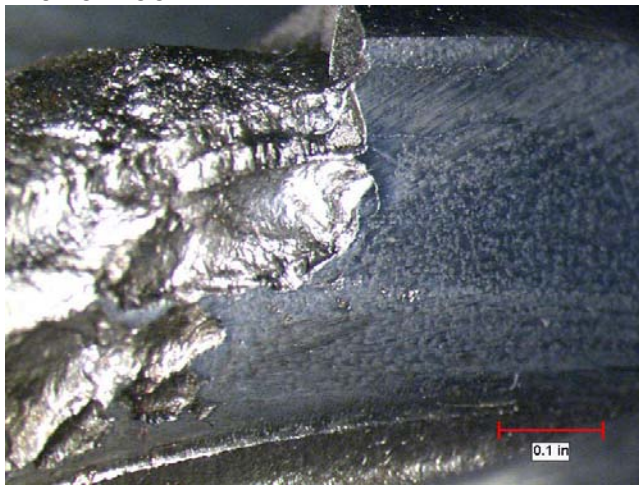
FIGURE 8: PITTING SPALLING FAILURE ON THE LEFT. NOTE AREA OF LOCALIZED HIGH CONTACT STRESS AT BOTTOM OF CONTACT WITH PITTING AT THE TOP.

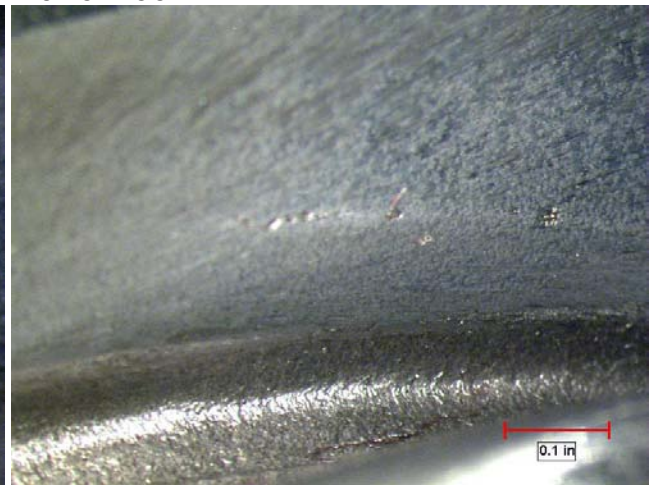
FIGURE 9: AREA OF LOCALIZED HIGH CONTACT STRESS AT THE BOTTOM OF CONTACT WITH LINE OF PITTING AT THE TOP.

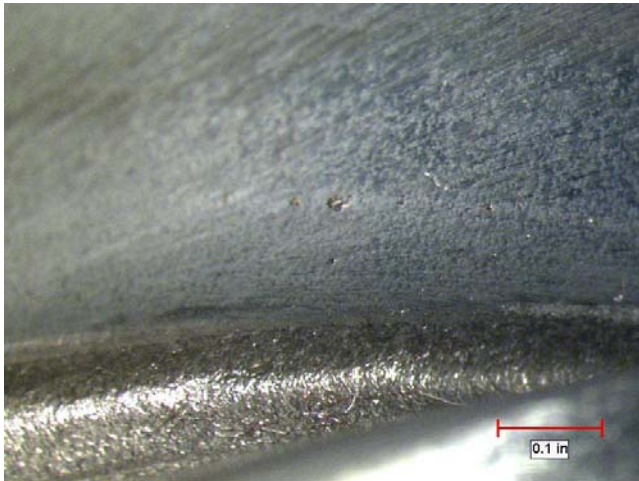
FIGURE 10: AREA OF LOCALIZED HIGH CONTACT STRESS AT THE BOTTOM OF CONTACT WITH LINE OF PITTING AT THE TOP.

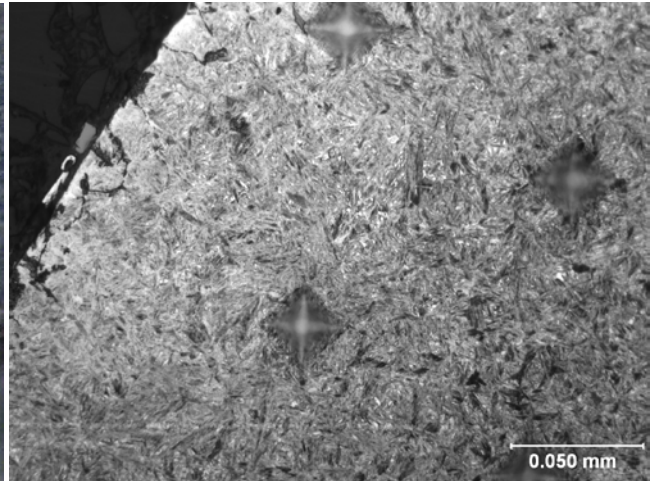
THE CASE MICROSTRUCTURE CONSISTS OF MARTENSITE, AND THE CORE MICROSTRUCTURE CONSISTS OF TRANSFORMATION PRODUCTS.

FIGURE 11: CASE MICROSTRUCTURE AT THE PITCH, 500X, 2% NITAL ETCHANT.

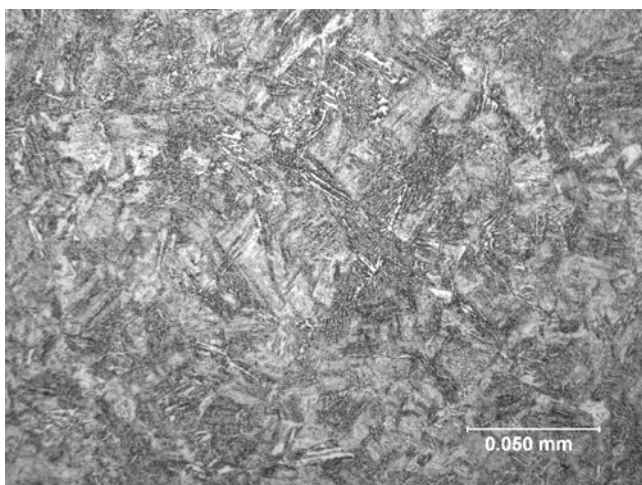
FIGURE 12: CORE MICROSTRUCTURE, AT THE PITCH, 500X, 2% NITAL ETCHANT.

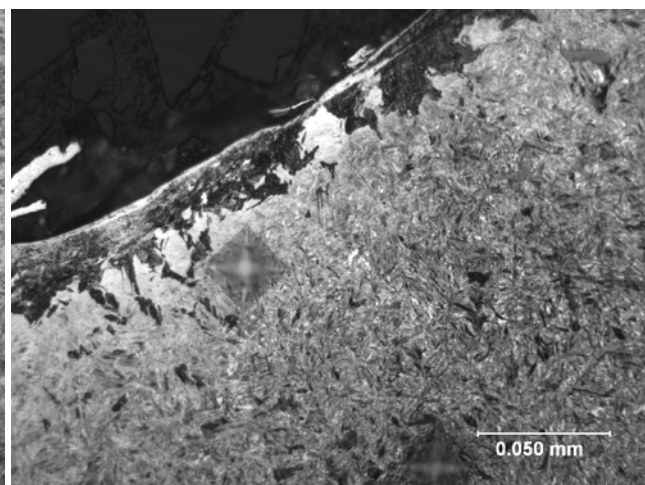
FIGURE 13: CASE MICROSTRUCTURE, AT THE ROOT, 500X, 2% NITAL ETCHANT.

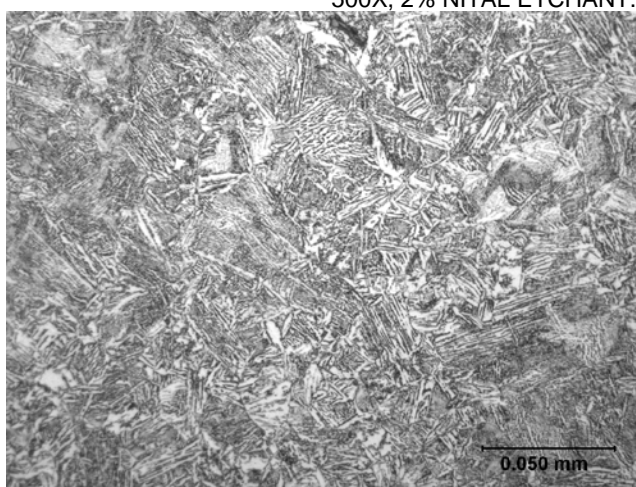
FIGURE 14: CORE MICROSTRUCTURE, AT THE ROOT, 500X, 2% NITAL ETCHANT.

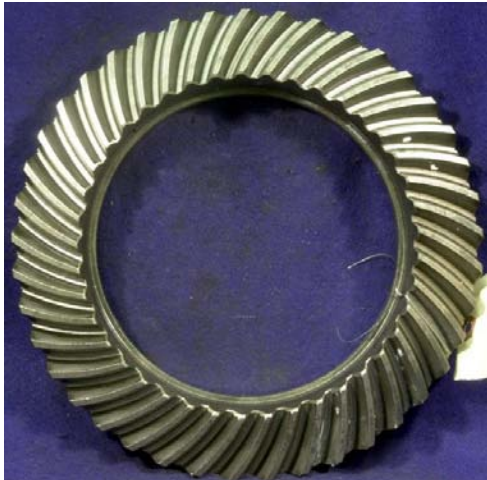
THE RING GEAR WAS RECEIVED WITH OUT ANY NOTICABLE CRACKS OR FAILURES. THERE WAS HEAVY CONTACT NOTICED NEAR THE TOP OF THE RING GEAR TEETH, FIGURES 4&5.

FIGURE 1: RING GEAR AS RECEIVED.

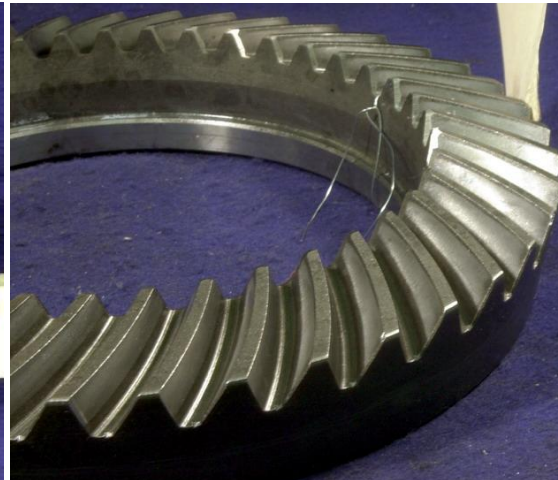
FIGURE 2: RING GEAR TEETH, SHOWING CONTACT PATTERN.

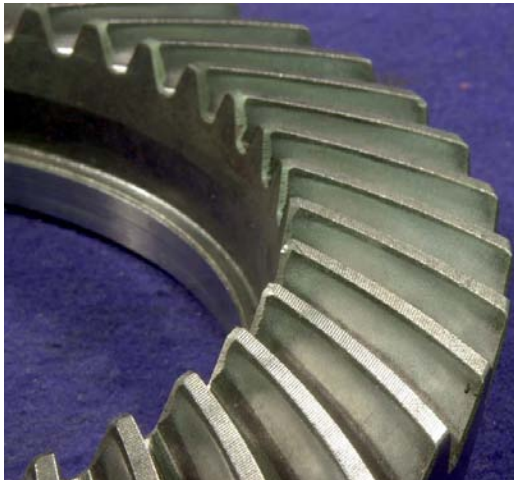
FIGURE 3: ALTERNATIVE VIEW OF RING GEAR TEETH, SHOWING CONTACT PATTERN.

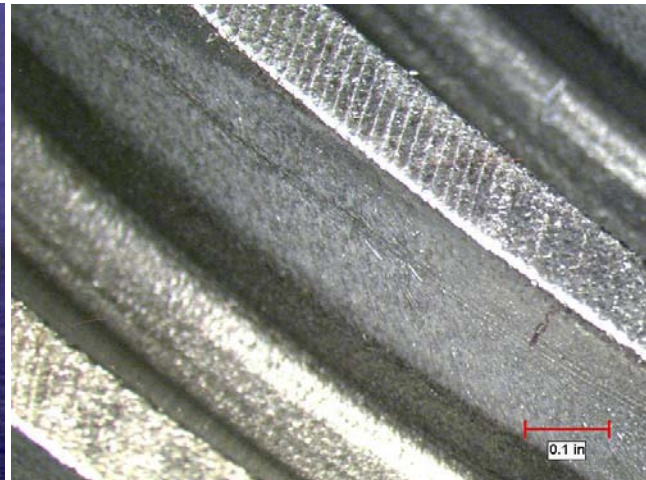
CONCLUSION : THE RING GEAR MEETS SPECIFICATION. AN AREA OF LOCALIZED HIGH CONTACT STRESS WAS NOTED ABOVE THE PITCH LINE WITH GROOVES OR LINES IN THE SLIDING DIRECTION, FIGURES 4&5.

FIGURE 4: CLOSE-UP OF RING GEAR TEETH, SHOWING AREA OF LOCALIZED HIGH CONTACT STRESS AND GROOVES OR LINES PRESENT ABOVE PITCH LINE.

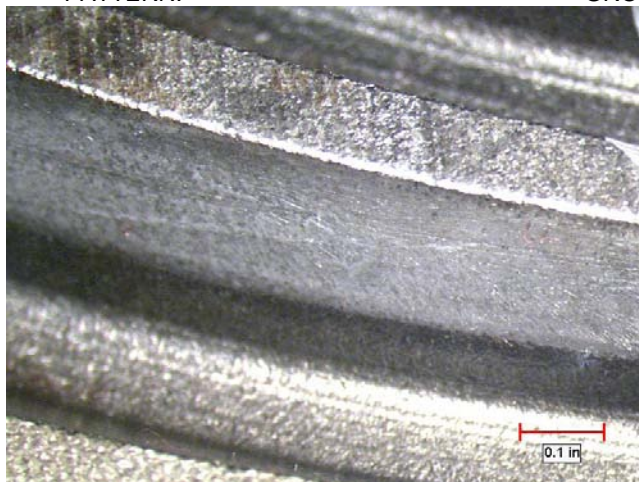
FIGURE 5: CLOSE-UP OF RING GEAR TEETH, SHOWING AREA OF LOCALIZED HIGH CONTACT STRESS AND GROOVES OR LINES PRESENT ABOVE PITCH LINE.

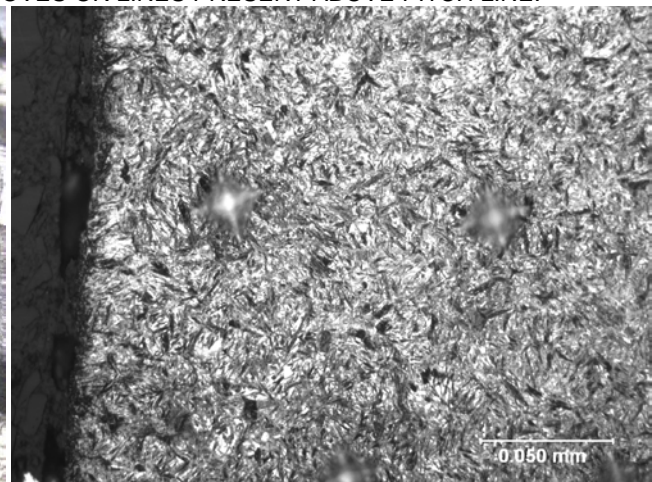
THE CASE MICROSTRUCTURE CONSISTS OF MARTENSITE, AND THE CORE MICROSTRUCTURE CONSISTS OF TRANSFORMATION PRODUCTS.

FIGURE 6: CASE MICROSTRUCTURE, AT THE PITCH, 500X, 2% NITAL ETCHANT.

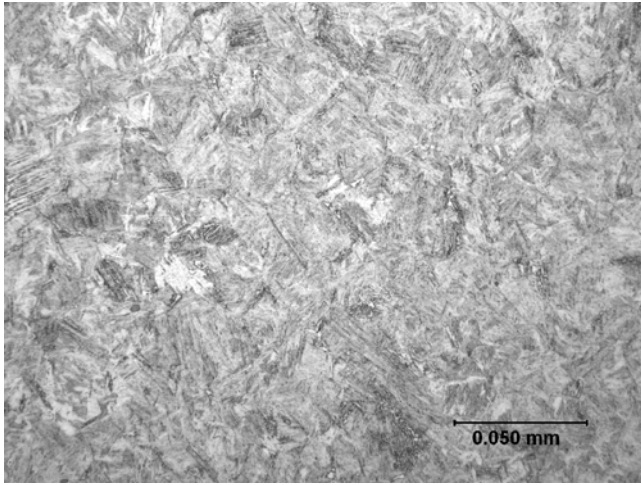
FIGURE 7: CORE MICROSTRUCTURE, AT THE PITCH, 500X, 2% NITAL ETCHANT.

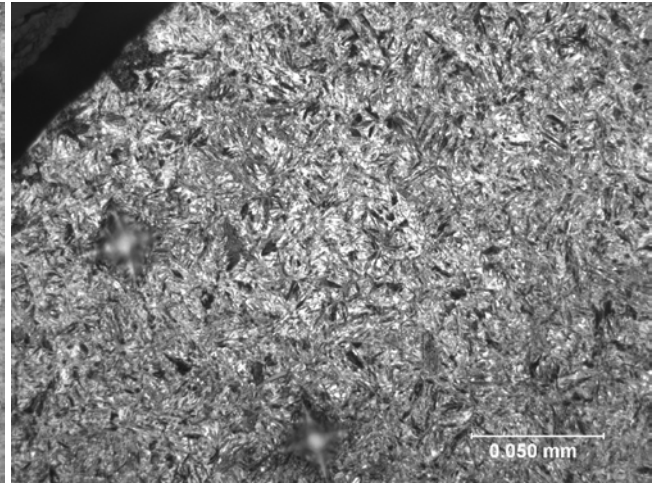
FIGURE 8: CASE MICROSTRUCTURE, AT THE ROOT, 500X, 2% NITAL ETCHANT.

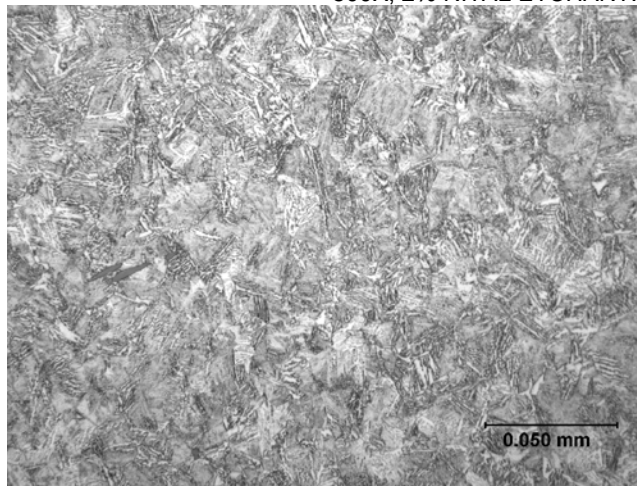
FIGURE 9: CORE MICROSTRUCTURE, AT THE ROOT, 500X, 2% NITAL ETCHANT.

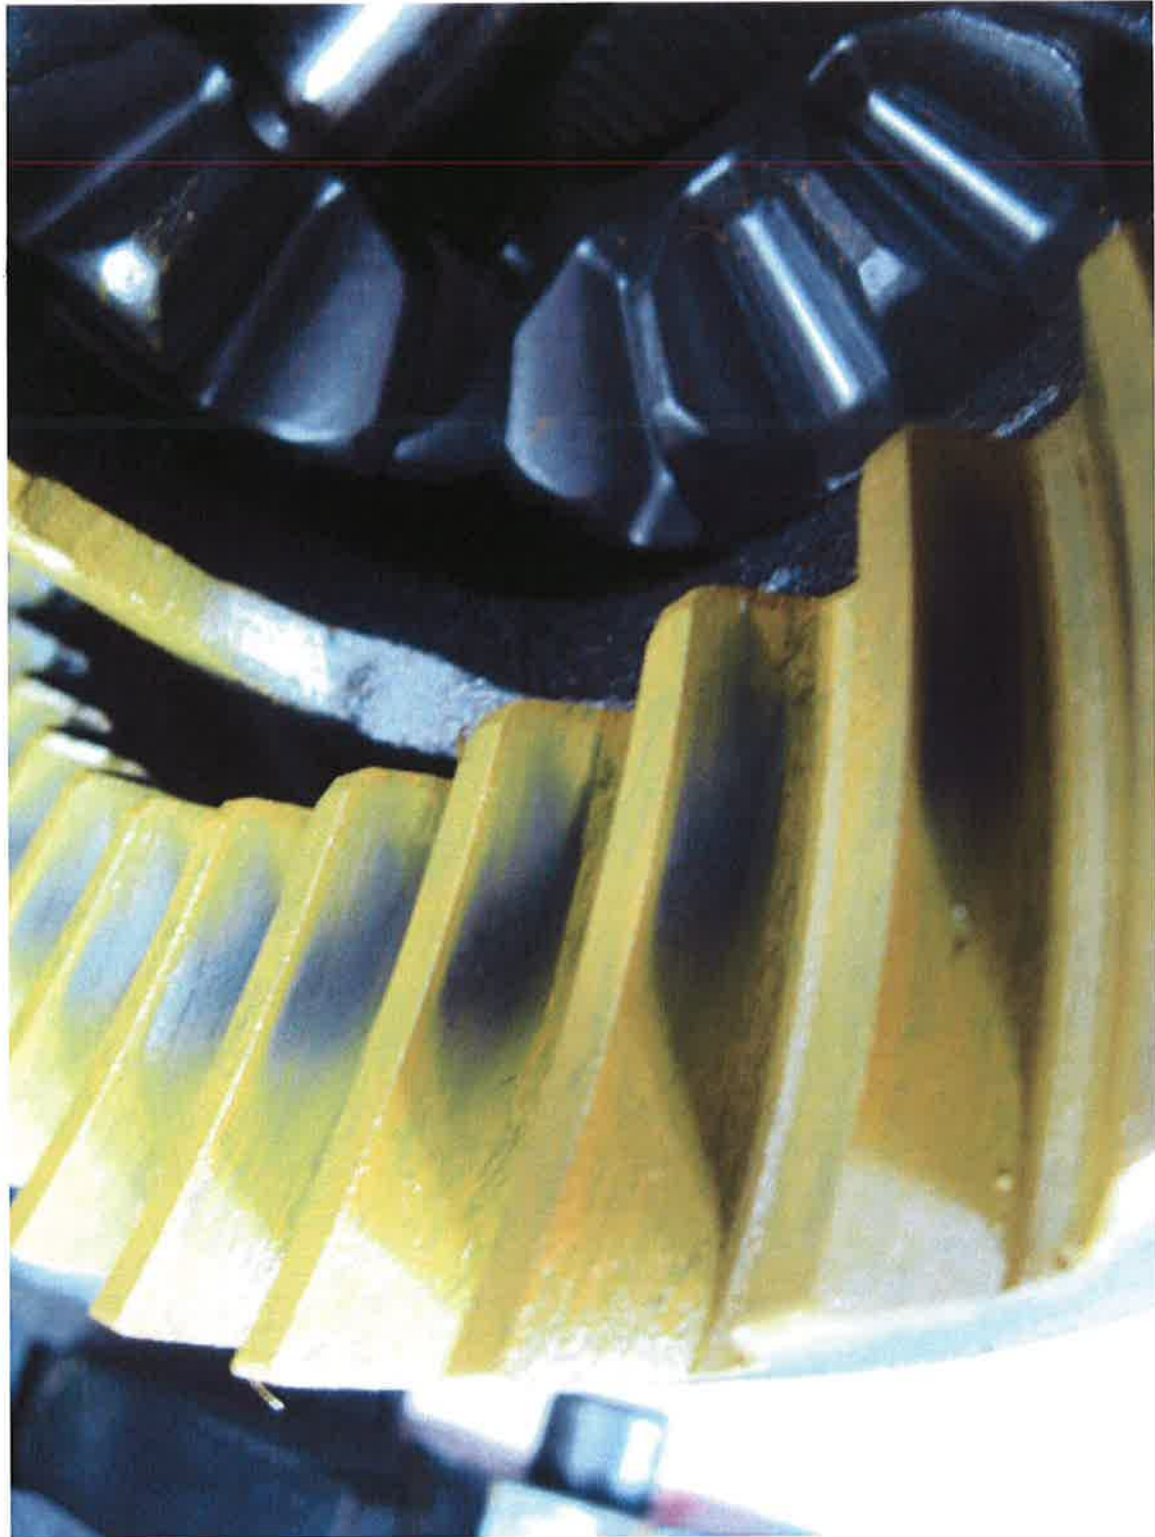
Axle Serial number ASTM 62
Fluid Code CMIR 67341
Notes: Broken Pinion Tooth

After test contact pattern

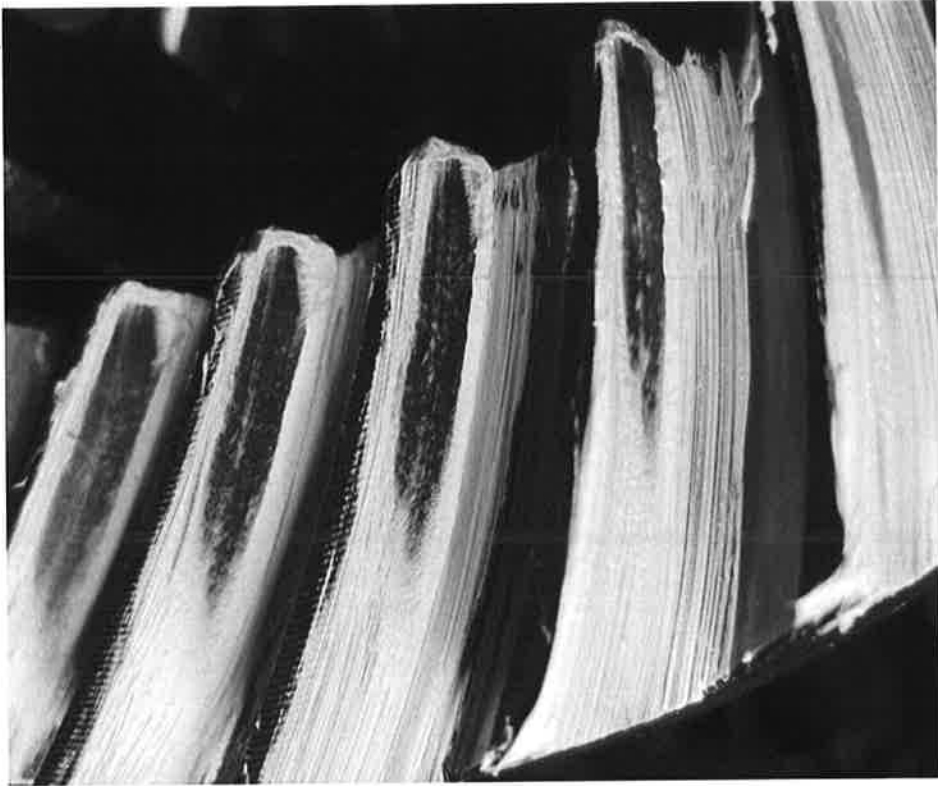
Before Test contact pattern

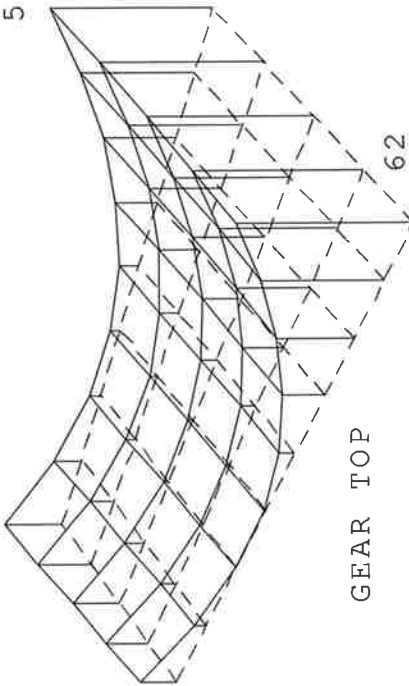
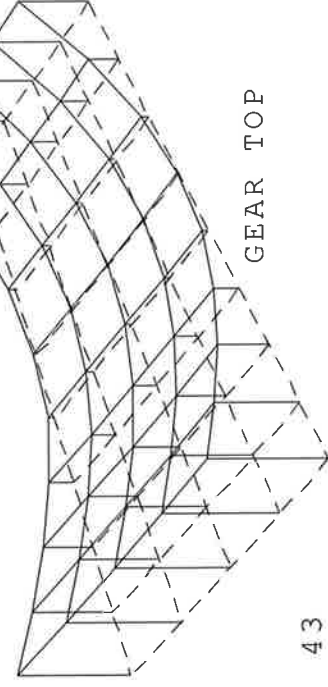
L37 Gear set pattern

EASE-OFF

[SCALE]
 [each division = .0020 inch]
 [dimensions shown in 1/10000 inch]

* EASE-OFF ZEROED AT MINIMUM VALUE

- Miller – Reviewed FEA analysis of the same gear 7L and compared it to a good result on that same oil. The FEA analysis shows that these two gear sets are essentially the same and they also line up with the 2005 shelf master. See attachment 4 for FEA analysis of gear set 7L.

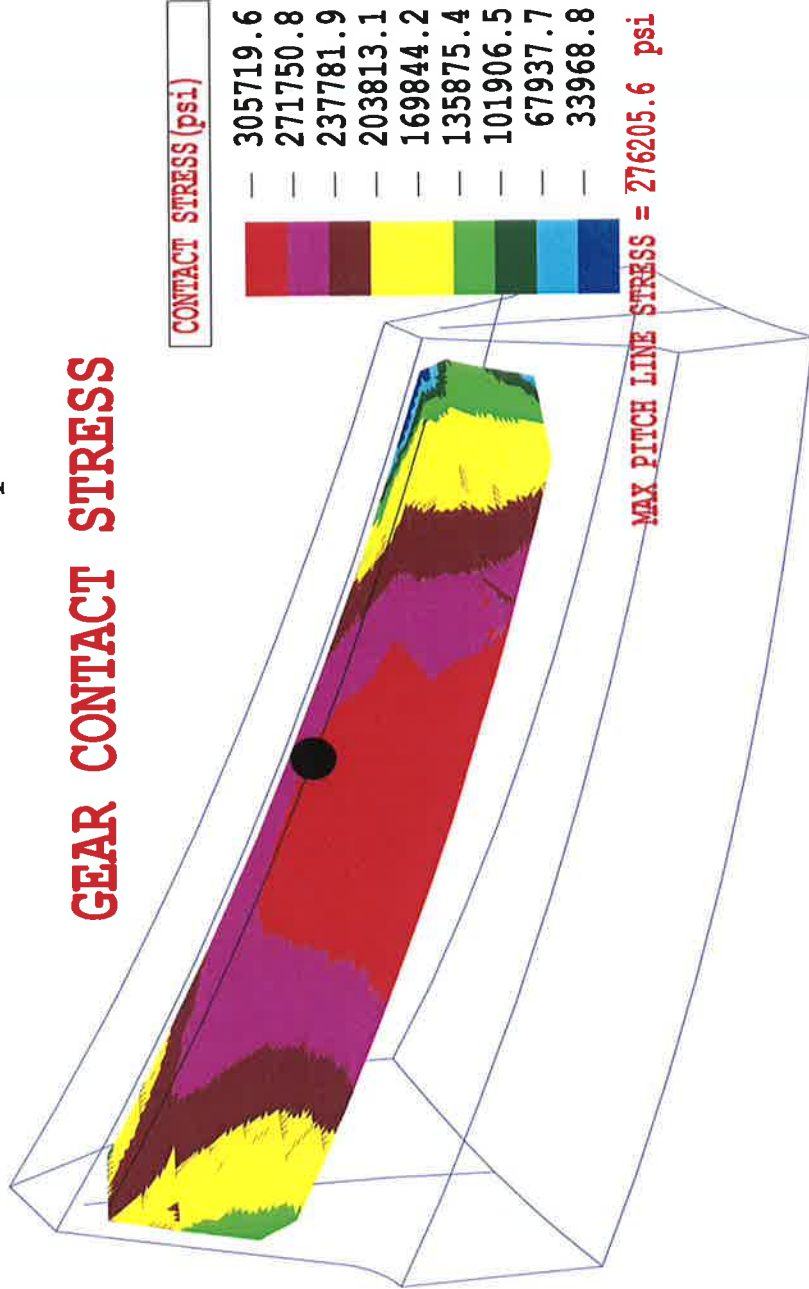
INPUT FILE: REVERSE-7L5
 OUTPUT FILE: REVERSE-7L5out
 GEAR TORQUE: 3480.000 lb-ft
 11\05\2009 VERSION 8.19 time:08:16am
 V= 0.0000 in
 H= 0.0000 in
 G= 0.0000 in
 cmf= 1.0000
 Separation factor= 0.00025
 E= .01295 in
 P= 0.00907 in
 G= 0.00392 in
 A= 0.00071 ra

GEAR CONTACT STRESS
