Report of Meeting
L-60-1 Surveillance Panel Conference Call
February 9th, 2023

Failure Analysis

Test gears

Examination Request

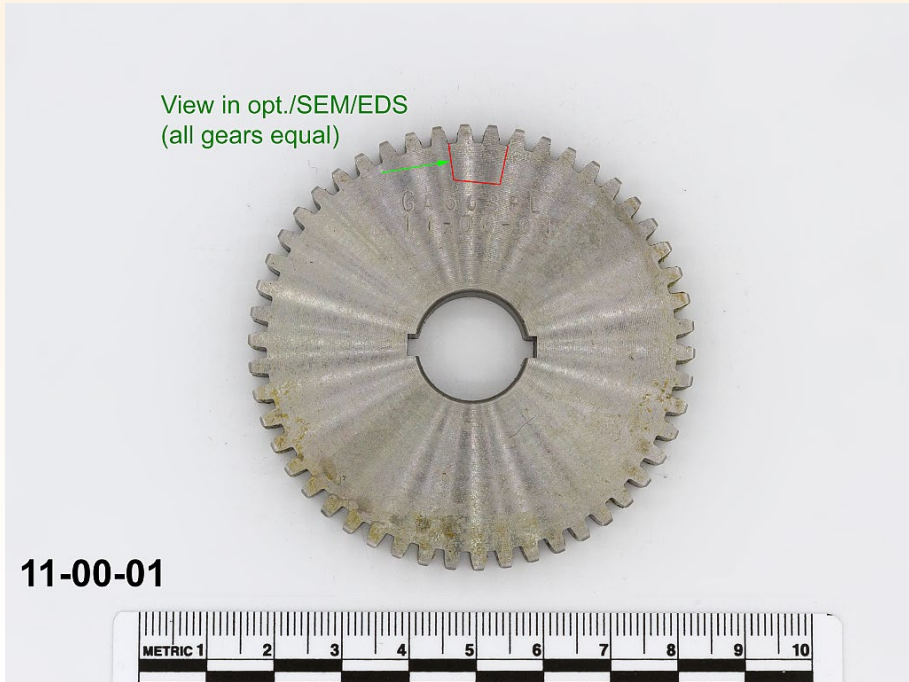
Examination – part 11-00-01

- Part in condition as delivered
 - Machined surface

- Gears were delivered in different conditions
 - 11-00-01 and 06-18-48 machined
 - 12-11-34 shot peened
- No significant difference in microstructure was examined
- Gears were not in condition prepared for test due to customer information
- No reason for different test results observed
- Further investigation may be taken in final testing condition
- Further investigation may be taken for red substance on surface after test which determines test result

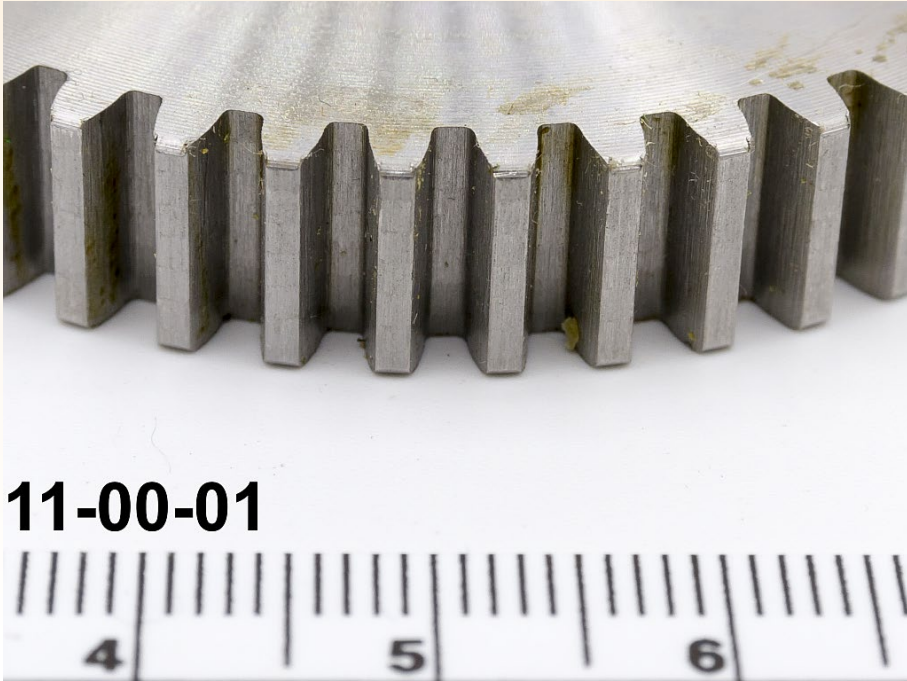
Examination – part 11-00-01

- Part in condition as delivered
 - Machined surface
 - Some residues from packaging paper

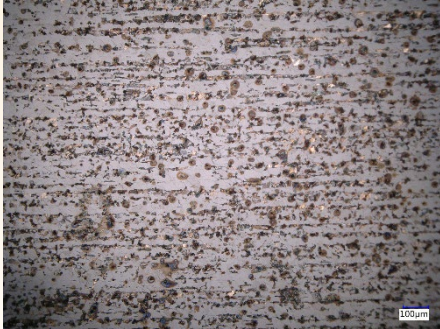
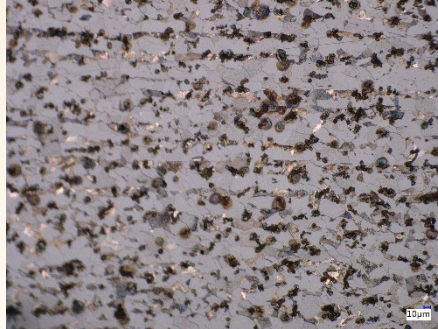
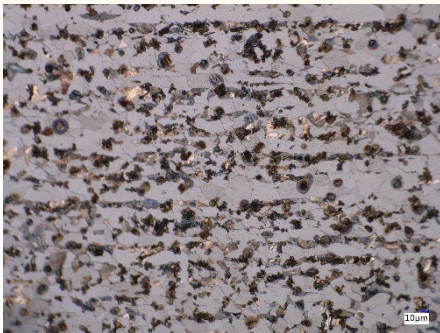
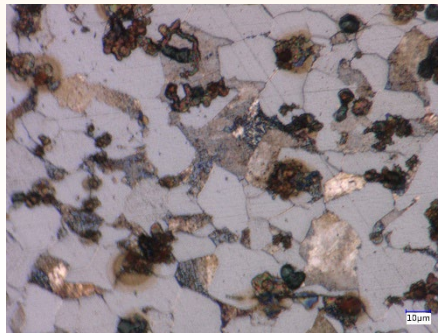
Examination – part 11-00-01

- Part cross section, nital etched
 - Microstructure ferrite/pearlite with some manganese sulfides

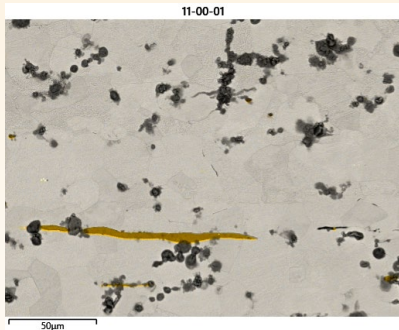
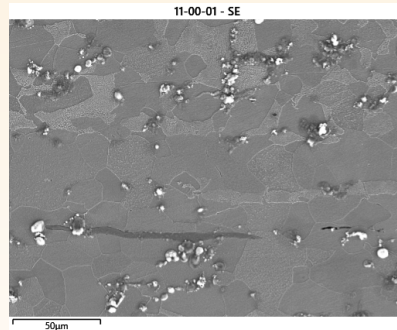
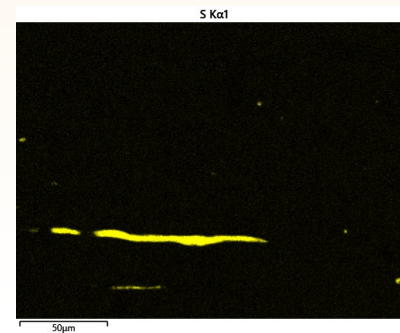
Examination – part 11-00-01

- Part cross section, nital etched
 - Microstructure ferrite/pearlite with some manganese sulfides

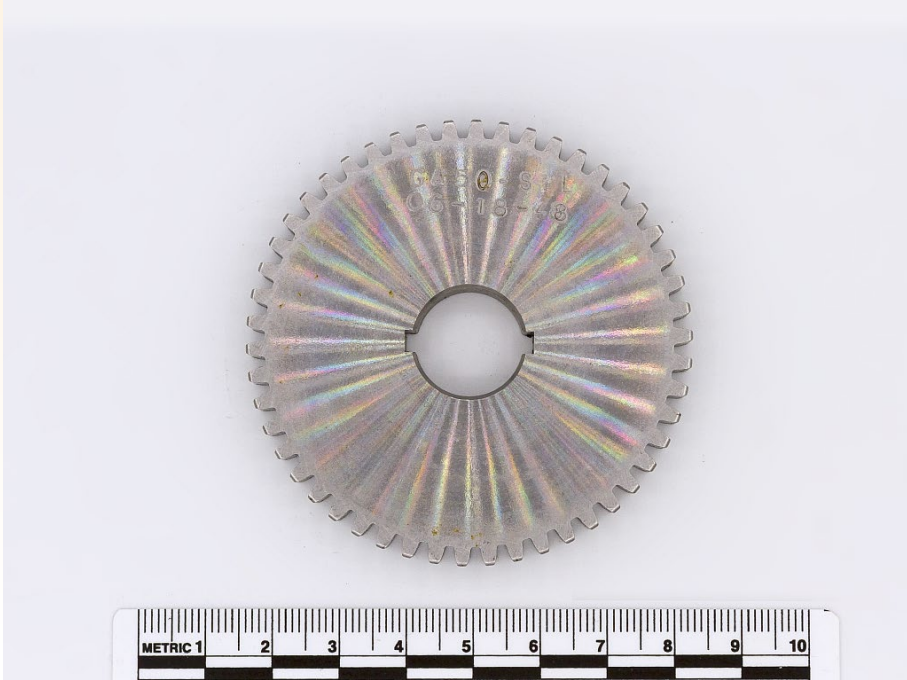
Examination – part 06-18-48

- Part in condition as delivered
 - Machined surface

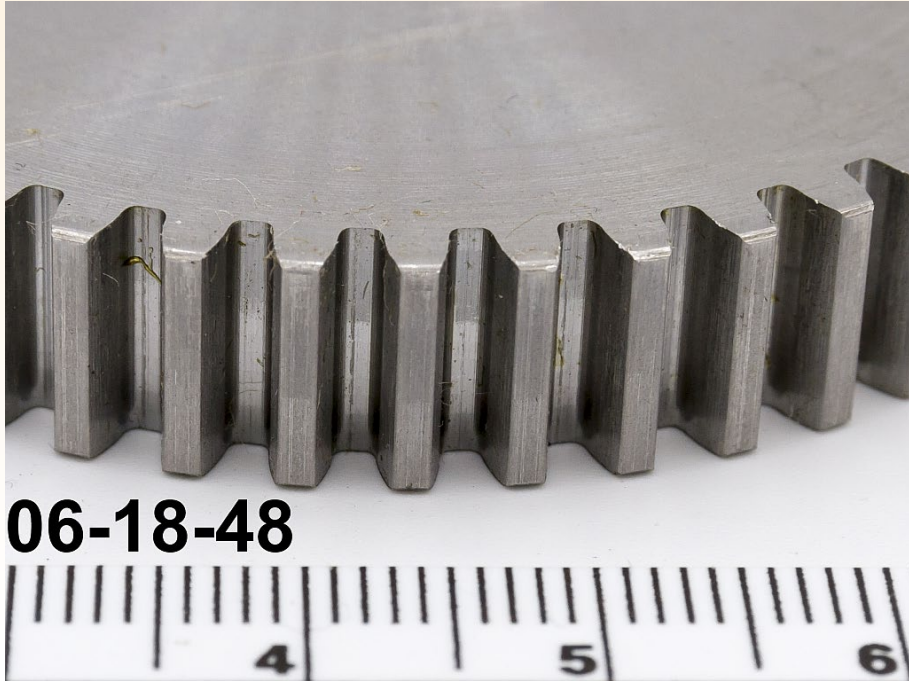
Examination – part 06-18-48

- Part in condition as delivered
 - Machined surface

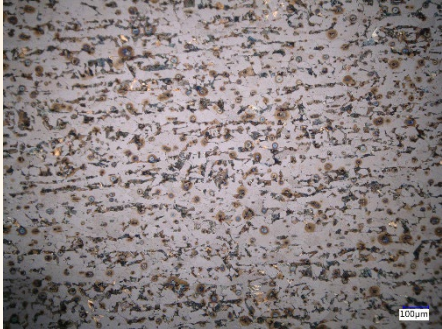
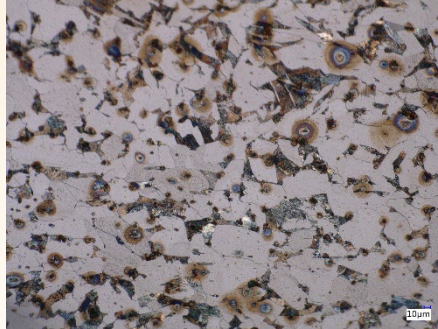
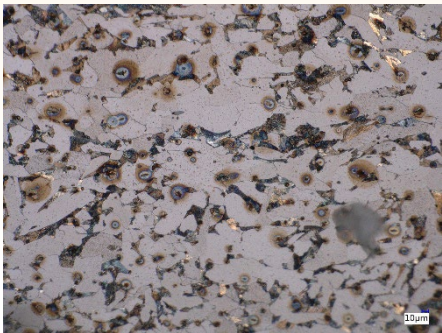
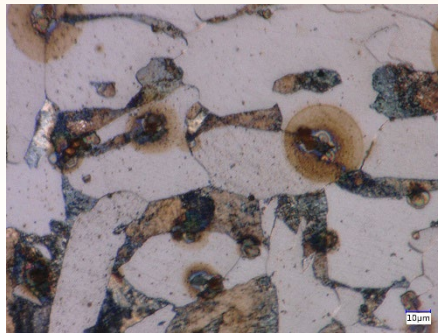
Examination – part 06-18-48

- Part cross section, nital etched
 - Microstructure ferrite/pearlite with some manganese sulfides

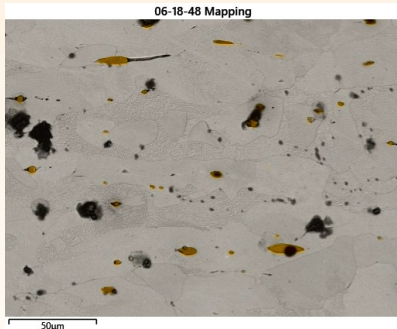
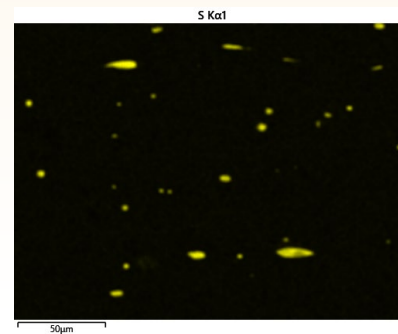
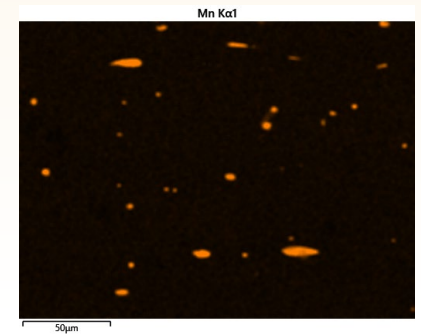
Examination – part 06-18-48

- Part cross section, nital etched
 - Microstructure ferrite/pearlite with some manganese sulfides

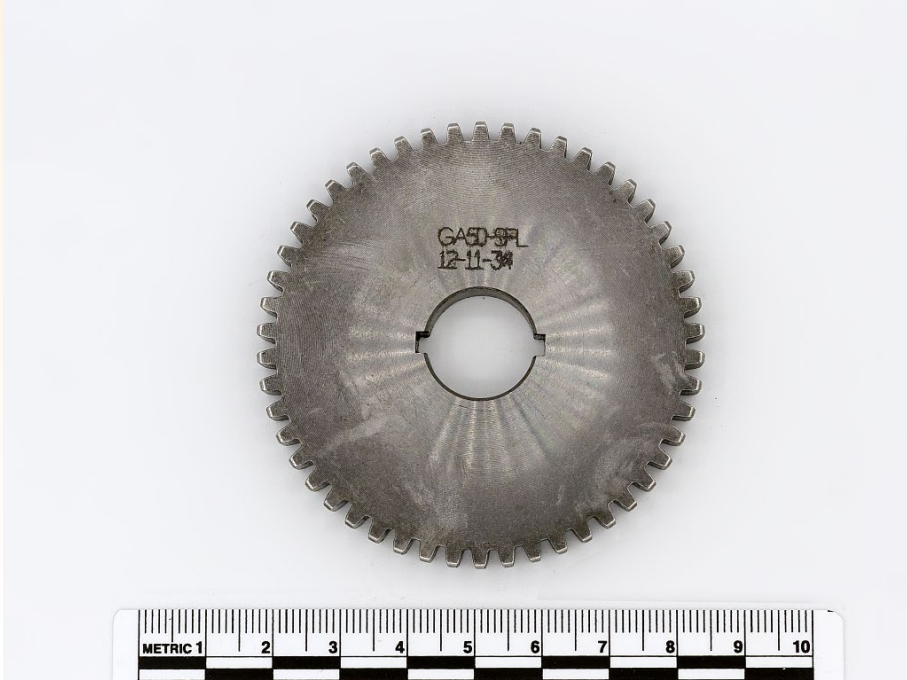
Examination – part 12-11-34

- Part in condition as delivered
 - Shot peened surface

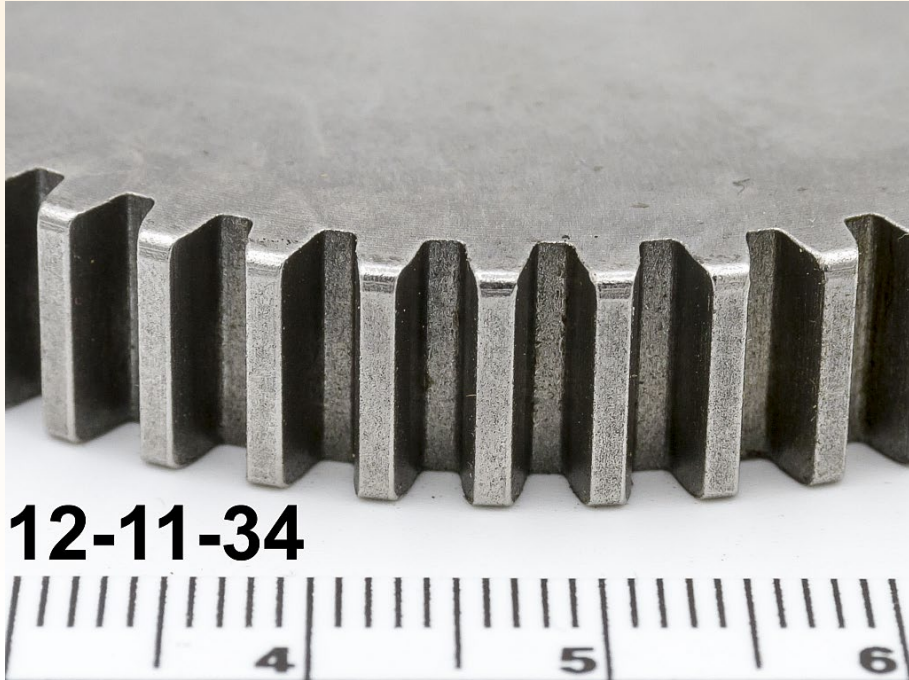
Examination – part 12-11-34

- Part in condition as delivered
 - Shot peened surface

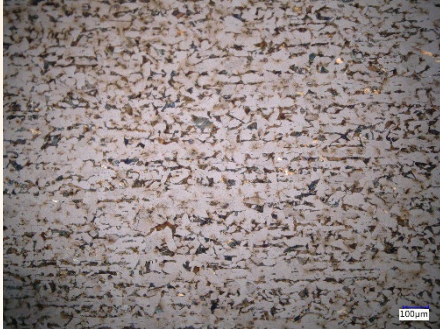
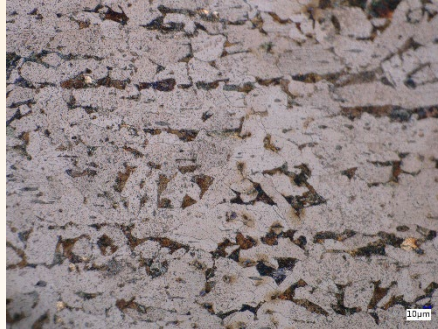
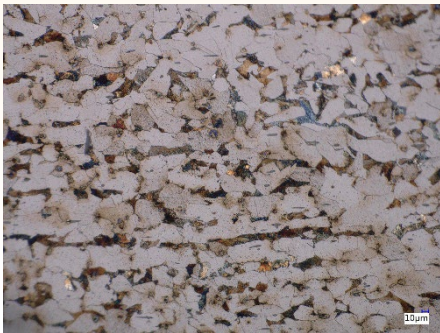
Examination – part 12-11-34

- Part cross section, nital etched
 - Microstructure ferrite/pearlite with some manganese sulfides

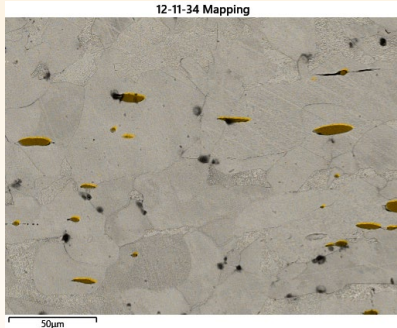
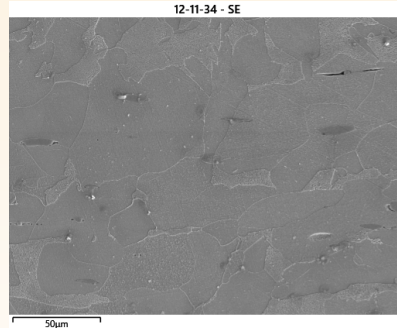
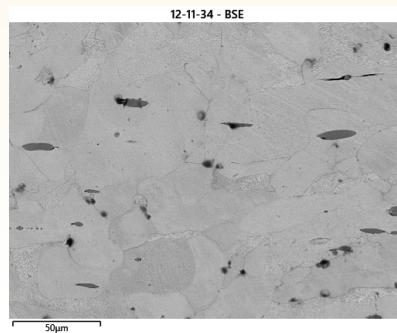
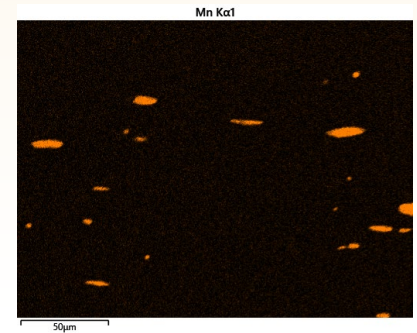
Examination – part 12-11-34

- Part cross section, nital etched
 - Microstructure ferrite/pearlite with some manganese sulfides
