**Report of Meeting**  
**L-60-1 Surveillance Panel Conference Call**  
**August 10<sup>th</sup>, 2023**

# L-60-1 Surveillance Panel Meeting

# Failure Analysis

Test  
gear  
S  
Dipl.-Ing (FH) Manfred Herz Dr.-  
Ing. Hans-Willi  
Raedt

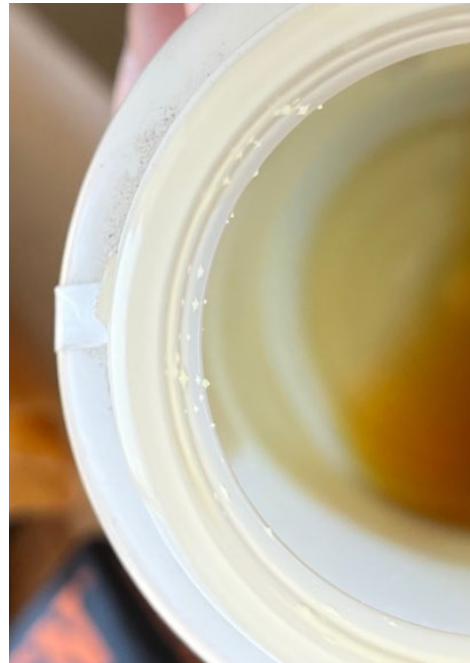
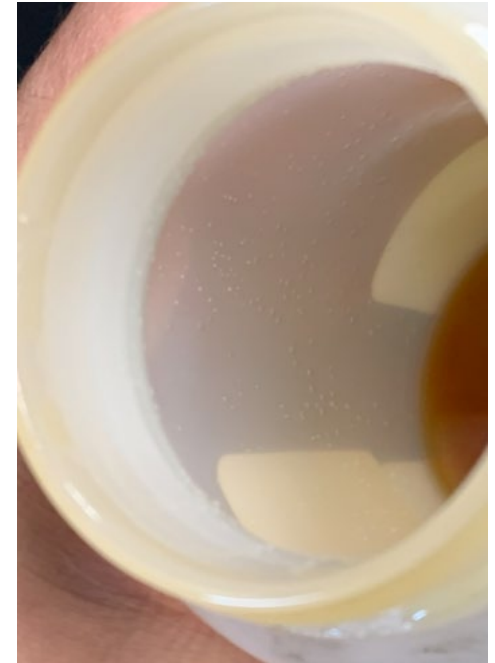
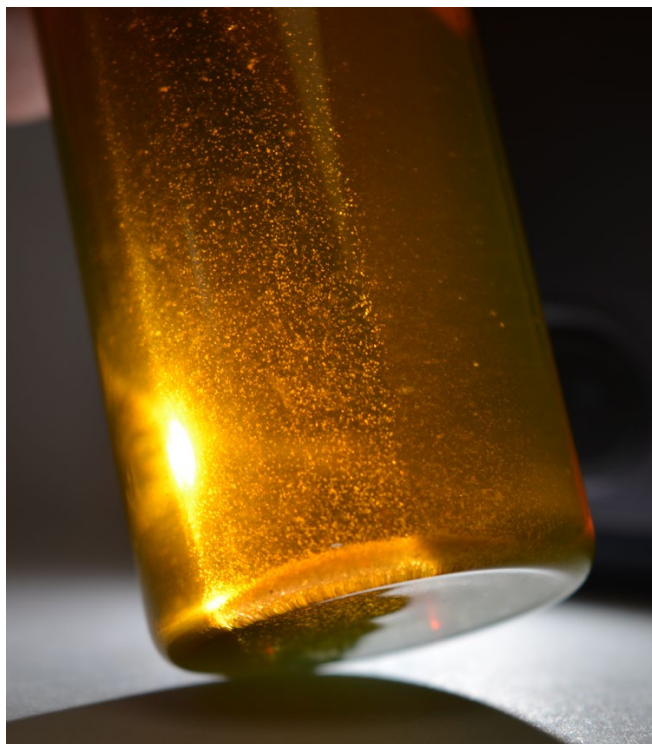
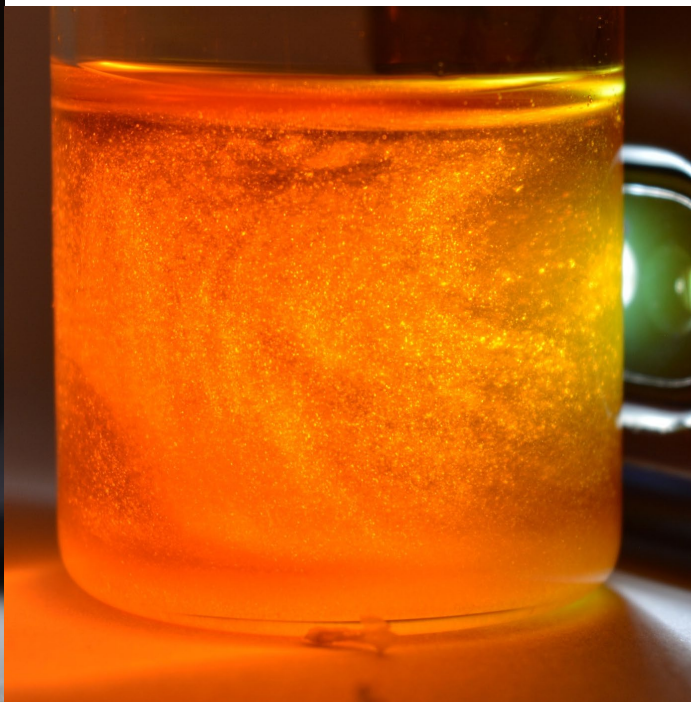
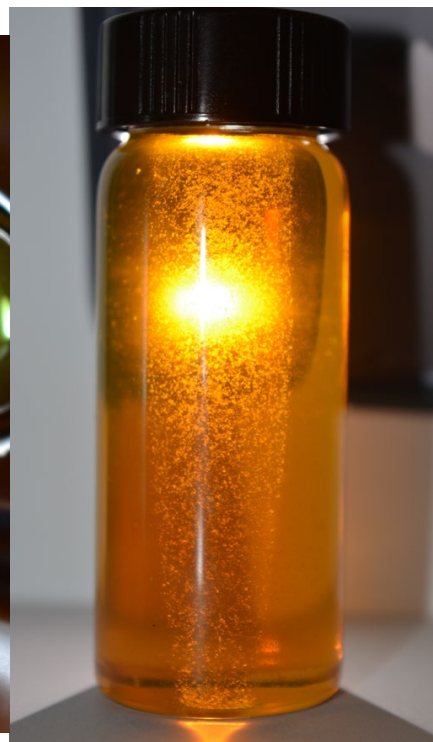
- There is an unknown substance in the Reference oils we received back in 2020-2022.
- Multiple labs have confirmed they are seeing this in some of their reference samples.
- Intertek was able to reference using reference oils we received this year that did not exhibit the same unknown substance.
- Could this be the cause of the industry severity issue?

- How do we proceed?
- If it is additive drop-out can we get it back into solution or does the oil need to be retired? If not, can we filter out the contamination?

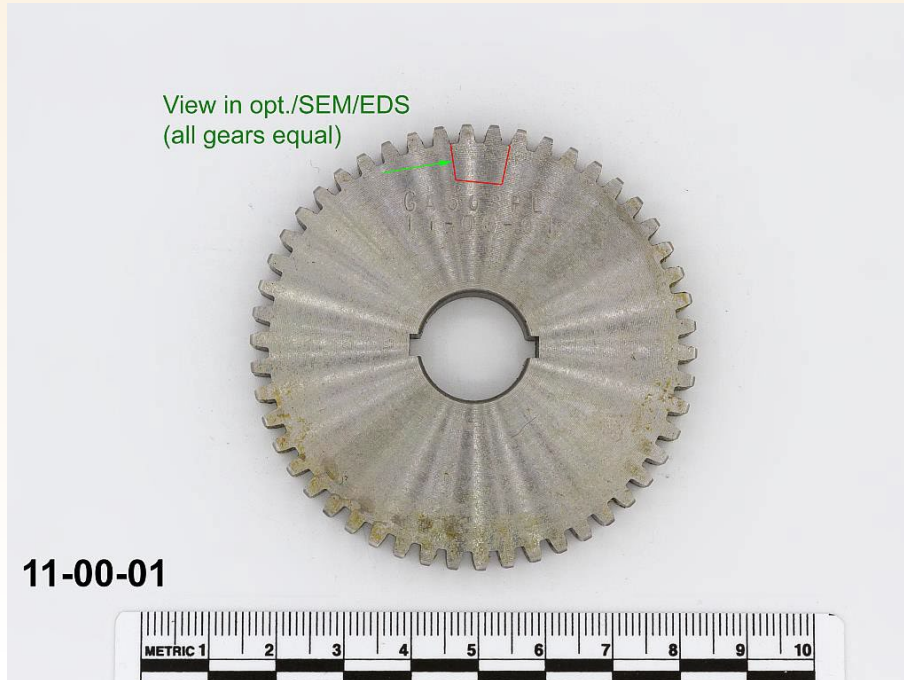
# Examination – part 11-00-01

- Part in condition as delivered
  - Machined surface

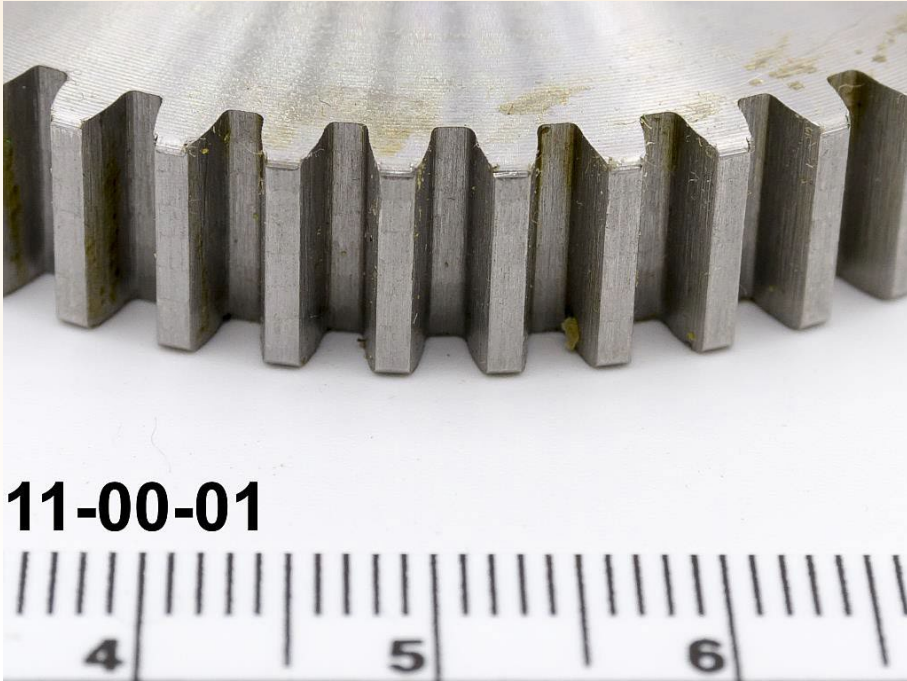
# Examination – part 11-00-01

- Part in condition as delivered
  - Machined surface
    - Some residues from packaging paper

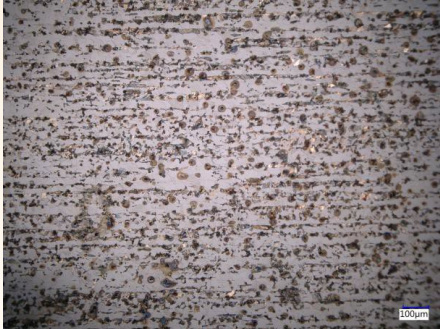
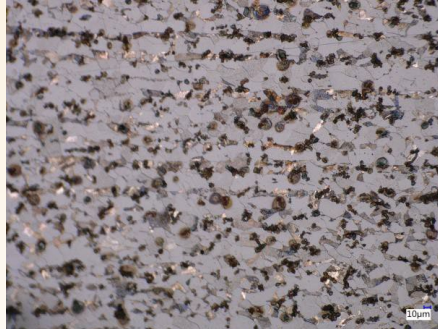
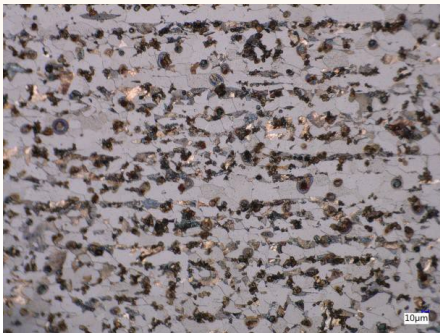
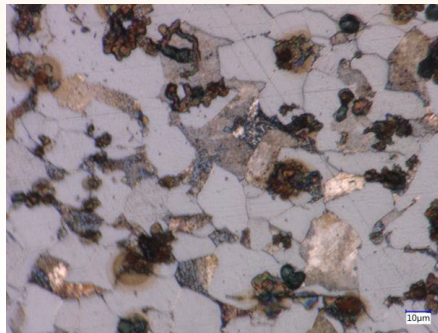
# Examination – part 11-00-01

- Part cross section, nital etched
  - Microstructure ferrite/pearlite with some manganese sulfides

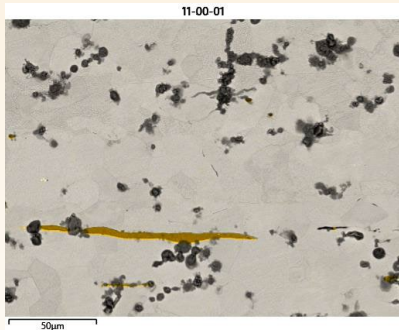
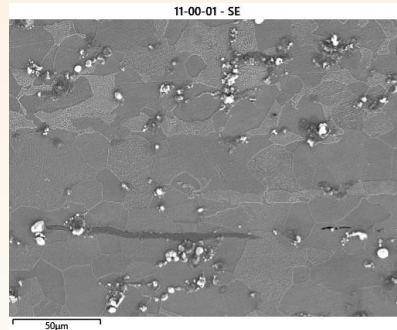
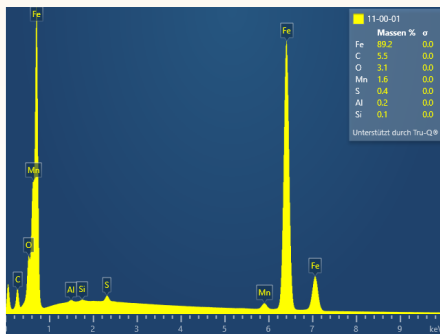
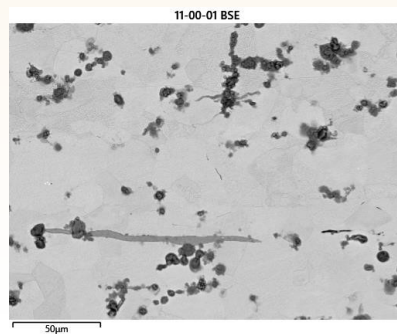
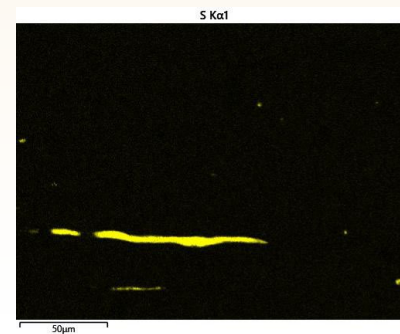
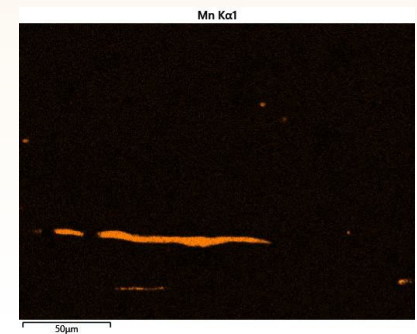
# Examination – part 11-00-01

- Part cross section, nital etched
  - Microstructure ferrite/pearlite with some manganese sulfides

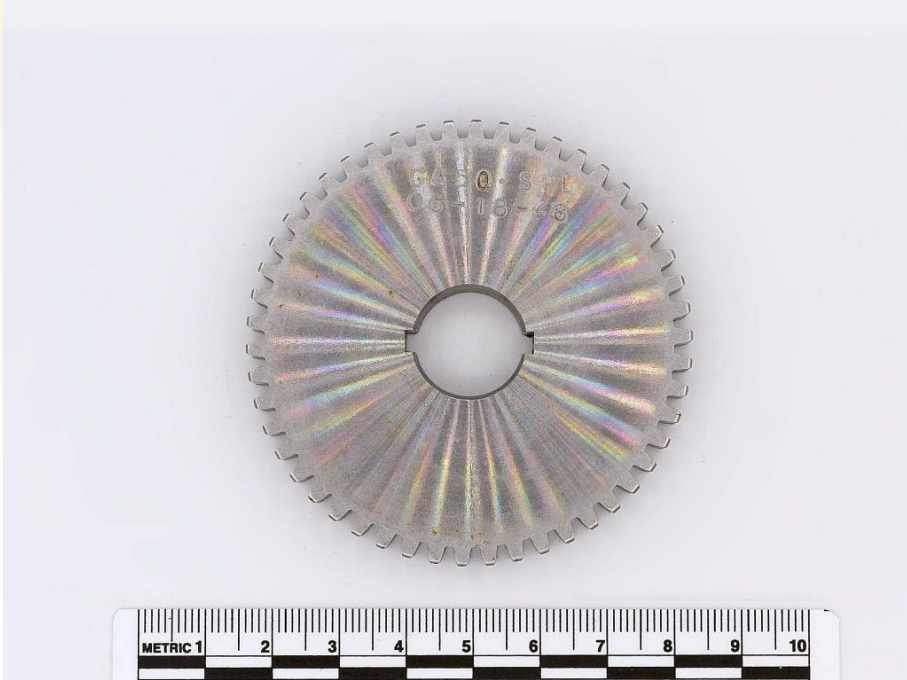
# Examination – part 06-18-48

- Part in condition as delivered
  - Machined surface

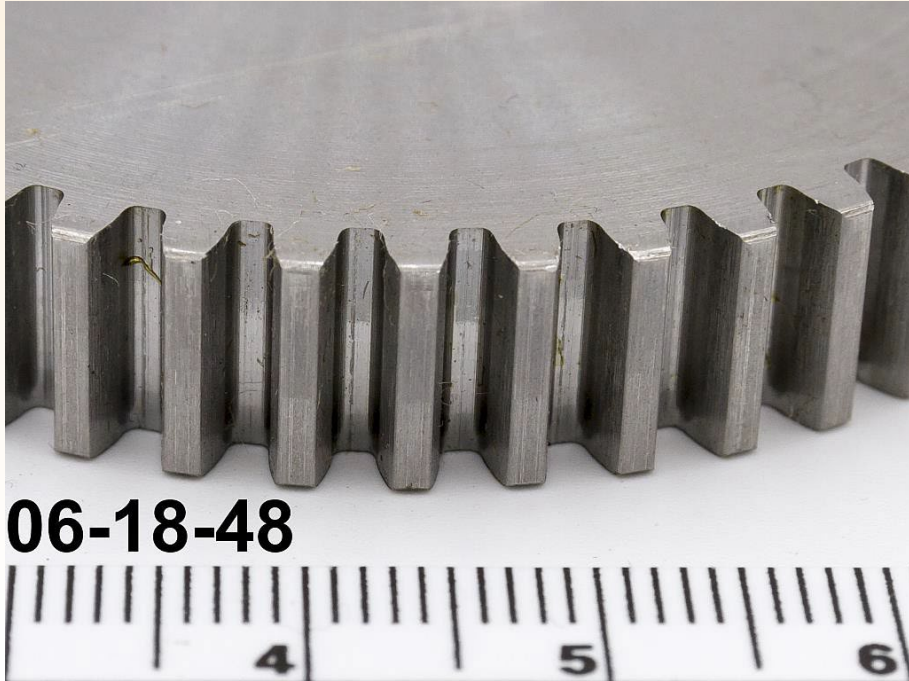
# Examination – part 06-18-48

- Part in condition as delivered
  - Machined surface

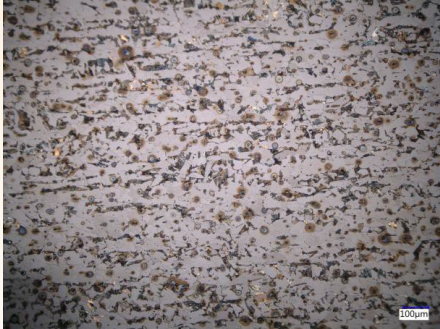
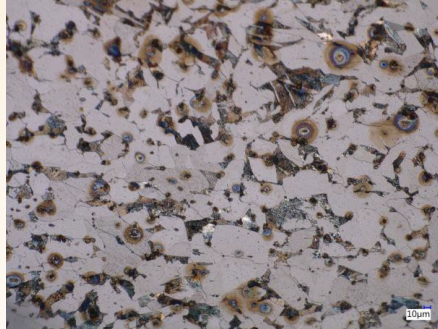
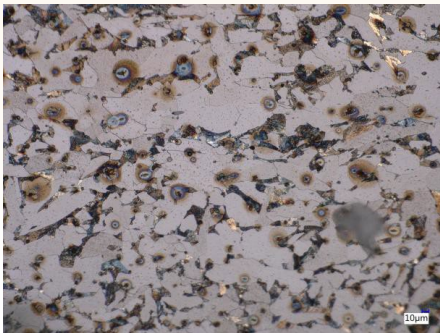
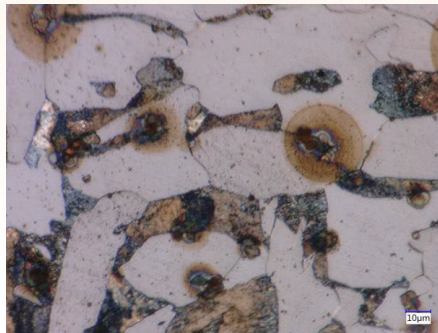
# Examination – part 06-18-48

- Part cross section, nital etched
  - Microstructure ferrite/pearlite with some manganese sulfides

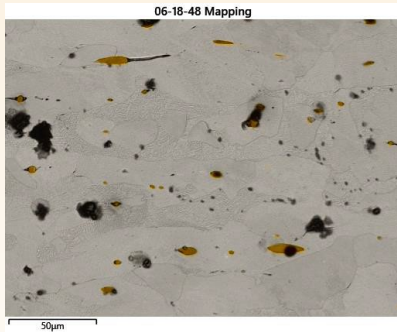
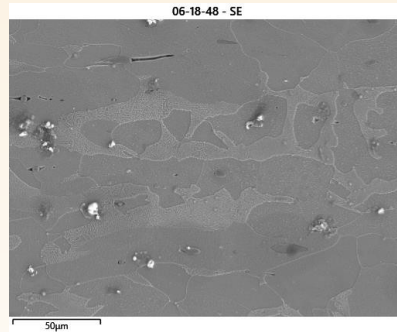
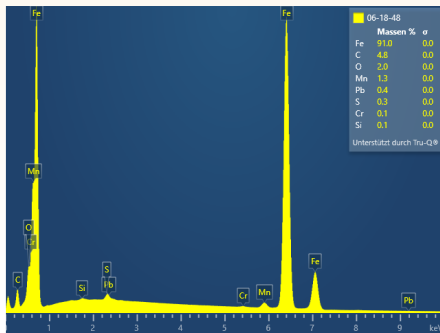
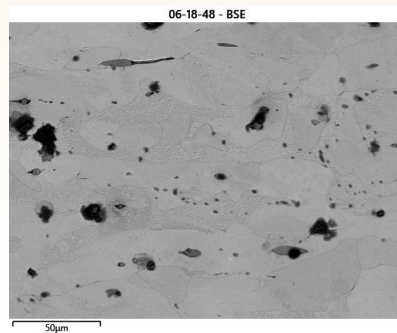
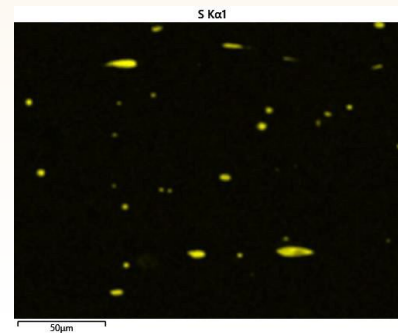
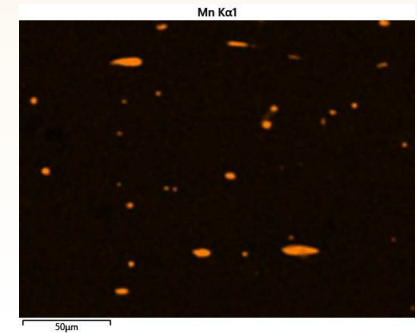
# Examination – part 06-18-48

- Part cross section, nital etched
  - Microstructure ferrite/pearlite with some manganese sulfides

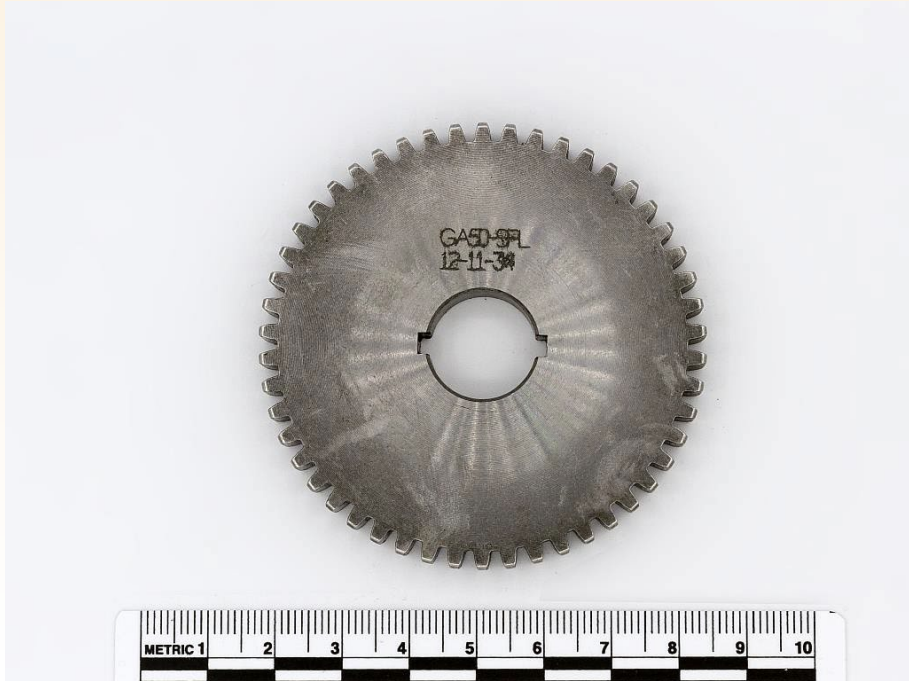
# Examination – part 12-11-34

- Part in condition as delivered
  - Shot peened surface

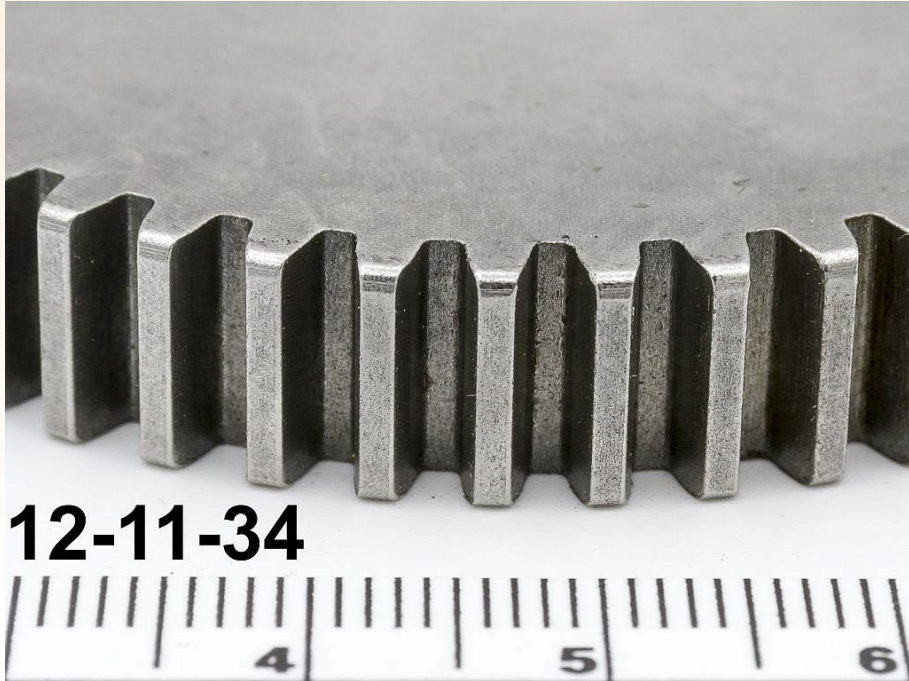
# Examination – part 12-11-34

- Part in condition as delivered
  - Shot peened surface

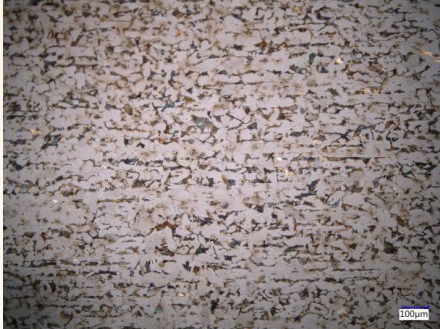
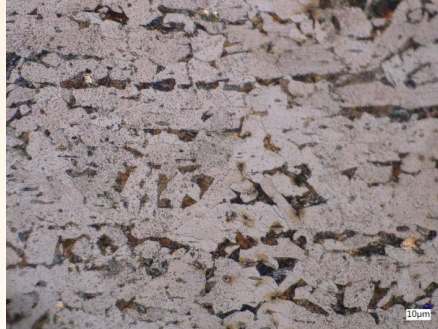
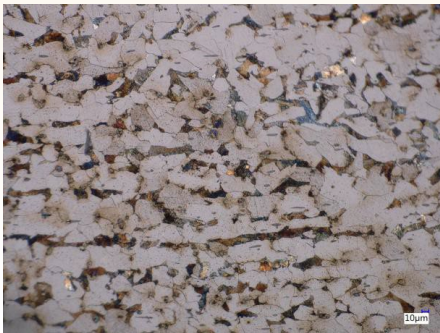
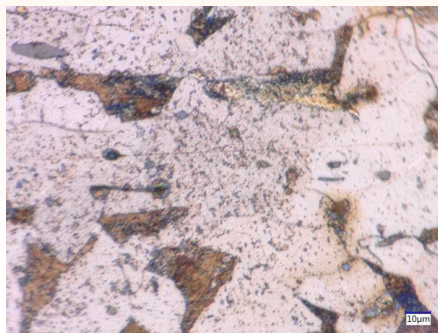
# Examination – part 12-11-34

- Part cross section, nital etched
  - Microstructure ferrite/pearlite with some manganese sulfides

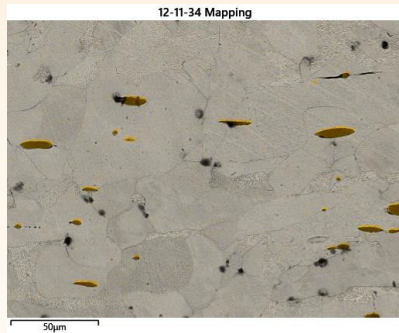
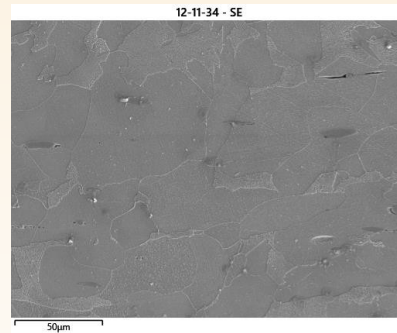
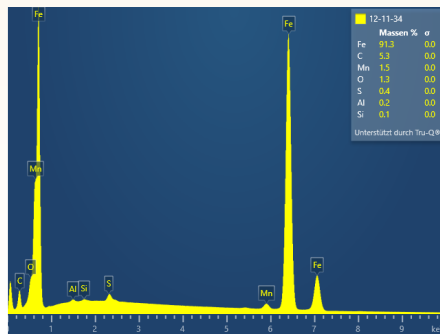
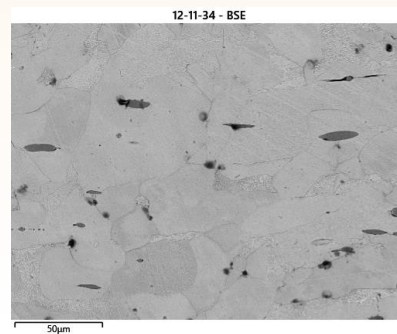
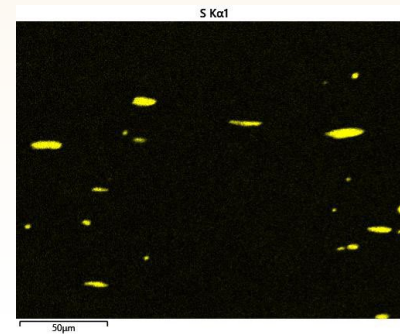
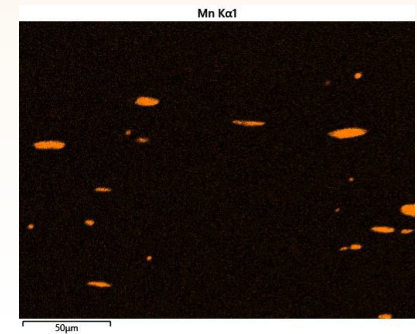
# Examination – part 12-11-34

- Part cross section, nital etched
  - Microstructure ferrite/pearlite with some manganese sulfides

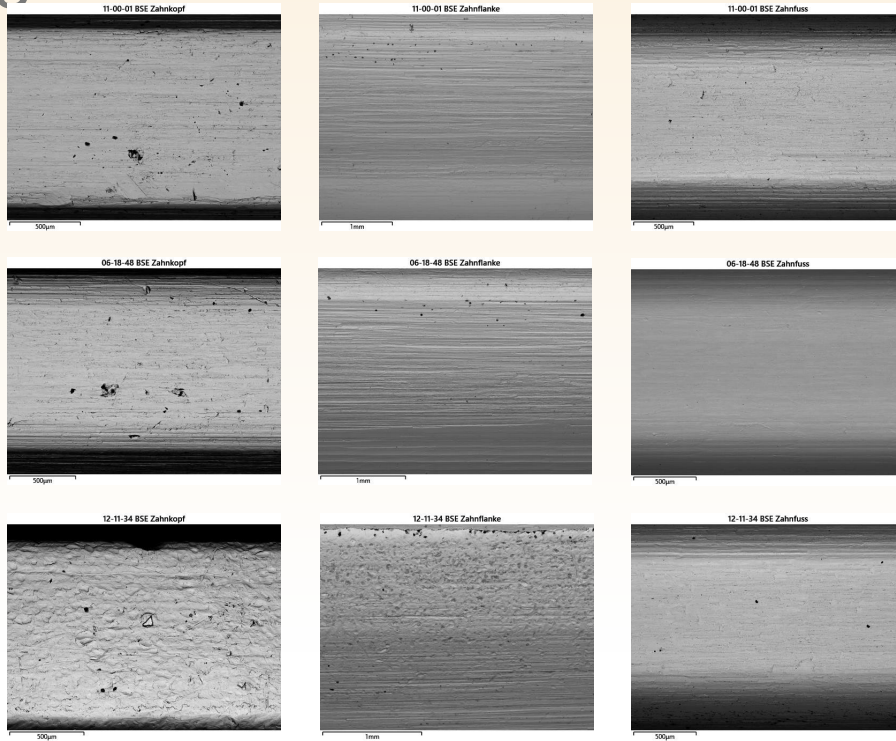
# Examination – Comparison of second gear batch

- Overview of gear surfaces
  - Surface comparison of three gears

- Gears were delivered in slightly different conditions on gear faces each one with one side ground and one side as machined or shot peened
  - 11-00-01 and 06-18-48 machined
  - 12-11-34 shot peened
- Surfaces show different conditions in gear tooth flanks
  - 11-00-01: Gear flank surface appears rough from machining
  - 06-18-48: Gear flank surface smoother than 11-00-01
  - 12-11-34: Gear flank surface shot peened
- Chemical composition with no significant difference
- Some dents with silicon inclusion on the grinded gear face on all parts
- Surface of gear face identical on all parts
- Differences in the test result can be attributed to different surfaces of the tooth flanks
- Further investigations of gears with different test results are recommended

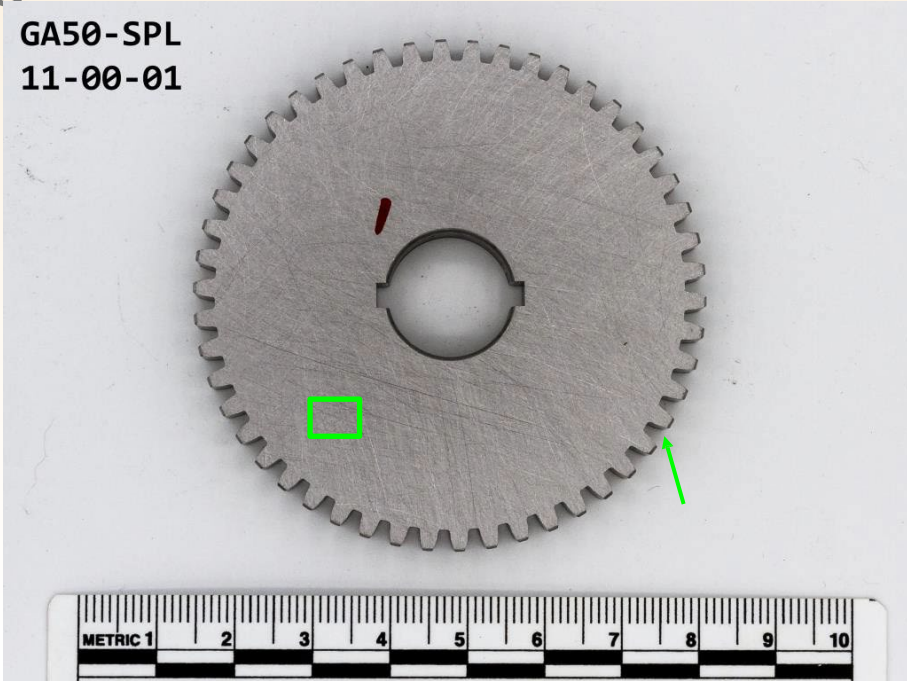
GA50-SPL  
11-00-01

- Overview ground surface
  - SEM areas shown in picture

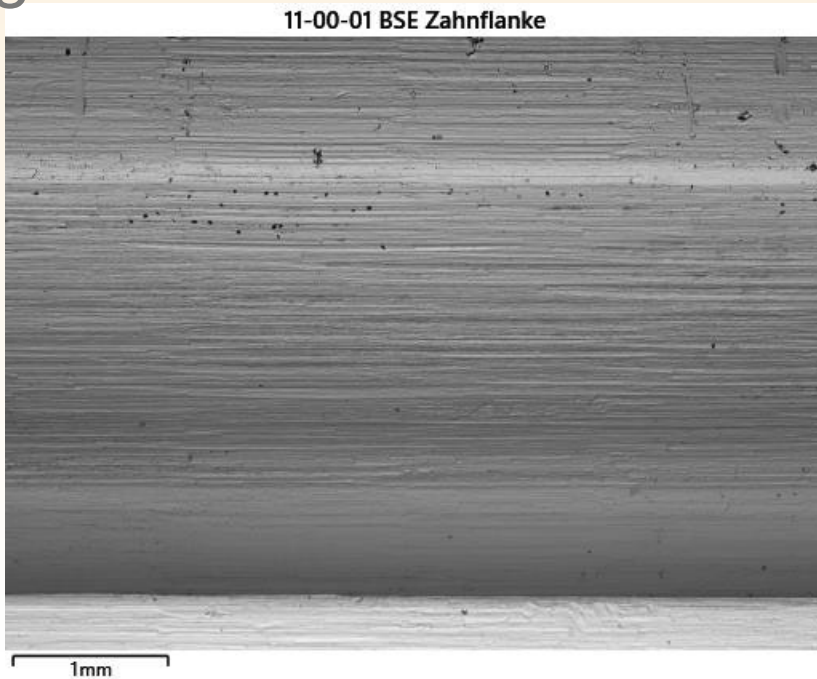
# Examination – part 11-00-01 - second gear batch

- Gear tooth flank
  - Rough surface from machining

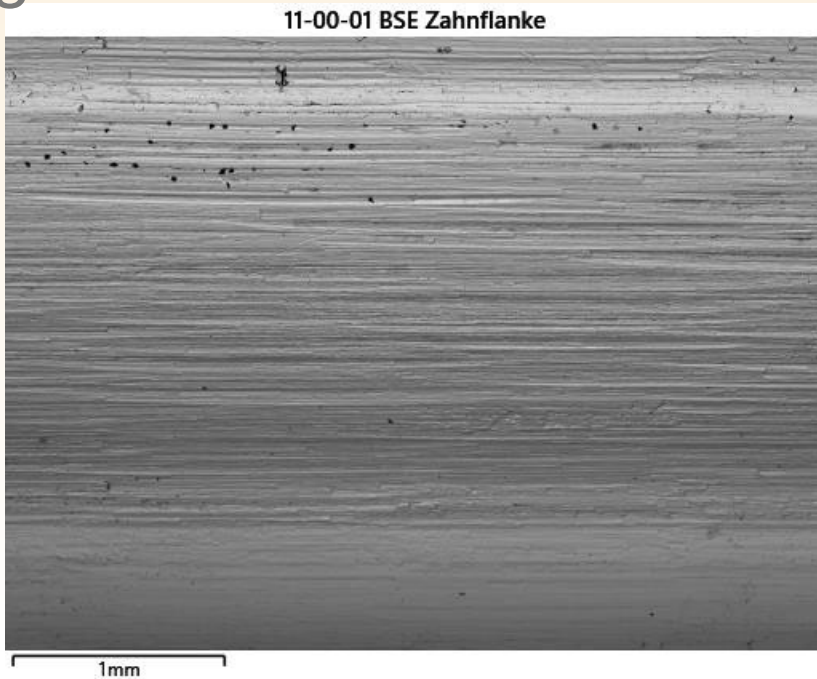
# Examination – part 11-00-01 - second gear batch

- Gear tooth flank
  - Rough surface from machining

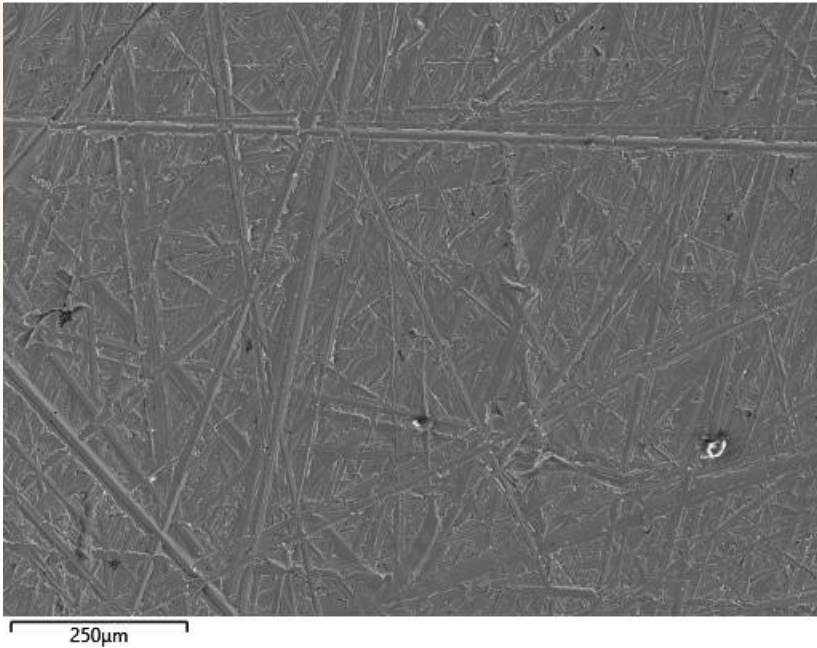
SE 11-00-01

- Gear face
  - Grinded surface with some silicon indentions

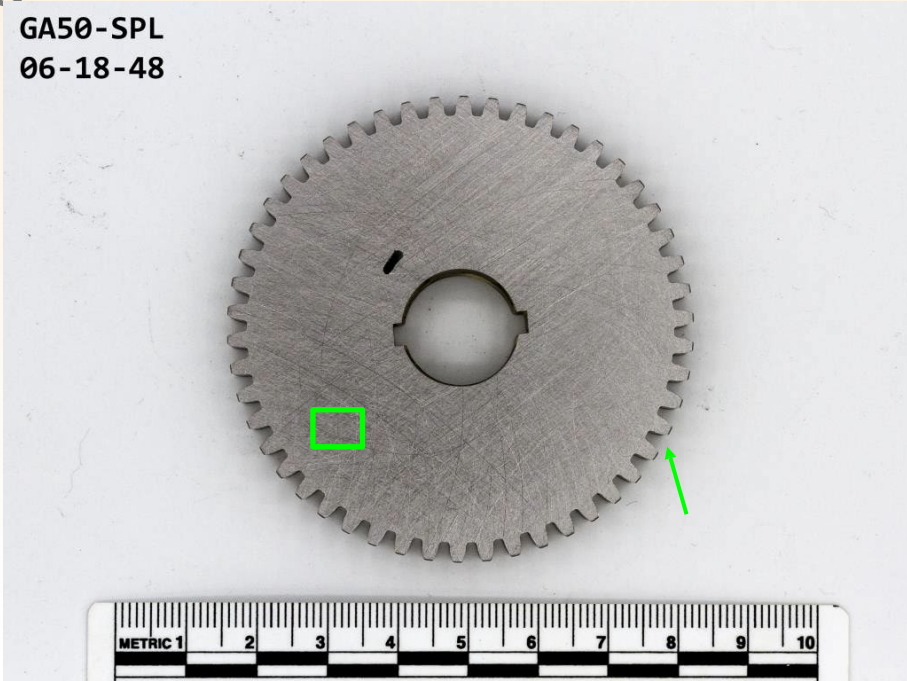
GA50-SPL  
06-18-48

- Overview ground surface
  - SEM areas shown in picture

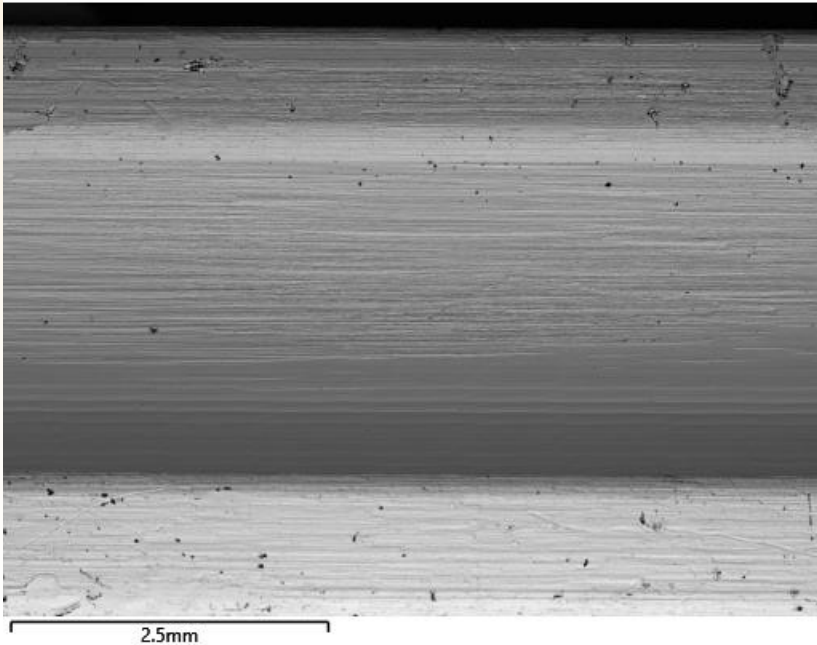
06-18-48 BSE Zahnflanke

- Gear tooth flank
  - Machined surface

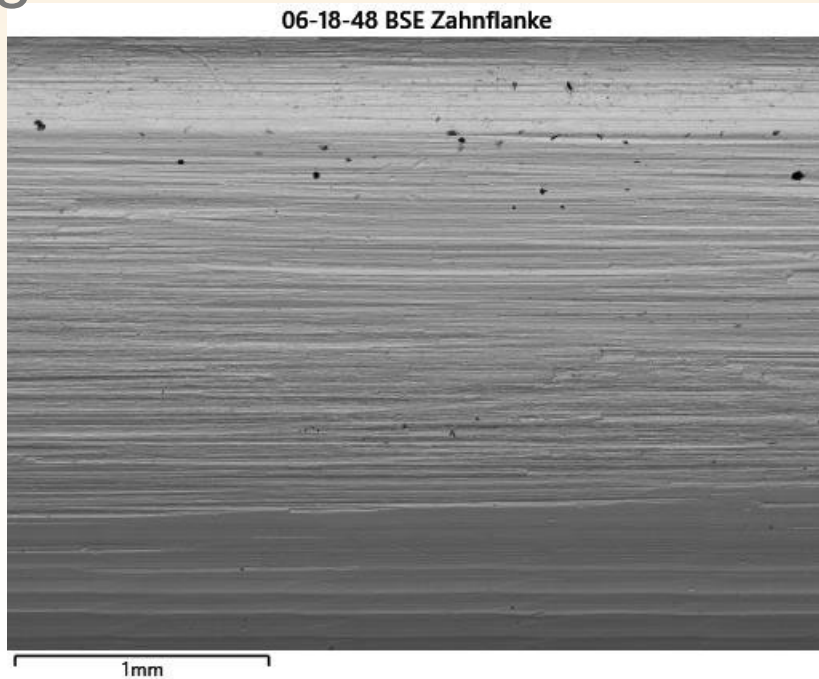
# Examination – part 06-18-48 - second gear batch

- Gear tooth flank
  - Machined surface

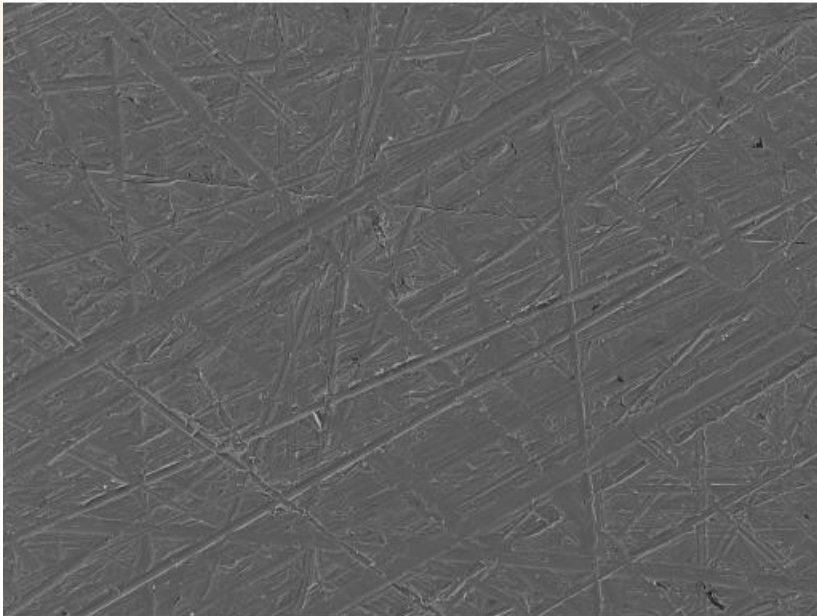
SE 06-18-48

- Gear face
  - Grinded surface with some silicon indentions

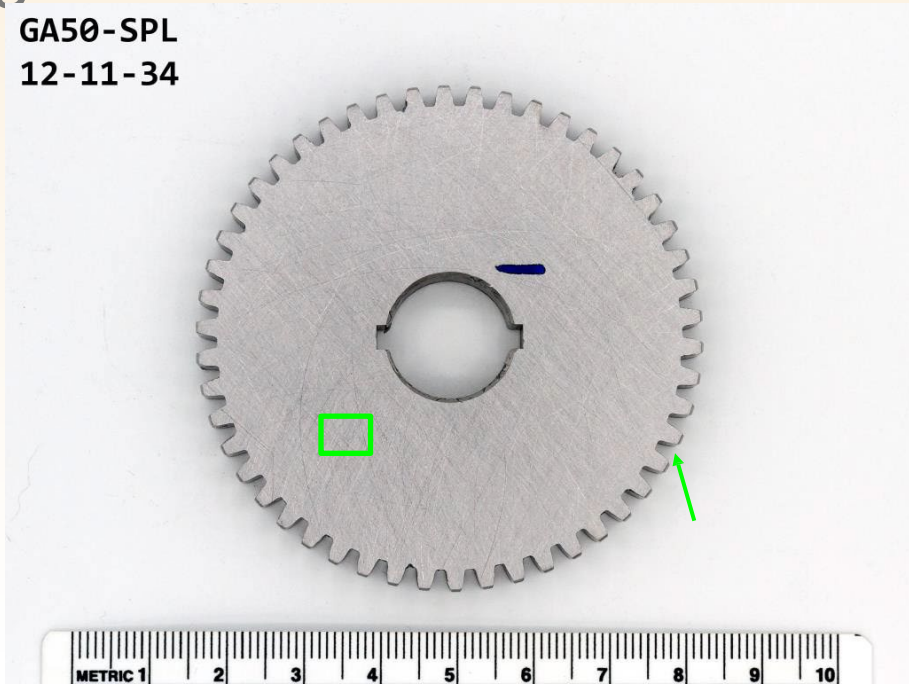
GA50-SPL  
12-11-34

- Overview ground surface
  - SEM areas shown in picture

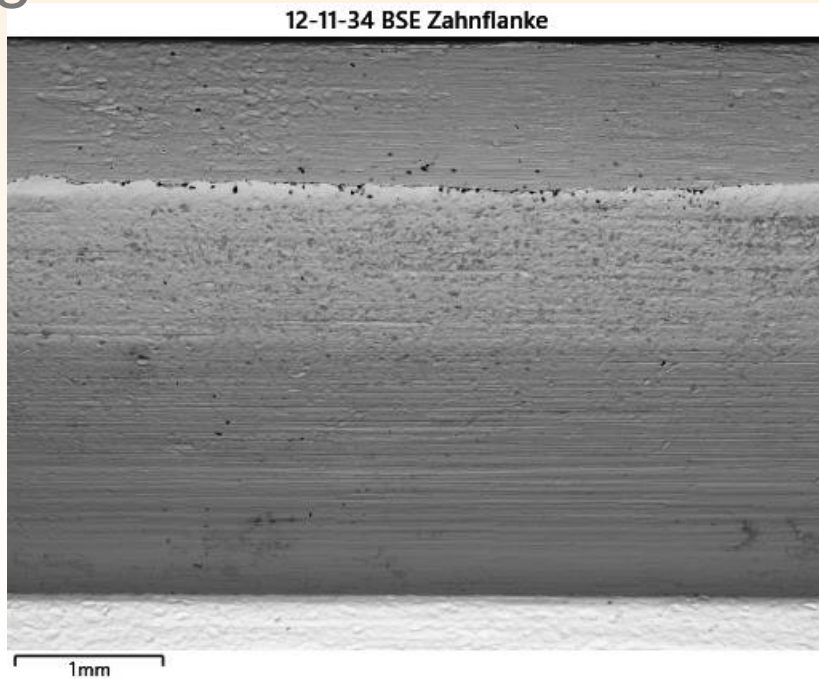
# Examination – part 12-11-34 - second gear batch

- Gear tooth flank
  - Surface machined and shot peened

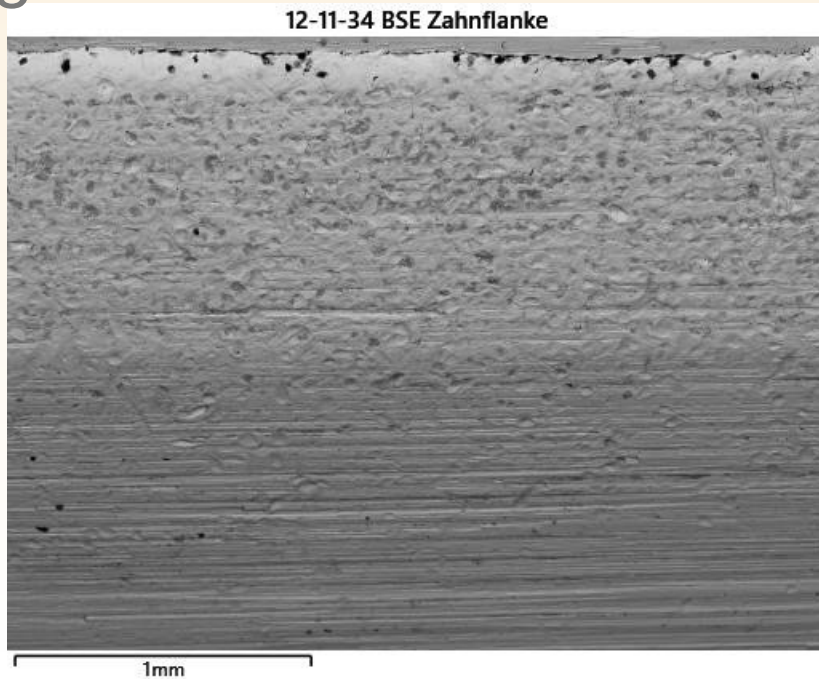
# Examination – part 12-11-34 - second gear batch

- Gear tooth flank
  - Surface machined and shot peened

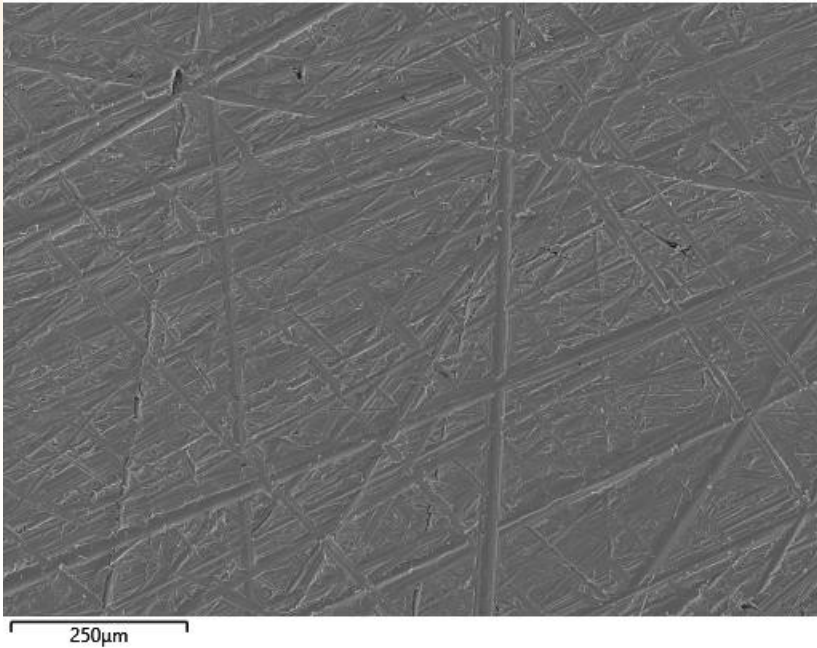
SE 12-11-34

- Gear face
  - Grinded surface with some silicon indentions

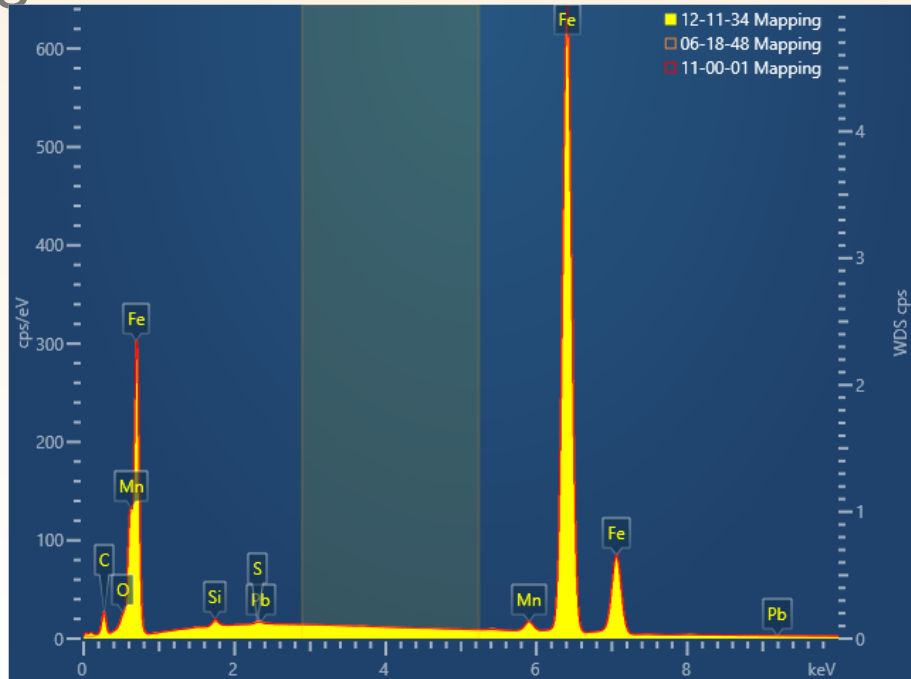
# Examination – Comparison - second gear batch

- Spectra comparison
  - Chemical composition similar within normal deviation

Masse-%	C	O	Si	S	Mn	Fe		
06-18-48 Mapping	6.84	0.67	0.25					
11-00-01 Mapping								
12-11-34 M

- Gears were delivered in different conditions
  - 11-00-01 and 06-18-48 machined
  - 12-11-34 shot peened
- No significant difference in microstructure was examined
- No significant chemical composition was examined
- Gears were not in condition prepared for test due to customer information
- No reason for different test results observed
- Further investigation may be taken in final testing condition
- Further investigation may be taken for red substance on surface after test which determines test result
