V1L500/P4T813 NON-LUBRITED MATRIX RESULTS

L37
Test: Matrix Test
Auth. Code: CMIR-59315 (SR-0266)
Oil: 04-0215
Run: LO-210344
SwRI: *6-27-08*
Date / Time: *D. Hawk*
Hours:

D6121 L-37

High Torque Test - Standard

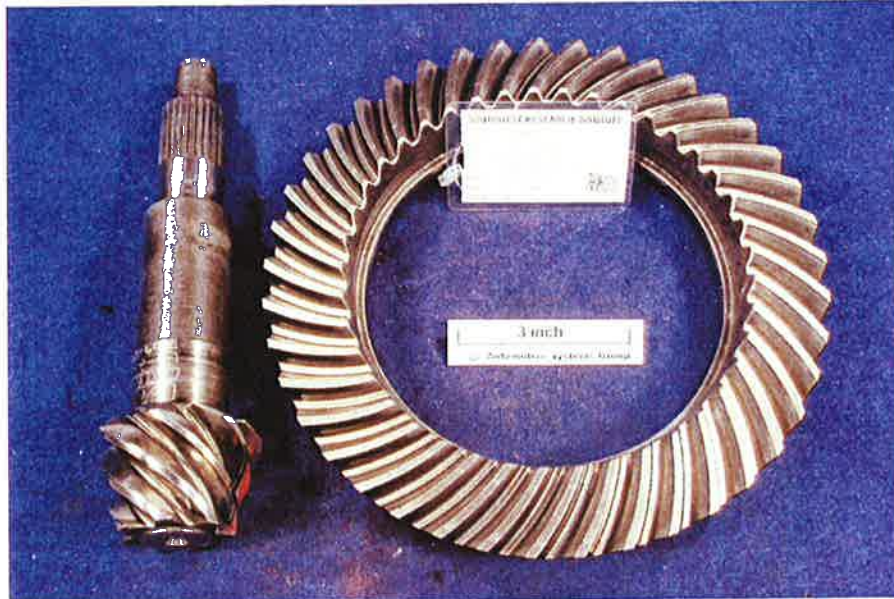
FIGURE 1: SWRI SAMPLE HYPOID DRIVE GEAR SET AS RECEIVED.

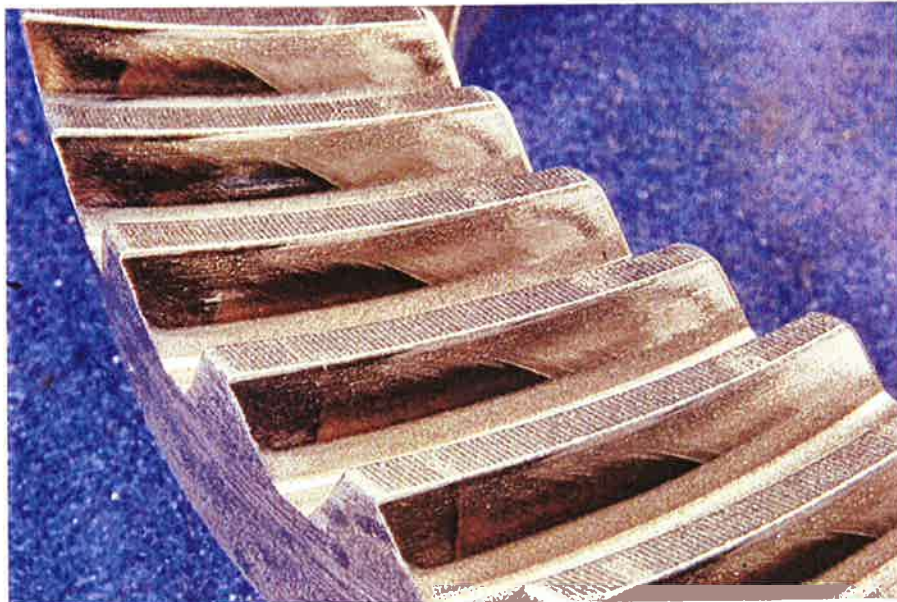
FIGURE 2: SWRI SAMPLE TYPICAL GEAR CONTACT PATTERN ON TOOTH DRIVE SIDE. NOTE THE HARD CONTACT AT ROOT AND UPPER FLANK EDGE NEAR TOP LAND ON THE HEEL END OF TEETH. THE OVERALL PATTERN IS BIASED TOWARD THE HEEL END.

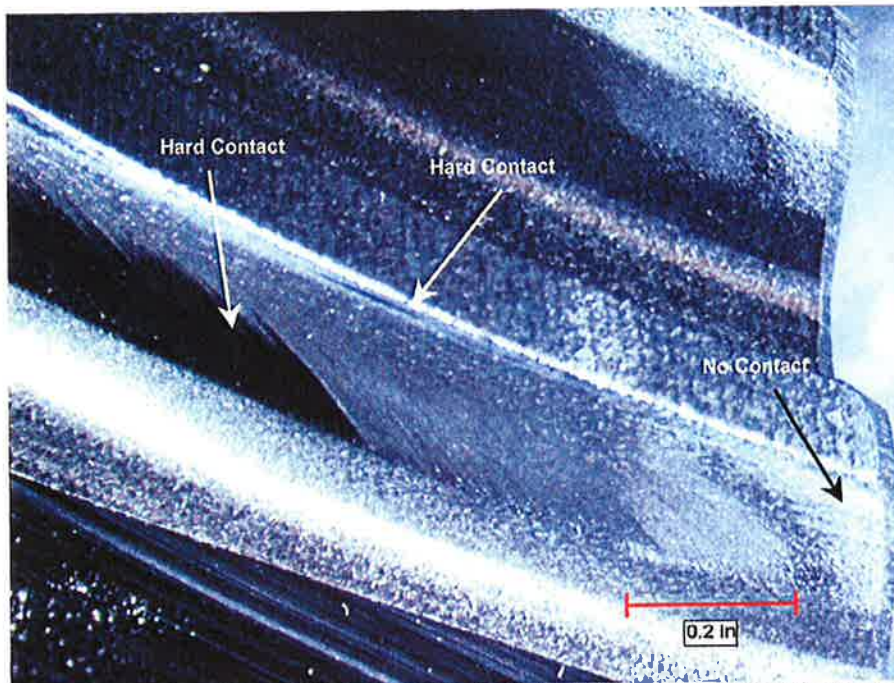
FIGURE 5: SWRI SAMPLE ENLARGED IMAGE OF FIGURE 3 GEAR TOOTH SURFACE ON DRIVE SIDE AT TOE END. NOTE UNEVEN REGION OF CONTACT BETWEEN UPPER AND LOWER FLANK, AND TOE END VERSUS TOOTH MID-SECTION. AREA OF HARD CONTACT IS VISIBLE AT UPPER FLANK EDGE ADJACENT TO TOP LAND.

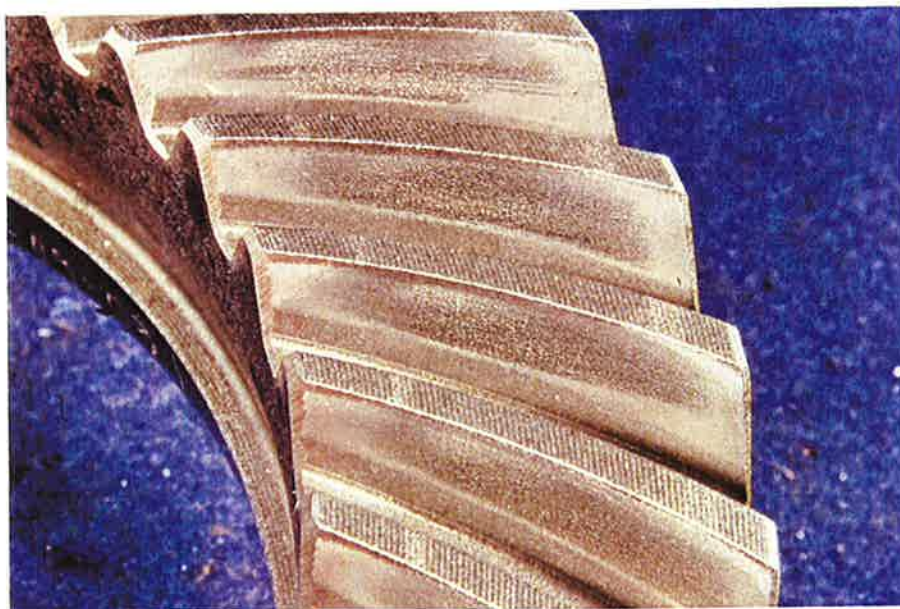
FIGURE 6: SWRI SAMPLE TYPICAL GEAR CONTACT PATTERN ON TOOTH COAST SIDE.

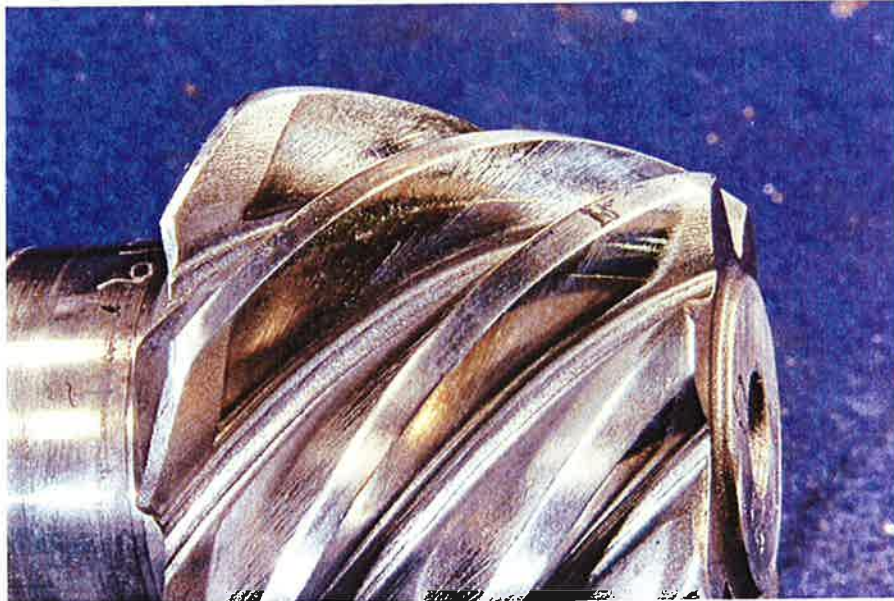
FIGURE 2: SWRI SAMPLE TYPICAL PINION GEAR CONTACT PATTERN ON TOOTH DRIVE SIDE. THE PATTERN HAS A DARKER REGION WITH POLISH AND RIDGING AT THE HEEL END, WHICH TRANSITIONS TO REGION OF LIGHTER POLISH AND RIDGING AT THE TOE END.

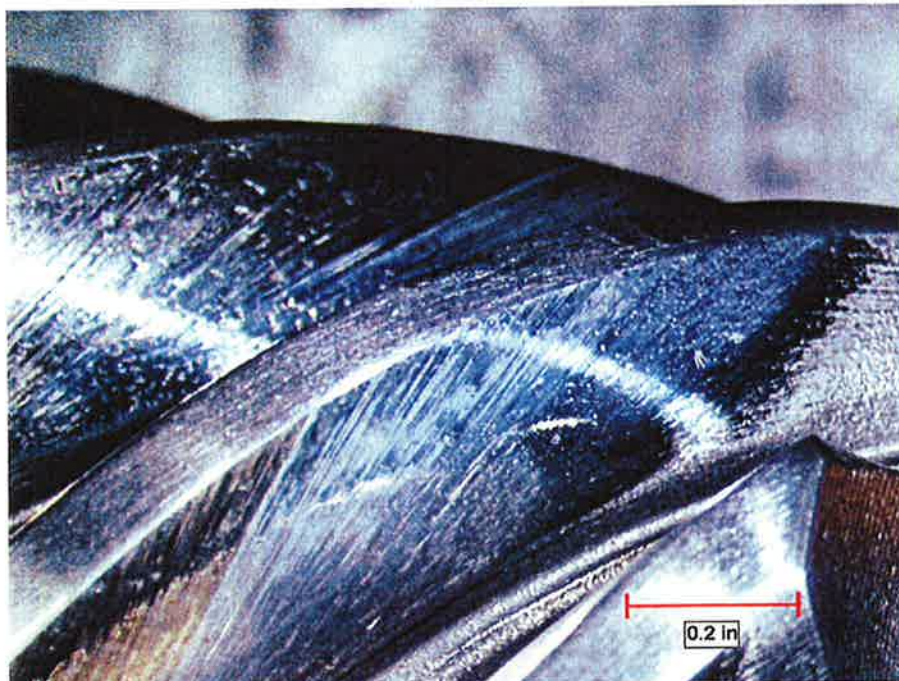
FIGURE 3: ENLARGED IMAGE OF FIGURE 2 PINION GEAR TOOTH SURFACE ON DRIVE SIDE. NOTE RIDGING PRESENT ON TOOTH FLANK.

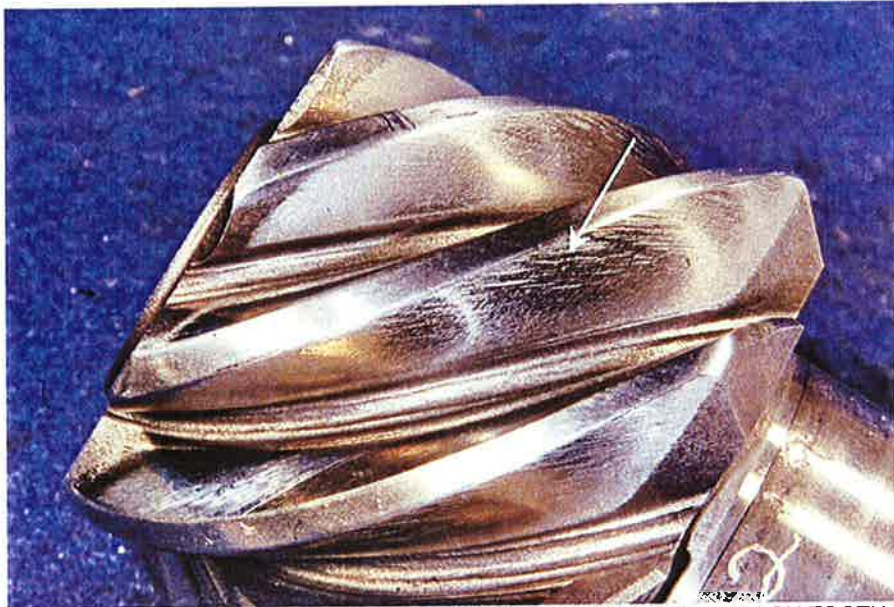
FIGURE 4: SWRI SAMPLE TYPICAL PINION GEAR CONTACT PATTERN ON TOOTH COAST SIDE. THE PATTERN IS MORE LIGHTLY POLISHED WITH SOME SCORING ON THE UPPER FLANK OF THE CENTRAL TOOTH REGION.

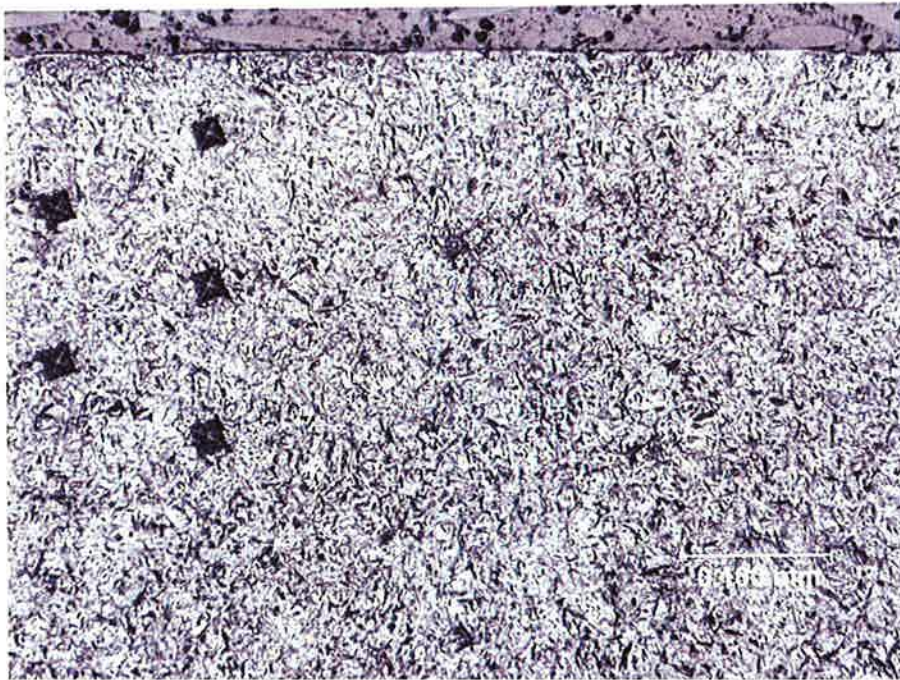
FIGURE 5: SWRI SAMPLE TYPICAL MICROSTRUCTURE OF THE PINION TOOTH CASE AT THE PITCH, CONSISTING OF TEMPERED MARTENSITE. ETCHED IN 2% NITAL.
