19R-04-14 Volvo Nodules

Rob Cumming

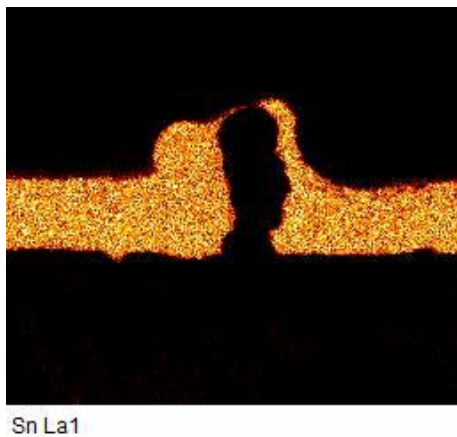
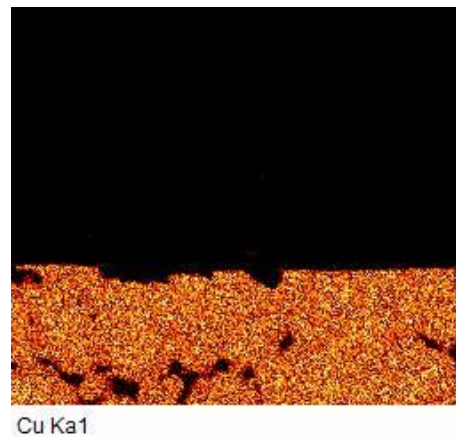
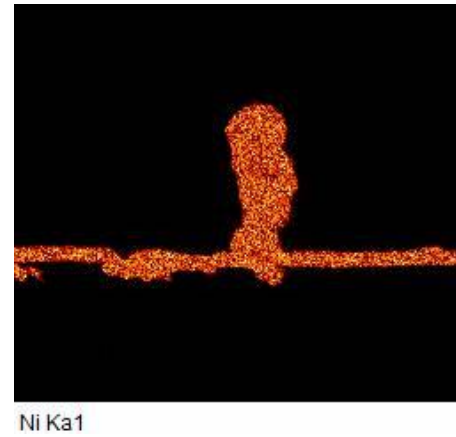
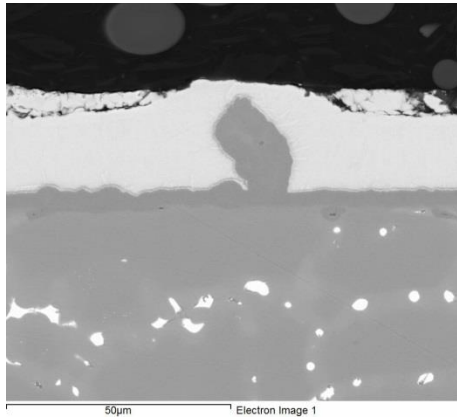
■ Nickel nodule
seen underneath
the tin overlay
