Committee D02 on PETROLEUM PRODUCTS AND LUBRICANTS

Unapproved Minutes of the October 27, 2015
Sequence IV Surveillance Panel Meeting.

Intake Camshaft Lobe Failure Issue

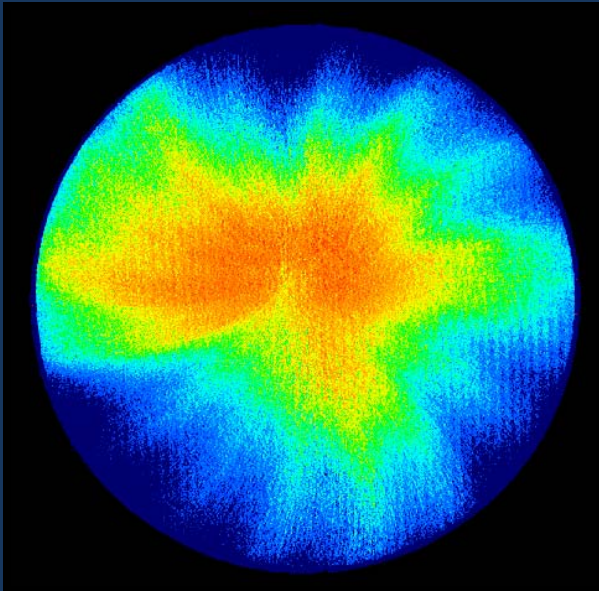
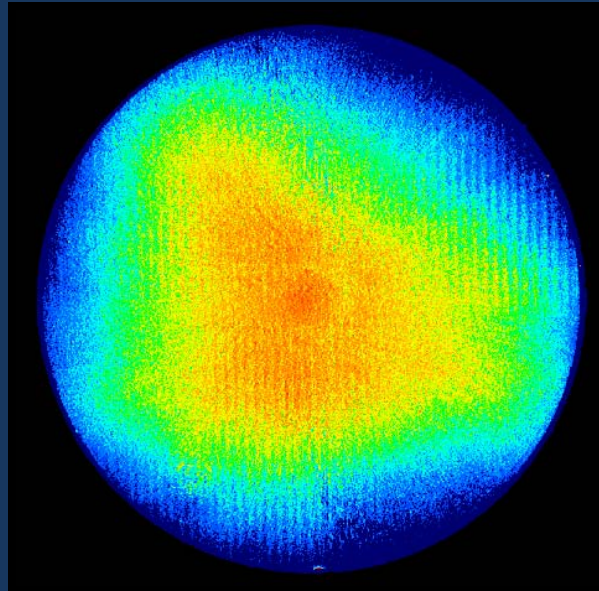
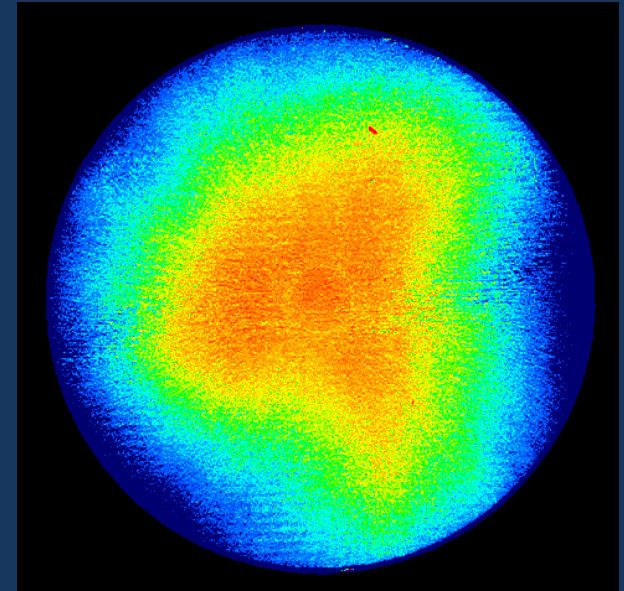
Proposed Hypothesis on Lifter Rotation

- Potential causes:
 - Valvespring orientation
 - Camshaft end-play
 - Asymmetric lifter surface topography

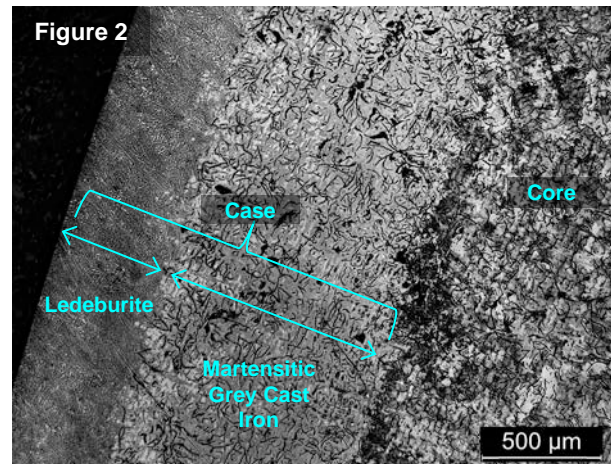
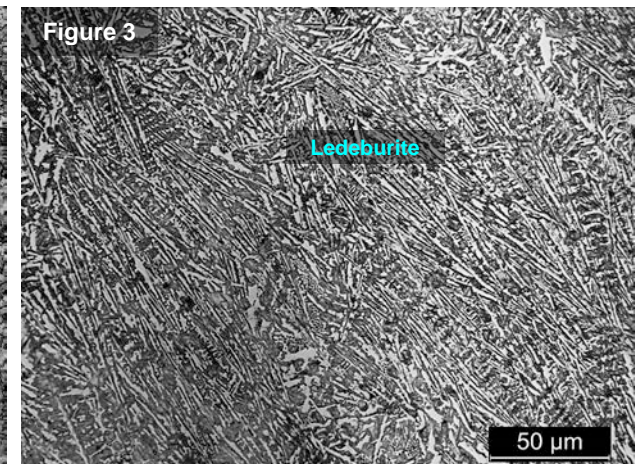
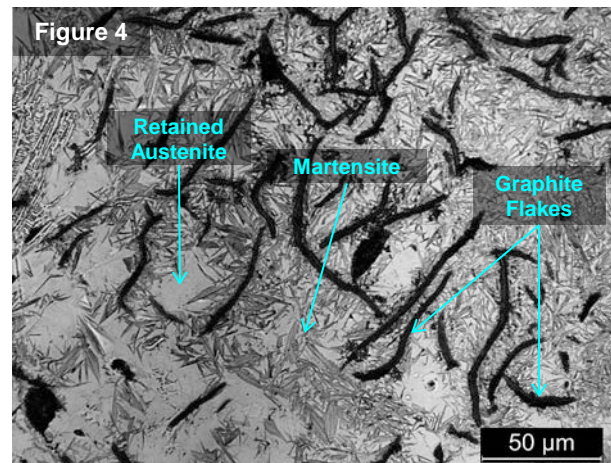
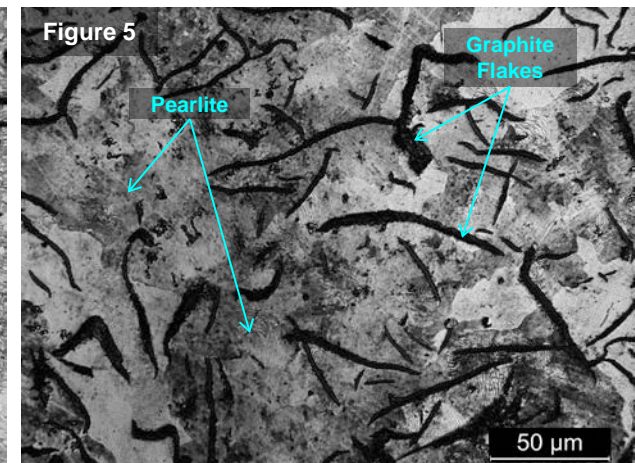
Probing the microstructure of a production cam lobe (provided by Toyota in 2012) reveals a case hardened grey cast iron microstructure. Case hardening in this case appears to have been achieved by laser surface processing (laser surface melting in this case) which has resulted in three distinct microstructural layers as shown the schematic of figure 1 and the low magnification metallograph of figure 2 capturing all three layers.

The outer layer is about 0.5mm thick is predominantly feathery ledeburite consisting of cementite (carbide) and martensite. The microstructure of this layer is shown in the micrograph of figure 3.

Below the top ledeburite layer is a 1mm thick layer of grey cast iron consisting of retained austenite (white constituent) and martensite matrix (figure 4).

The microstructure of the bulk of the cam lobe beyond the hardened case layers is shown in the micrograph of figure 5 and shows a typical grey cast iron structure with type A graphite (i.e. randomly oriented large flakes) in a pearlitic matrix and small volumes of free ferrite. This is the as-cast structure of this camshaft. Case hardening, as shown in the schematic of figure 1 is only done on the nose side of the cam lobe. No case hardened layer was observed in on the surface of the base circle of the cam lobe.

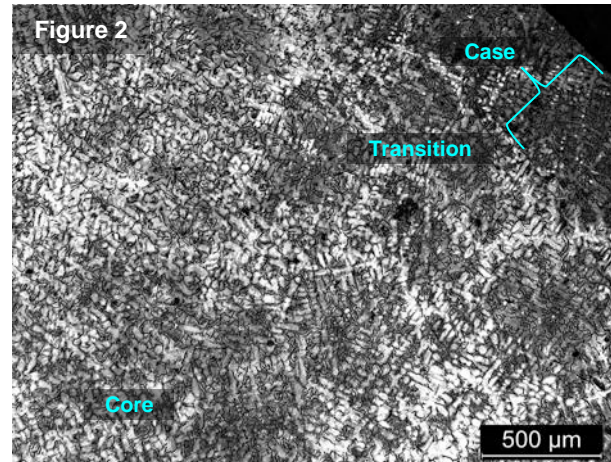
Figure 2

The microstructure of the test cams (used at Intertek and SWRI) also consists of a case hardened structure typically seen in flame hardened or induction hardened grey cast iron specimens. The schematic of figure 1 shows the observation that the case is present through out the entire periphery of the lobe (unlike the production cams discussed in previous pages). The low magnification micrograph of figure 2 encompasses the observed hardened surface layer (case) and the core microstructure. The microstructure of the case (fig. 3) consists of a fine type D (dendritic) graphite network in a martensite and retained austenite matrix (giving the observed HV400 hardness). The microstructure of the transition region between the case and the core mainly consists of similar dendritic graphite in bainite and fine pearlite and small volumes of free carbide (figure 4). Further away from the surface of the lobe, the microstructure of the core (figure 5) transitions from dendritic graphite in a pearlitic matrix to more of type A graphite flakes also in a predominantly pearlite matrix.

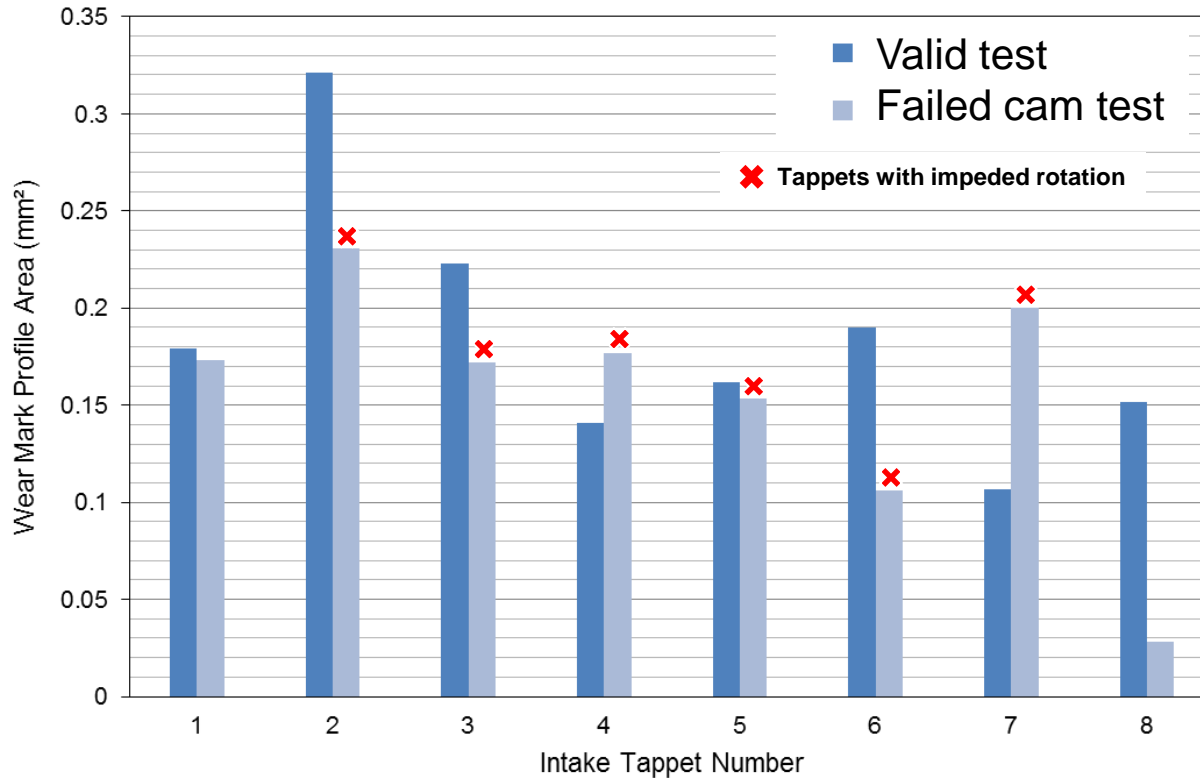
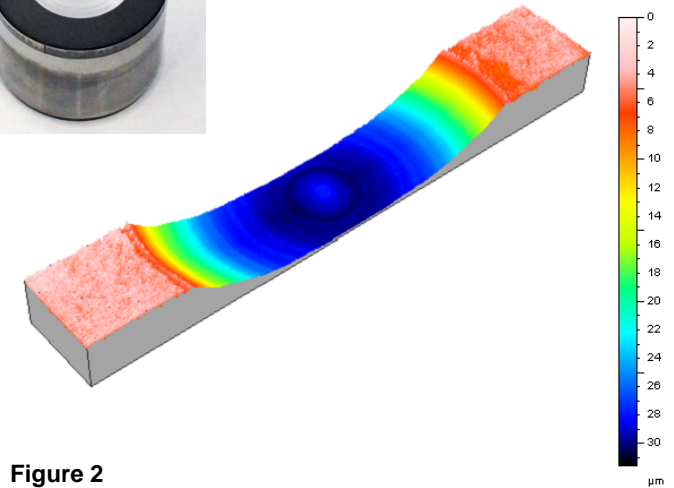
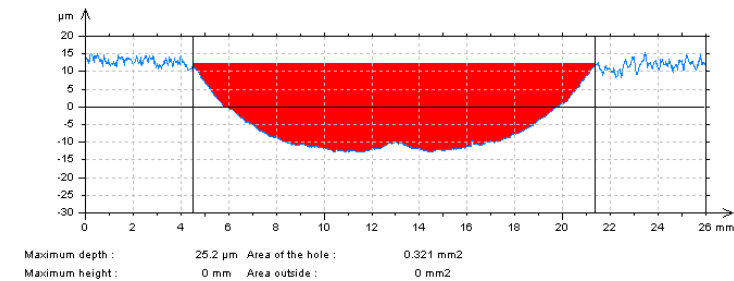
Tappet Wear: Top Surface

Intake tappets from the corresponding valid test
