Caterpillar C13 Low Viscosity Study

SOUTHWEST RESEARCH INSTITUTE®

July 2024, updated September 2024

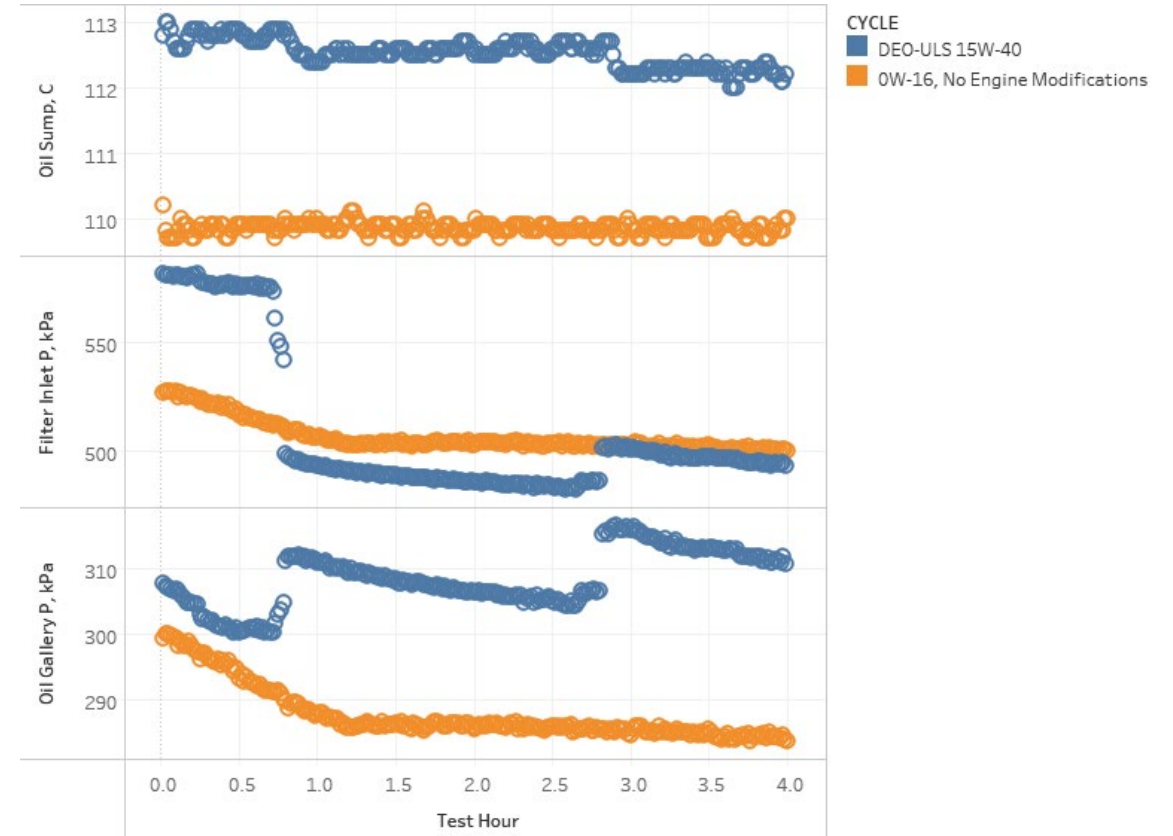
Operation 2

- ~2-3 degree delta noted in sump temp
- More pressure jumps seen with DEO-ULS, possibly more active internal control valves or things stabilizing
- 0W-16 gallery pressure stabilized near 280 kpa, DEO-ULS closer to 310 kpa

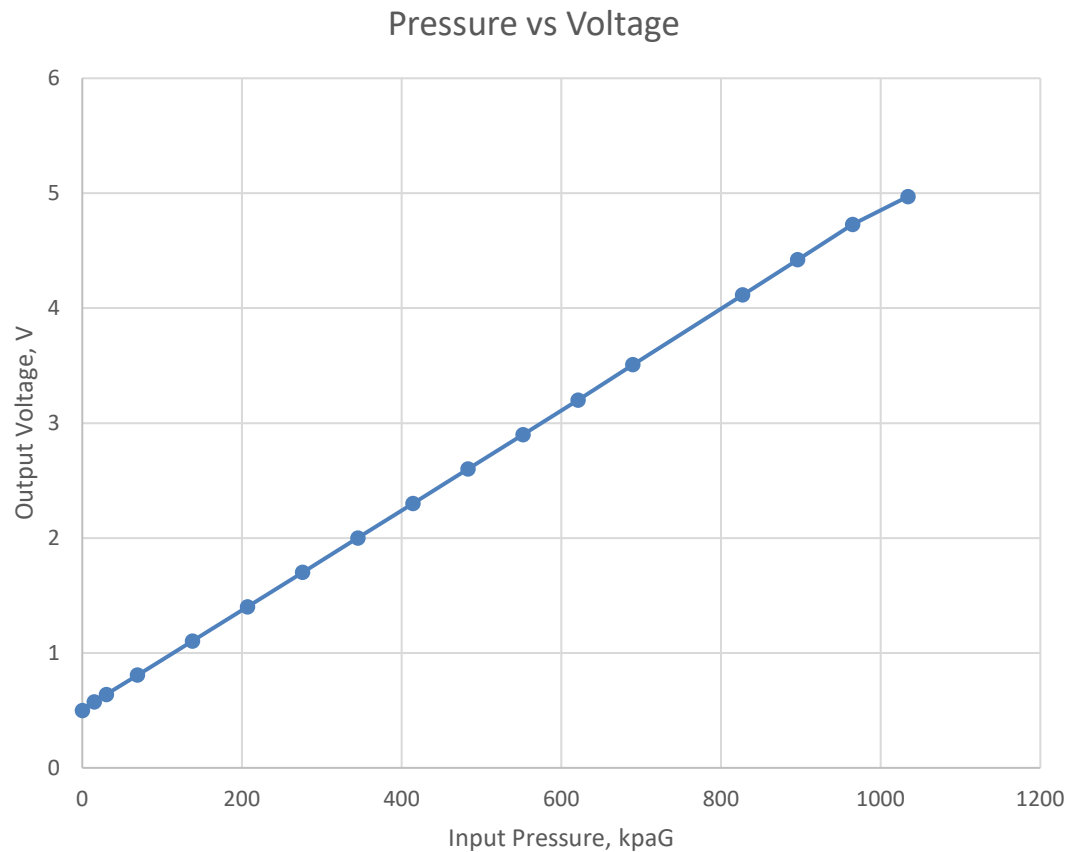
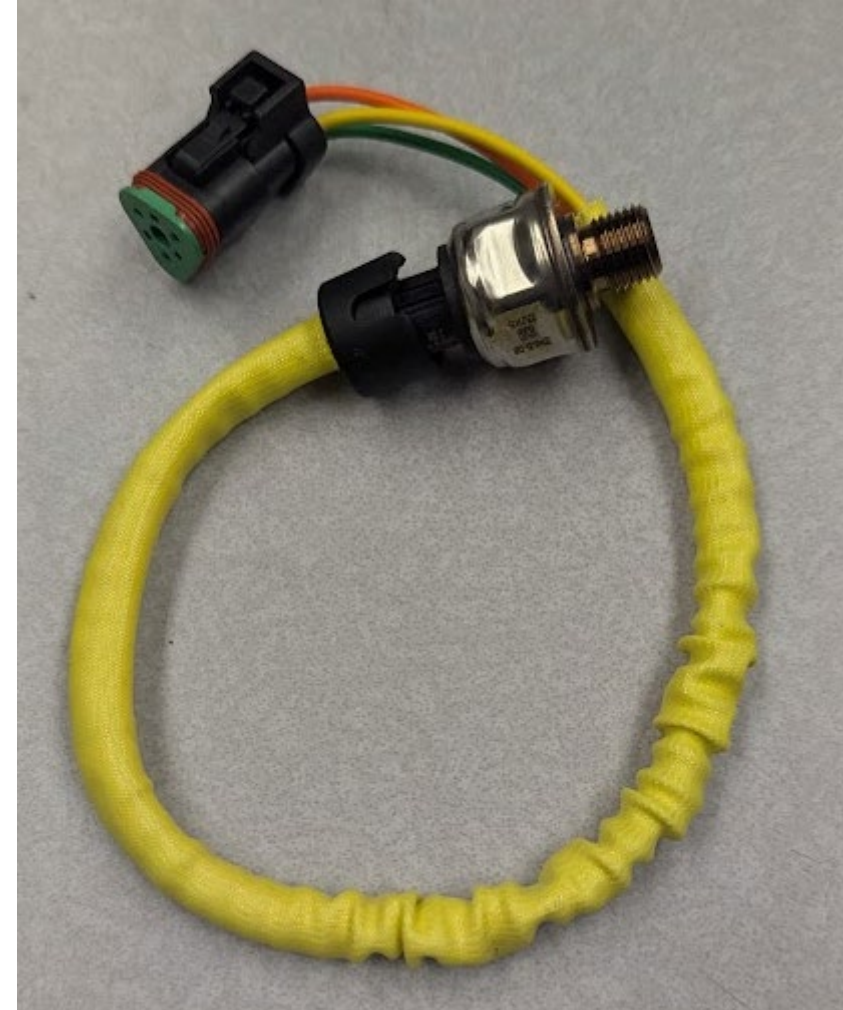
ECM Oil Pressure Sensor – 194-6725

- 3-wire sensor
- 0-5V input/output

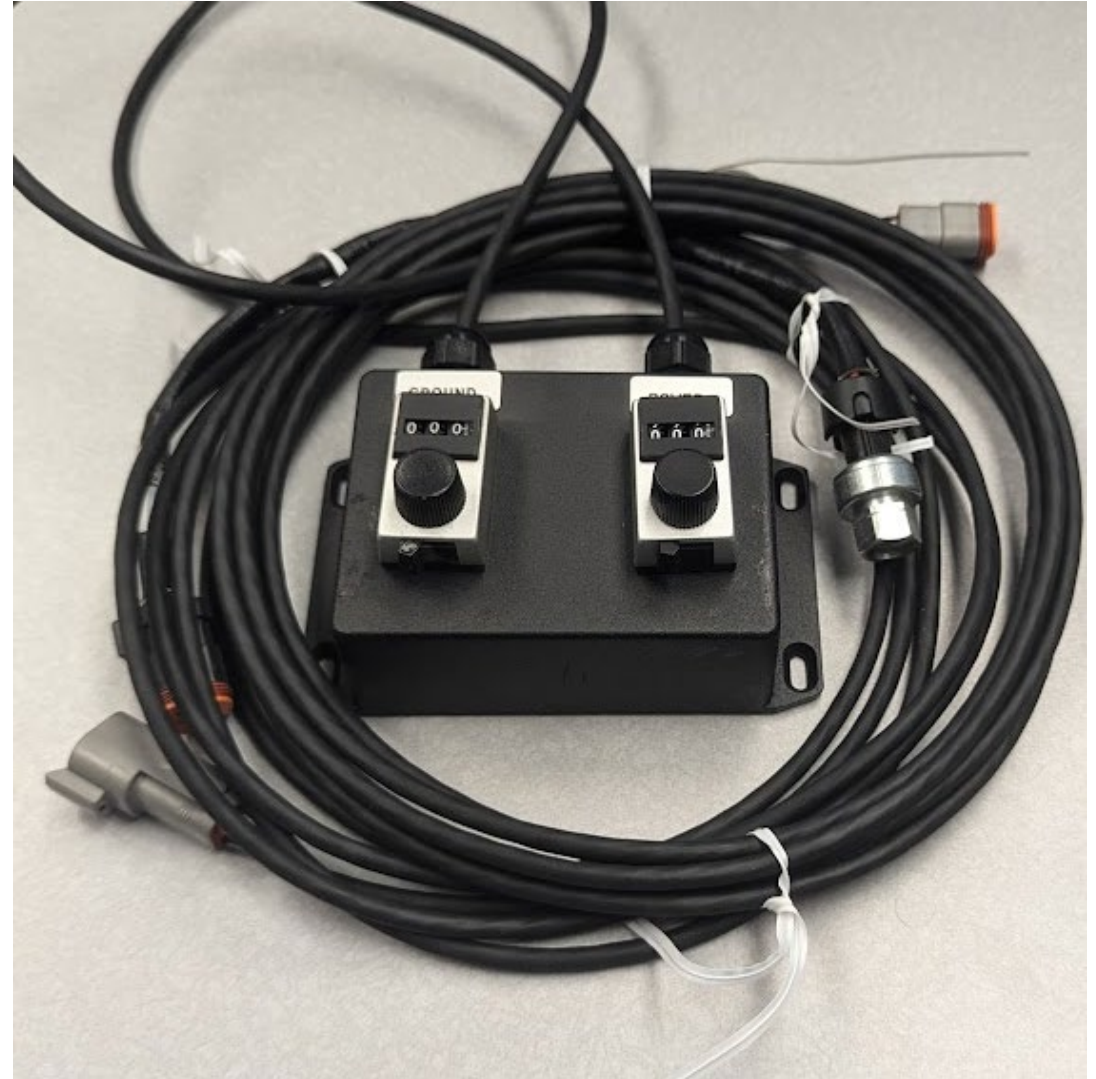
Next Steps

- Install jumper in between pressure sensor and ECM to add resistance and raise the “ECM Pressure” value
- May need to add something to the IVA system as well, will investigate after the main oil pressure sensor study

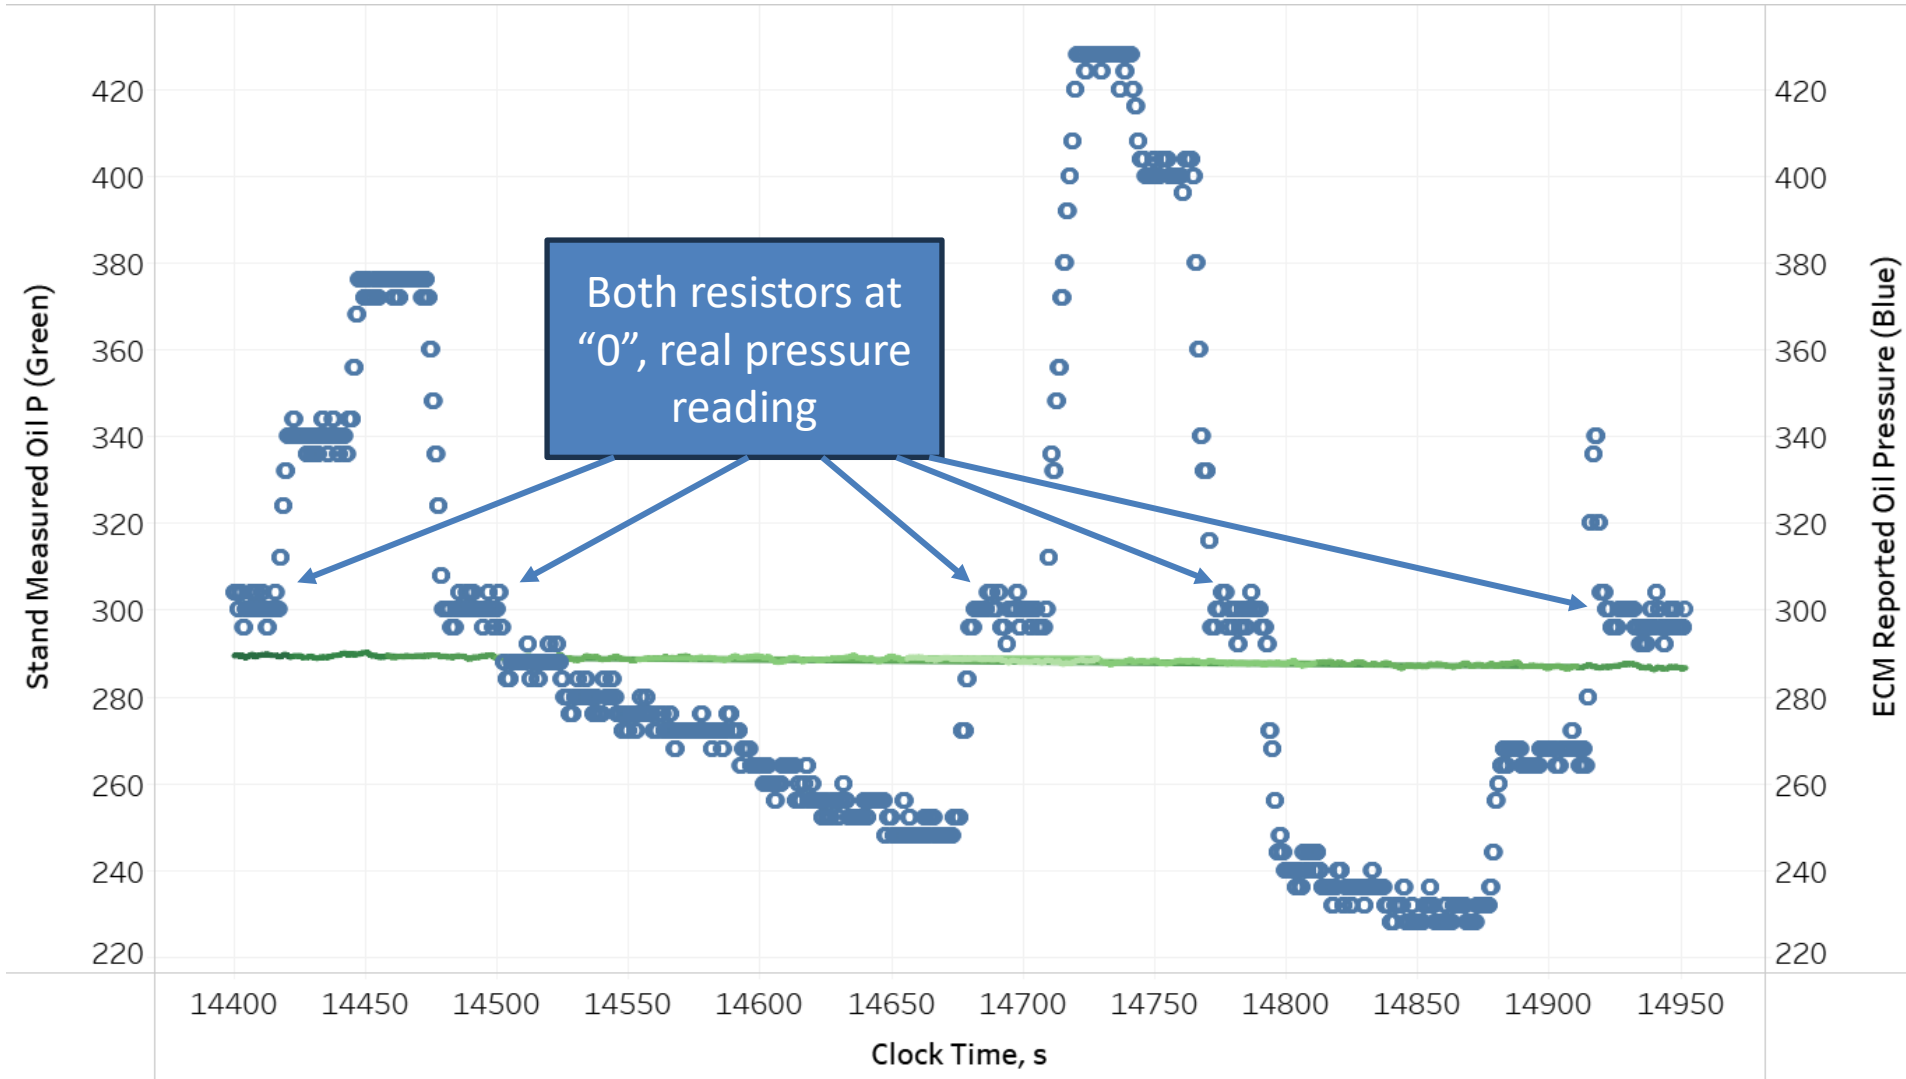
Follow On Efforts

- First “Warning” appears around 300kpa ECM measured gallery pressure
- First “Alarm” seemed to appear around 230 kpa measured gallery pressure
- Due to the nature of the sensor and resistance balancing across the bridge, response is not linear

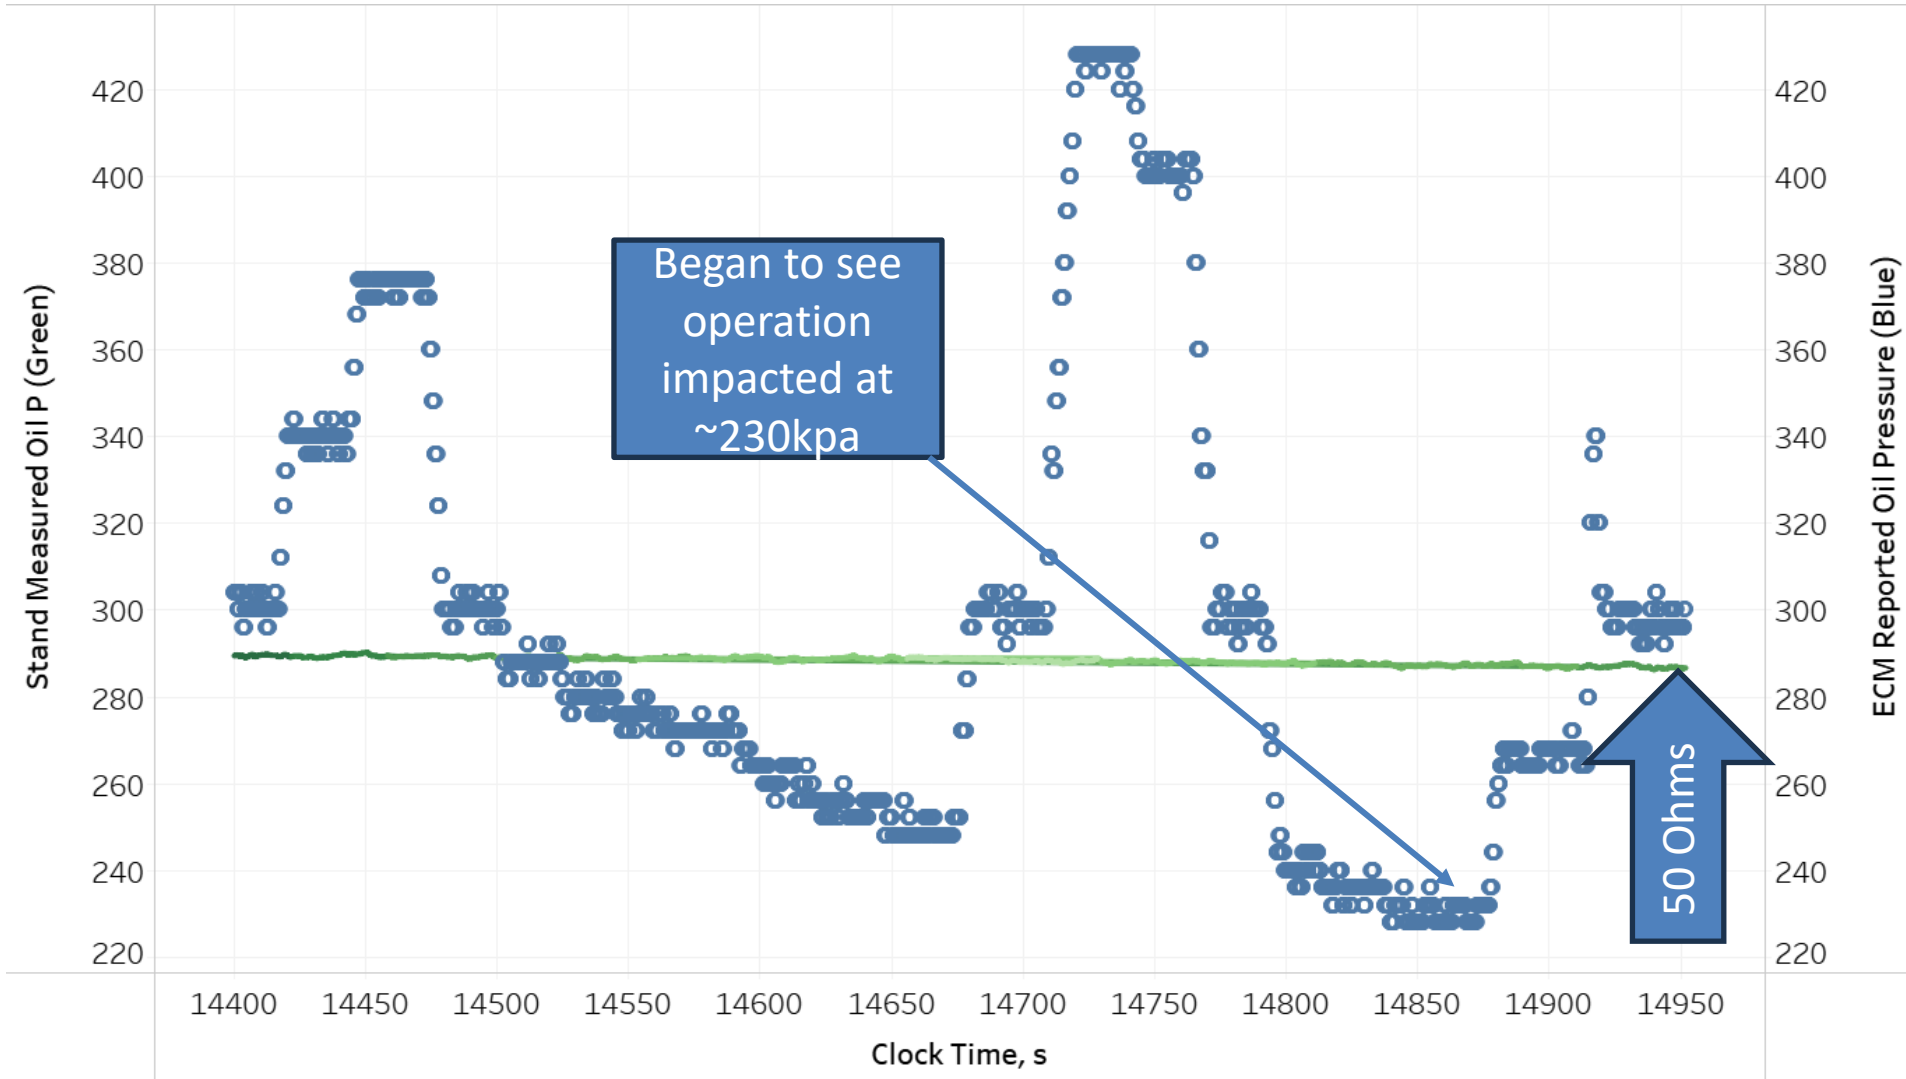
Follow On Efforts

- If an oil exhibits low enough pressure at the gallery to begin triggering flags, the inclusion of a 50 Ohm resistor between the sensor Pin B and the ground should be enough to shift the ECM value into a non-flagging region
- No impact to actual oil pressure or safety of operation, that's on the stand to catch
- IVA system response not evaluated
 - No parameter reported in CAT ET/CAN data for feedback
 - More complicated system that relies on oil P as a hydraulic fluid for IVAs and has internal feedback. Adding resistance may cause more harm than benefit. Likely build related or IVA failure
