Mack SP Teleconference Call Meeting Minutes Thursday, December 6, 2012 10:30 am EST

T-11 Issues

T-12 Severity Issues with TUXO hardware

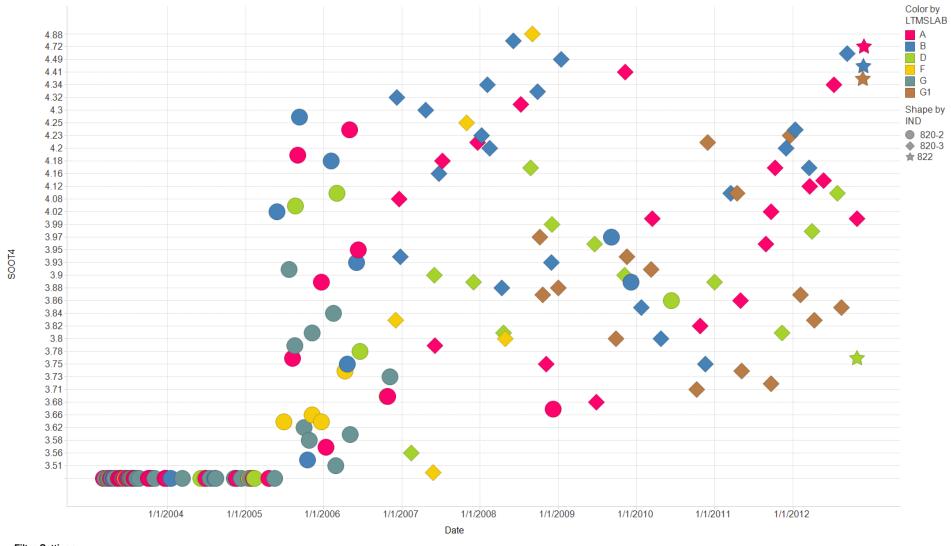
ATTACHMENT 1

In regards to reference oil, Jim Rutherford reviewed a presentation (**Attachment 1**) that he prepared for the panel. The Soot @15 cSt Viscosity Increase appears to be the only real problem with the data. Bob Campbell expressed the concern that the effects of injection timing may be contributing to the problem (**Attachment 2**, originally presented in 2006). Bob stated he saw three options: make this oil work; investigate modifying or tweaking this oil; get a new oil. Scott Richards suggested adding tighter restrictions on soot control as a possible fourth option. Greg mentioned a concern about the rate of soot generation affecting test severity.

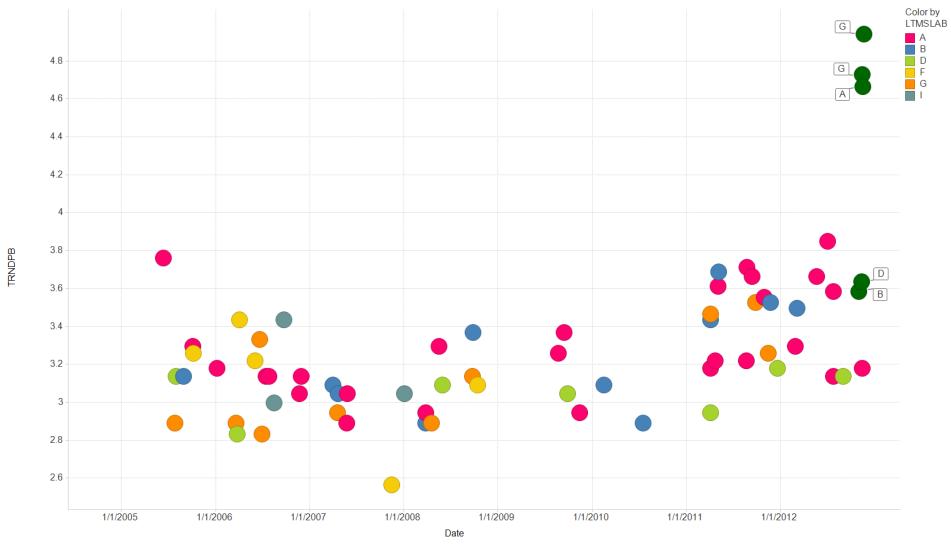
ATTACHMENT 3

Jim Rutherford prepared and reviewed a presentation for the panel (**Attachment 3**). Jim Matasic also presented a bearing analysis (**Attachment 4**). Jim Matasic stated, that in general, nothing really stood out in the analysis as being different between the old and new bearings. Bob Campbell will send his low wear bearing to Jim Matasic for analysis. **ACTION: Bob Campbell.**

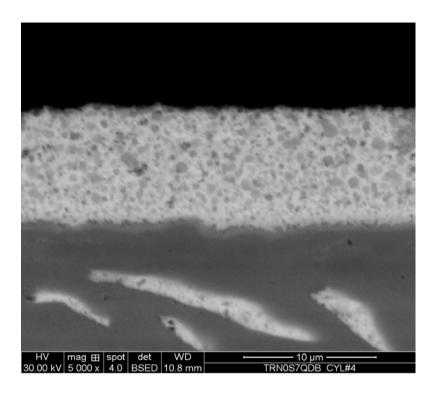
Attachment 4

Mack T-12 U. Rod Bearings

Cross Sections

TRNSJQ\	/PB EOT 3/6	5/12 Batch "W" Low Pb	TRN OS7QDB EOT 10/31/12 Batch "X" Low Pb					
 CYL# >	1	2		3	4				
Sn	10.6	8.4		6.5	16.3				
Cu	25.3	26.2		21	26.4				
Pb	64.2	65.4		72.4	57.3
