Nissan Task Force
Teleconference Meeting Minutes
July 23, 2009

1. The group reviewed the objectives of the task force.
 - a. Solve the mild severity shift problem
 - b. Ensure that the industry has enough calibrated stand capacity for GF5.

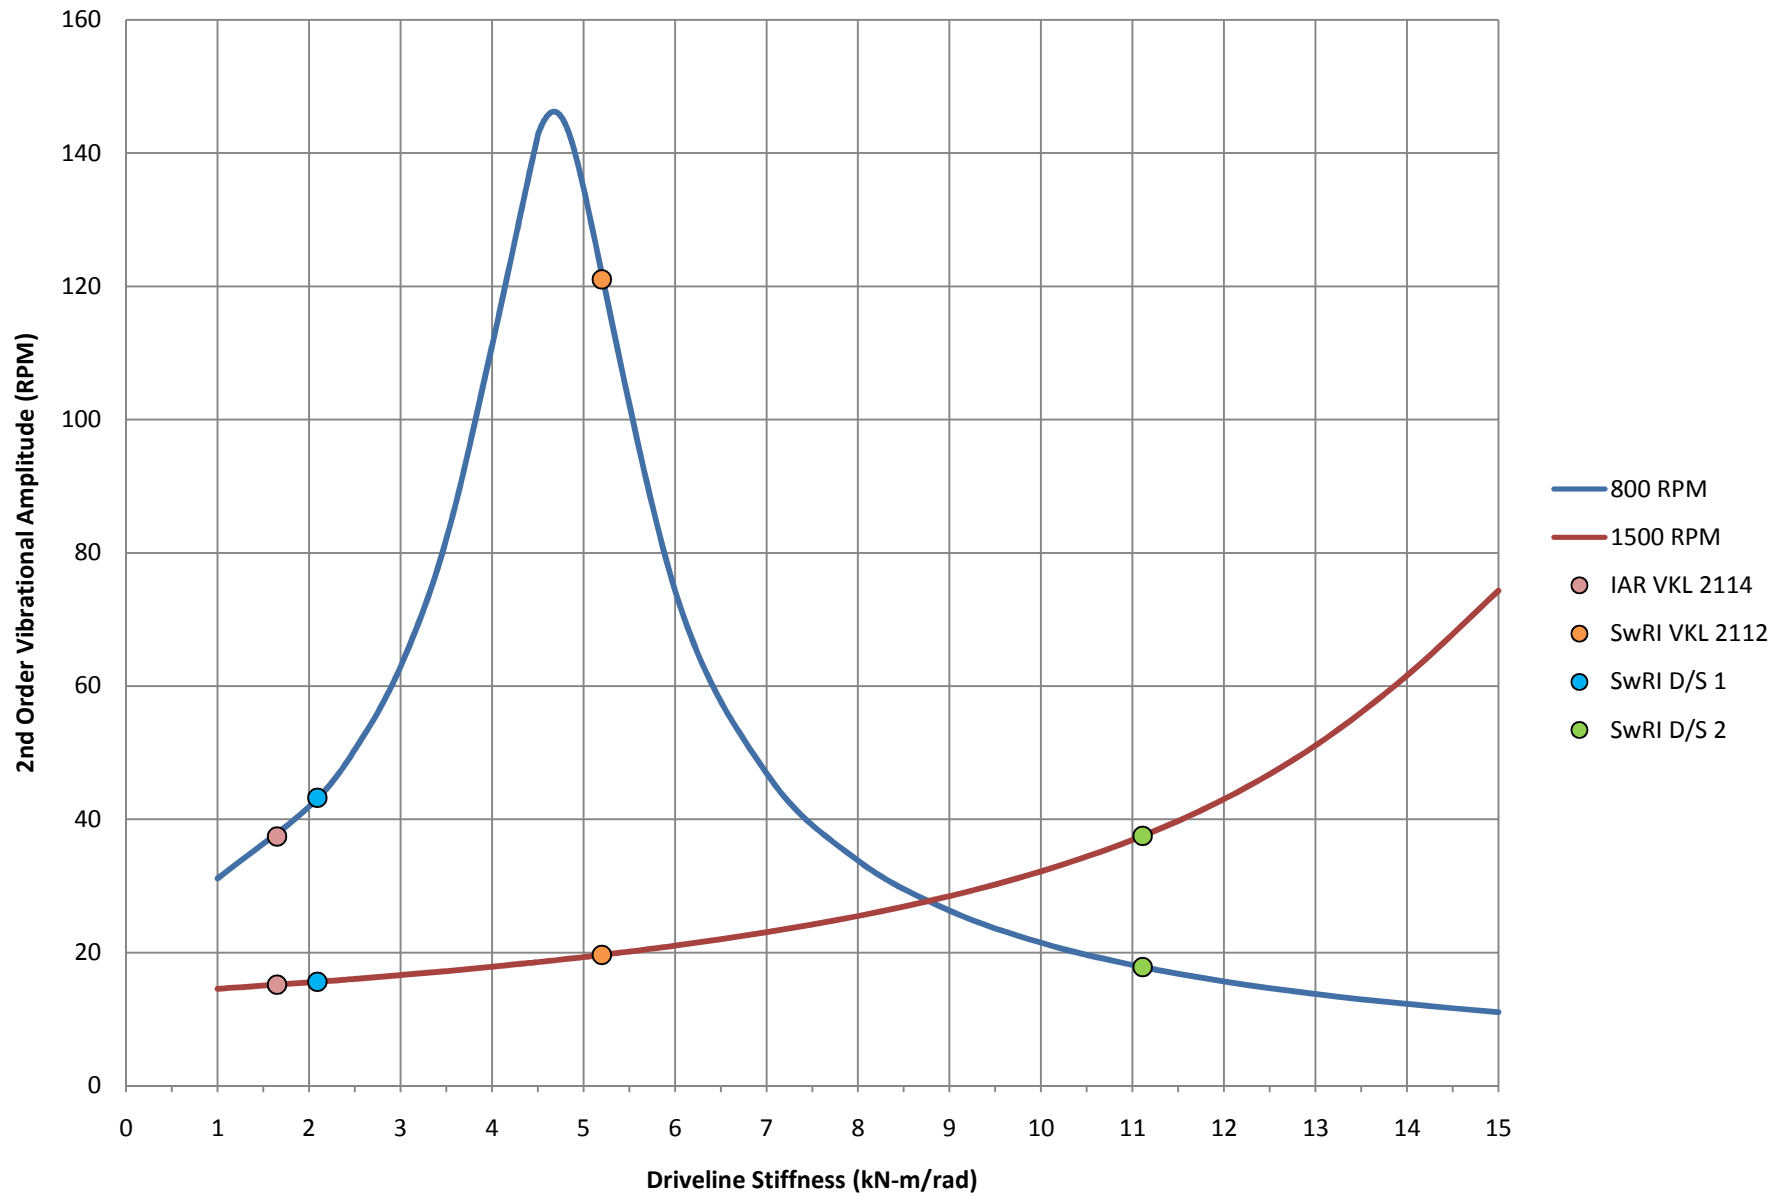
Vibrational Amplitude of Various Drivelines at 800 RPM and 1500 RPM

- c. LZ has 1 stand calibrated
 - d. Ashland has 1 stand available
3. In regards to the mild severity shift, there is strong data showing that driveline stiffness and engine mounting damping are the main contributing factors. SWRI has conducted several modeling experiments and correlated the stiffness levels to severity. At Intertek, the same effect was seen when switching from an undamped system to a damped system. In addition, the Intertek lab showed that failed mounts caused high levels of vibration and also contributed to a mild result. Eric Liu has provided us with the results of his modeling experiments (See Attachment 1) Eric stated that if the resonance point of the driveline system occurs at 800 rpm the test results will shift mild.
