# Sequence IV Surveillance Panel | MINUTES

<b>Relevant Test:</b>	Sequence IVA and IVB
<b>Note Taker:</b>	Chris Mileti
<b>Meeting Date:</b>	June 6 <sup>th</sup> through June 8 <sup>th</sup> , 2017
<b>Comments:</b>	Three day Sequence IV Surveillance Panel Meeting hosted by Intertek. The goal of this meeting was to develop a forward action plan for the Sequence IVB Test.

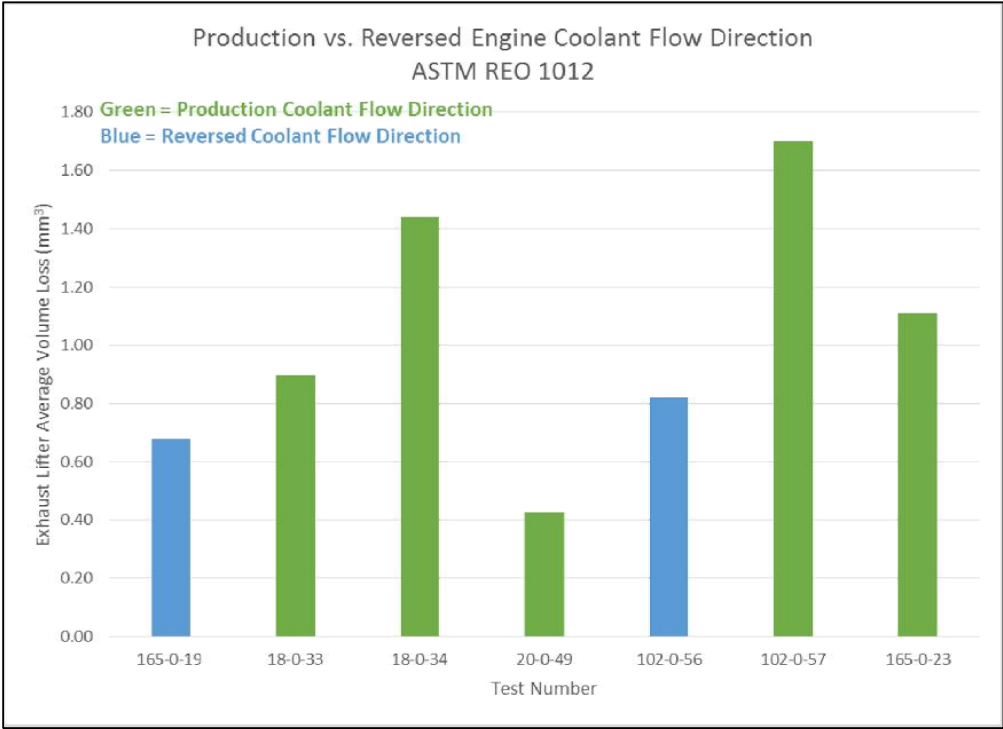
(a) Exhaust lifter wear continues to be highly variable.  
 (3) Chart 4 and Chart 5:

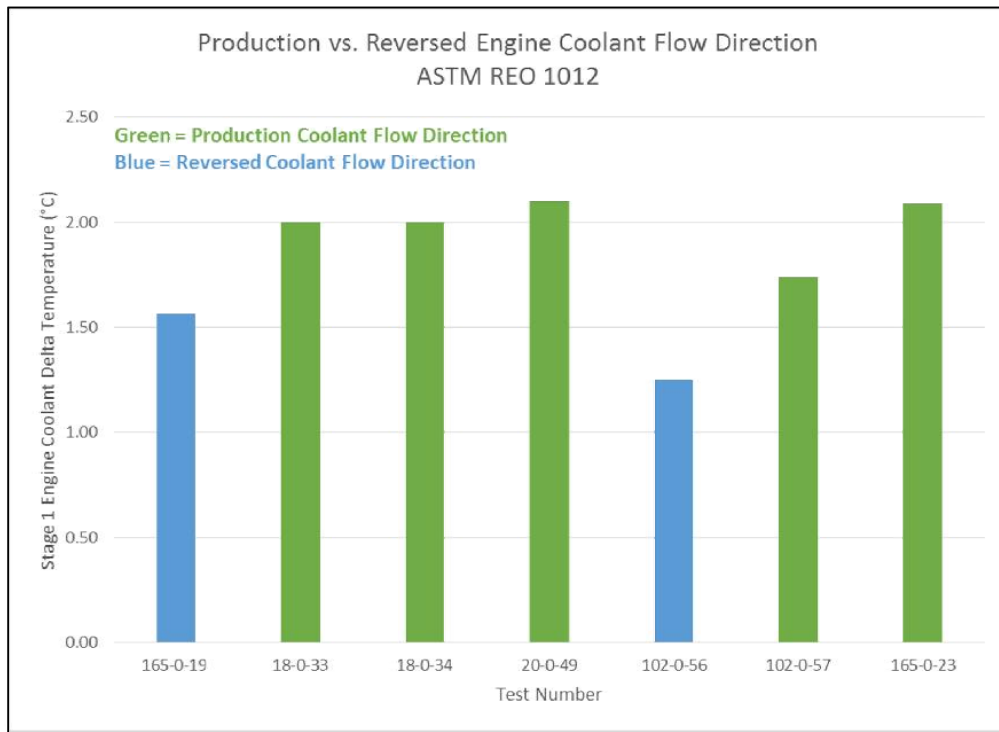
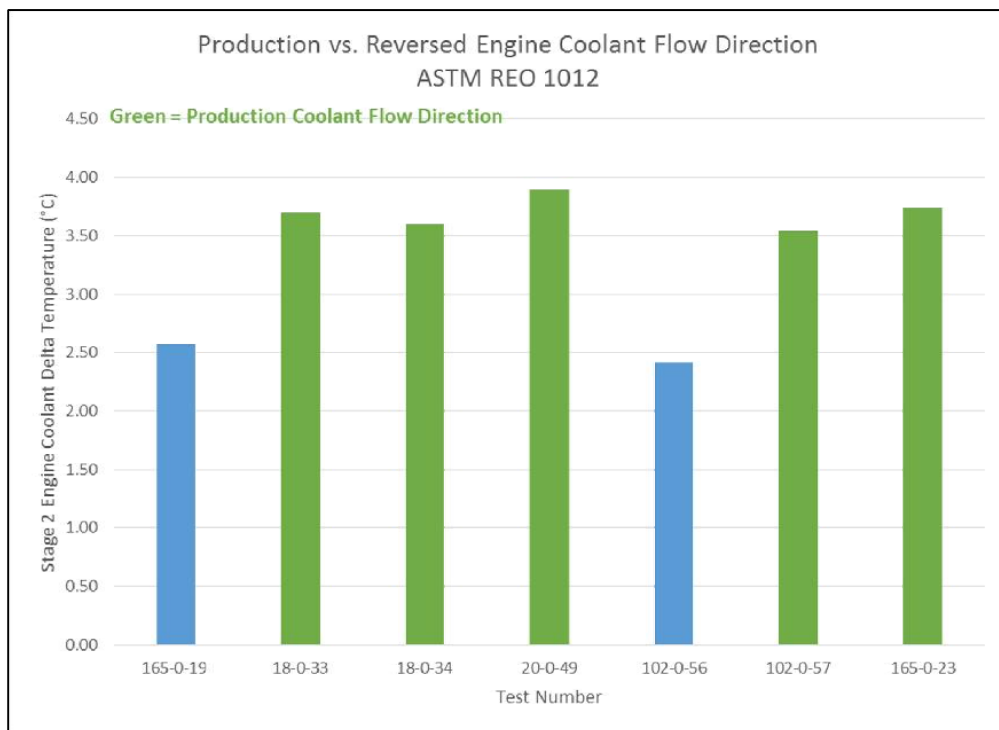
(a) The coolant temperature differential is clearly different between the two flow directions.
