# IVB Precision Matrix Follow-Up | MINUTES

<b>Relevant Test:</b>	Sequence IVB
<b>Note Taker:</b>	Chris Mileti
<b>Meeting Date:</b>	05-17-2017
<b>Lubrizol Attendees:</b>	Mileti, Brys, Matasic and O'Malley
<b>Comments:</b>	This meeting was scheduled to discuss the investigations that have taken place since the Precision Matrix was temporarily halted.

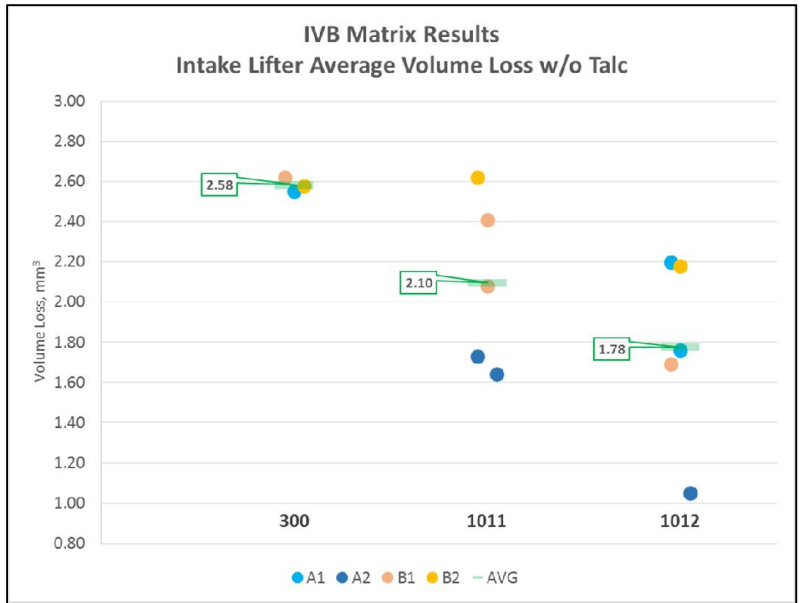
- (1) The results for REO300 are tightly clustered.
- (2) There originally appeared to be a significant amount of variability with REO1011.
  - (a) However, this "variability" may actually be the result of bias with one stand (Stand A2 in the chart below).

(b) The last two runs yet to be completed on Stand A2 are with REO300.

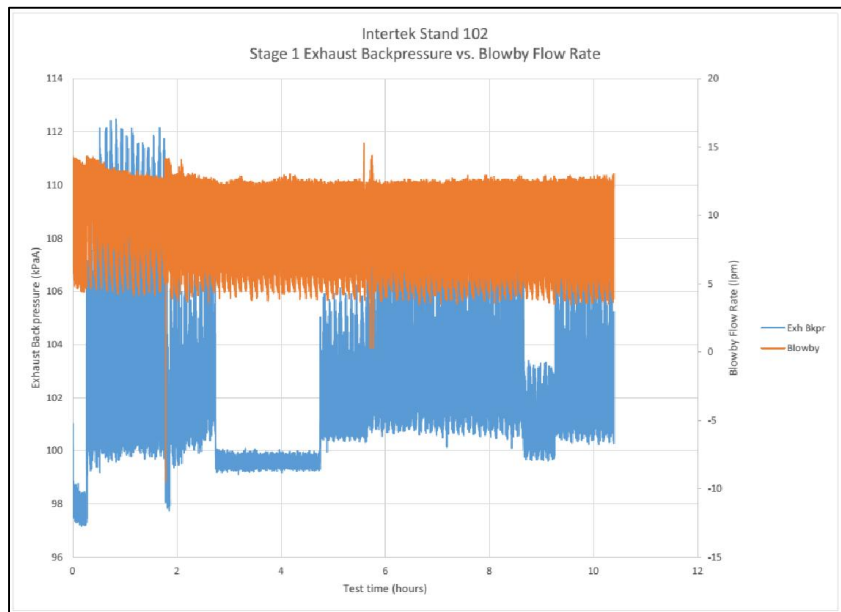
**ii) Exhaust Backpressure Experiment #1:**

- (1) Intertek did not find a correlation between exhaust backpressure and blowby flow.

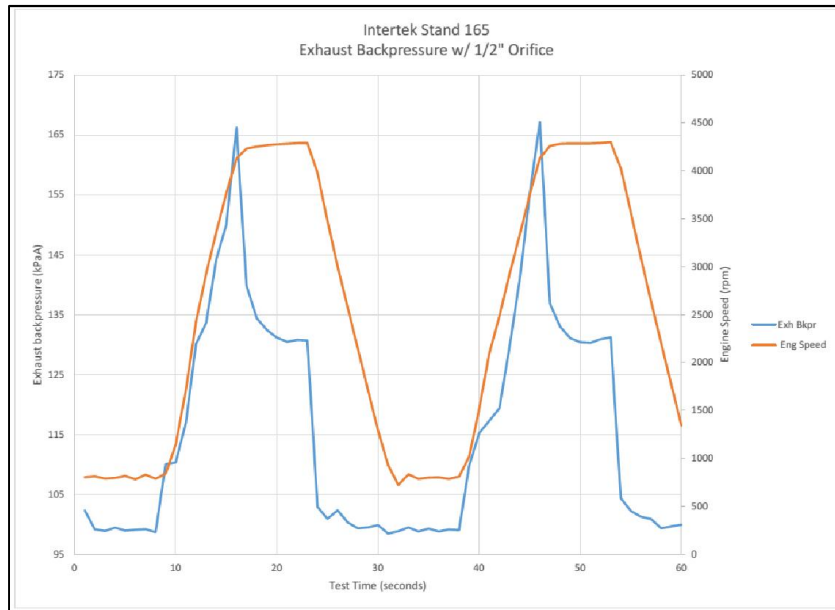
**iii) Exhaust Backpressure Experiment #2:**

- (1) The restrictor in the exhaust system did not help Stage 1 backpressure control.
  - (a) The orifice could not build enough pressure.
- (2) The restrictor actually made the Stage 2 backpressure control worse.

- iv) Intertek believes that the group should reconsider using a set point for the Stage 1 exhaust backpressure.
