## Caterpillar C13 Test Matrix Update

# C13 Test Status

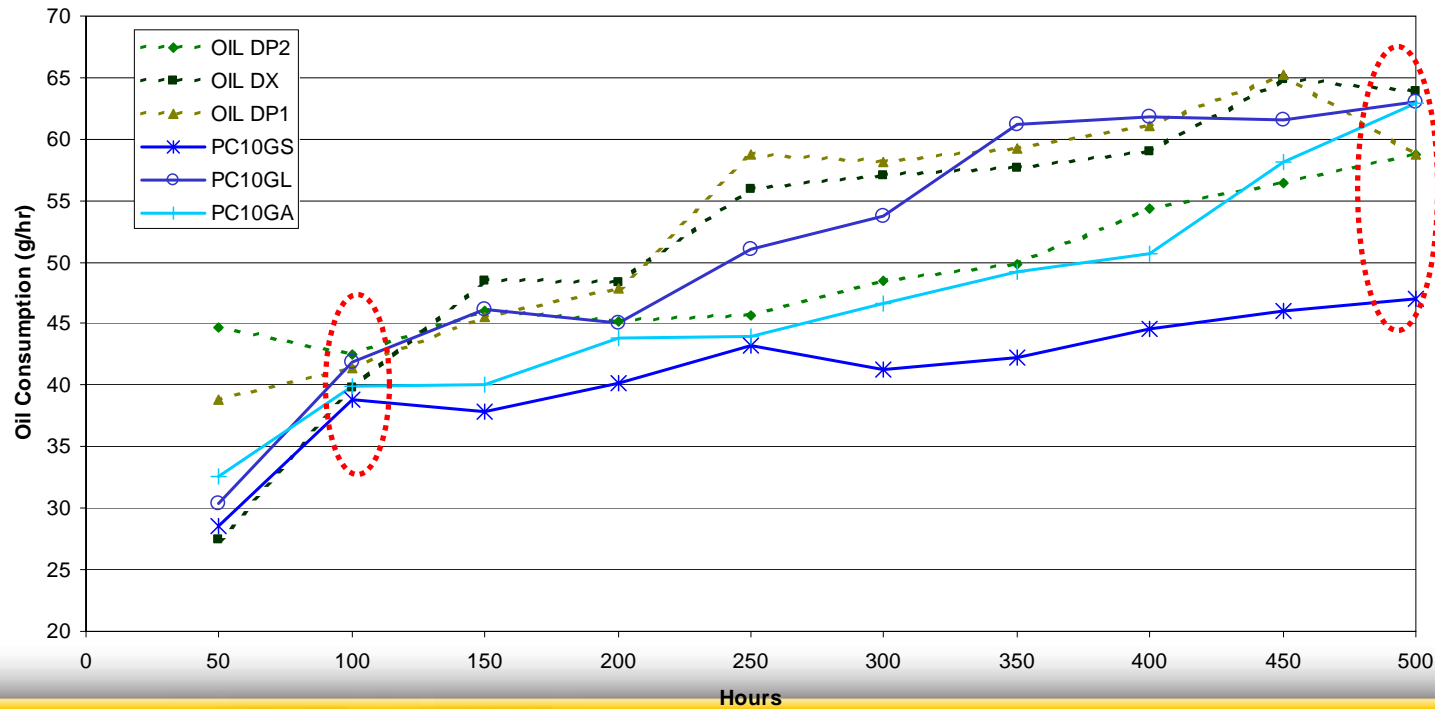
ATTACHMENT 3, 2 OF 9

1. Oil PC10G - 3 tests included in Matrix Completed
2. Oil PC10G Oil consumption repeats with Oil D tests
3. Averages of Oil Cons of Oil D and Oil G runs similar

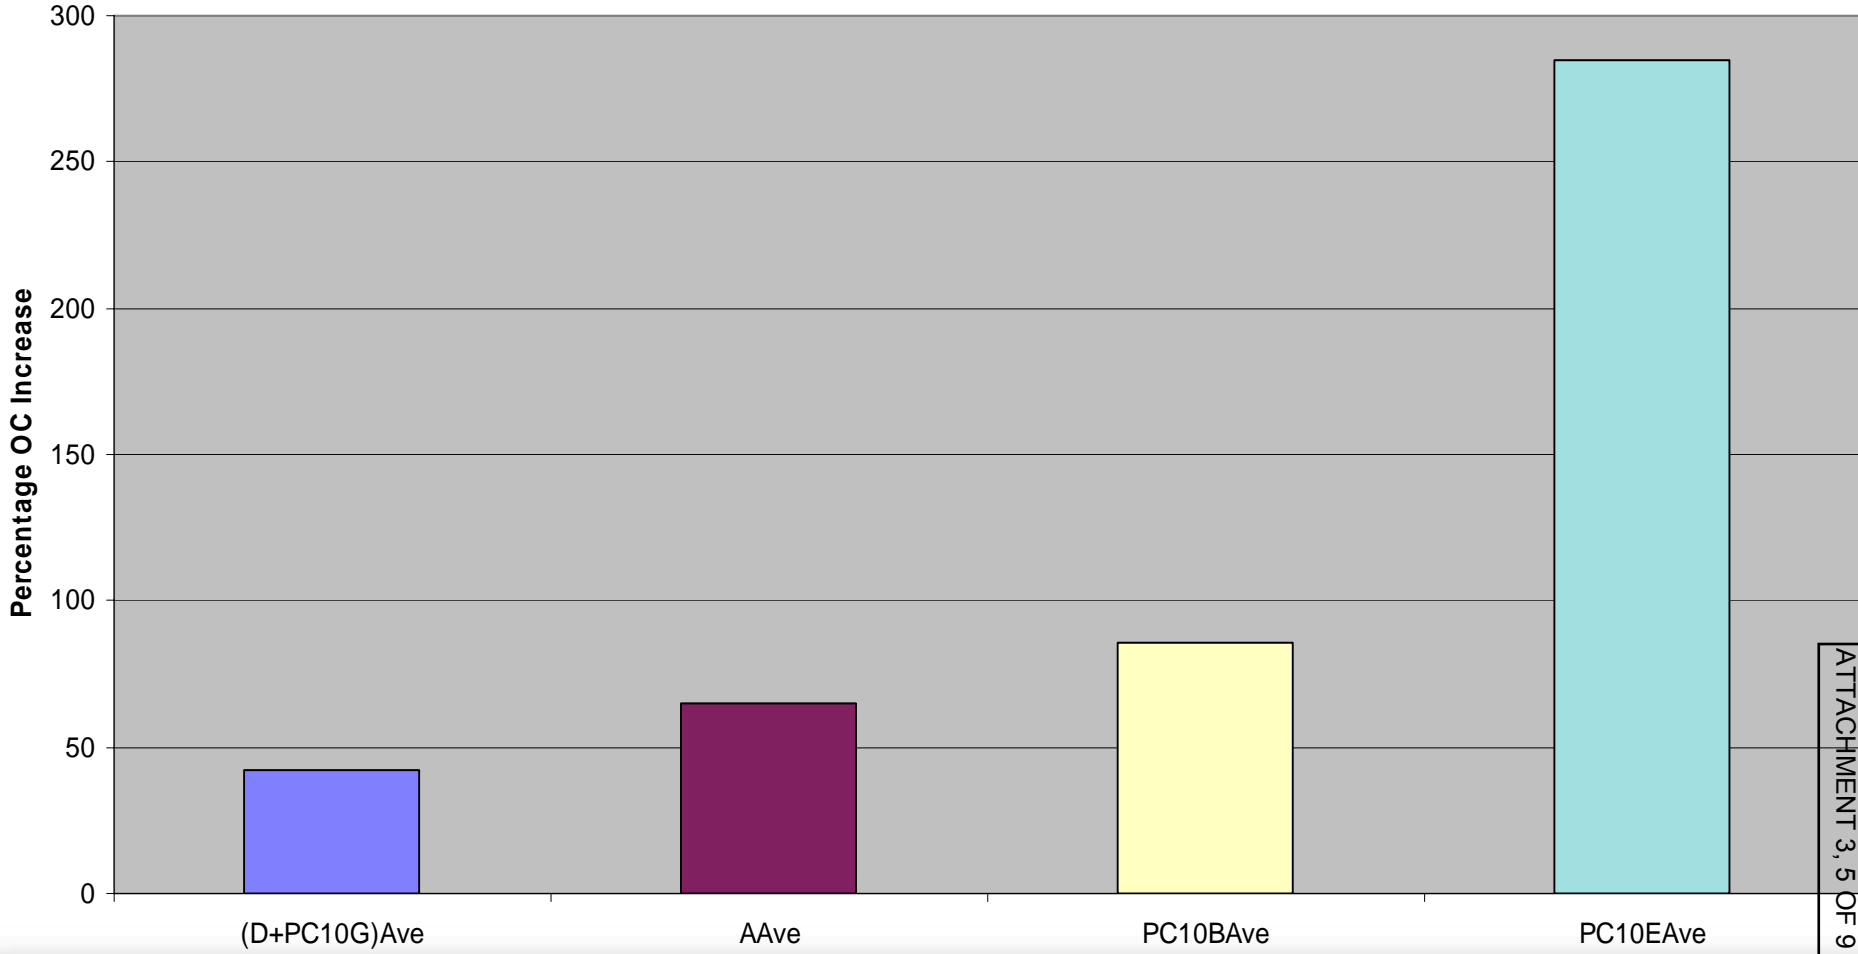
## C13 Percentage Oil Cons Increase

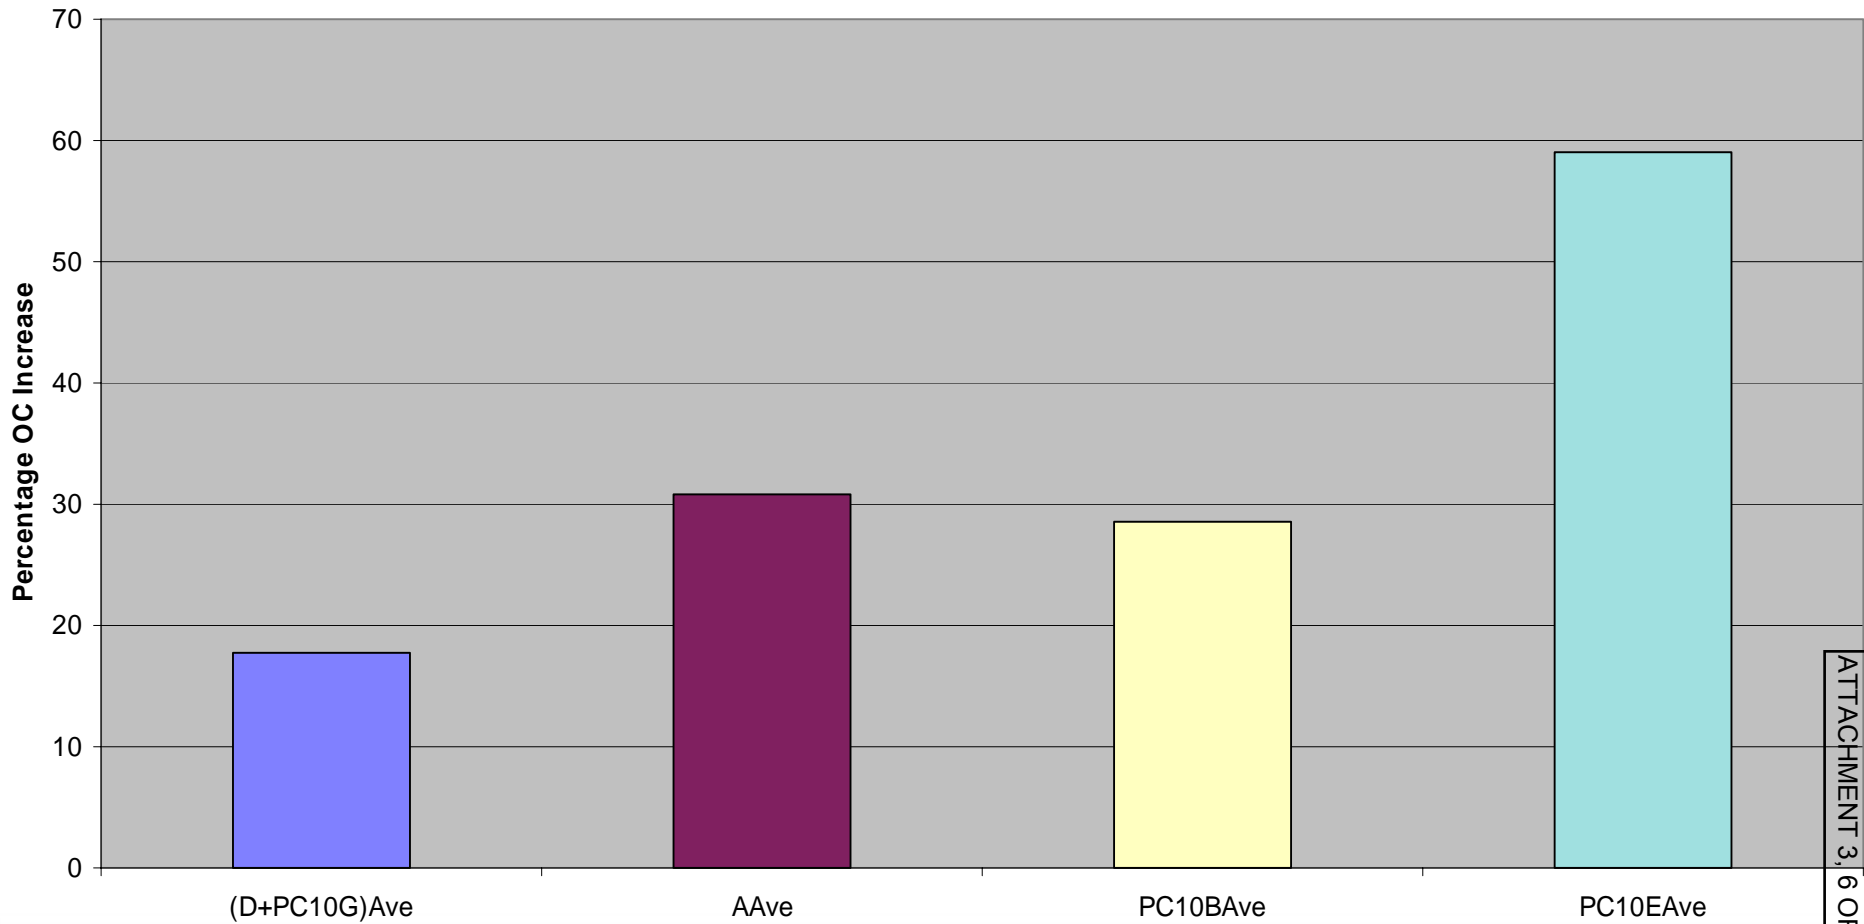
## C13 Delta Oil Cons (Increase)
