Volvo/Mack CPD Report T8/T11/T12/T13

Volvo/Mack CPD Report Contents

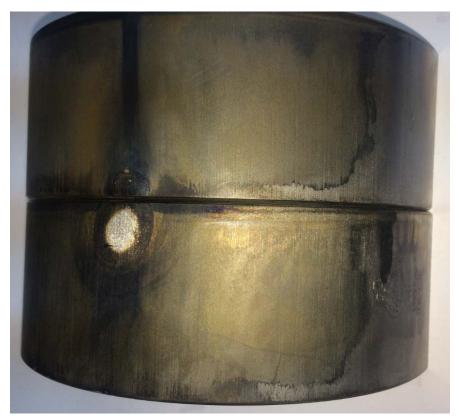
Volvo/Mack T11/T12 Main Bearings

- Batch "P" going into kits after Kit #182107
- Reject Rate of ~75%
 - Damaged backs
 - Scratches, nicks

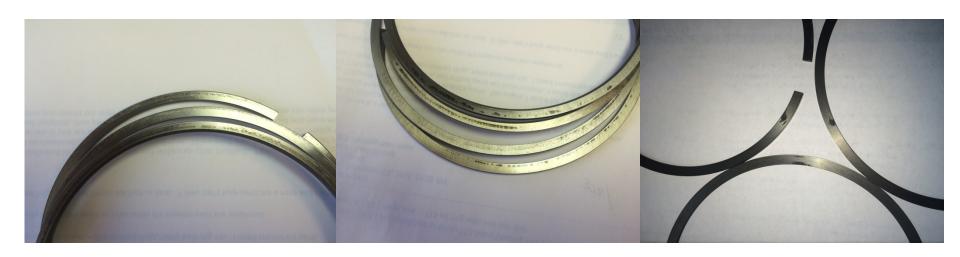
Volvo/Mack T12/T13 Stained Rings

- Receiving stained rings in both T12 and T13
- Oronite studied the rings
- Volvo/Mack says rings are "OK to use"

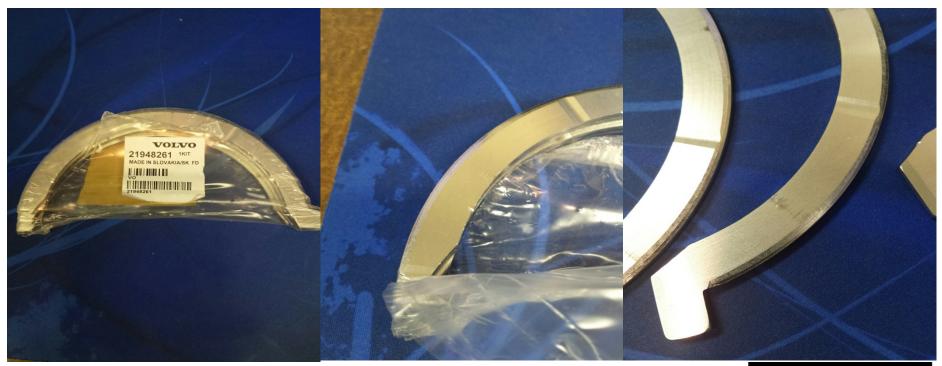
Volvo/Mack T13 Thrust Washers

Rejecting approximately 50% for nicks, dings or scratches

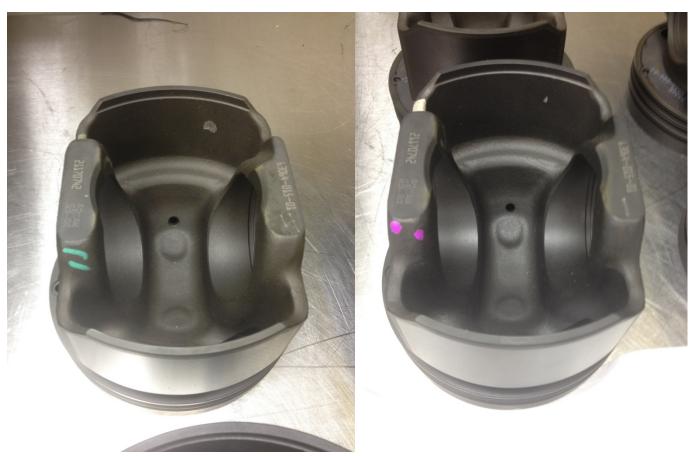
Volvo/Mack T13 Piston Oil Hole Chamfer

• 2 different piston oil holes
