Test Monitoring Center

MEMORANDUM: 06-074
DATE: October 9, 2006
TO: Don Bartlett, Chairman, L-37 Surveillance Panel
FROM: Donald Lind
SUBJECT: L-37 Reference Test Status from April 1, 2006 through September 30, 2006

The following is a summary of the L-37 reference oil tests that were reported to the Test Monitoring Center during the period April 1, 2006 through September 30, 2006.

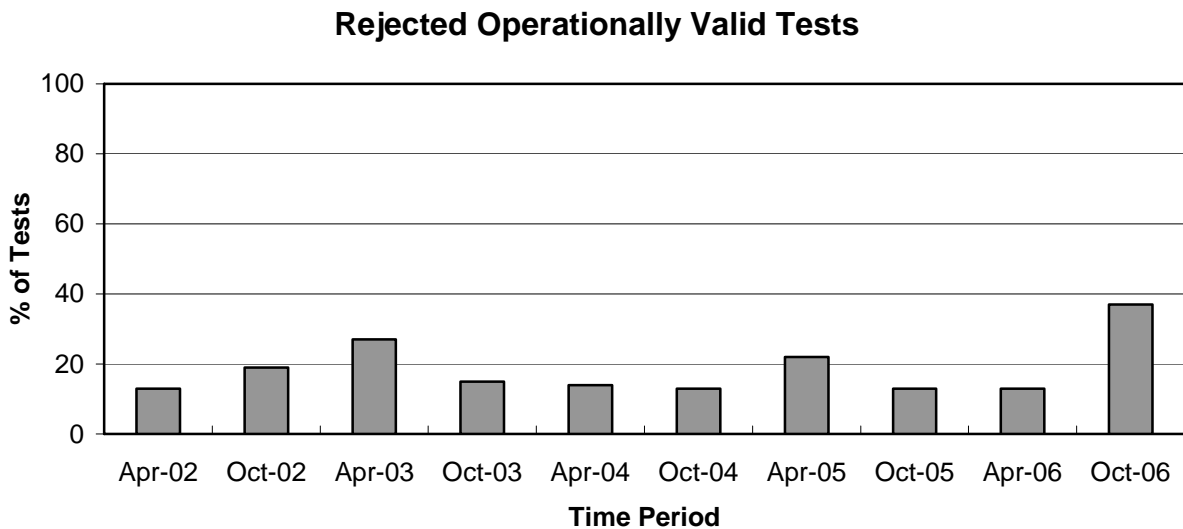
The operationally valid statistically rejected test rate, as shown below, indicates an increase with respect to the previous period. The increase is influenced by one lab (Lab B). Lab B had 6 of the seven statistically rejected tests.

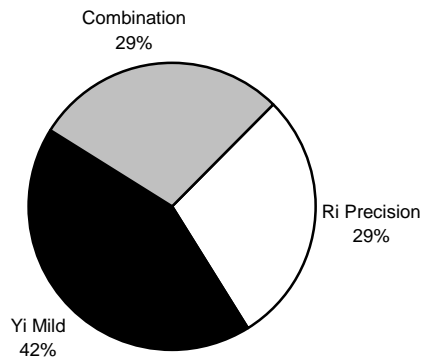
Distribution of LTMS Stand Alarms

A detailed list of reasons tests failed the acceptance criteria is shown in Table 1. The following charts summarize these reasons with a breakdown by parameter of the failed tests.

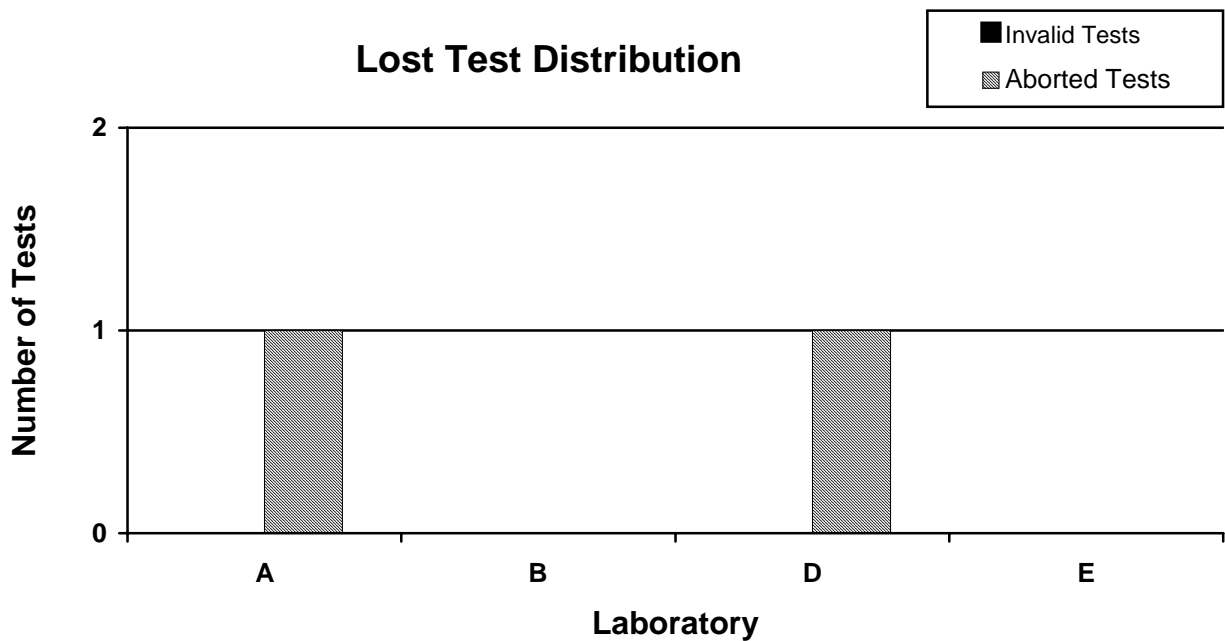
The laboratory distribution of lost tests is shown below. A detailed list of reasons for tests declared operationally invalid or aborted is shown in Table 2.

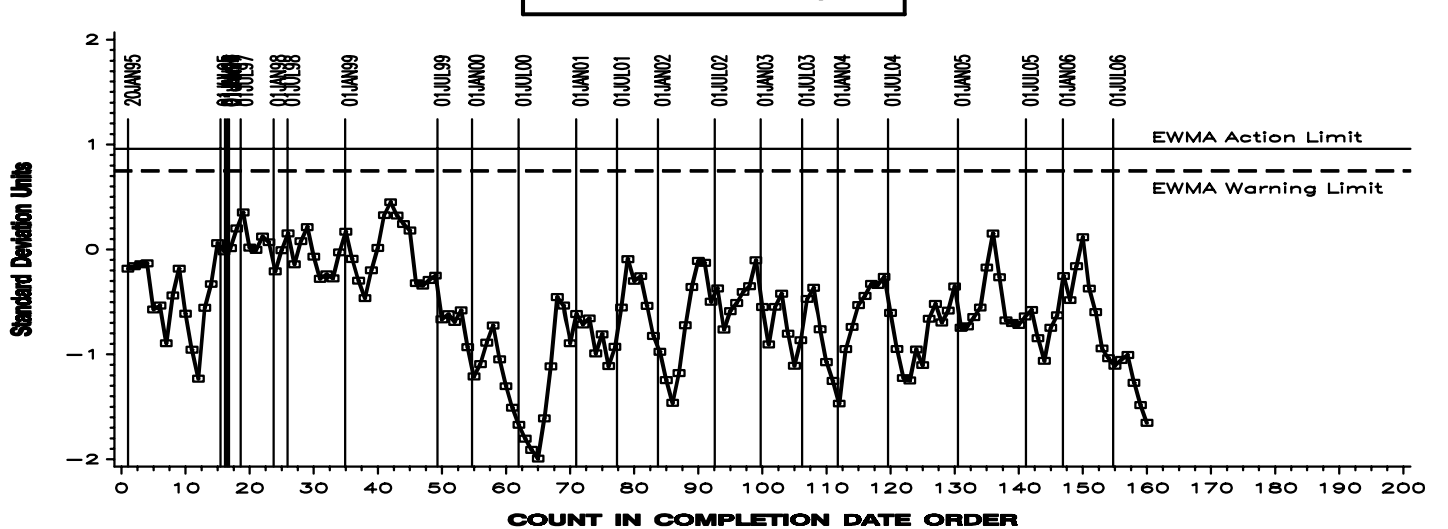
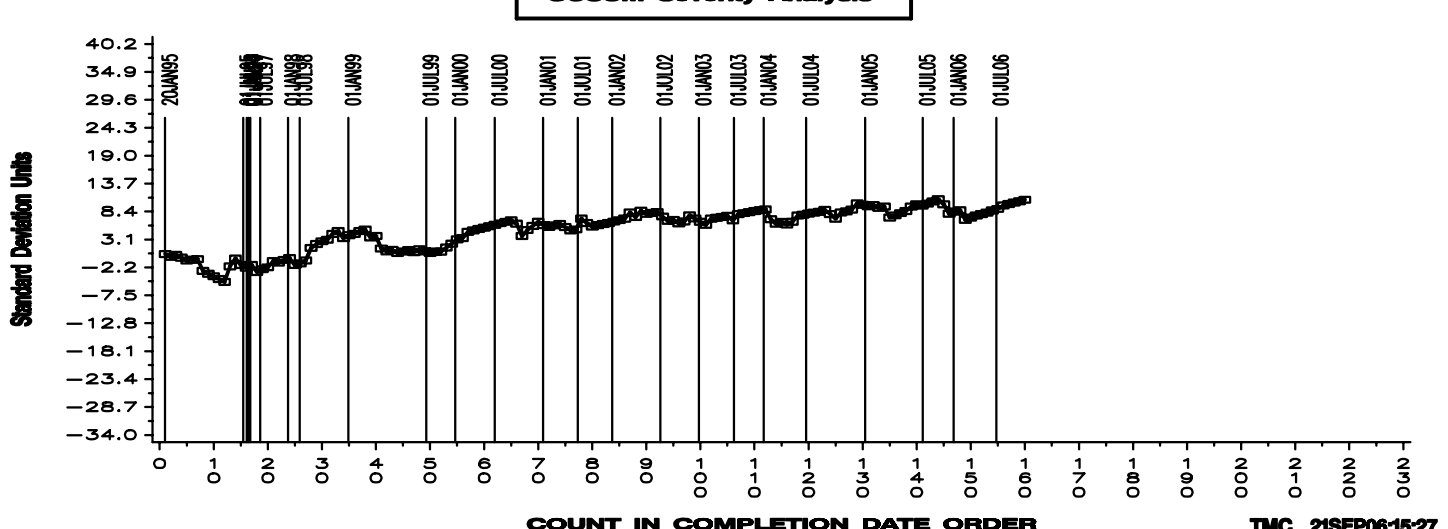
FINAL PINION GEAR WEAR

Figure 1 is the Industry Control Chart for Pinion Wear (Lubrited Hardware)

L-37 LUBRITED INDUSTRY OPERATIONALLY VALID DATA

Figures 1 through 4 are the lubrited industry control charts for pinion Wear, Rippling, Ridging, and Pitting/Spalling, respectively. Figures 5 through 8 are the lubrited industry control charts of the last 20 test results for pinion Wear, Rippling, Ridging, and Pitting/Spalling, respectively. Severity and precision EWMA charts for pinion Wear, Ridging, and Pitting/Spalling were in control this report period. Rippling triggered one severity EWMA warning alarm. The alarm does not appear to be related to any one lab, stand, or reference oil.

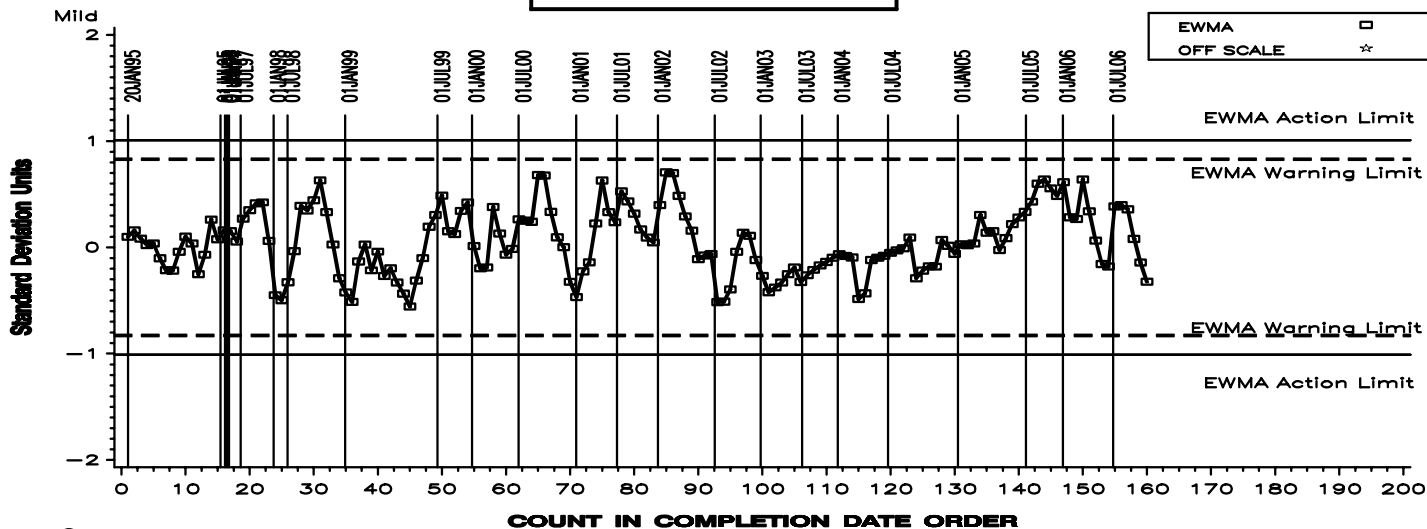
FINAL PINION GEAR PITTING/SPALLING

Figure 4 is the Industry Control Chart for Pinion Pitting/Spalling (Lubrited Hardware)

L-37 LUBRITED INDUSTRY OPERATIONALLY VALID DATA

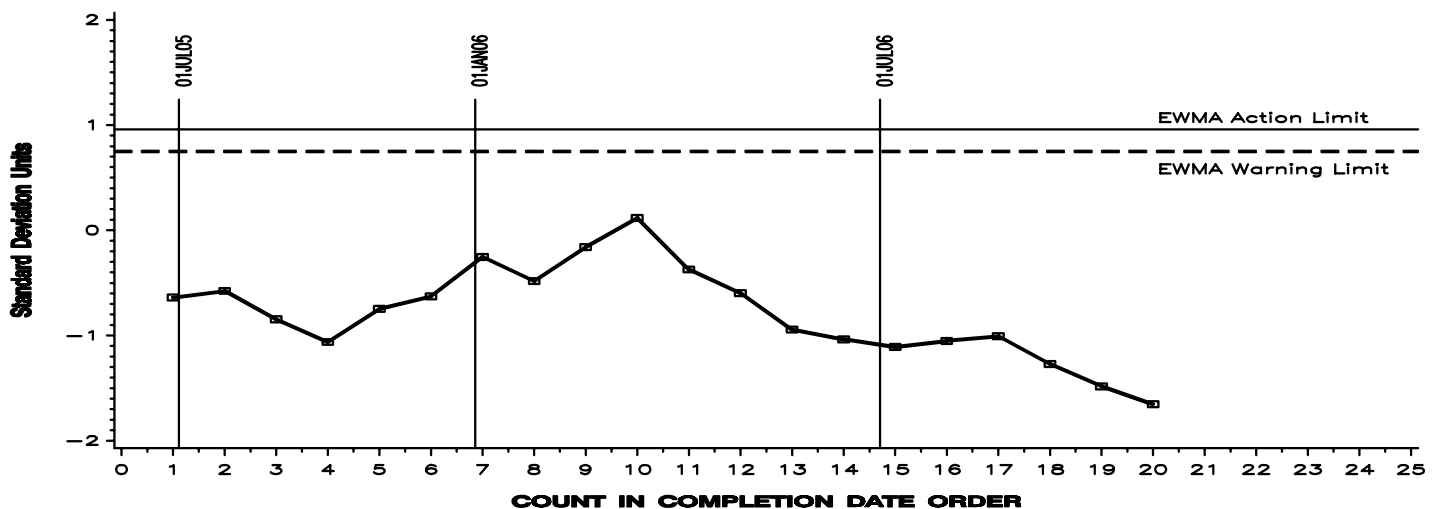
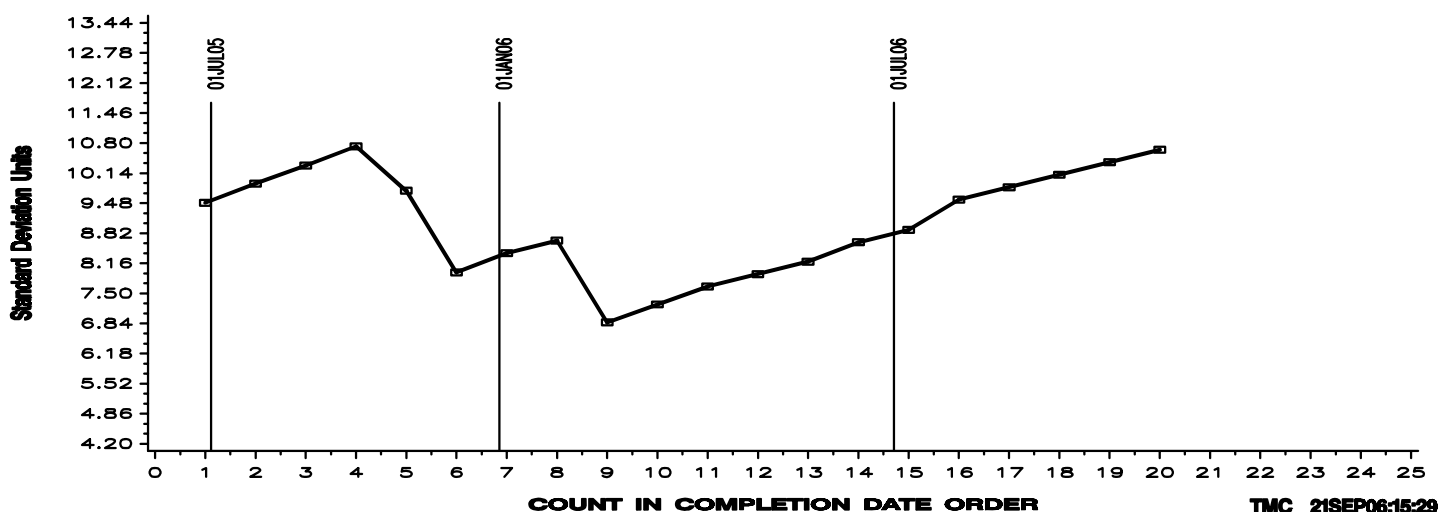
FINAL PINION GEAR WEAR

Figure 5 is the Industry Control Chart of the last 20 test results for Pinion Wear (Lubrited Hardware)

L-37 LUBRITED INDUSTRY OPERATIONALLY VALID DATA

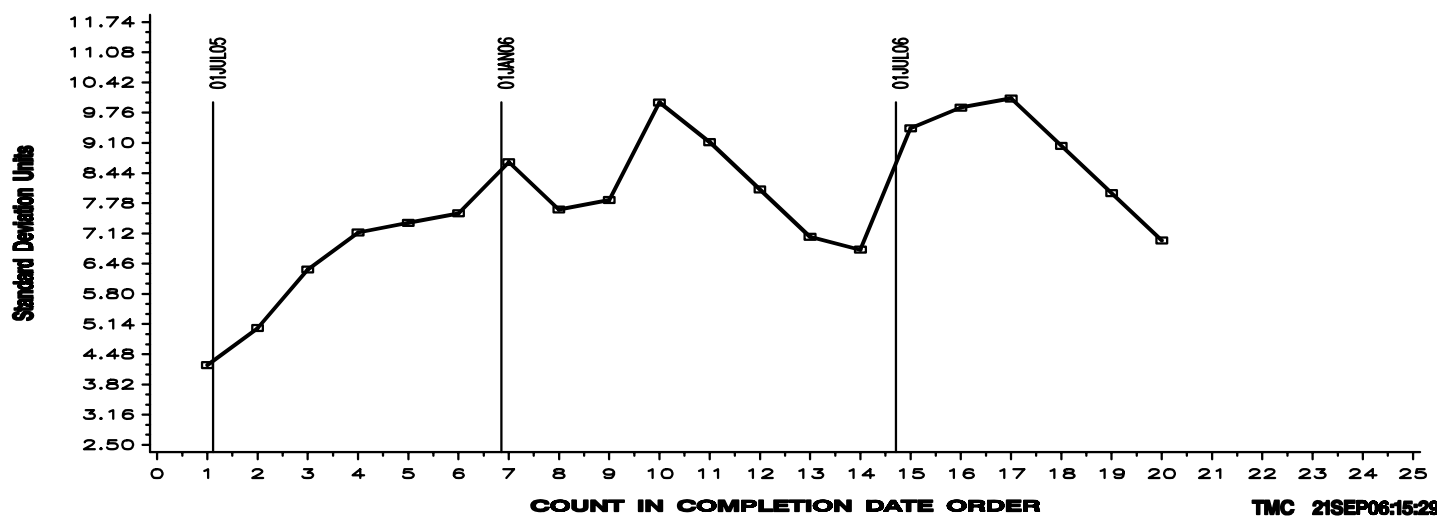
Figure 8 is the Industry Control Chart of the last 20 test results for Pinion Pitting/Spalling (Lubrited Hardware)

L-37 LUBRITED INDUSTRY OPERATIONALLY VALID DATA

FINAL PINION GEAR PITTING/SPALLING

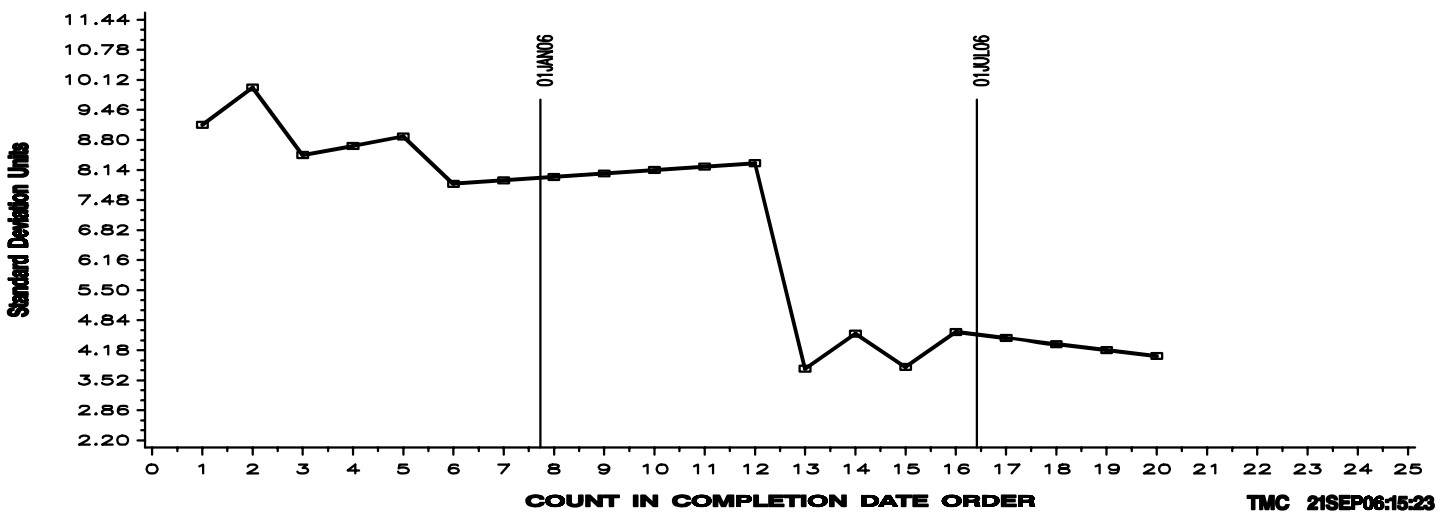
Last 20 Test Results FINAL PINION GEAR PITTING/SPALLING

Figure 16 is the Industry Control Chart of the last 20 test results for Pinion Pitting/Spalling (Non-Lubrited Hardware)

L-37 NONLUBRITED INDUSTRY OPERATIONALLY VALID DATA

Figures 9 through 12 are the non-lubrited industry control charts for pinion Wear, Rippling, Ridging, and Pitting/Spalling, respectively. Figures 13 through 16 are the non-lubrited industry control charts of the last 20 test results for pinion Wear, Rippling, Ridging, and Pitting/Spalling, respectively. Severity and precision EWMA charts for pinion Wear, Ridging, and Rippling were in control this report period. Pitting/Spalling triggered one severity EWMA warning alarm. The alarm does not appear to be related to any one lab, stand, or reference oil.
